# 33<sup>RD</sup> RCI INTERNATIONAL CONVENTION AND TRADE SHOW

## WATERPROOFING AND INTEGRATION OF EXPOSED AIR HANDLING UNIT (AHU) CLADDING WITH THE BUILDING ENVELOPE

DAVID P. MARKMAN, PE

DANIEL GIBBONS, PE

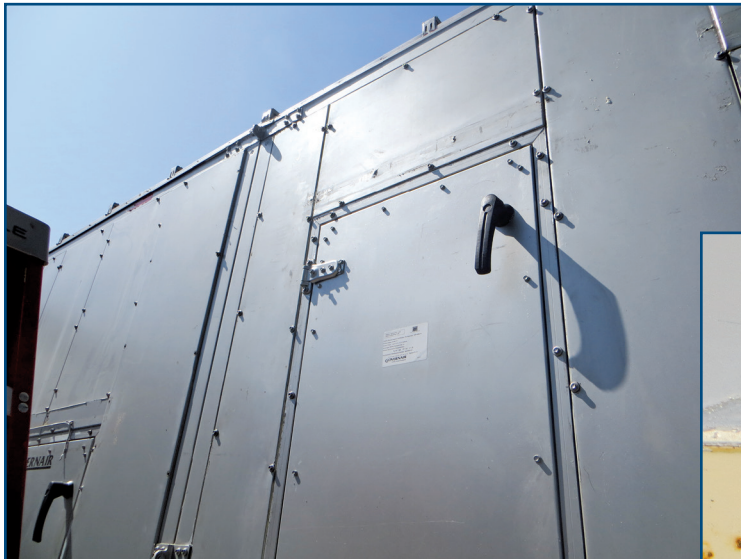
The majority of AHUs are constructed of insulated metal wall panels. This typically takes the form of a metal skin infilled with spray polyurethane foam or fiberglass batt insulation. The metal wall panels typically are back-sealed to an interior frame with a compressed foam gasket and have a bulk water exterior-applied sealant joint placed between them as shown in *Figures 1* and *2*.

**Figure 1 – Metal wall panel construction.**

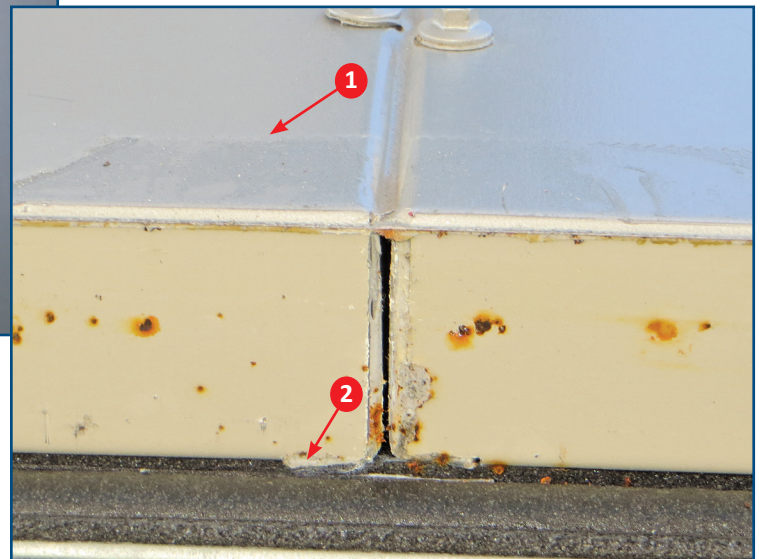
The industry standard for minimum sealant bond line and sealant joint width is 6 mm. As you can see in *Figure 2*, the joint width does not meet this requirement. The sealant joint shown in *Figure 2* acting as the primary weather seal would

**Figure 2 – Sealant joint (1) between metal wall panels and foam gasket (2).**

not be acceptable on the building envelope and should not be acceptable on an AHU that is now acting as a component of the building envelope. On many AHUs, this is just a bulk water diverting seal. However, at this size, the joint does not have the same performance as a joint designed per industry standards. In the above case, the wall panel returns are break metal with the edges butted together. The joint does not incorporate welded corners. Interior fillet sealants are installed at the factory. To speed construction, the wall panels are also fastened to the unit in the factory. This makes portions of the primary weather seal unavailable for field verification. Wall panel construction and similar joints are common across the industry. When identifying paths of water intrusion, the wall panel construction can be a common component of the path.

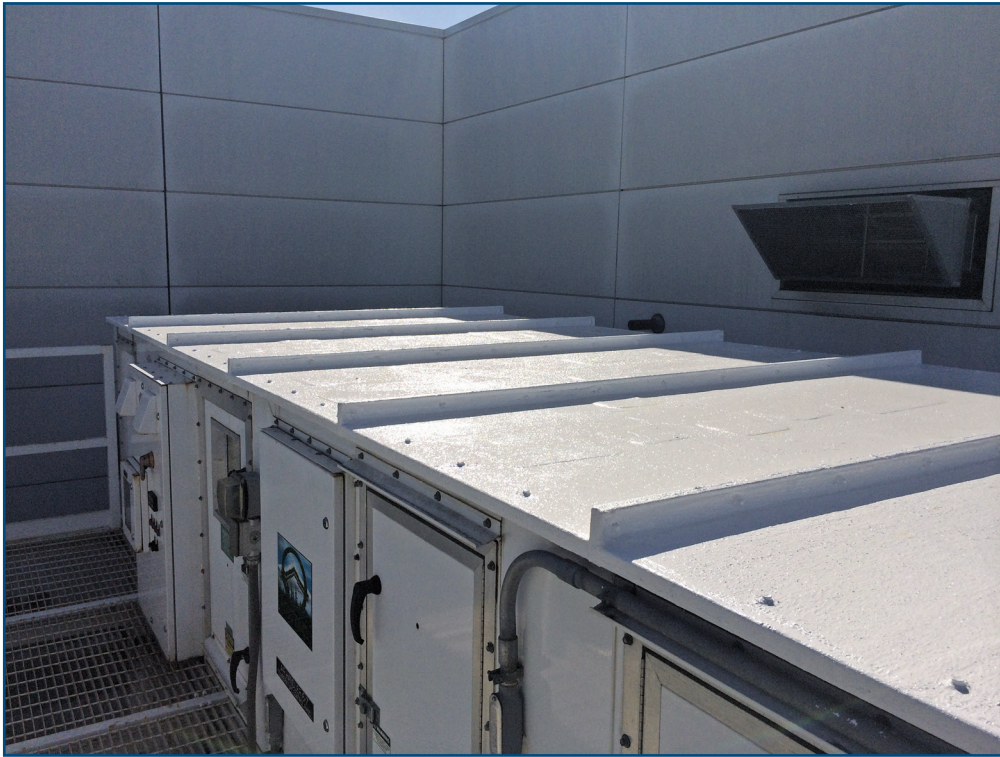
**Figure 3 – Single-direction roof slope.**

On the majority of the authors' projects, the AHU is rectangular in cross section, with the top of the unit level. To address the concern of ponding water, a sloped roof is typically constructed on top of the flat top-of-unit. Depending on the width of the unit, this sloped roofing section can have single-direction slope, as shown in *Figure 3*, or a single roof ridge with two directions

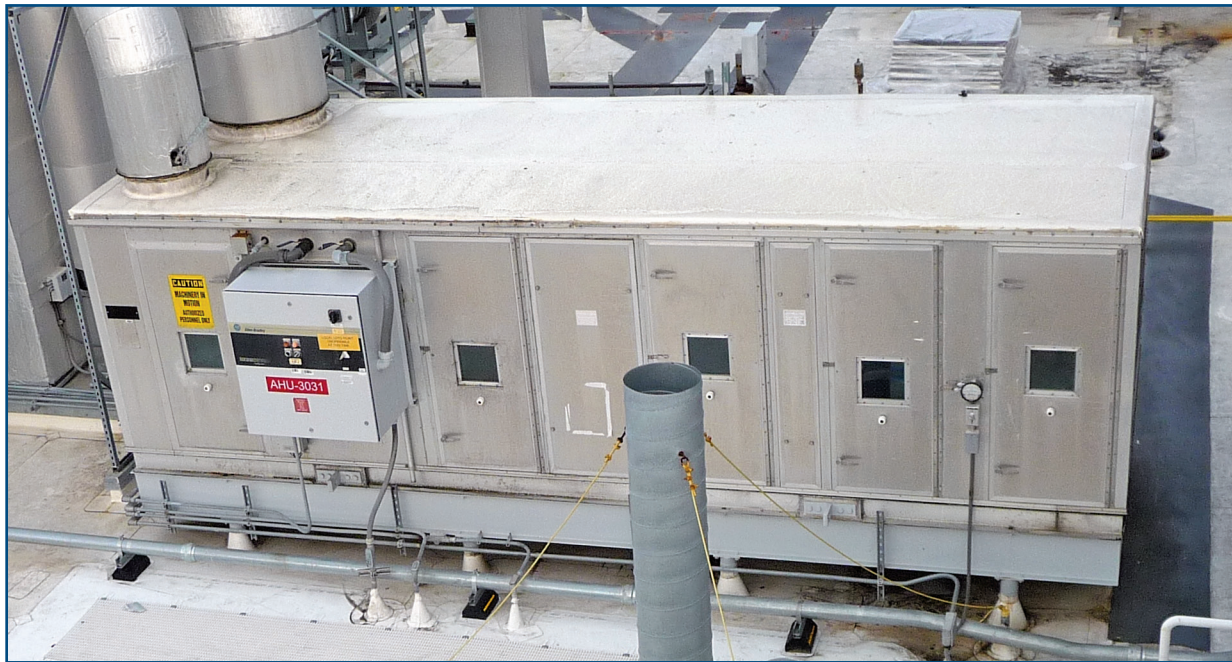
**Figure 4 –  
AHU mounted  
on posts.**

**Figure 5 –  
Close-up of  
unit mounted  
on posts.**

As shown in *Figures 4 and 5*, with the unit mounted on posts, the contractor can install the roof membrane under the AHU. In this way, the only discontinuities introduced in the building envelope are the posts and any potential ductwork under the unit. Depending on where the AHU exhaust and supply ducting are routed, any duct openings that occur below the AHU will still require curbs; however, the overall discontinuity created by the AHU is reduced. In our review of five projects, the surface area of these discontinuities can be as little as 5% of the typical footprint plan area of the unit. Installing the unit on posts as shown in *Figure 5* effectively removes the rooftop AHU from the building envelope. The AHU becomes an isolated piece of rooftop equipment whose function as equipment will continue to have an effect on the building, but its impact on the building envelope is reduced. In addition to reducing the impact of the AHU on the building envelope by extending the building envelope continuously under the AHU, the ponding and roof slope cricketing is avoided because water can flow directly under the units. Complete reroofing does require the space below the unit to be tall enough to facilitate construction. These tangible benefits to the building do come with some drawbacks. The cost of posts is often higher than the cost of curbs. Additionally, the installation of the posts can take longer than the installation of curbs.

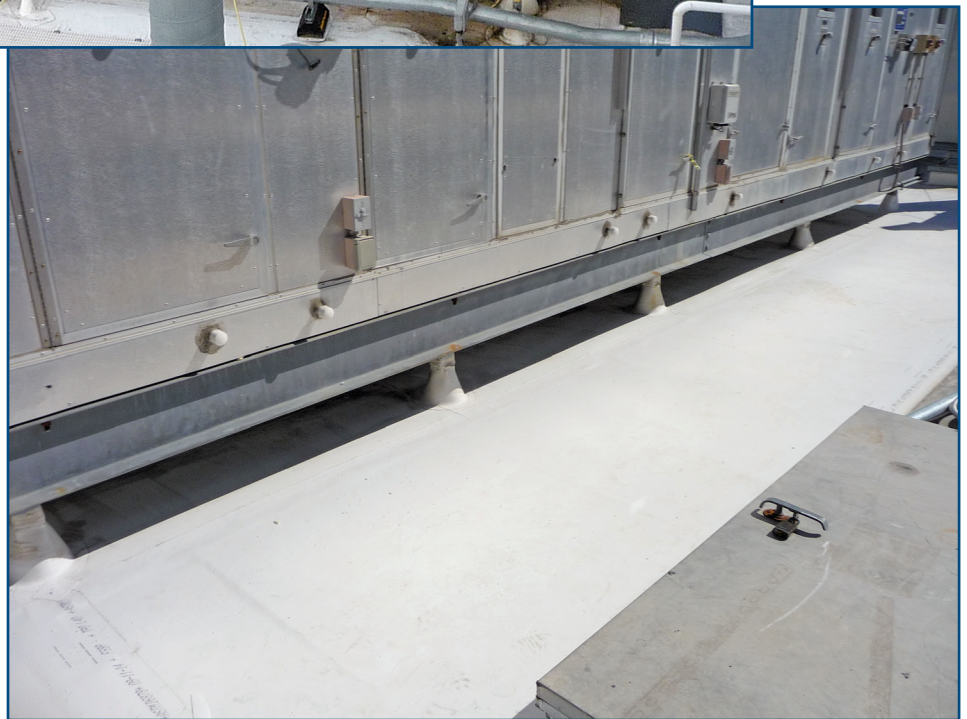
The most common method of transitioning from the building envelope to the AHU envelope is to place the AHU on a curb. The roofing membrane terminates at the top of the curb, and the AHU is placed above. The AHU now becomes a component of the building envelope, and the continuity of the building envelope must be maintained. Commonly, the AHU has a perimeter structural base frame taking the form of a structural C-channel (*Figure 5*). If the unit comes in one single section, joints in the C-channel can be fully welded in the factory. This maintains the continuity of the building envelope. If the unit comes in multiple sections, the joint where sections come together is often referred to as the demount joint. Joints in the perimeter structural support—either at demount joints or joints in the structural support—should be sealed. However, this may not occur. This is primarily due to the AHU manufacturer’s installation of a sheet metal counterflashing that extends from the AHU wall down over the structural channel and counterflashes the roof membrane termination. If this flashing is installed in the factory, then this flashing will be discontinuous at the demount lines and will prevent sealing of the perimeter structural support joints. Water can still bypass this flashing—either through unsealed laps in the flashing or by

wind-driven rain passing up and under the bottom of the base-of-wall flashing. An alternative to providing a continuously welded or sealed structural channel is to extend the roof membrane to the top of the C-channel and integrate it to the base of the wall panels with a sheet metal Z-flashing or liquid-applied self-terminating membrane.

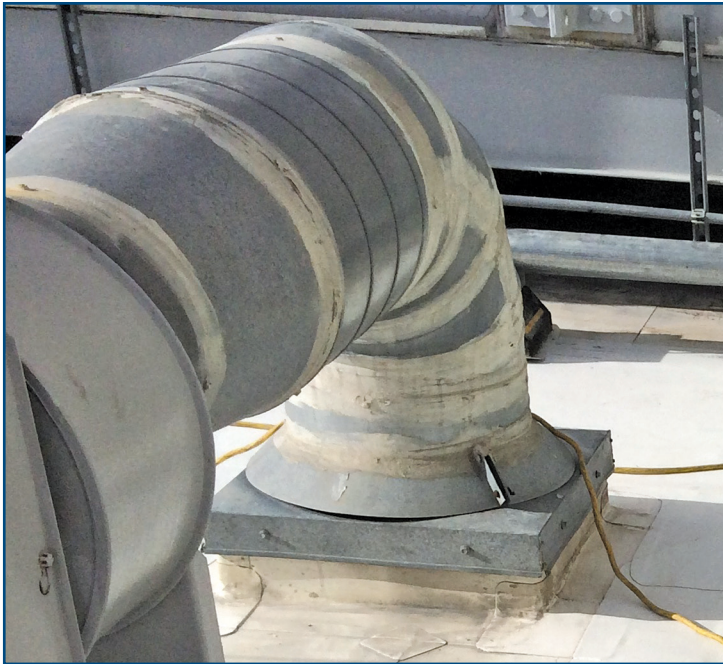
**Figure 6 – Typical duct penetration.**

building. The intake and exhaust ducts that connect the AHU to the building can occur directly below the unit or they can duct to the sides of the unit and enter the building away from the AHU. Care must be taken with these duct penetrations, similarly to all other rooftop penetrations. The duct penetration is typically offset from the top of the roof by placing the duct on curbs (*Figure 6*).

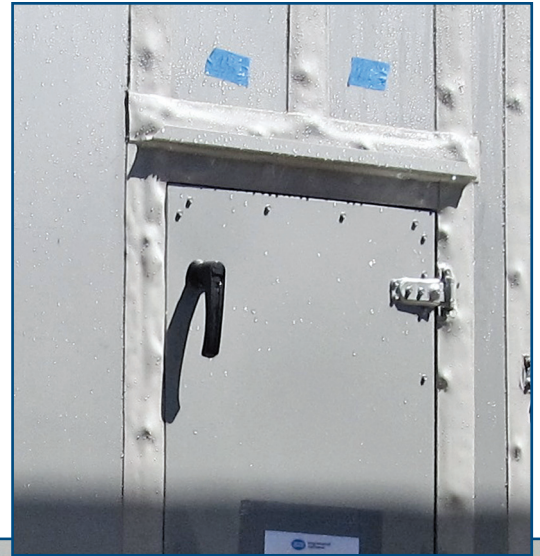
**Figure 7 – Using an ASTM E1105 spray rack to test base of unit flashing.**

The authors were called in to assist a building owner during construction. Construction was nearly complete. The building had rooftop-mounted AHUs. These units were recently installed, and during the first rain event, water was observed within the interstitial space below the units and within the occupied space on the floor below. Additional investigation after the initial event found water within the AHU unit and within the insulated metal wall panels. The following investigation discovered water intrusion through portions of the AHU wall assembly, door assemblies, and standing seam metal roofs. The integration of the unit to the primary roof membrane was tested and performed appropriately. After the investigation, repair procedures were agreed upon that required installing preformed silicone tape over all exterior joints in the unit roofs and walls (*Figure 8*).

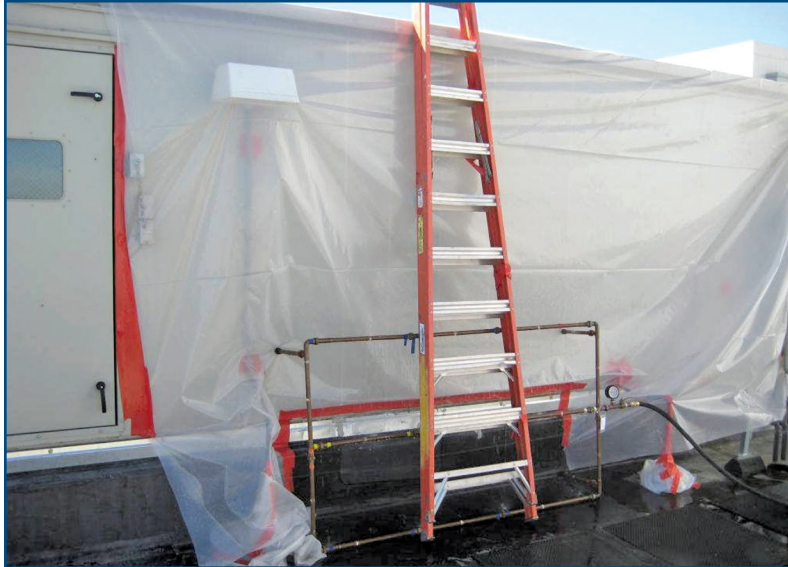
**Figure 8 – Preformed silicone tape over all joints in AHU.**

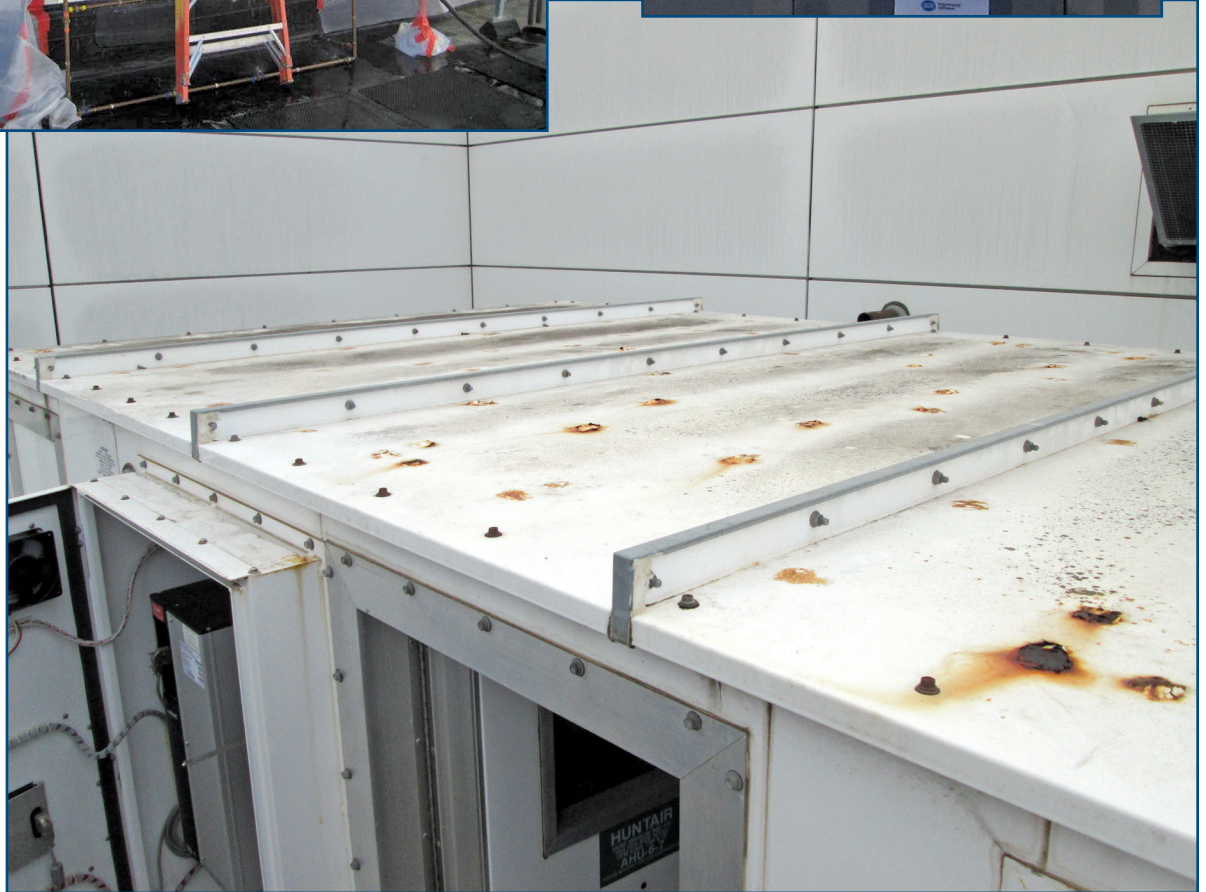
As shown in *Figure 9*, this rooftop AHU showed significant corrosion on top of the standing seam metal roof. The combination of water ponding and a marine environment were the primary sources of corrosion. However, other units on the same building, exposed to a similar environment and of a similar vintage, did not exhibit this corrosion. This was primarily an anti-corrosion coating failure, and the repair was to re-coat the standing seam metal roof.

**Figure 9 – Coating failure on metal roof.**

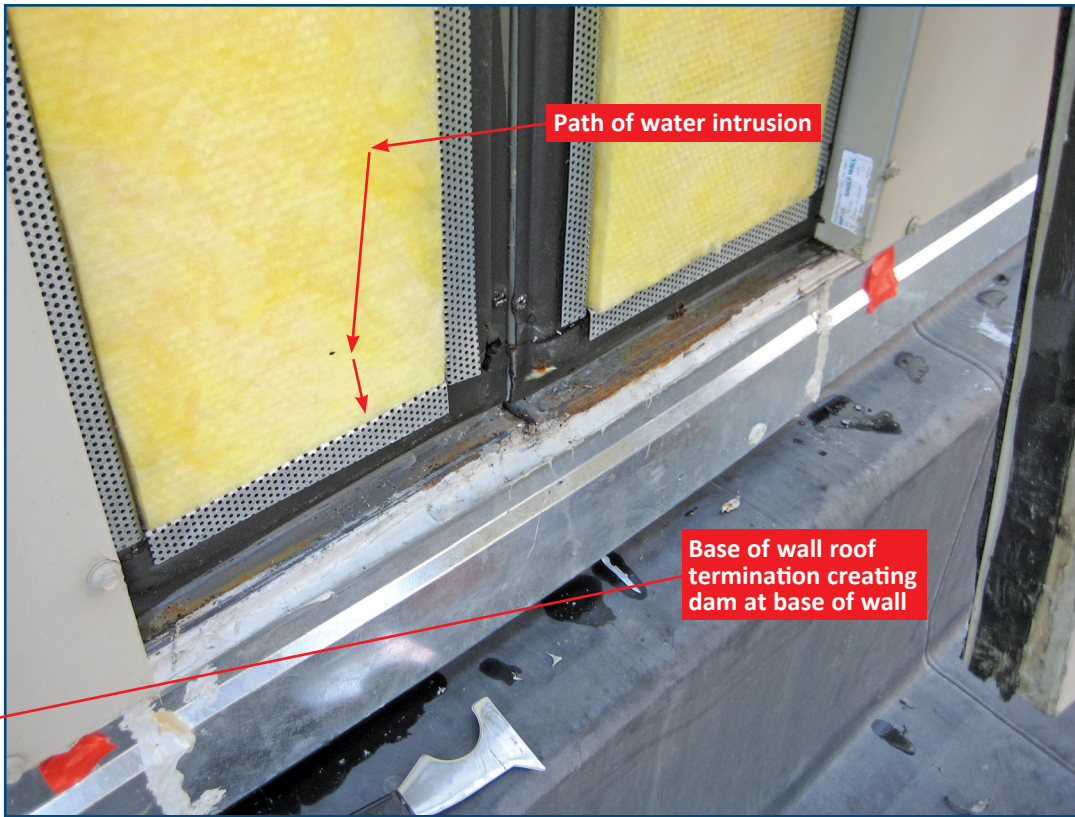
*Doors, and Curtain Wall by Uniform or Cyclic Static Air Pressure*, to subject different sections of the AHU to sustained water spray. After each test, the wall panels were removed to check for water intrusion (Figure 10). Figure 10 also shows the condition where two wall panels from different AHU sections come together at the demount line. Above the stainless steel counterflashing, you can see the gap between the units. The exterior wall panels are designed to

seal at the black gasket. This makes the area outboard of the gasket the wet zone. Water draining down the panel joint is directed into the joint at the demount line and thus into the building. See the arrow in Figure 10. In addition to water leakage at some of the demount lines, the original roofing system terminated onto the base of the exterior AHU wall panels. These panels are not barrier wall panels that are

*Figure 10 - Wall panels removed after water test.*

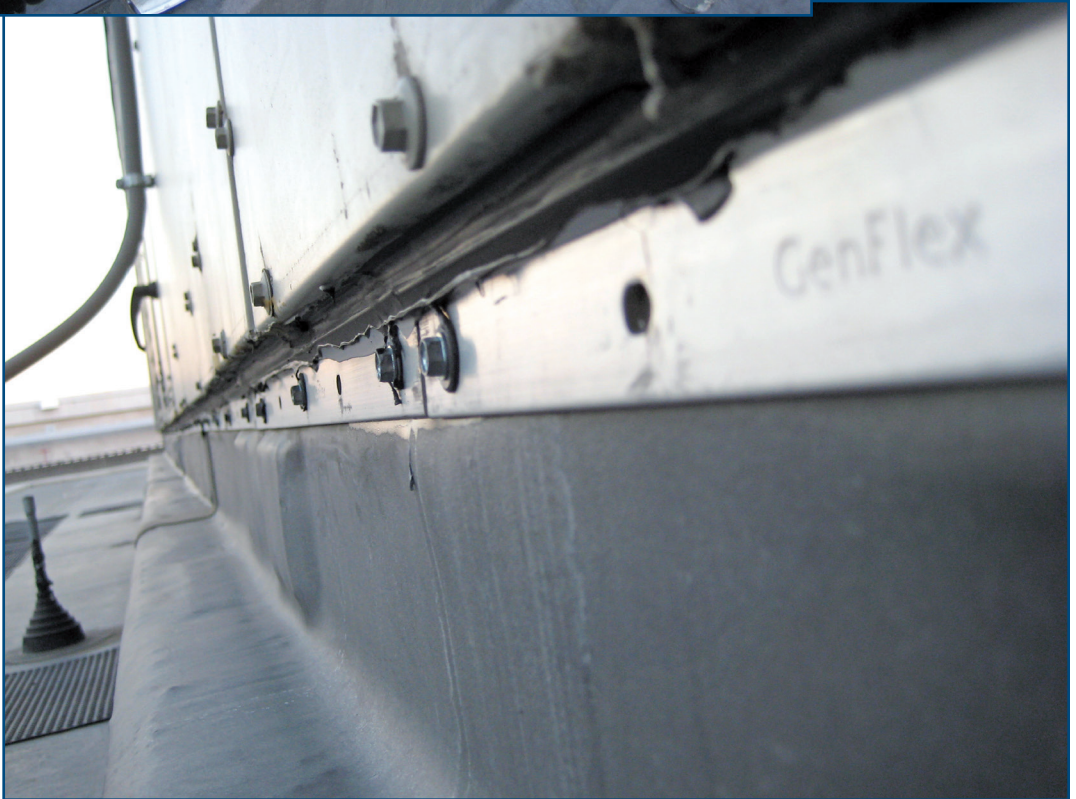
*Figure 11 - Roof membrane terminated to base of wall panel.*

designed to seal at the face of the panel, but they are a modified drainage system that has the primary seal back at the gasket-to-frame joint. As shown in *Figure 11*, the roofing membrane terminated onto the face of the wall panels. This effectively created a dam at the front face of the panels at the base of the wall. This dam prevented water from flowing out of the wall panels. *Figure 11* also shows the new repair counterflashing and roof termination installed below the base-of-wall panels to remove the dam created by the original roofing.
