The Journal of RCI

Roofing Failures

Detection and Repair to Uplift-Compromised Adhered Single-Ply Roof Membranes

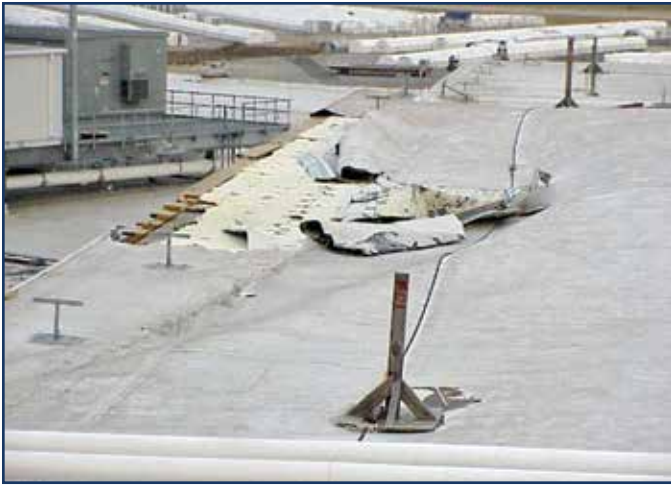
Figure 2 – Uplift damage to adhered PVC roof assembly.

geographic locations, and atop varying roof decks, from corrugated steel—where positive air pressure introduced through large wall openings was a notable contributing factor, to poured-in-place structural concrete—where positive pressure was a nonfactor. In these cases, a number of failures were noted as having commenced along the roof edge (as shown in the PVC roof system

failure in *Figure 2*) to select areas of the roofs that were nowhere near a roof edge and that had occurred at a relatively lower wind speed (45 to 65 mph) than we would have anticipated.

This PVC roof uplift damage occurred while the building was still under construction, without the building envelope being sealed, and with temporary coverings on walls and door openings. After occurrence of numerous uplift-compromised areas in the field of the roof and away from a roof edge, a series of investigations were conducted to closely examine all conditions and factors contributing to the uplift failure of this particular roof system, which over a number of years had increased to affect over 400,000 sq. ft.

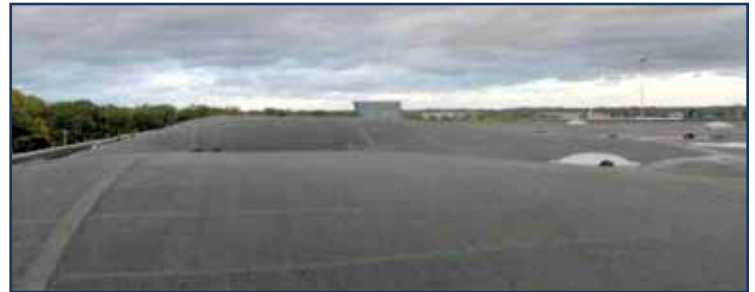
Disbonded single-ply membrane areas are apparent when the roof is noticeably elevated in what appears from a distance to resemble the top of a large balloon such as the EPDM and PVC roofs seen in *Figures 3* and *4*. Other failures are detected by the sound of flapping membrane and/or leakage at compromised membrane areas.

Figure 3 – Uplifted EPDM at compromised area.

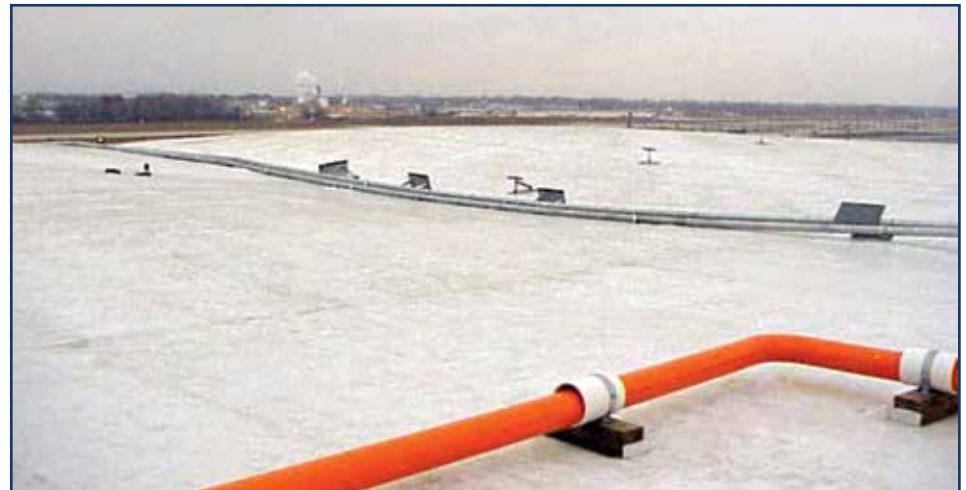
Figure 4 – Uplifted PVC roof at compromised area.

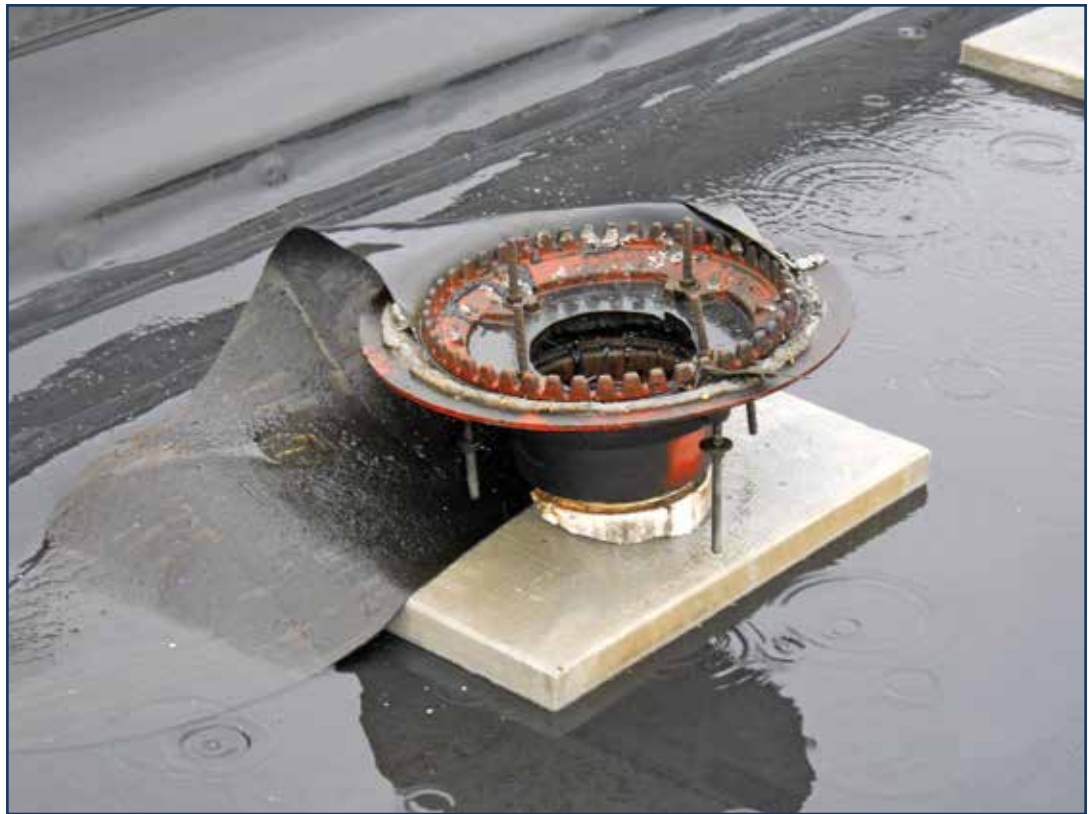
uplifted single-ply membranes can include roof drains, as can be seen in *Figure 5*. In this example of a dislodged roof drain on an EPDM roof system atop a corrugated steel roof deck assembly, the PVC piping fractured and the membrane tore free of the building, resulting in widespread leakage and interruption to the building operation.

Figure 5 – Dislodged roof drain on uplifted EPDM area.

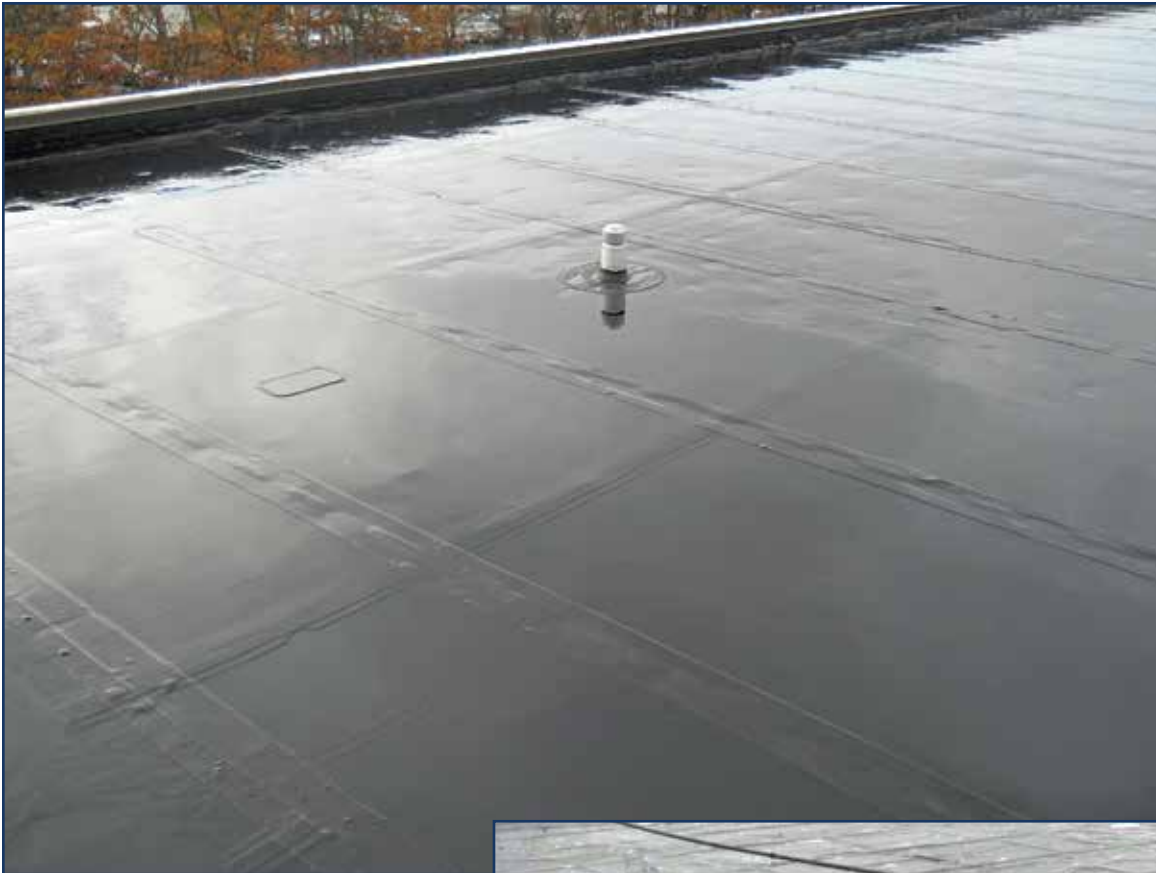
Figure 6 – Disbonded EPDM membrane area in foreground; adjacent area in background is still bonded.

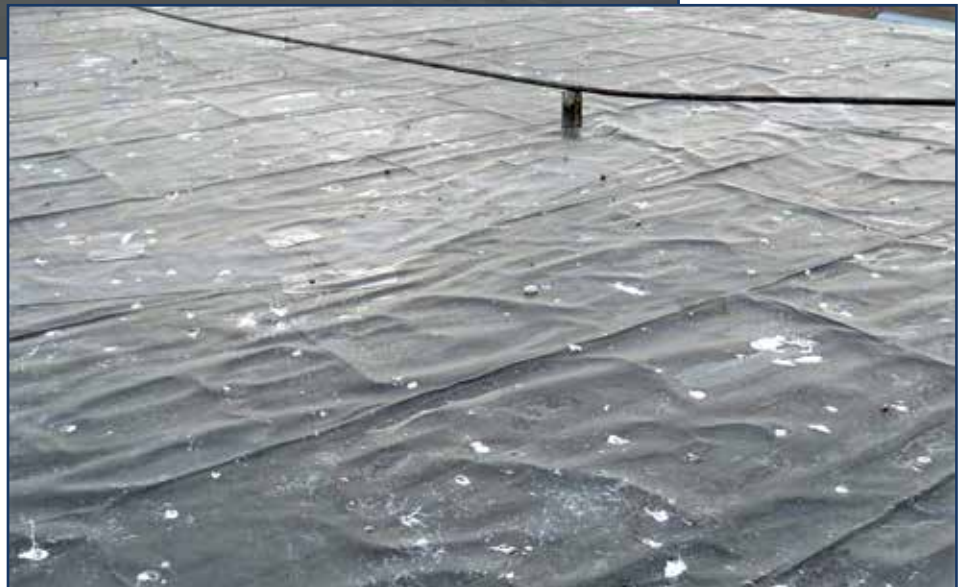
Figure 7 – Disbonded EPDM membrane with iso facer adhered to underside, pulled free of the foam core.

Uplift damaged or disbonded EPDM membrane areas where the insulation facer pulled free of the foam core and remains adhered to the backside of the disbonded membrane have a very distorted surface appearance, as seen in *Figure 7*. Once disbonded areas of an adhered single-ply membrane are identified, remediation work should commence in a timely fashion to halt the size of uplift-damaged areas.

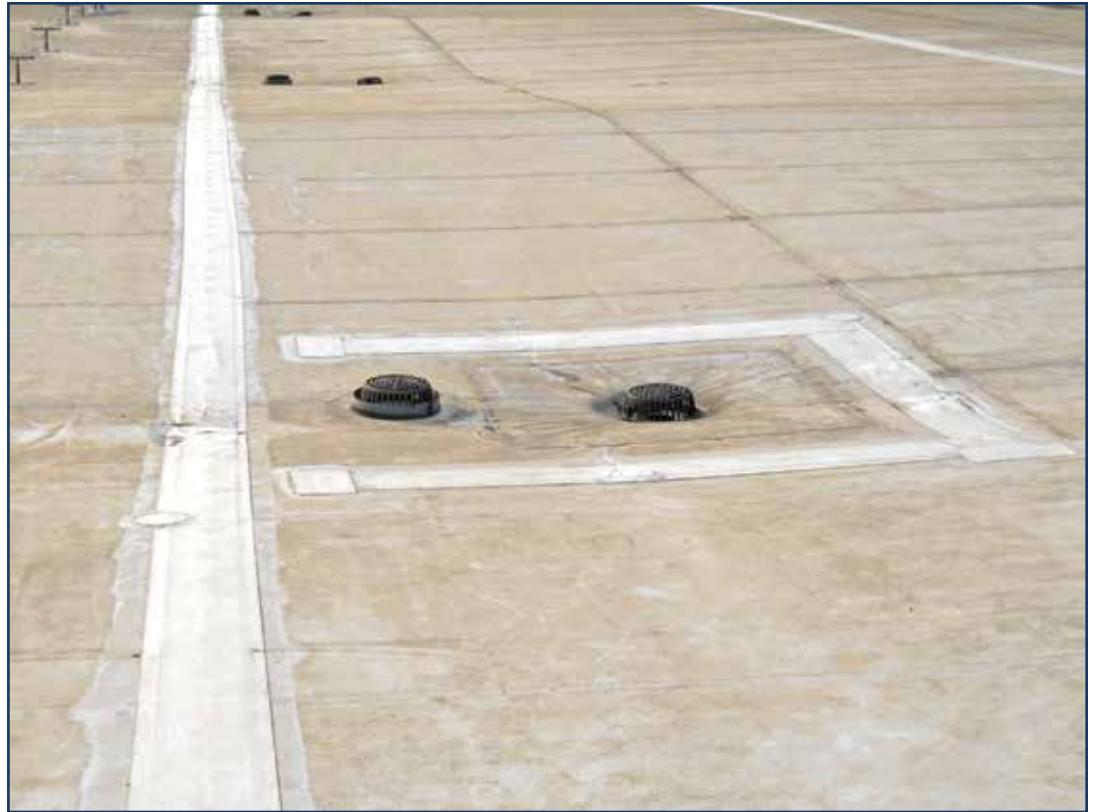
Figure 10 – Battens around roof drain on uplifted area.

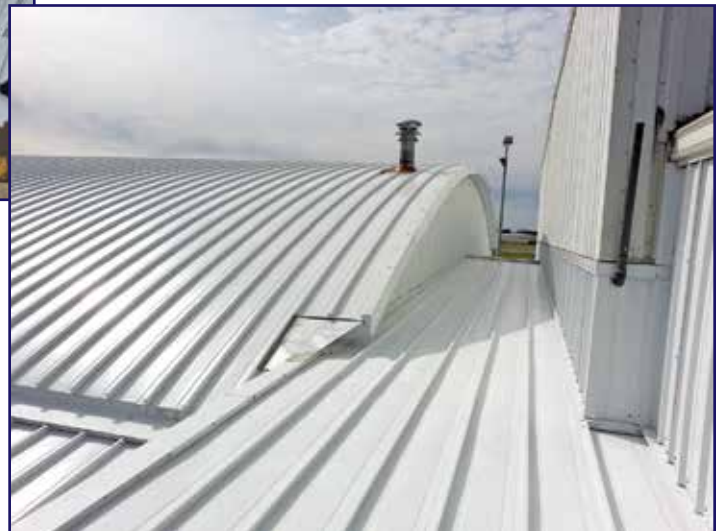
Figure 5 – Finished application showing continuous panel, step-down, and welded stainless flashing.

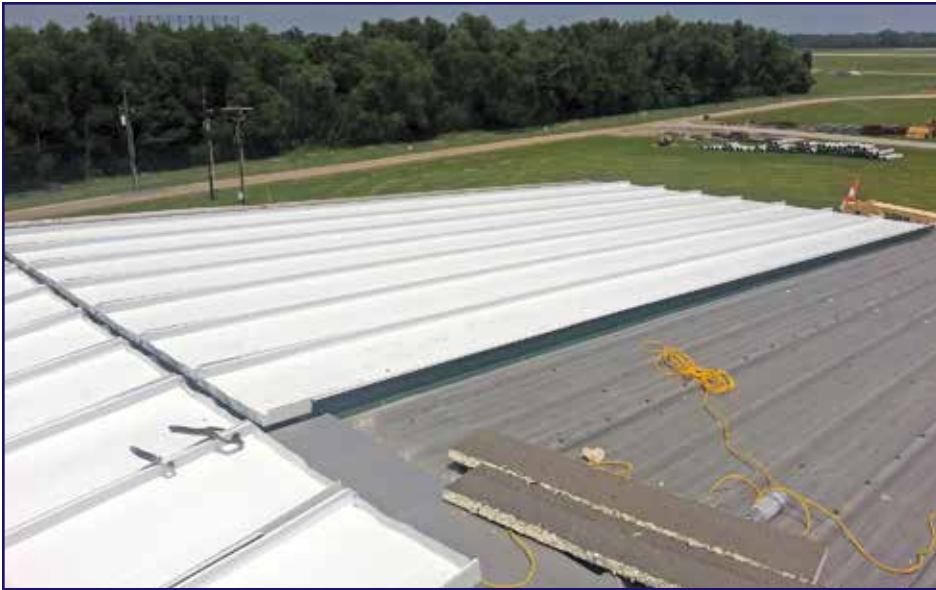
Figure 6 – Installation of the 24-gauge Galvalume symmetrical panels.

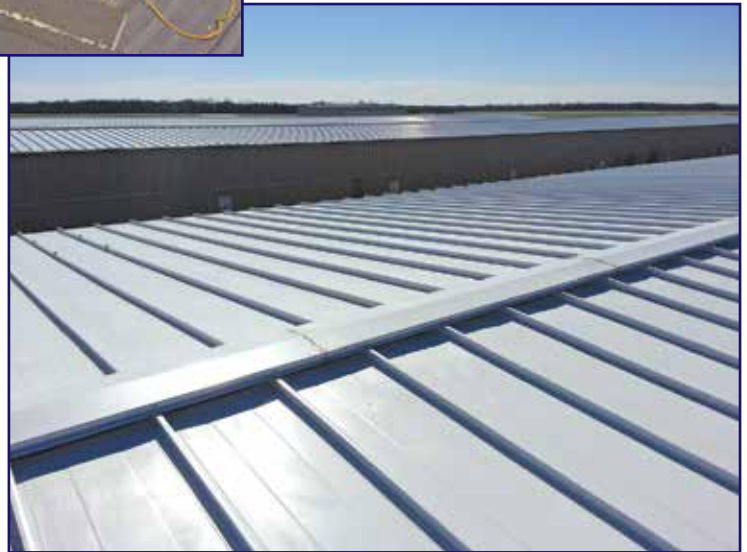
Figure 7 – A 24-in.-wide frameless symmetrical re-cover system with wind clamps in corner zone per FM requirements.

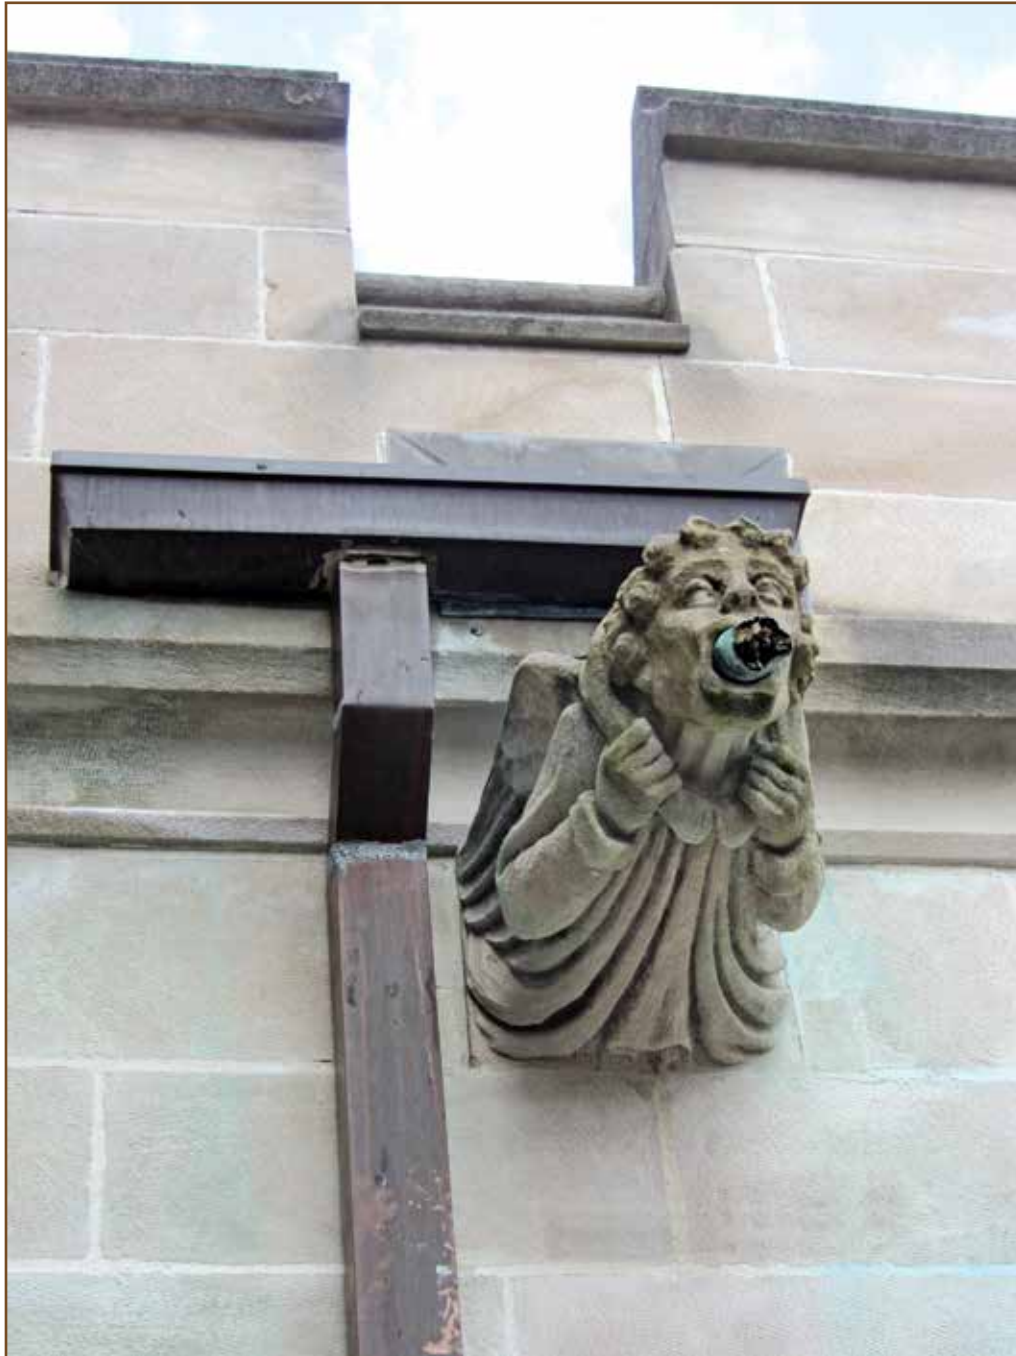
Photo 2 – Original scupper drain with 2000 retrofit gutter.

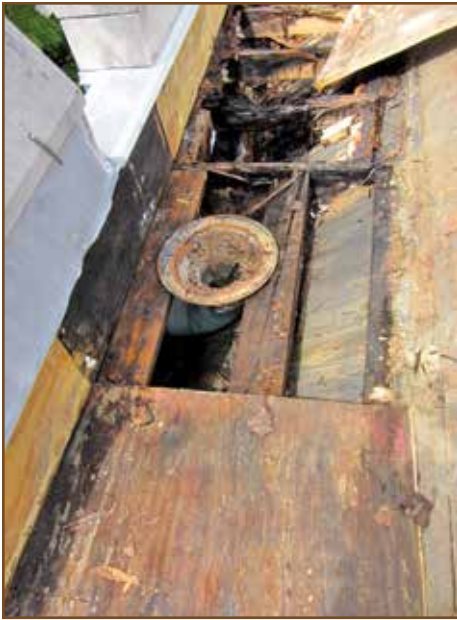
Photo 4 – 2000 gusset installation in 2011, with deteriorated framing from solder seam failure and condensation.

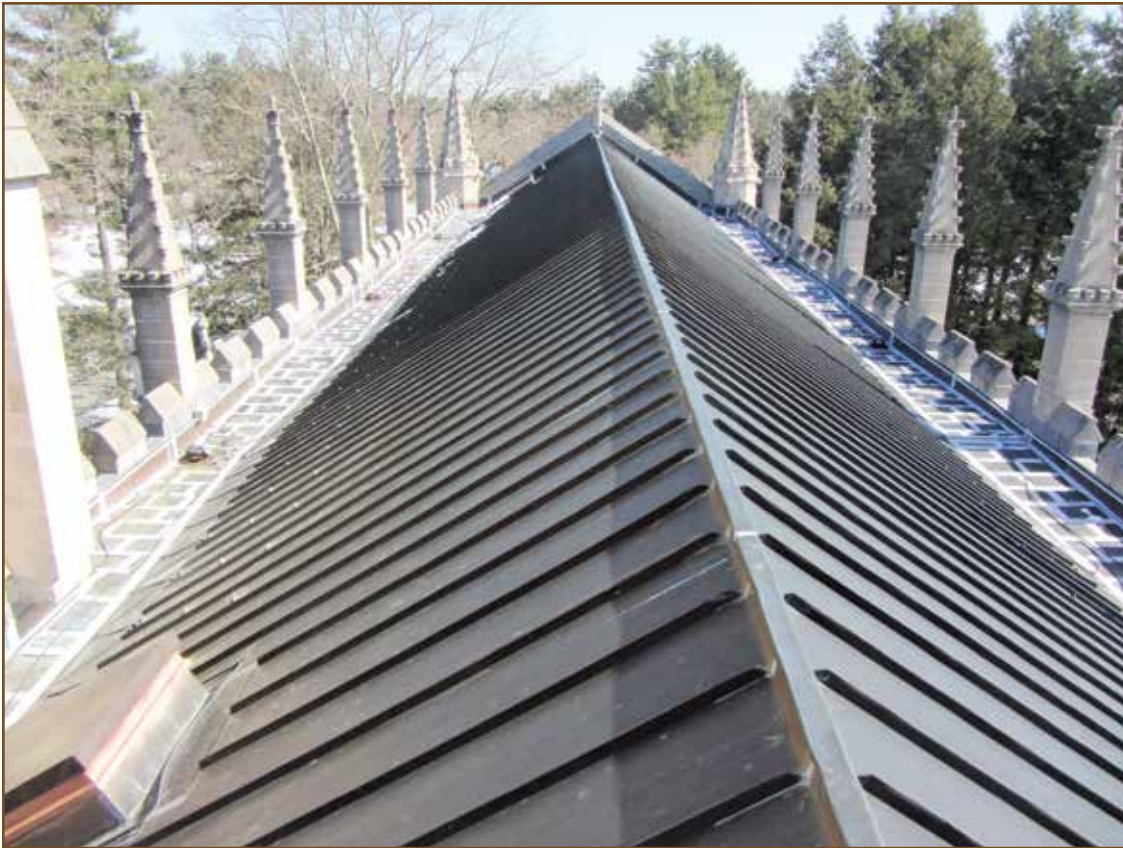
Photo 6 – Nave roof (note temporary gusset repairs).

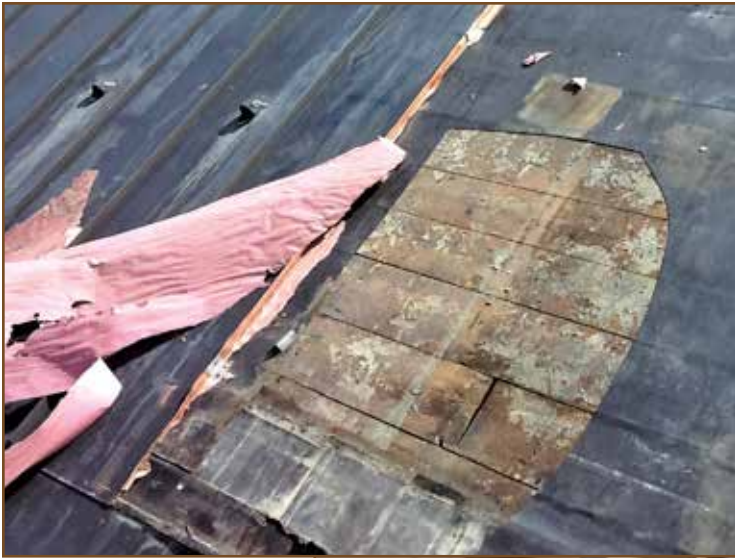
Photo 7 – 2000 EPDM underlayment assembly.

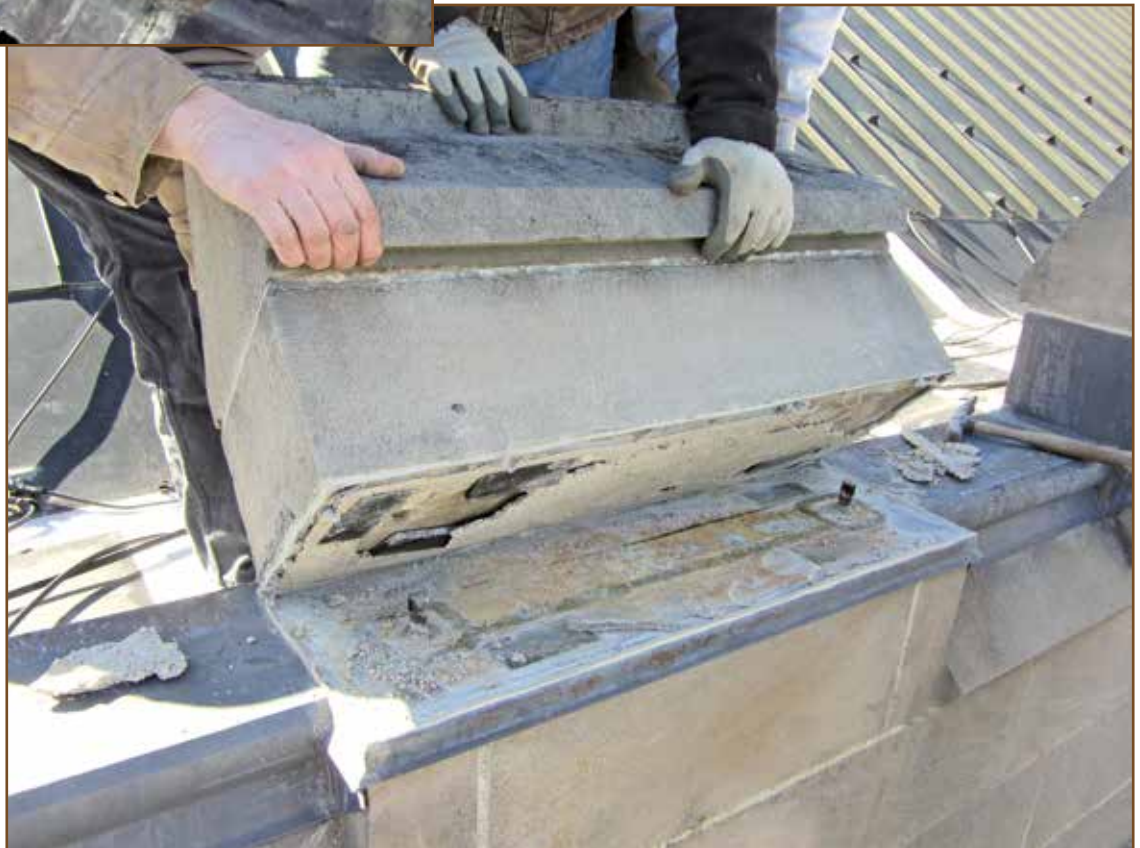
Photo 8 – Merlon stone attachment inspection (note 1-in. pin pipe).

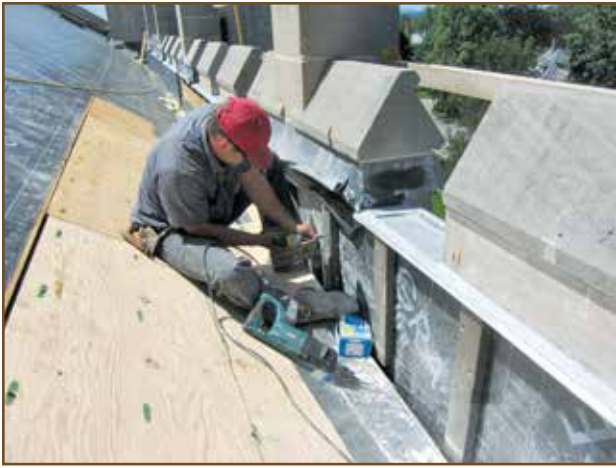
Photo 9 – Nave parapet wall vent construction in 2012.

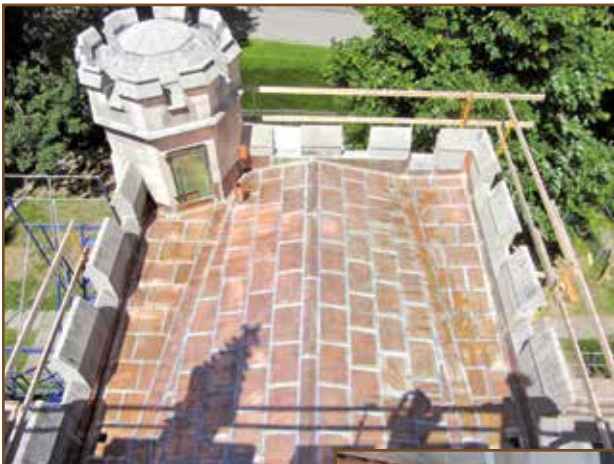
Photo 11 – 2012 semitranssept roof flat-seam copper installation.

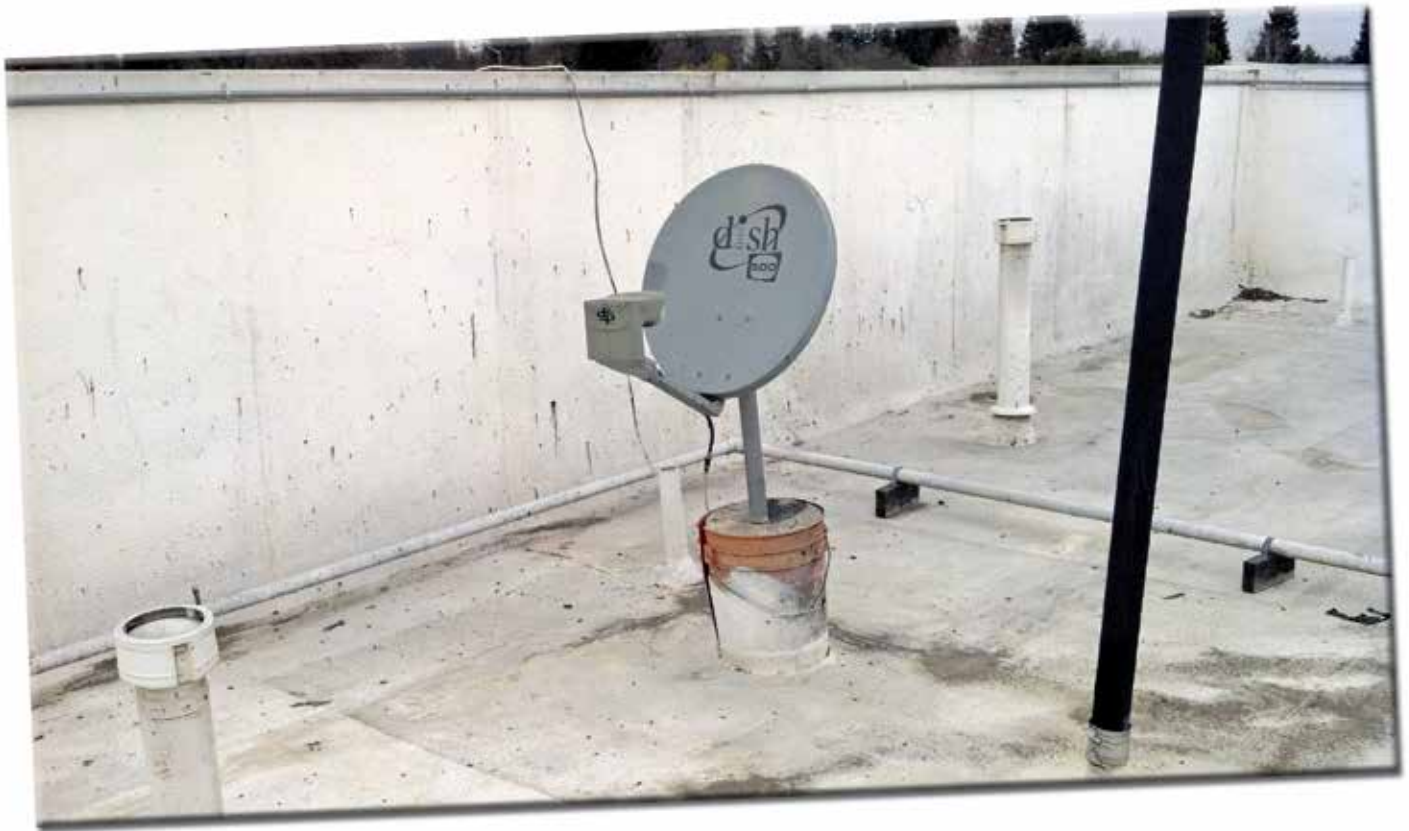
This new and improved way to mount a satellite dish on one's roof was discovered during a routine roof evaluation survey. Too bad the roofer coated it in, allowing water to get below the coating.
