The Journal of RCI, Inc., the Institute of Roofing,
Waterproofing, & Building Envelope Professionals

December 2006 • Vol. XXIV • No. 11 • \$10.00

CONCRETE AND CLAY TILE

5 TILE ROOF SYSTEMS: ANALYSIS AND INSPECTION TECHNIQUES

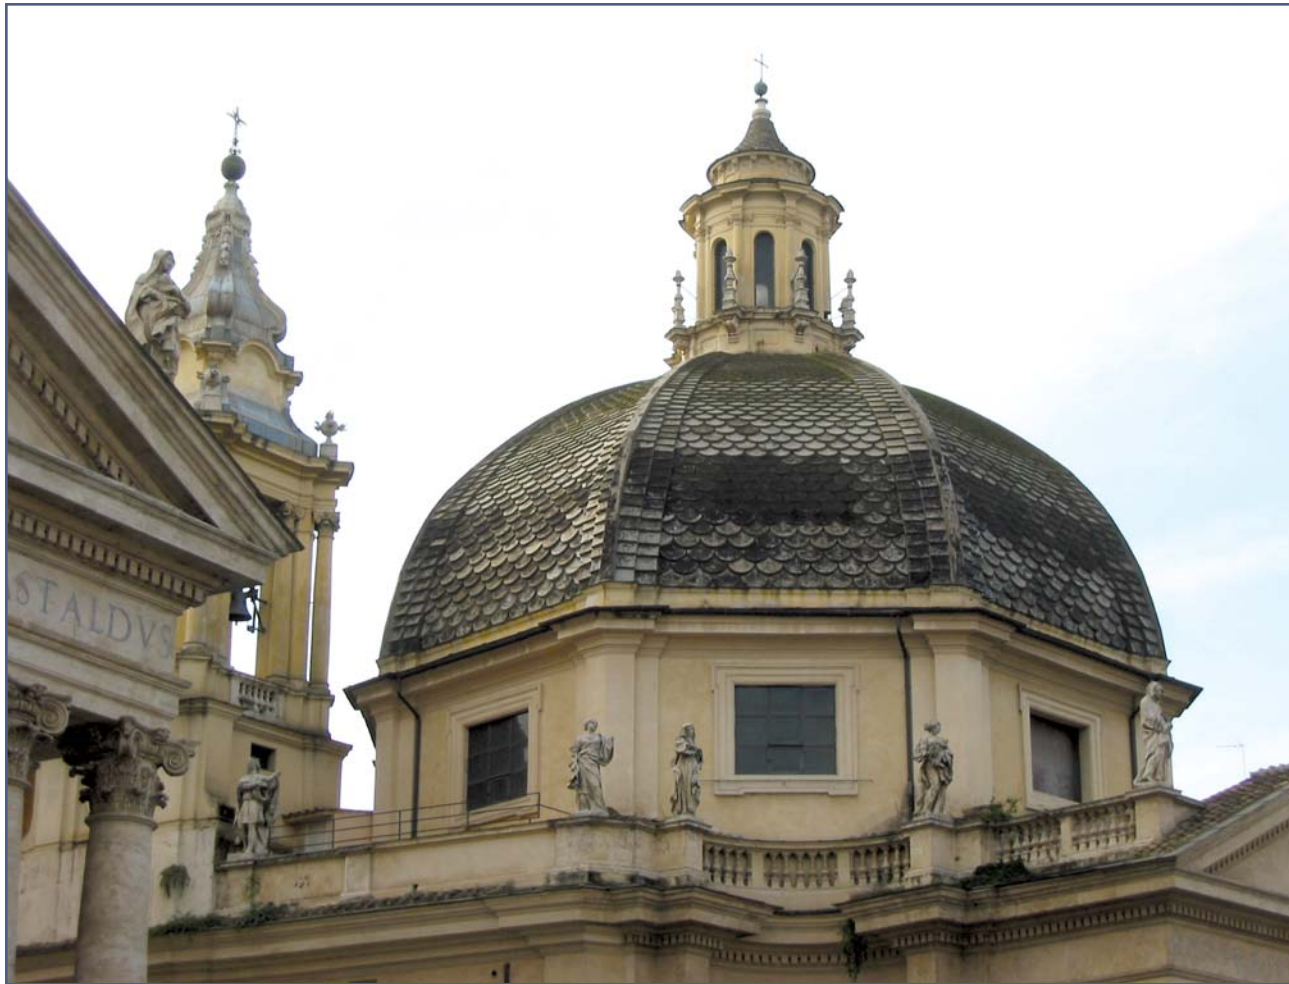
Photo 1 – Flat clay tile on a dome at the Pantheon, Rome, Italy. Photo by Robert L. Fulmer.

While some basic elements of tile roofing have been a part of the world's architectural legacy for thousands of years, our more recent past has seen significant growth and change within the industry (Photo 1).

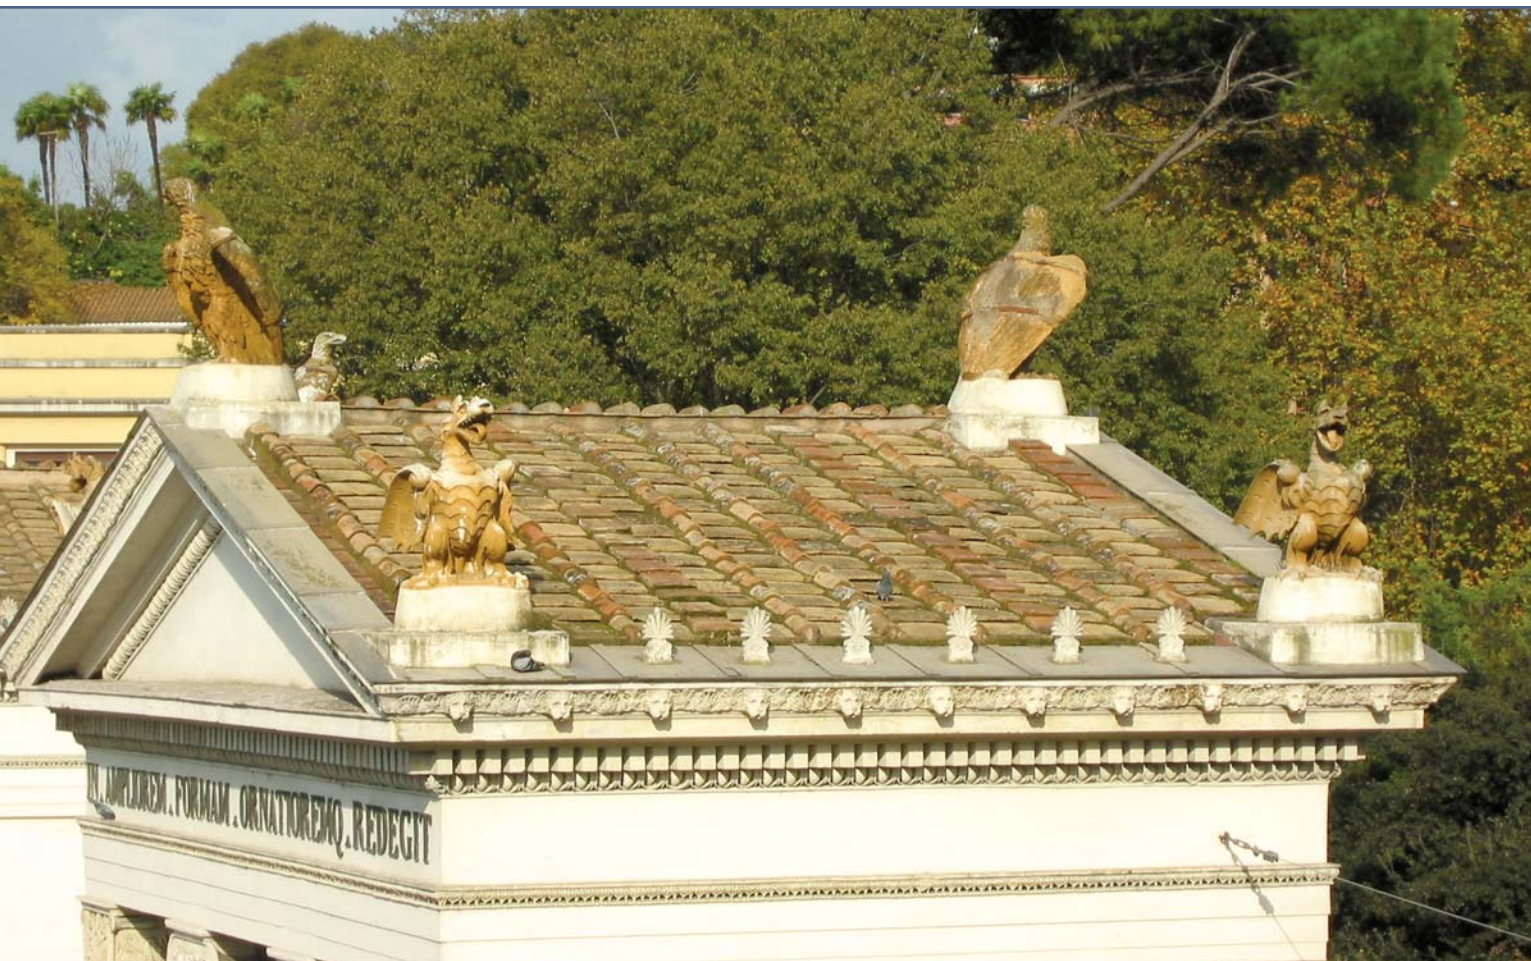
Photo 2 – Flat clay tile in the Piazza del Popolo, Rome, Italy. Photo courtesy of Robert L. Fulmer.

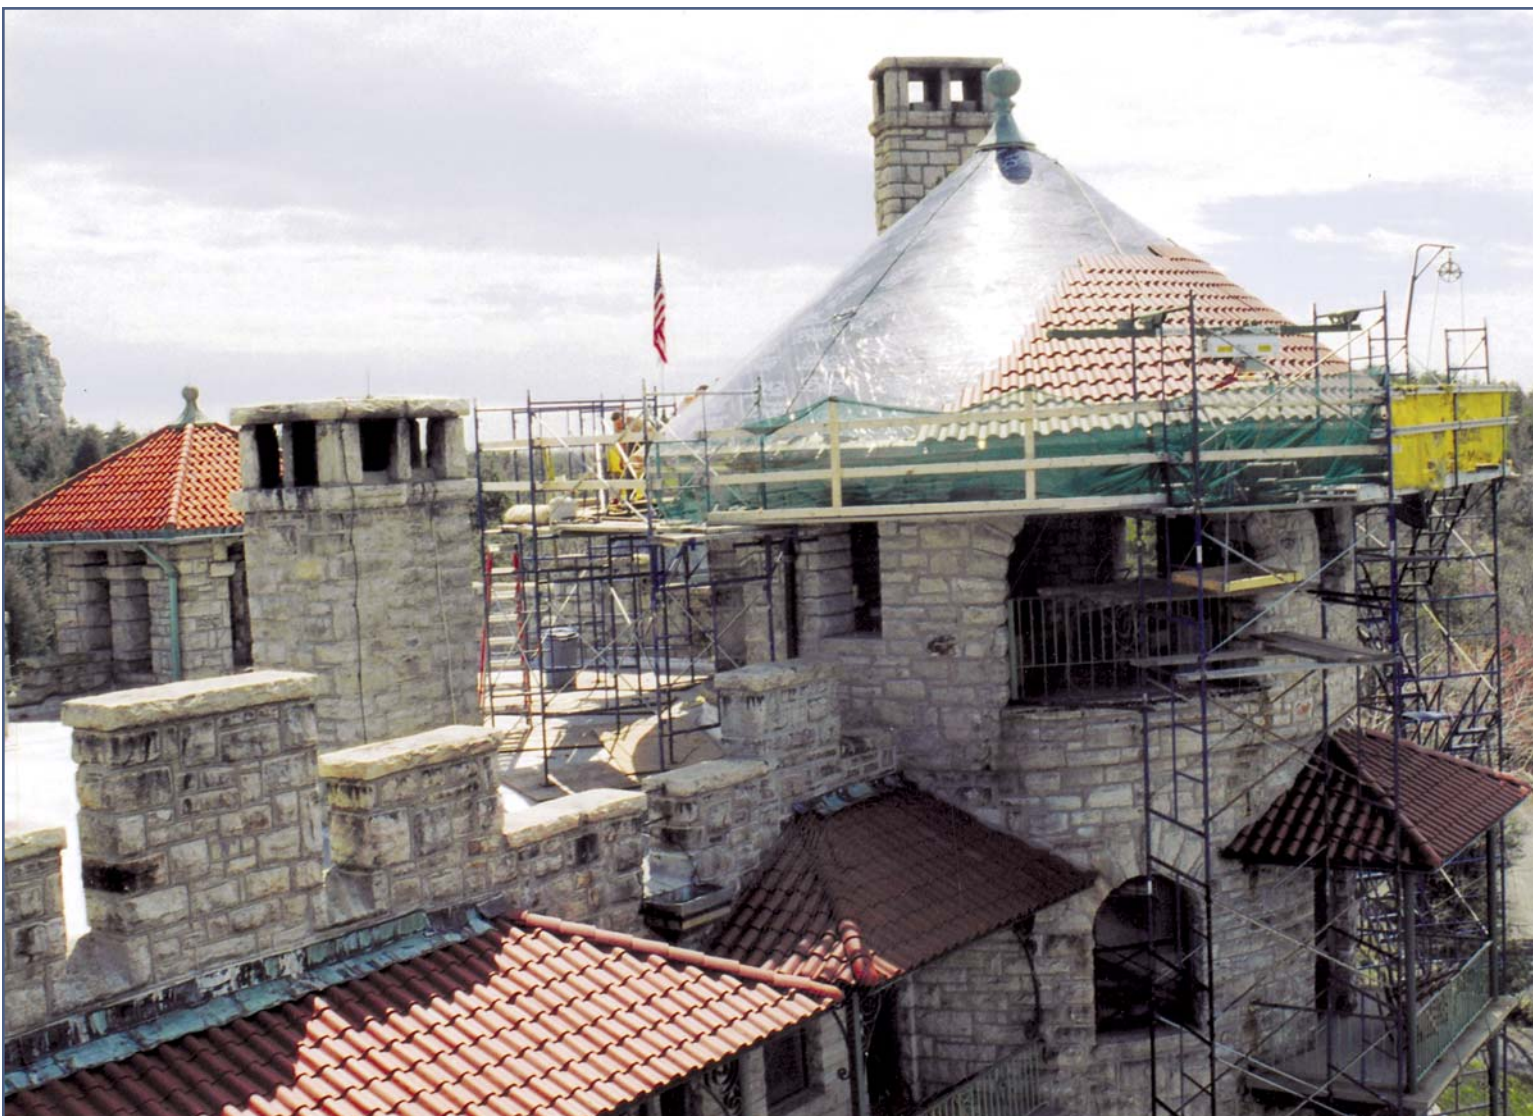
Photo 3 – Process of replacing original Ludowici Celadon clay Spanish tile (initially installed at the turn of the 20th century) with new tile by the same manufacturer on an historic hotel in upstate New York (the original tile came from Celadon's plant in Alfred, NY). Photo by Robert L. Fulmer.

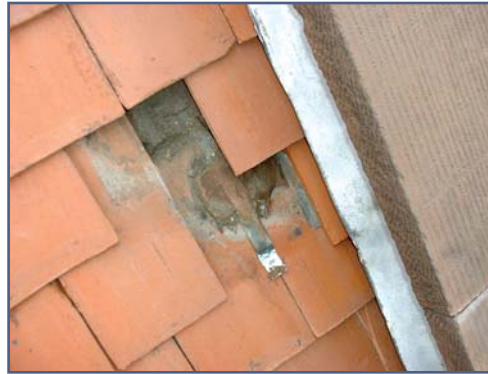
Photo 4 – Clay overlapping (flat shingle) tile exhibiting signs of water absorption. Photo by Robert L. Fulmer.

Clay tiles also absorb water; however, porosity is a function of the density of the clay used and the vitrification process. Vitrification is the process that turns clay to glass by applying heat (firing). Clay tiles that are not thoroughly vitrified are softer and consequently possess a shorter service life. Freeze/thaw cycles in colder climates cause spalling when moisture expands as it freezes. Spalling and flaking are the result of normal water absorption and wear process. Flaking begins on the surface of the tile and continues throughout the life of the tile until the flaking wears completely through. The presence of these elements is sometimes incorrectly diagnosed as tile failure. During examination of a representative number of tiles, the flaking should be dislodged. If algae or lichen are present under the flaking, the process is a slow, natural one. If bright, clean clay is exposed, the process is accelerated and newer. This could be the result of environmental factors (i.e., hail damage, excessive hot and cold temperature variation), or it could indicate premature tile failure.

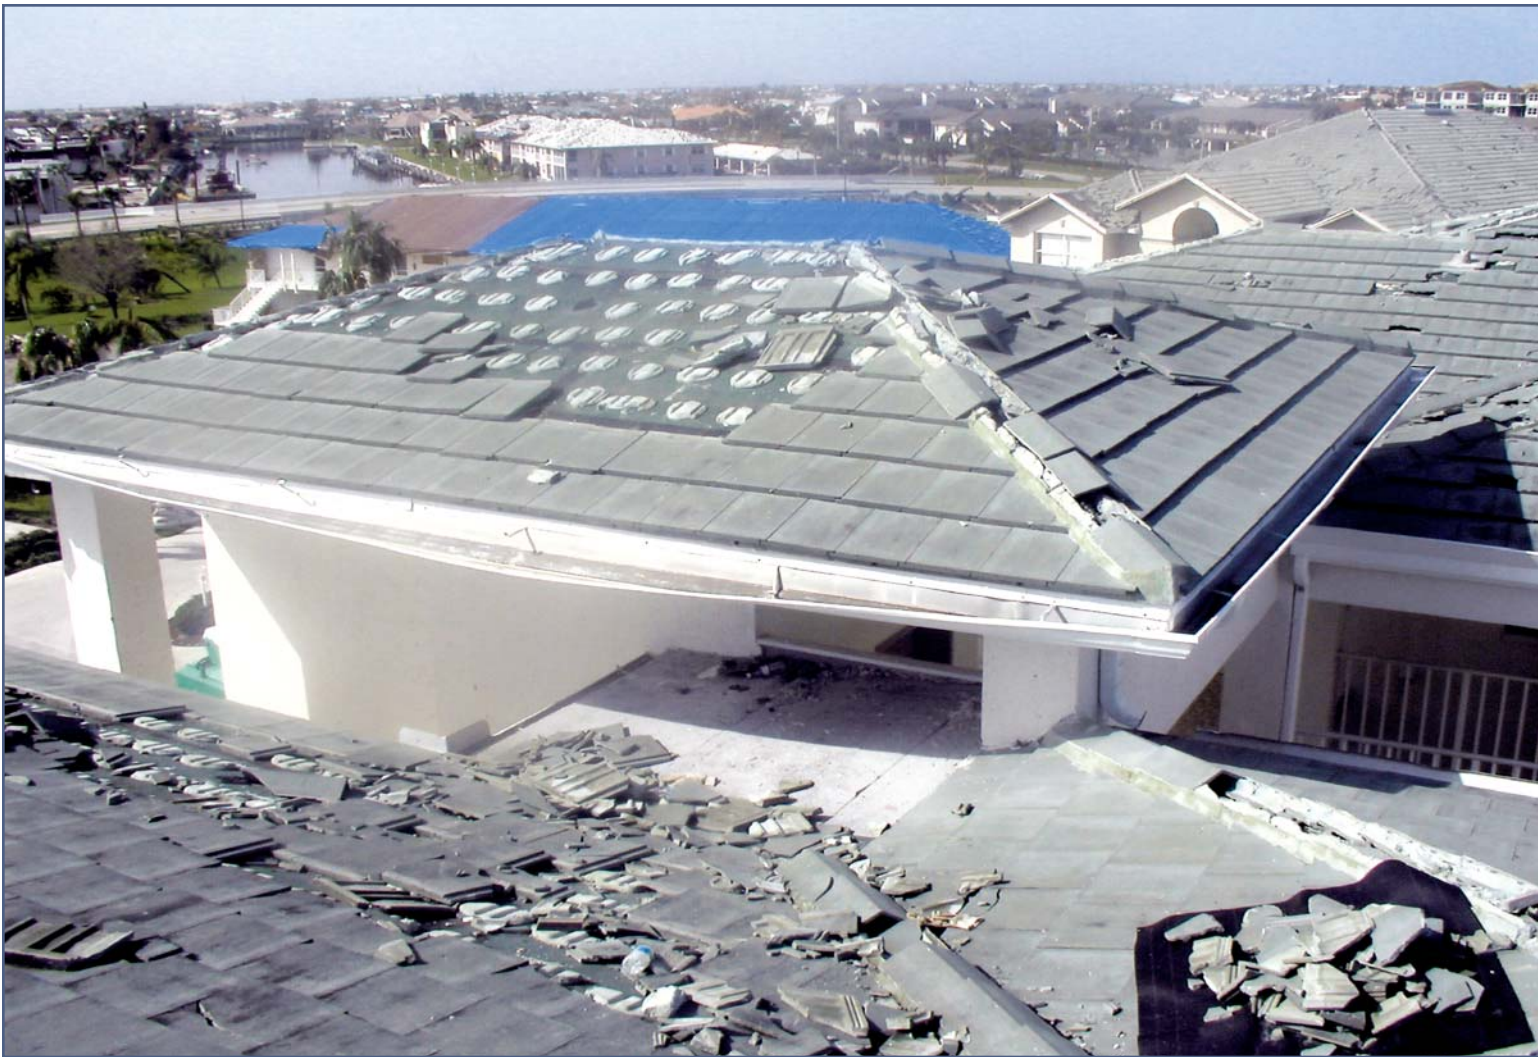
Photo 5 – Example of a ridge tile failure in a concrete tile roof system. Photo courtesy of Warren French.

severe wind event. Because Punta Gorda is an older community, most tile roofs were older, mortar-set concrete tile. Overall, system performance of the older, mortar-set tiles was the poorest. Mortar deterioration and subsequent loss of adhesion resulted in either substantial numbers of tile blown from the roof deck, or completely missing rakes and ridges (Photo 5).

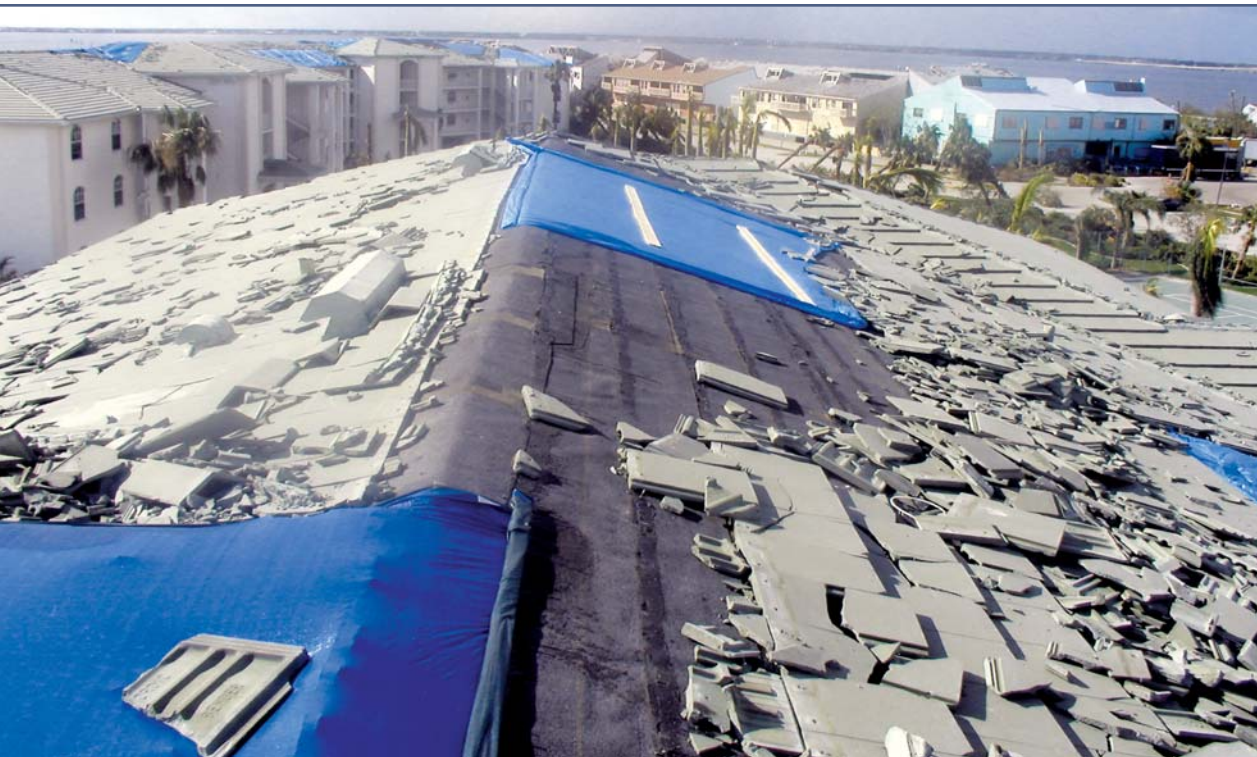
Photo 6 – Upper concrete tile roof exhibiting partial failure of the “foam-set” system, possibly due to an improper foam mix. Lower roof exhibiting damage from flying debris. Photo courtesy of Warren French.

1. Failure of the ridge tile occurred on roofs that did not use a ridge nailer board, but relied on mortar without fasteners.
2. The second failure source was an installation error occurring when the two-part foam mix was improperly mixed, resulting in the foam being either “part A rich” or “part B rich” (Photo 6).

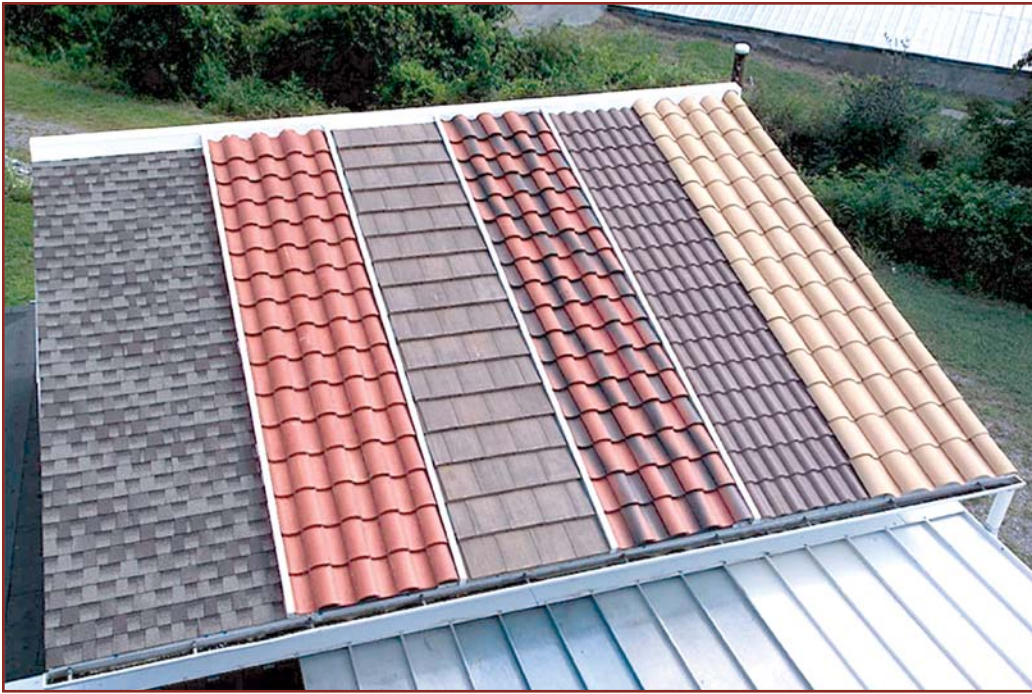
Figure 2 – An assembly of steep-slope attics was placed on top of the ESRA. Clay and concrete tiles were installed by the Tile Roofing Institute.

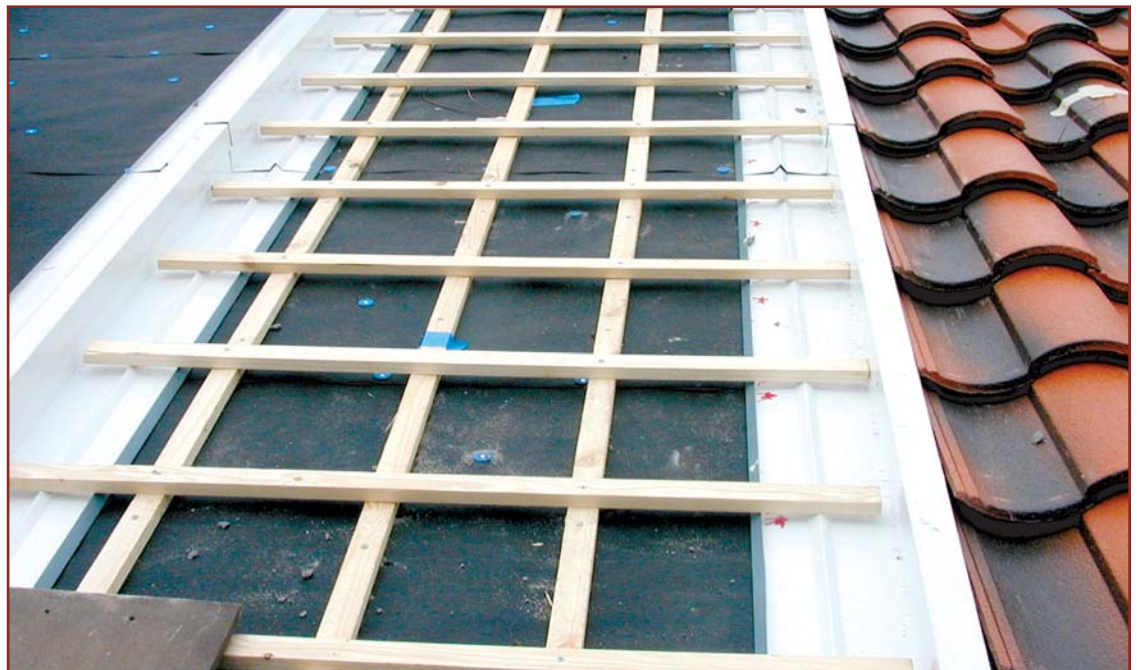
Figure 3 – Construction of the roof deck showing battens and counter-battens for attaching the slate tile. The parapets are used to limit airflow on the underside of the tile to within a given test roof.

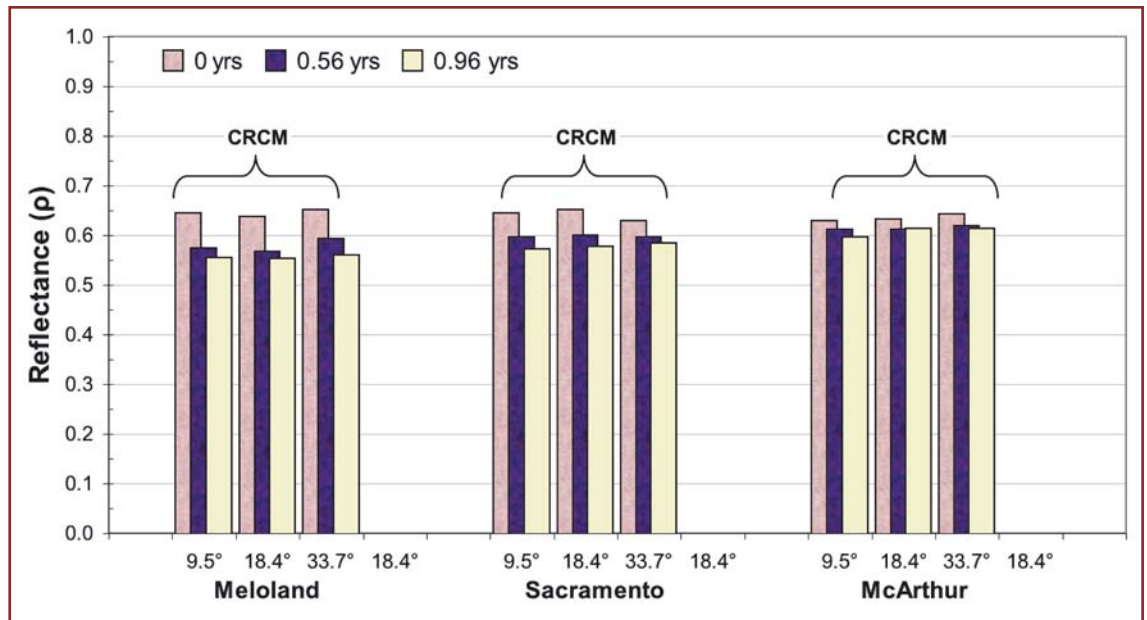
Figure 5 – Solar reflectance of clay tile exposed at weathering sites in California.

Data for clay tiles are also shown for field exposure testing in three of the 16 climatic zones of California. The clay samples are identical to those tested at ORNL. They show a loss of solar reflectance that occurs because of climatic soiling. The worst soil-

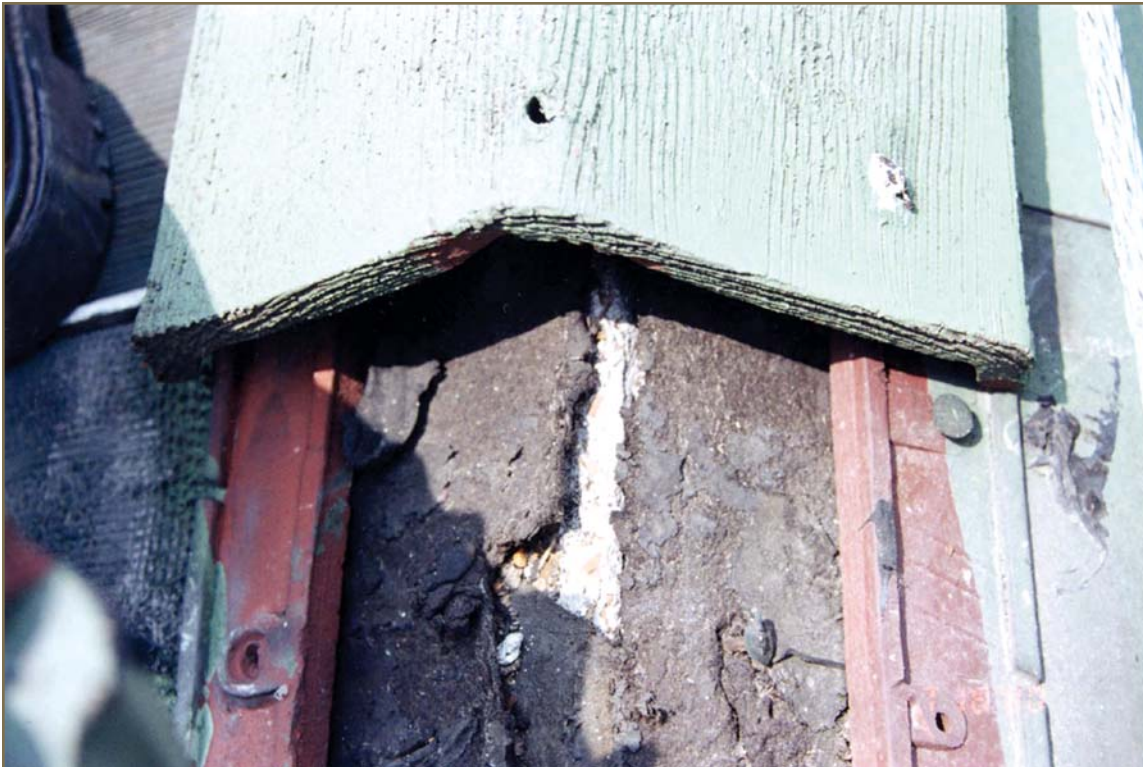
Photo 1 – Torn felt membrane underlayment. Asphalt-saturated felt embrittles with age and becomes prone to tearing.

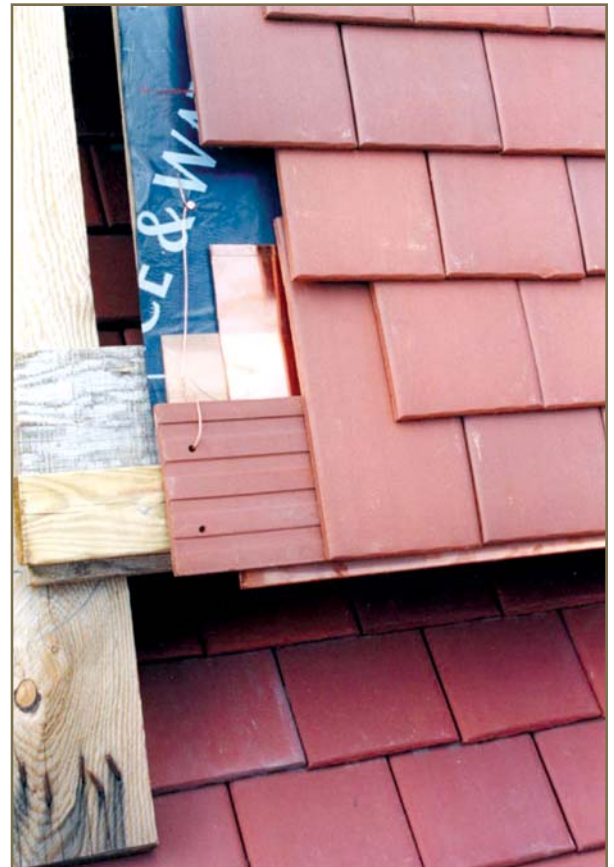
Photo 2 – Fastening eave and valley tiles (not shown) with wire ties can avoid penetrations through metal flashings, which would result in less reliable waterproofing performance.

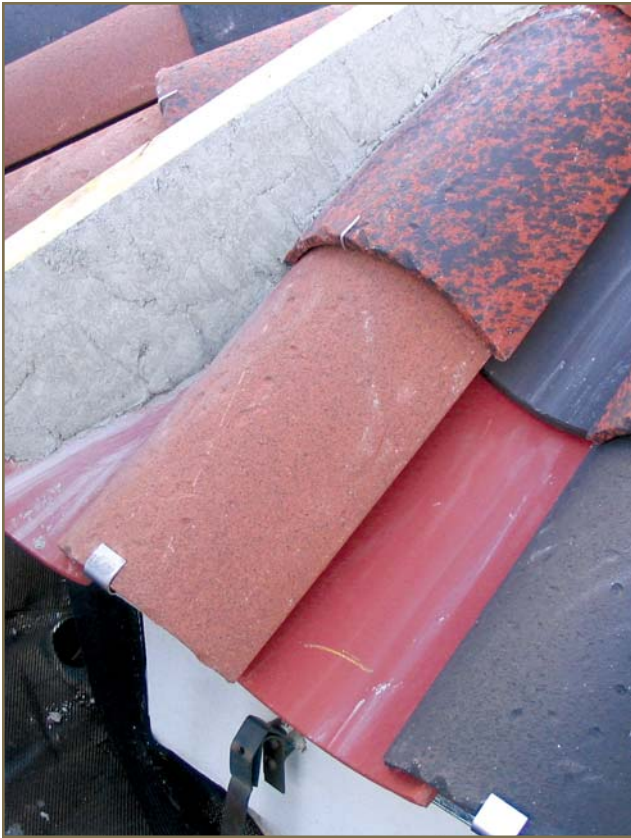
Photo 3 – Nose clips are used to resist uplift forces on tiles. The photo shows both a wire nose clip in the field of the roof (top) and a custom-manufactured nose clip along the roof eave (bottom). Custom-manufactured nose clips may be required to provide adequate stiffness and length to fasten above, rather than through, metal flashing along roof eaves.

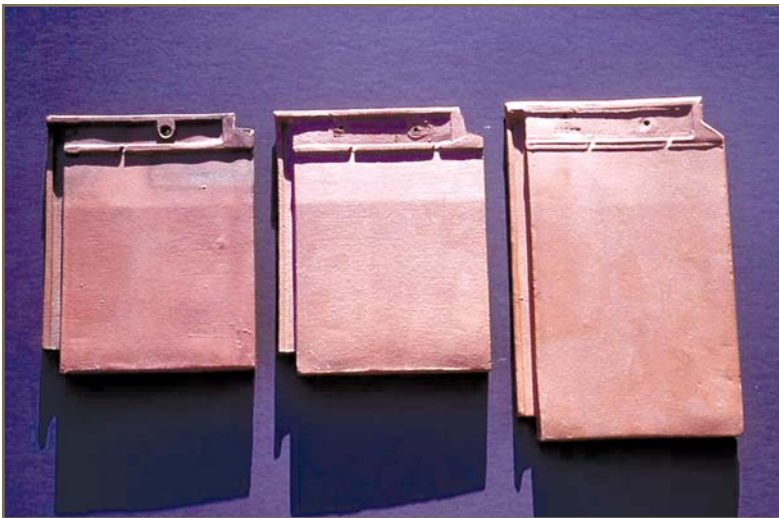
Photo 6 – The devolution of tile surface features: Three generations of tile from the same manufacturer show loss of surface articulation from a circa 1951 roof tile (left) to its later (center) and contemporary (right) counterparts. On the earliest tile (left), note the raised hub at fastener hole to protect fastener hole from leakage and deeper drainage channel (indicated by longer shadow from back leg of top channel). These features are muted or eliminated on later tiles to right.

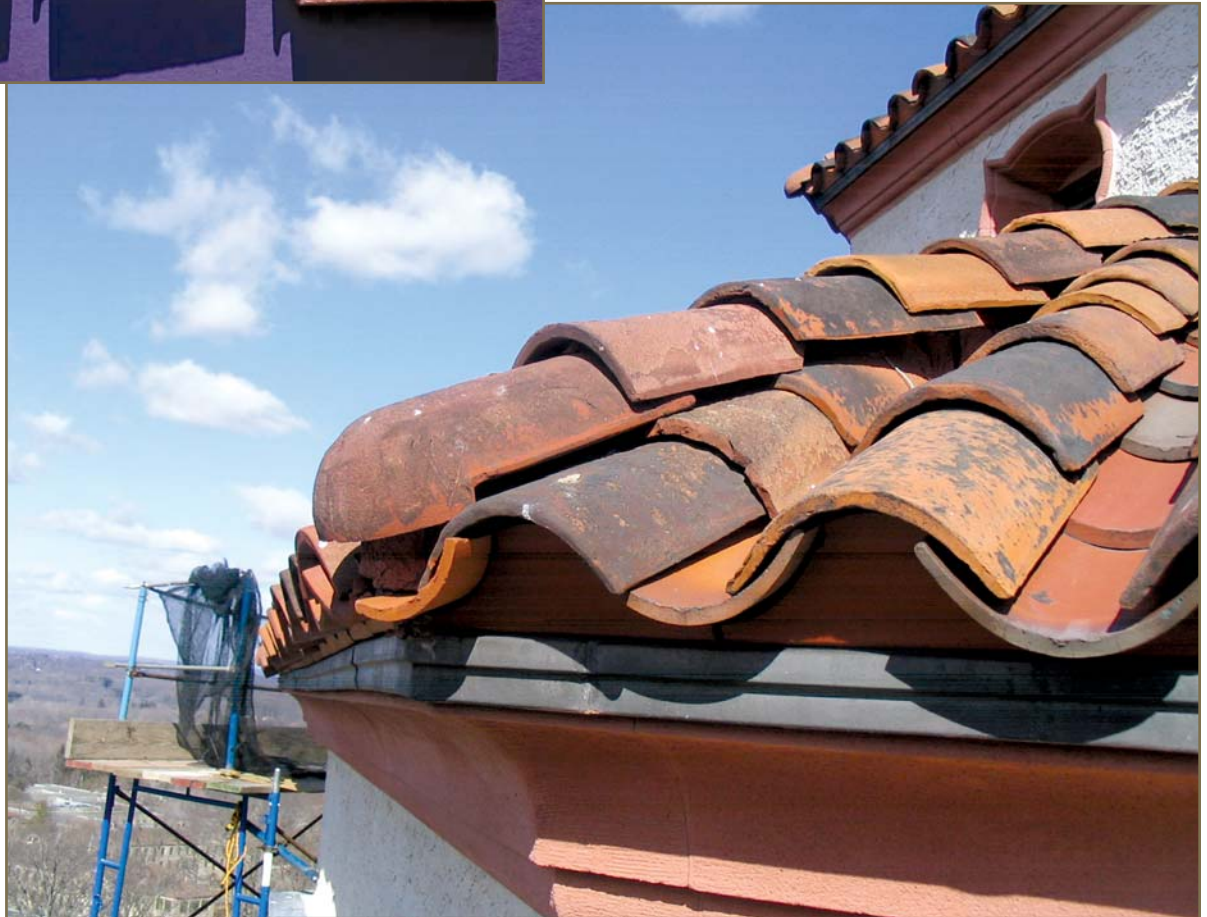
Photo 7 – Accessory tiles, such as the rounded hip closure tile shown above (or tiles for ridges, rakes, and starter courses) are often available from manufacturers for various tile shapes and styles. In some cases, these require special order and have considerably longer lead times than typical field tile shapes. Identify and order accessory or custom tile shapes early to avoid delays during construction.

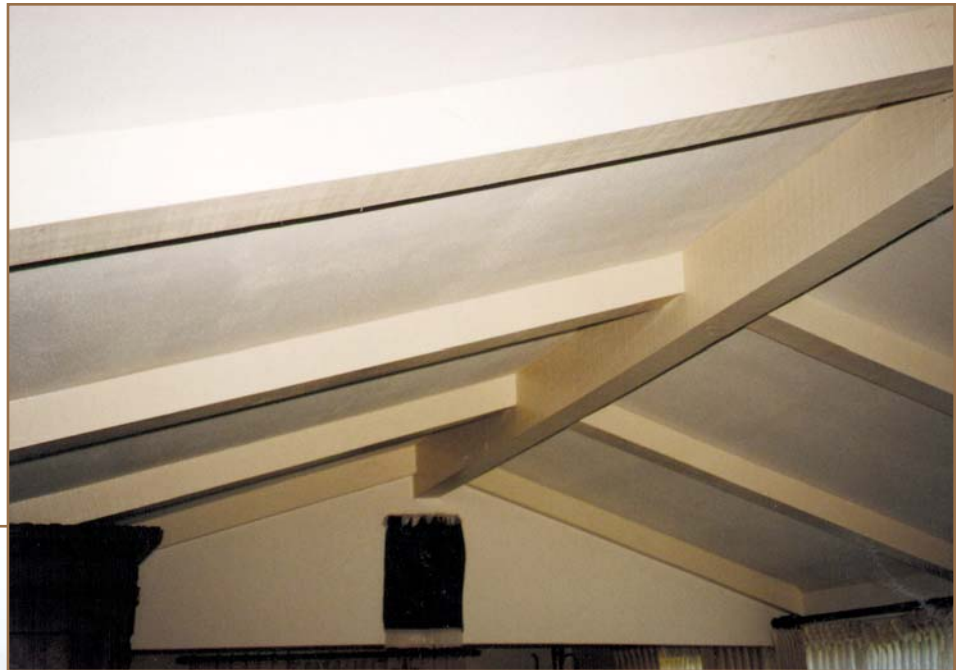
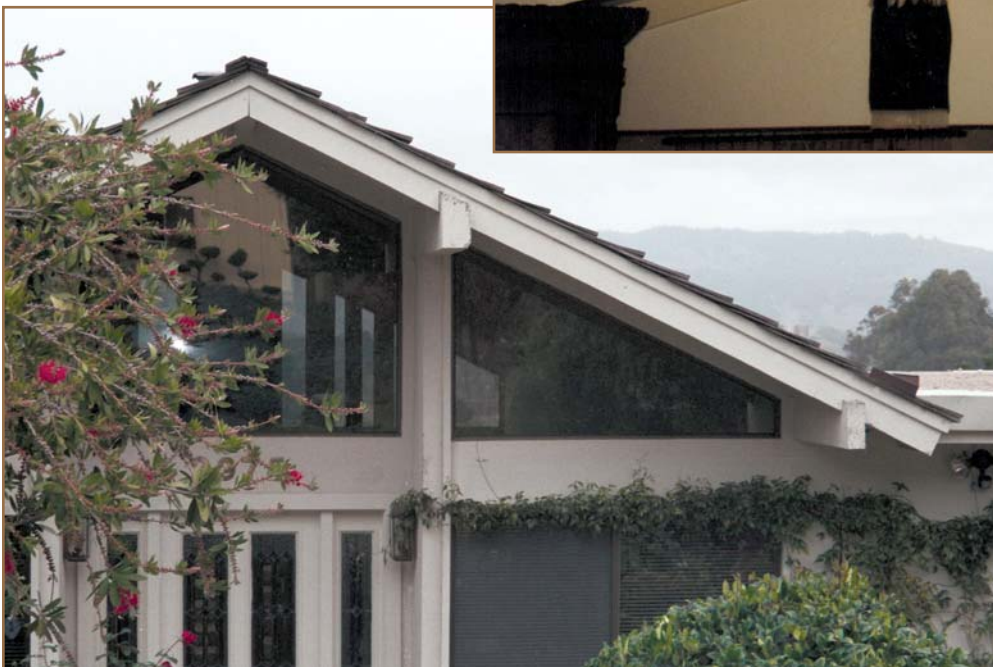
Photos 1 (left) and 2 (above) - Steep roofs without conventional attic spaces (e.g., enclosed rafter spaces).

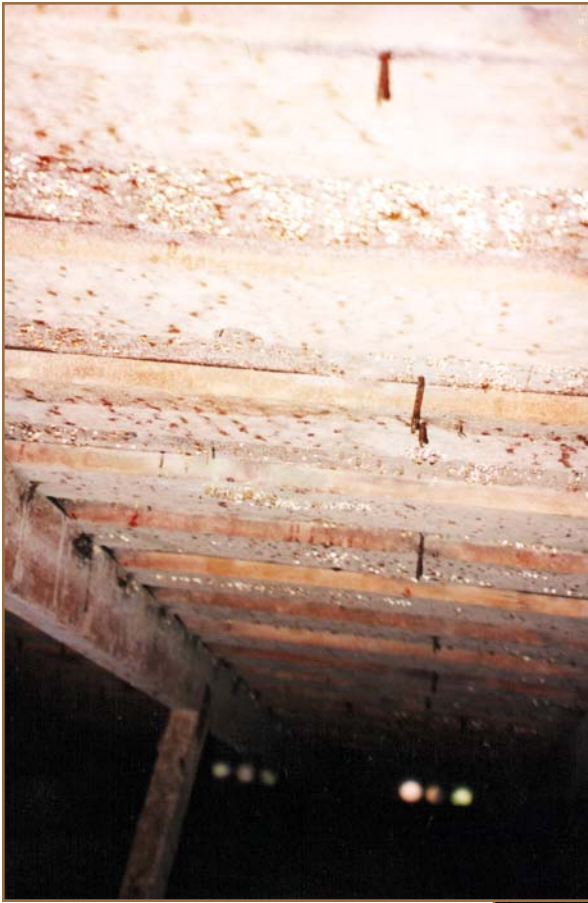
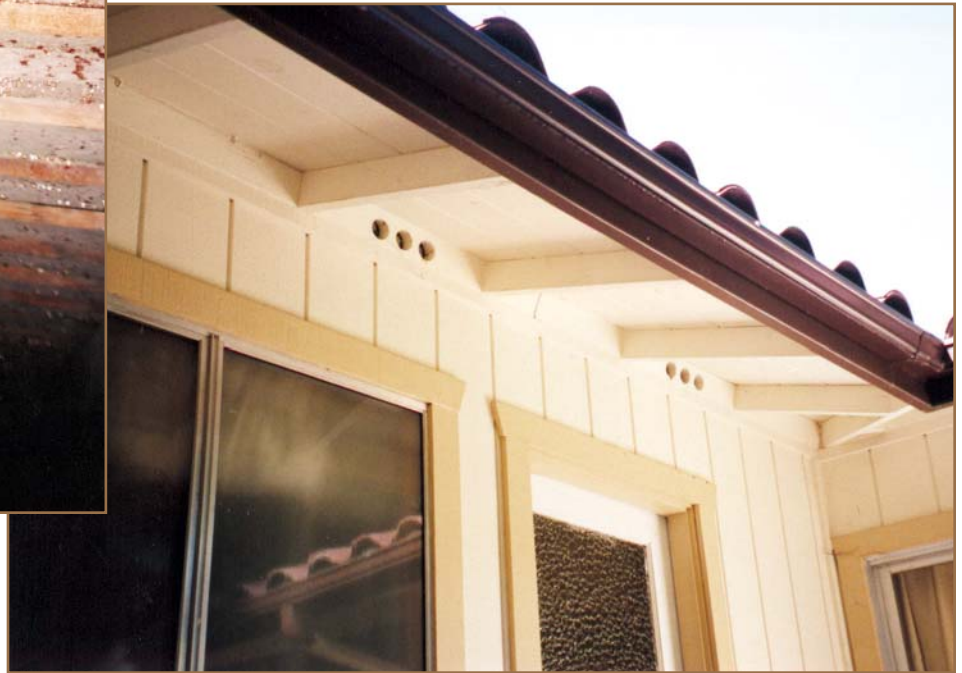
Photos 3 (left) and 4 (below) – Literally thousands of water droplets form on the underside of a plywood and spaced sheathing roof deck despite conventional attic eave vents on a project where a self-adhered membrane underlayment was installed as part of a roof replacement project.

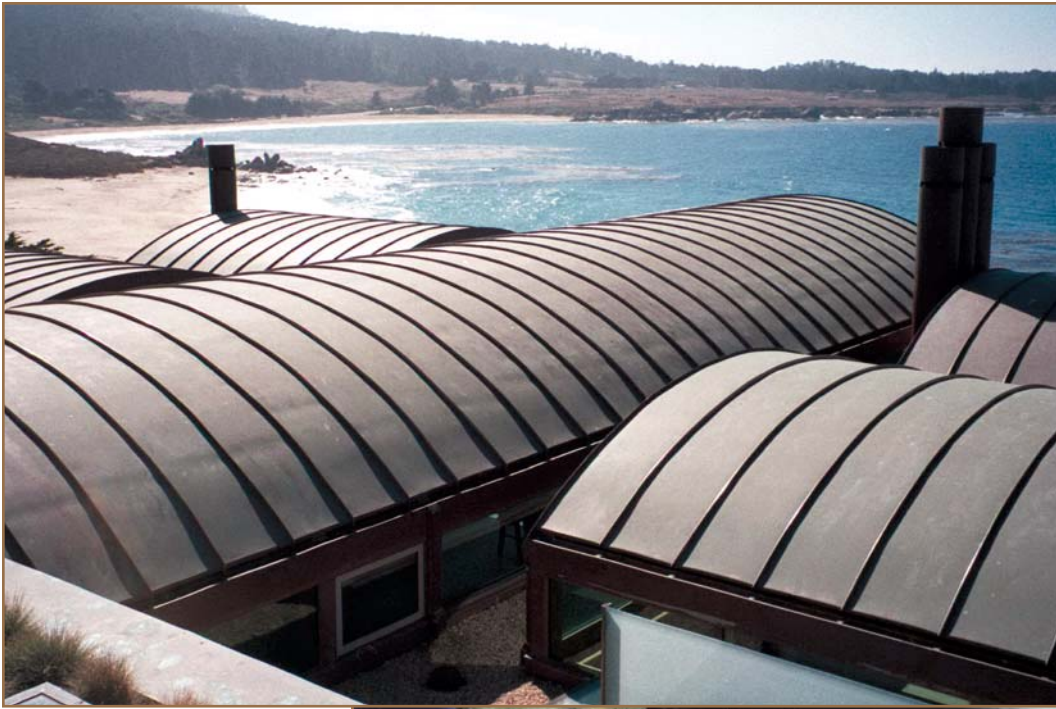
Photos 5 (left) and 6 (below) – Saturated plywood sheathing below self-adhering membrane underlayment in a non-vented barrel roof with a standing seam copper covering.

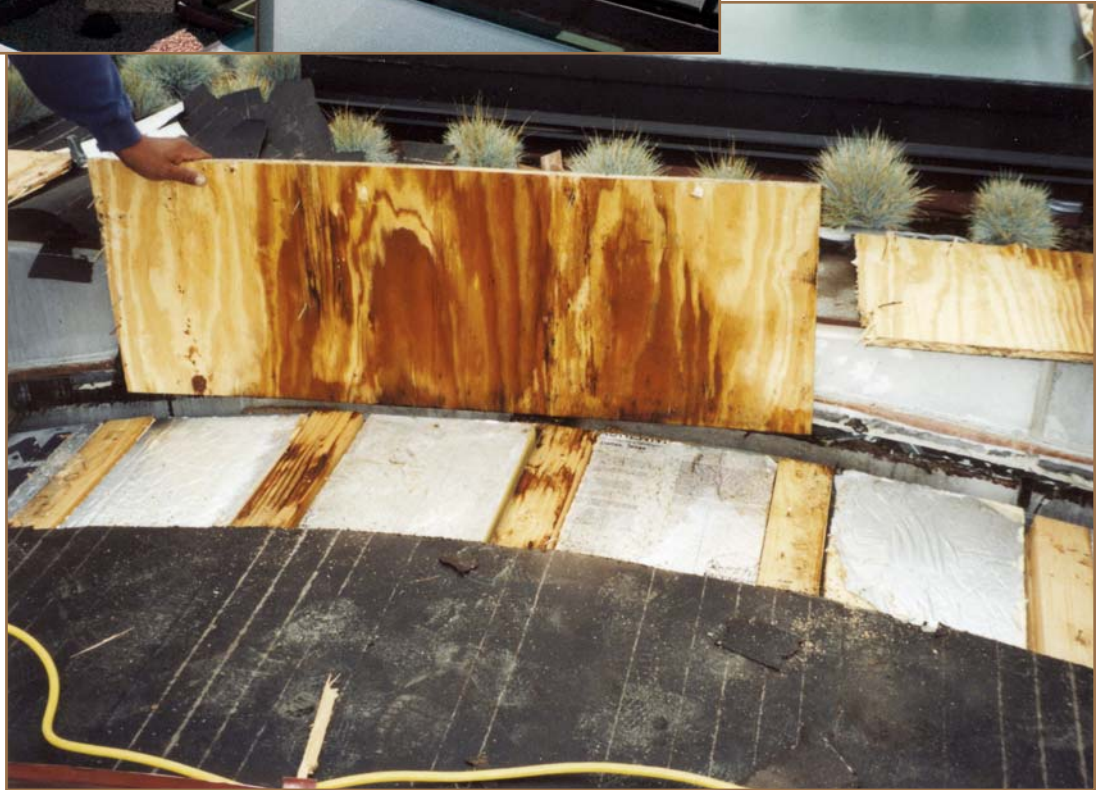
Photos 7 (left) and 8 (below) – Severe plywood deck deterioration with fungi growth caused by condensation over a laundry room in multi-family apartment building.

Figure 7 shows severe deterioration caused by water vapor migrating through the ceiling of a laundry room and condensing on “cold,” underside surfaces of a plywood roof deck above enclosed and insulated (but not vented) rafter spaces in Minnesota. Throughout the winter, water vapor in the air in the laundry room (68°F, 50% RH) migrated upward and outward through the gypsum board ceilings and into rafter spaces filled with fiberglass batt insulation and covered by the plywood roof deck. Whenever the underside of the plywood was at a temperature less than the dewpoint of the water vapor in the air inside the rafter spaces (for this example, assumed to be about 49°F), it condensed. Eventually, the plywood became wet enough (and warm enough) to support growth of wood decay fungi.
