Journal of the Roof Consultants Institute

Interface

May 2004
Vol. XXII, No. 5
\$10.00

METAL ROOFING REVISITED:

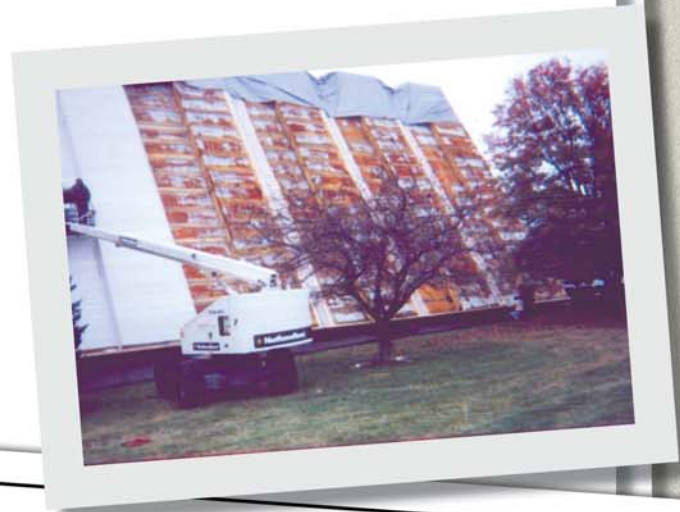
Removal of 8-foot-wide fiberglass panels and exposure of original sprayed polyurethane foam roof.

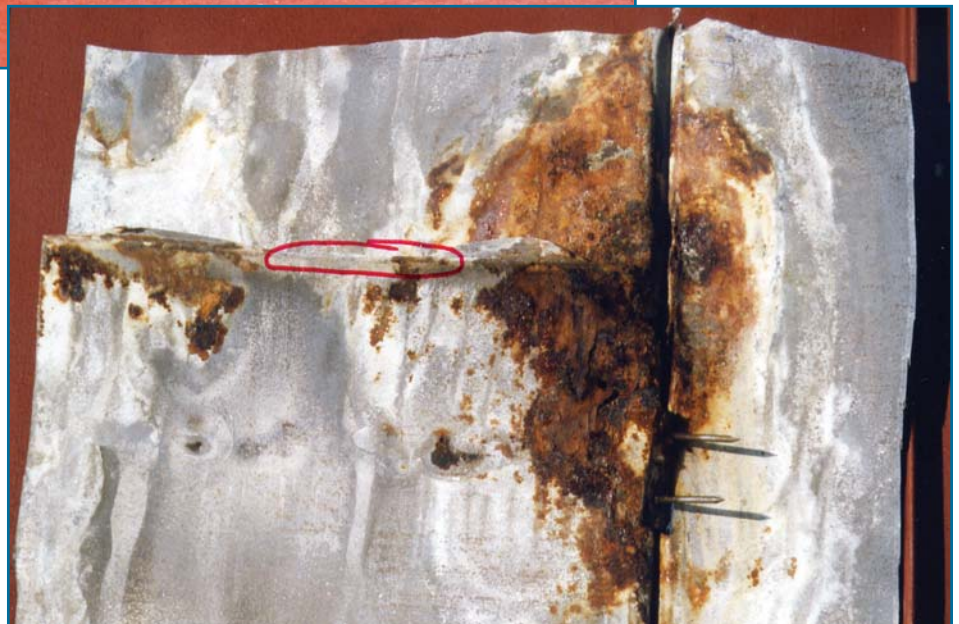
Right: Figure 9: View of the underside of the panel shown in Figure 8. The circle indicates the upper end of the down-slope panel. A panel clip with two nails occurs in the lower right portion of the photo.

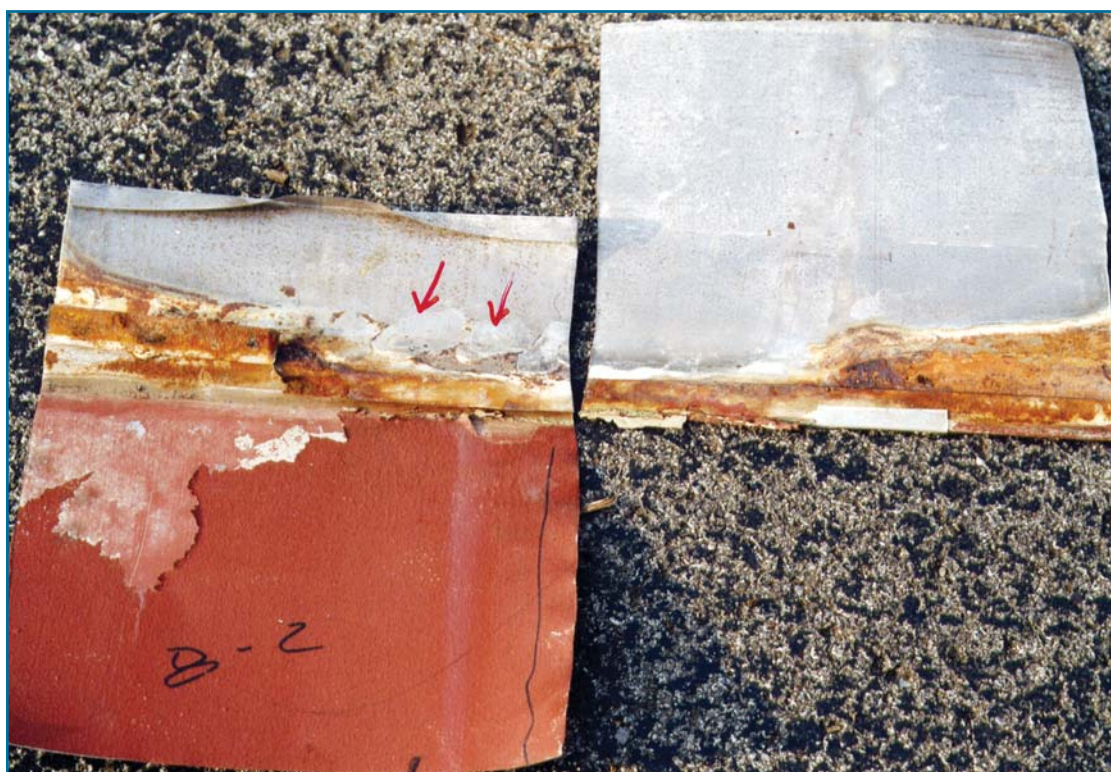
Figure 10: The left panel is the down-slope panel. The arrows indicate solder that was used to attach the lock-strip. Both sides of the lock-strip were very corroded. The right panel is the underside of the up-slope panel.

Because the corrosion attack was coming from the underside of the panels and it was in an advanced state, the panels could not be effectively repaired. To avoid damage to the OSB and wood decking, the author recommended that the entire roof covering be removed and replaced. Reroofing work commenced that fall.

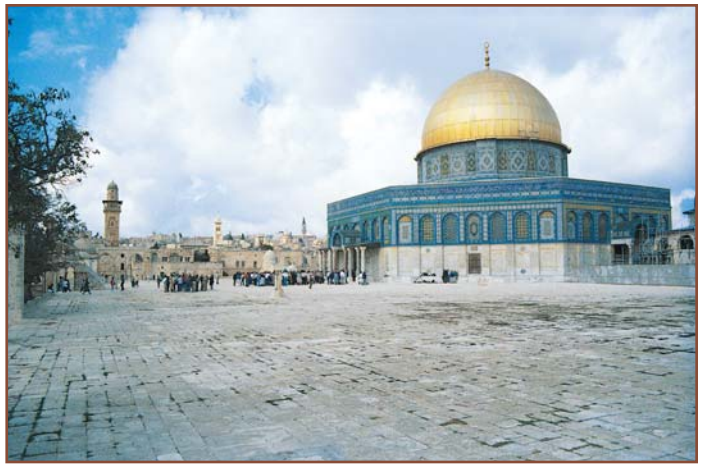
The Dome of the Rock, finished in 691 following the Turkish conquest of Jerusalem, is believed to have originally sported a gold roof. It is now gold leafed aluminum. (All photos courtesy of Metal Roof Advisory Group, Ltd.)

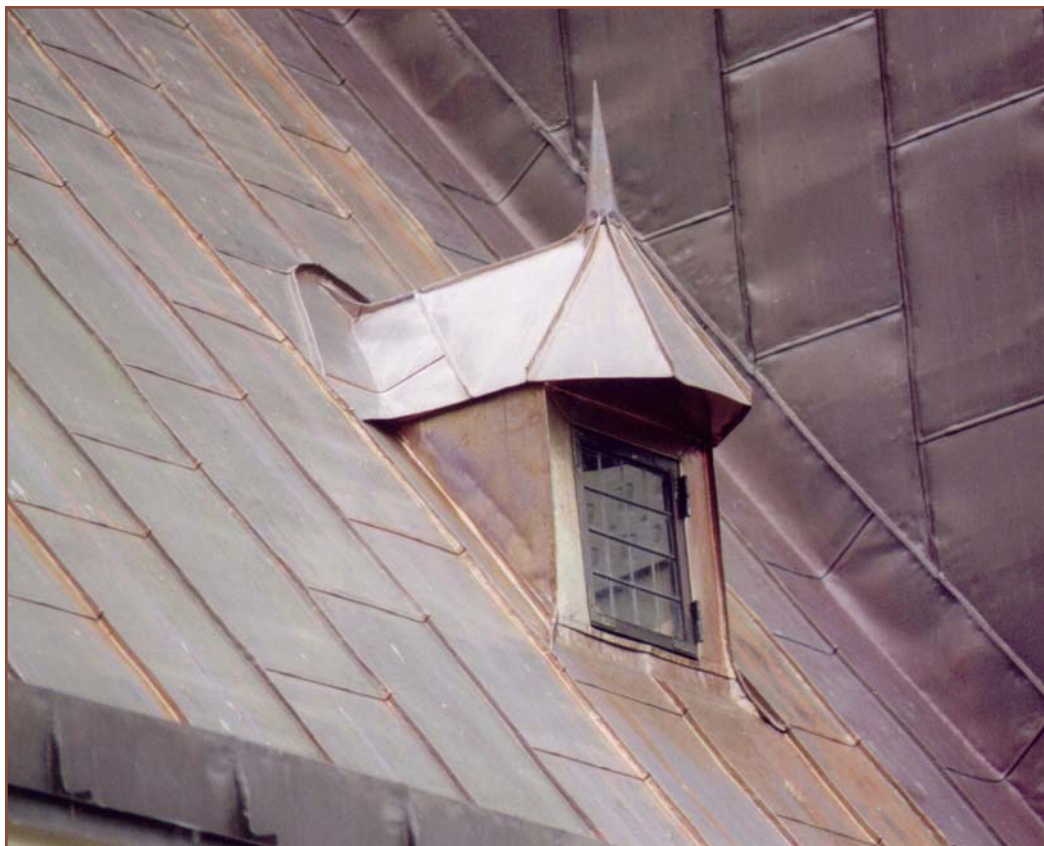
Greater detail and weather integrity can be accomplished with soft crafted metals as shown on the Kronborg Castle in Denmark.

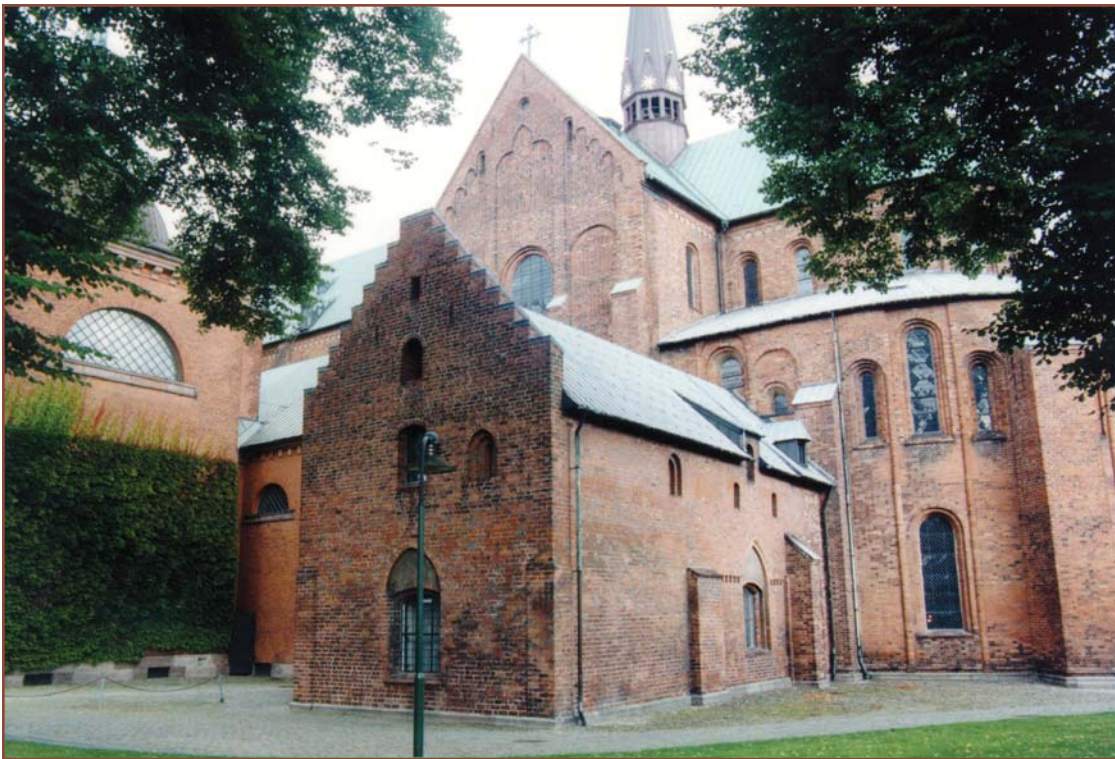
The Roskilde Cathedral in central Denmark dates back to 1170 and features a lead roof.

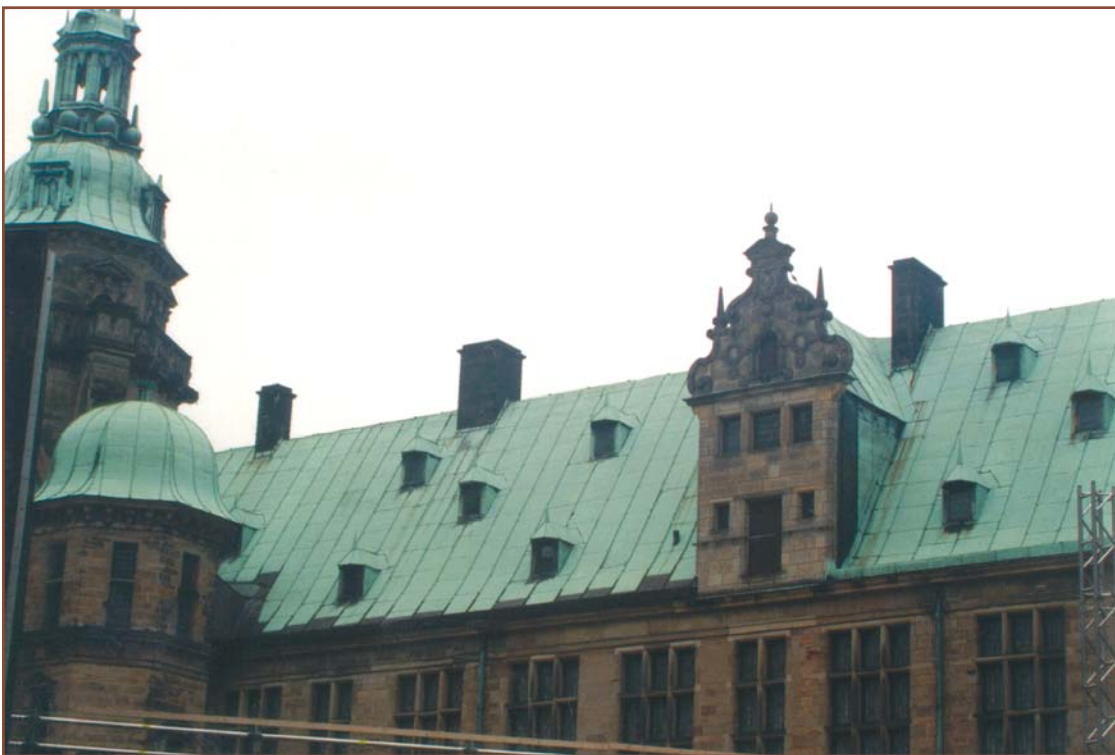
A copper roof tops the Kronborg Castle in Helsingør (Elsinore) Denmark (above, top), which was built in the 1500s and was the setting for Shakespeare's Hamlet.

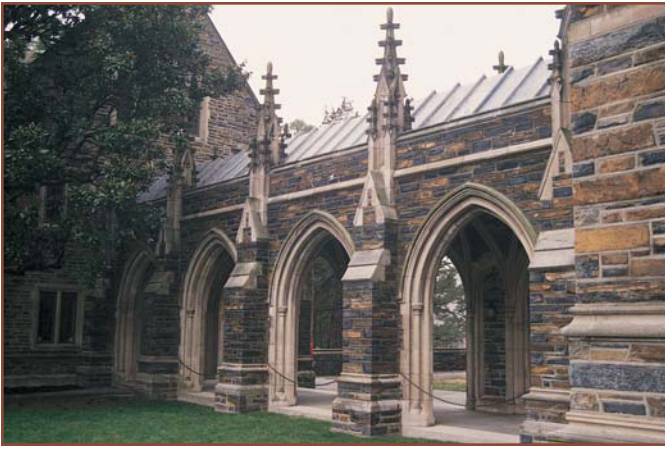
This LCC batten roll roof on the Chapel of Duke University (above) was installed in the late 1930s. The craft of metal roofing was brought to North America by such European artisans as Paul Revere.
