Brick Masonry Takes on Water

So What's New?

By
**LYLE HOGAN,
PE, RRC**

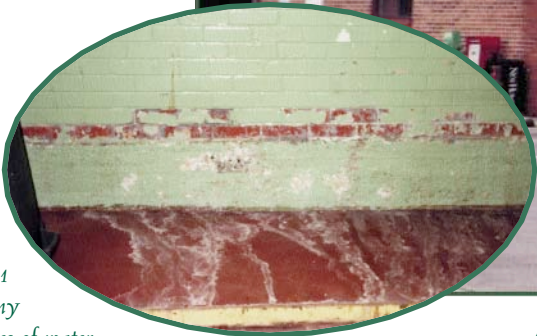
Above: Figure 2—Leaking gutters can supply a substantial amount of water for a masonry wall to absorb.

Brick construction will take on water. With or without a coating, and irrespective of the builder's talent, four inches of brick masonry will not stop wind-driven rain¹. Blowing rain can bypass eave overhangs and influence areas of a wall that do not routinely experience wetting. Leaking gutters (Figure 2) also supply a substantial amount of water for a masonry wall to absorb.

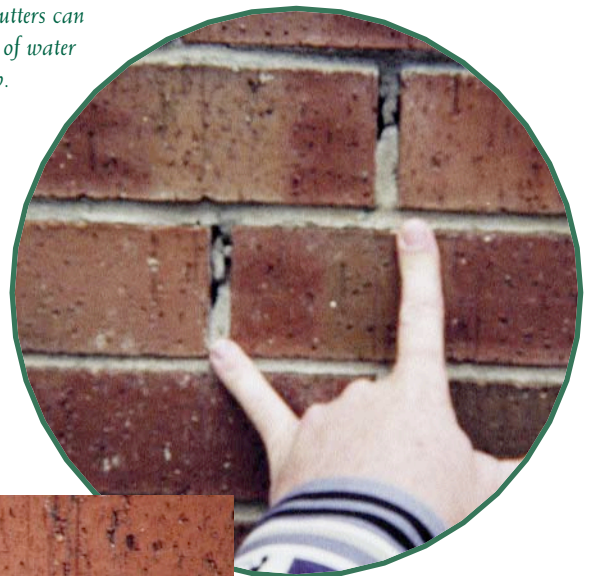
Above: Figure 3—Improperly filled mortar joints will admit significant amounts of water.

Improperly tooled joints will admit significant amounts of water (Figure 3). Inadequately filled head joints are a common observation. Wire reinforcing within mortar joints is sometimes arranged too close to the outside face (Figure 4). This causes the thin mortar cover to break away, resulting in yet

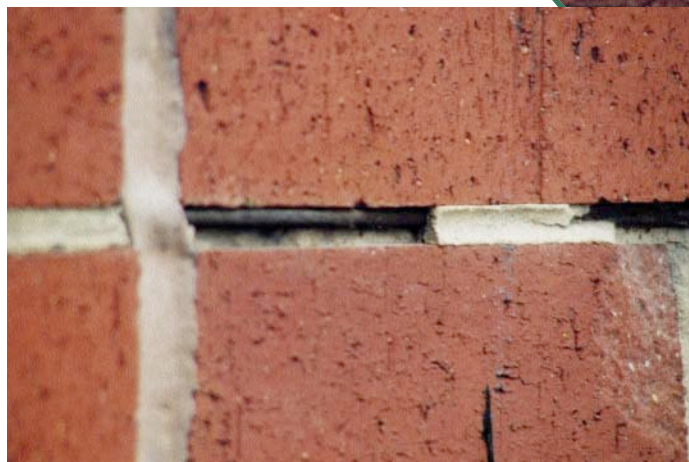
Figure 4—Wire reinforcing within mortar joints is sometimes arranged too close to the outside. This causes the thin mortar cover to break away, resulting in more avenues for water entry.

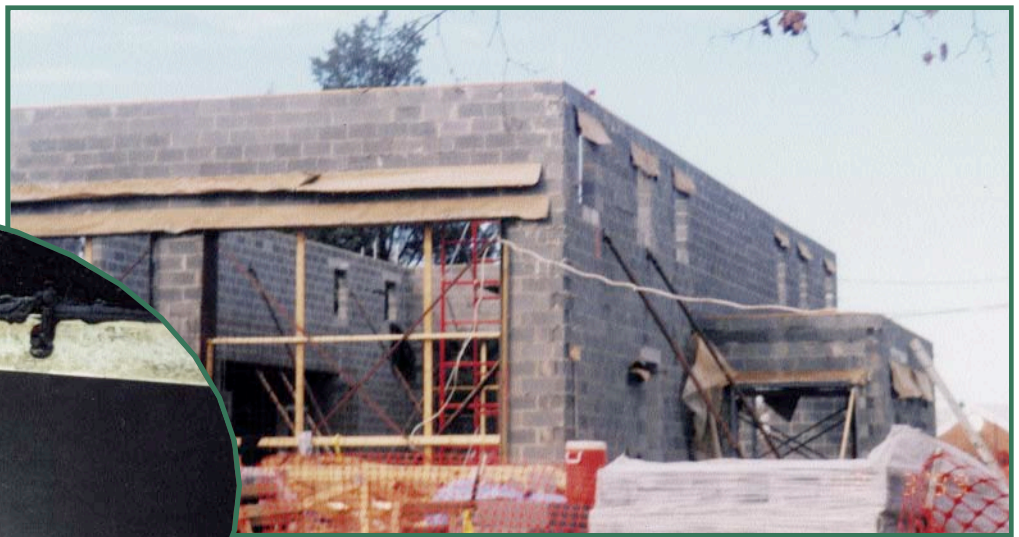
Figure 12—Asphalt-coated copper is now in wide use as the thru-wall flashing. It is easy to shape and can offer functional diversion of water when formed as a continuous component.

Polymeric membrane products have been successfully substituted for conventional thru-wall metals (Figure 11). These membranes are usually PVC (polyvinyl chloride), although long-term durability in such application has been questioned. Asphalt-coated copper is also in wide use as a thru-wall component (Figure 12). It is easy to shape and can offer functional diversion of water.
