Using Infrared Thermography to Determine the Presence and Correct Placement of Grouted Cells in

SINGLE-WYTHE CONCRETE MASONRY UNIT (CMU) WALLS

By Gregory R. Stockton and Lee R. Allen

Reprinted, with permission, from Volume 3700 *Thermosense XXI, The Proceedings of SPIE-The International Society for Optical Engineering*, 1999.

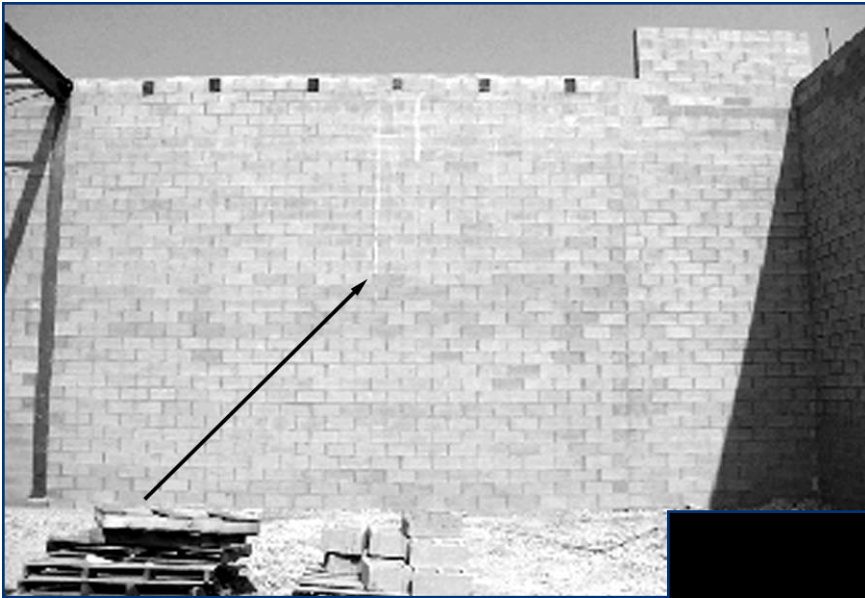
Figures 1 and 2) Photograph and thermograph of CMU wall with excess grout.

save the expense of putting a highly skilled supervisor on the job. His past experiences tell him to concentrate on what "shows." If the grouting and reinforcement of the walls are of great concern, the GC will lay out the building for his masons. We often find quite a bit of wasted grout in "over-poured" walls. This is due to a long-perceived notion that too much concrete is always better. However, owners concerned about heating and cooling costs do not want excess grouting in the walls, since it displaces the amount of insulation that can be installed. See *Figures 1 and 2.*
