Pushing the Building Envelope...

Below Grade

By Phil Haisley, AIA

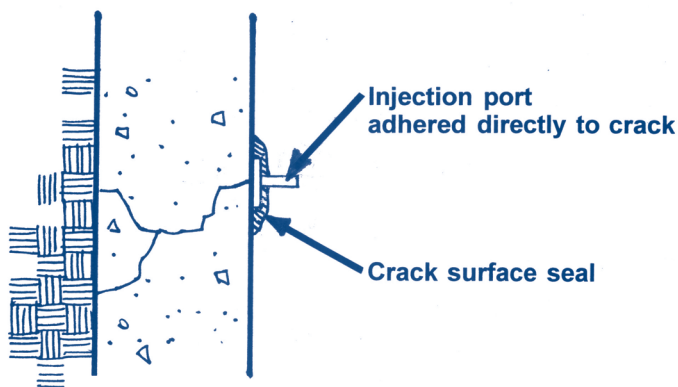
Epoxy Injection Port

Figure 2: Epoxy Injection Port. Ports are glued to the face of the crack with epoxy, then the face of the exposed crack is sealed with epoxy between ports to force resin into the wall and prevent resin loss on the working side.

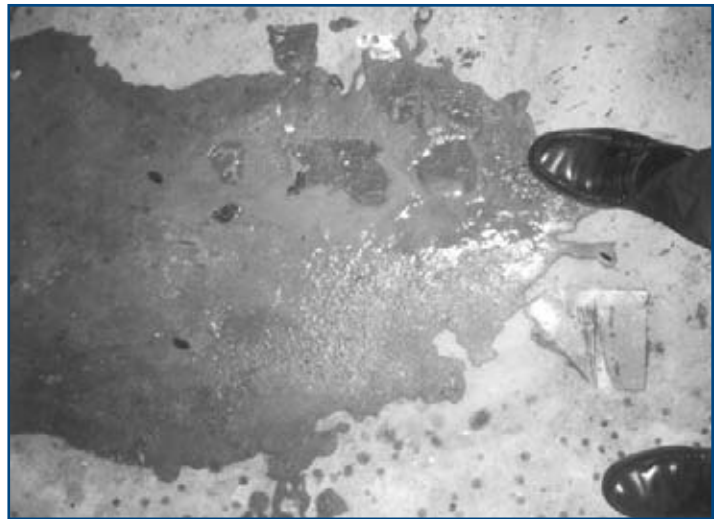
Figure 3: An underground, stream-washed bentonite waterproofing from the foundation wall and through cracks in below-grade walls of this Honolulu parking structure resulted in a slick slurry of clay on the parking deck. (Photo by Phil Haisley)

exterior side. Persistent leaks developed and worsened over time, leaving slick streams and a slurry of bentonite clay on the decks (Figure 3). Water streamed in through joints in the foundation slab (Figure 4) and through cracks in walls (Figure 5). Investigation of subsurface conditions suggested that an intermittent sub-surface stream had scoured bentonite material from exterior surfaces, resulting in periodic leaks at upper levels and chronic leaks at lower levels. The injection contractor managed to alleviate the leak problems with two rounds of low-pressure epoxy injection, spaced one year apart, even though leaks were active and cracks were contaminated with bentonite. The second round of injection work was completed approximately two years ago, and formerly wet, treacherous areas are presently dry (Figures 6 and 7).

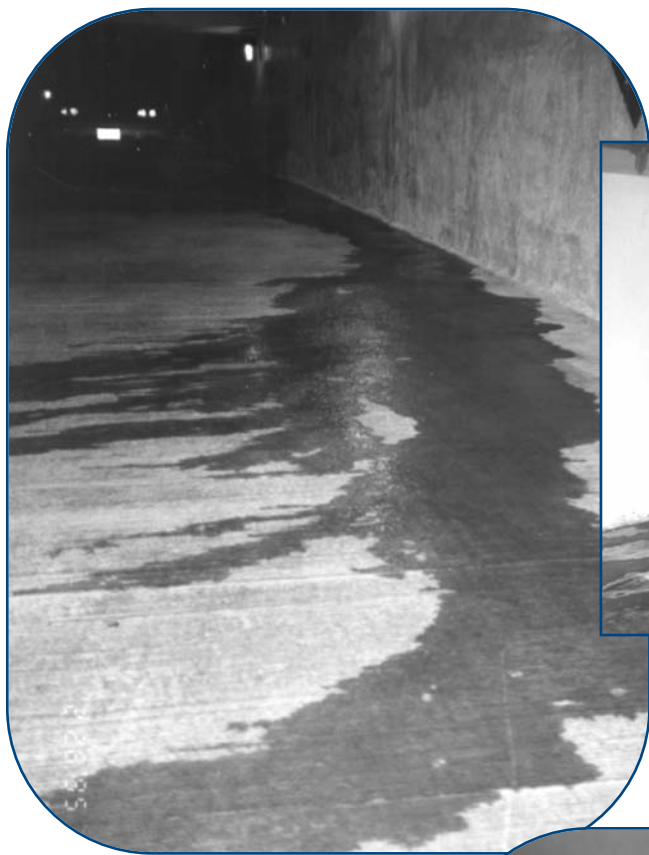
Figure 4: Above, hydrostatic pressure forced water through construction joints between the slab and foundation wall. This slab is approximately 15-20 feet below the water table. (Photo by Phil Haisley.)

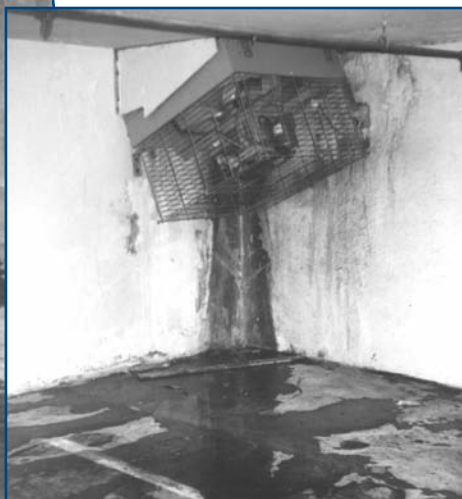
Figure 5: Above, a constant stream of water down this ventilation shaft and through two levels of parking resulted from waterproofing failure at cracks through foundation walls. (Photo by Phil Haisley.)

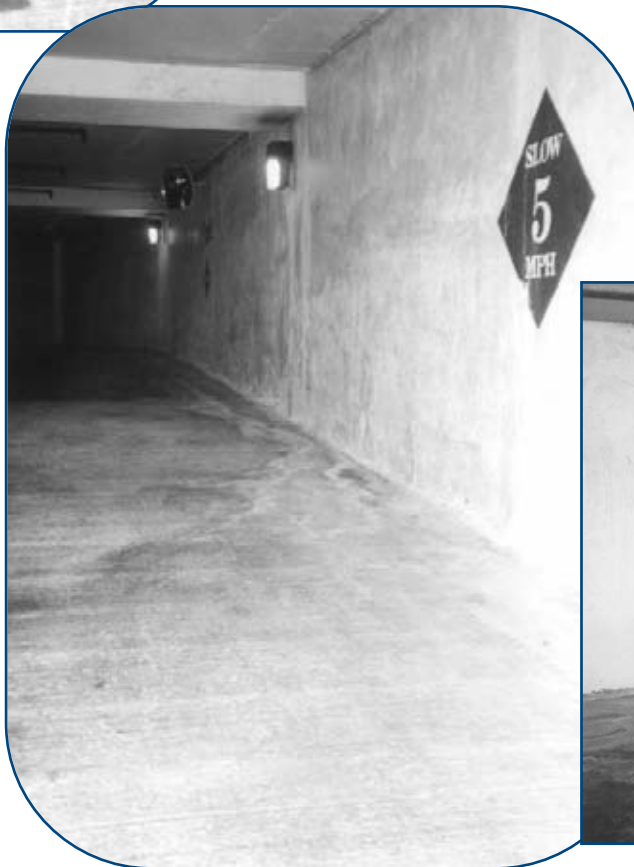
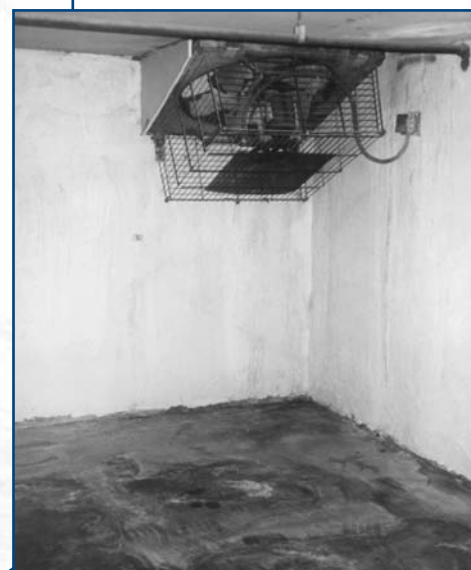
Figure 6: Above, left, epoxy injection sealed the leaking construction joint shown in Figure 4 against static pressure of the surrounding water table. Figure 7, above, right: Wet, treacherous areas around the base of the ventilation shaft shown in Figure 5 are dry after epoxy injection of wall cracks, although leaks were continuously active, and cracks were contaminated with bentonite. (Photos by Phil Haisley.)

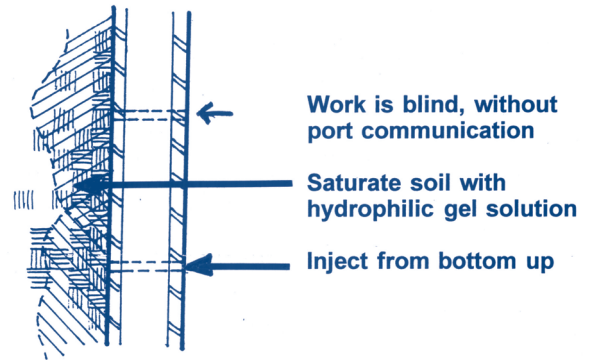
Polyurethane Gel Soil Barrier

Figure 8: Gel injection through porous walls can fill voids and saturate back-fill materials, forming a flexible blind-side seal to repair breaks in existing waterproofing membranes.

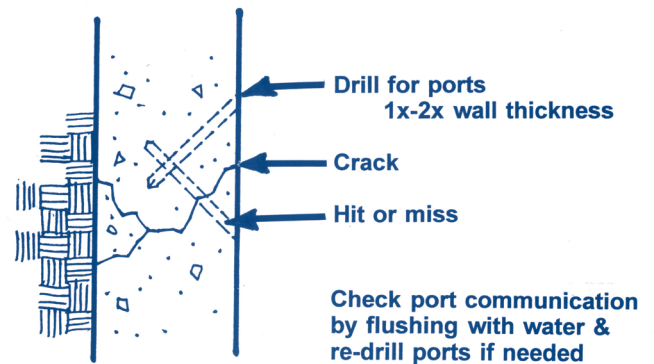
Ports for Grouts & Gels

Figure 9: Injectors or "packers" are secured into drilled holes for chemical foam or gel injection. Holes are normally drilled at an angle designed to intersect the crack just beyond the mid-point of the wall thickness. Alternating ports on either side of the crack help ensure that ports will not miss cracks that are not perpendicular to the wall surface.

Injection ports for gels and foams are usually drilled through cracks at an angle alternating from either side with the goal to intersect the crack just beyond the center of the wall or slab. Port spacing can start at a wider spacing than with epoxy injection (2x wall depth) if there is good communication between ports. Drilled injection holes are blown or vacuumed, and cracks

can be flushed with lots of fresh water (150-750 psi) to clean cracks and check port communication. If cracks are "missed," (see Figure 9), the ports can be re-drilled at a closer spacing (1x depth).

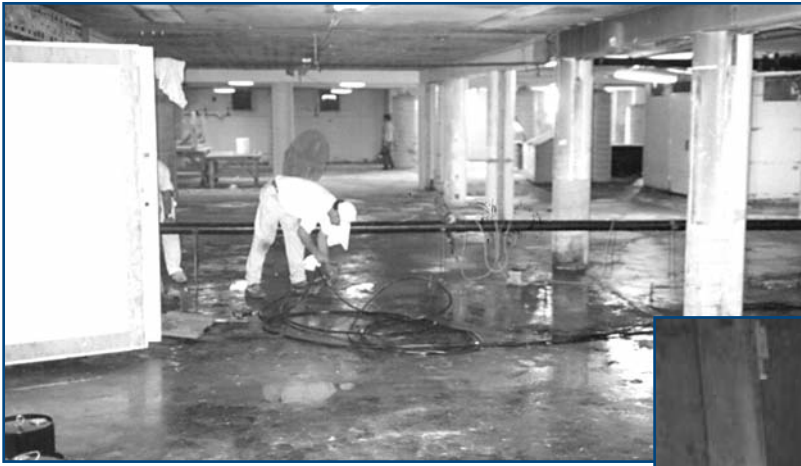
Figure 10: Standing water in the Waikiki basement above came and went with the tide, through slab cracks, foundation walls, broken floor rains, and sump pits. (Photo by Structural Systems Inc.)

In Waikiki, the water table is just below grade elevation. Because land is at a premium and building heights are restricted, basements and basement leak problems are not unusual. Even half basements are prone to fluctuating hydrostatic pressures up to three feet above finished floor at high tide. The shallow basement of one such hotel was plagued for years by seepage through spreading slab cracks, broken floor drains, and persistent standing water

on floors (Figure 10). The injection contractor managed to bring leak problems under control by first filling cracks with polyurethane foam, then injecting through the slab to establish gel barriers behind leaking cracks. (Figure 11 shows slab after injection.)

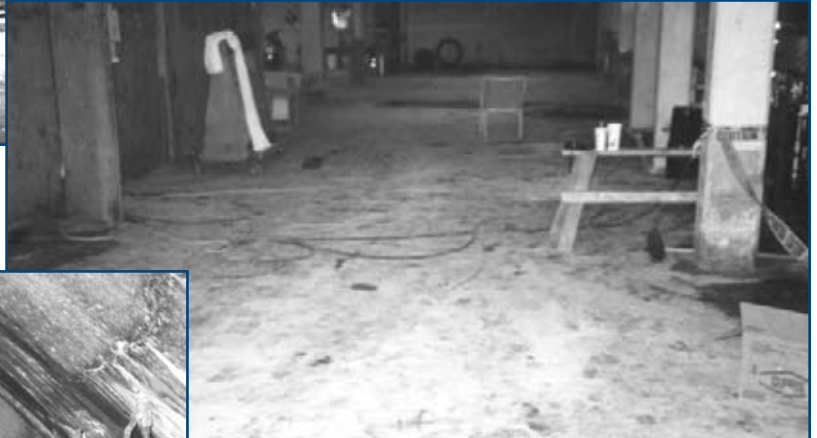
Figure 11: Above, the same basement slab shown in Figure 10 after a combination of gel and foam injection sealed slab cracks and created a soil barrier under the slab and around sump pits. (Photo by Structural Systems Inc)

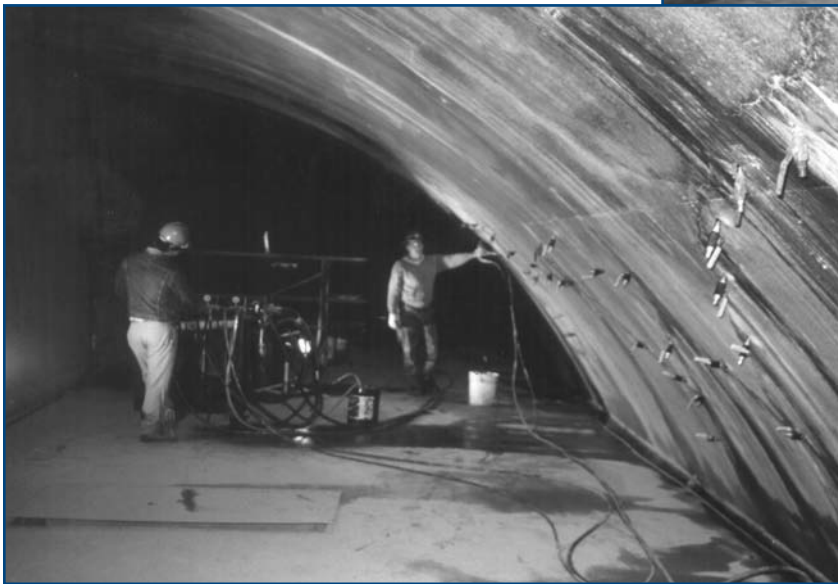
Figure 12: Waterproofing was "value-engineered" out of this highway tunnel project! Injection chemicals solved subsequent water intrusion problems at cracks through the concrete vault. (Photo by Structural Systems Inc.)

Vertical and overhead gel injection was required to stop leaks through a highway tunnel in the Koʻolau mountain range (Figure 12). Ordinarily, no crack seal is required; excess foam can simply be cleaned from exposed surfaces (Figure 13). In this case, surfaces were tiled after cleaning. The effectiveness of hydrophilic polyurethane in high volume leak conditions is demonstrated in waterproofing repair at tie-back anchor penetrations for a high-rise office tower in downtown Honolulu. The parking structure is entirely below grade with foundations extending well below the water table at sea level. The Pacific Ocean was determined to drain into the building excavation around and through casings for foundation tiebacks. The injection contractor stopped the flow by using fast-reacting mixture and stuffing openings with rags and oakum long enough to get the chemicals into the active leaks (Figure 14).

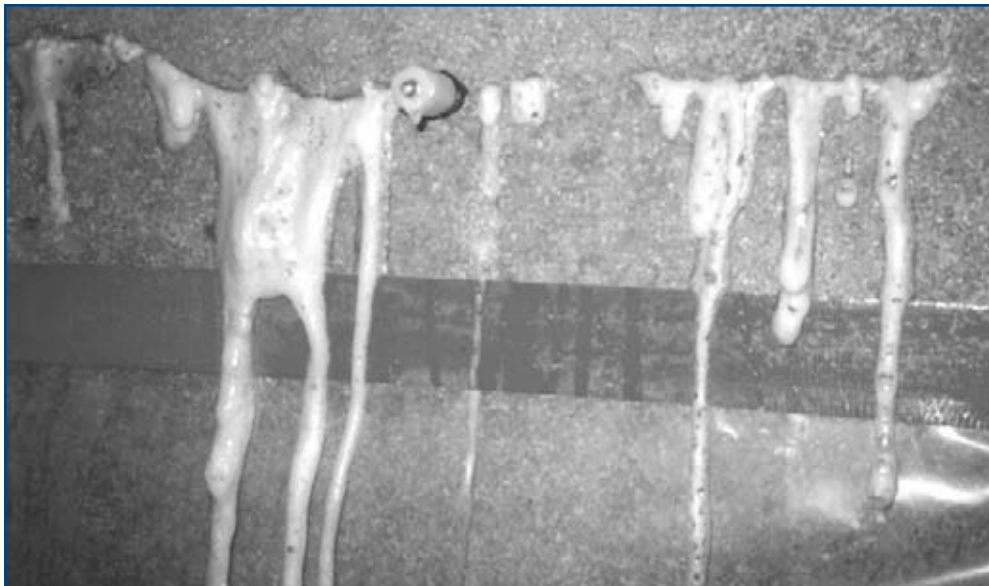
Figure 13: Surfaces of cracks are typically left unsealed for chemical injection. Ports are flushed with water to clean cracks and check communication between ports and are then injected until cracks are filled with chemical. Surface residues are easily cleaned after injection resins cure. (Photo by Structural Systems Inc.)

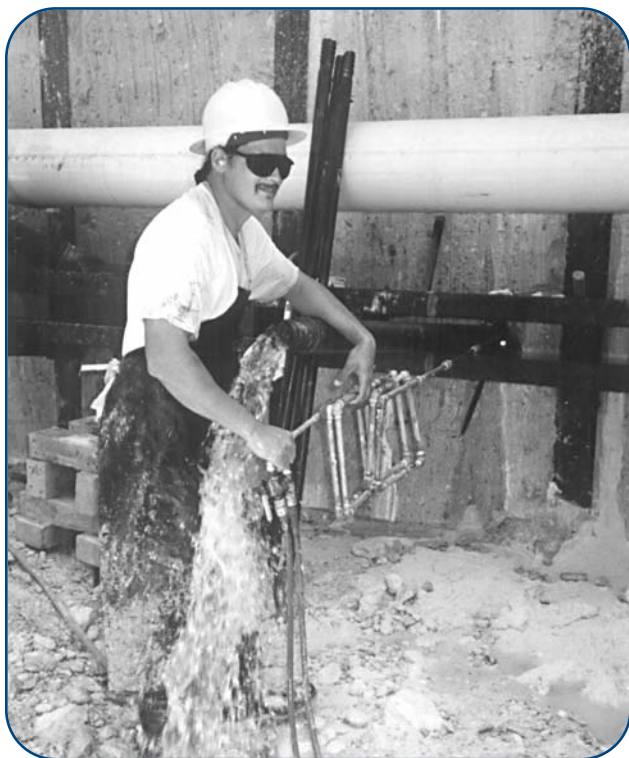
Figure 14: Water forces its way around casings for tie-back anchors and into a below sea-level excavation during construction of a Honolulu high-rise office tower. The injection contractor stemmed the flow with rags and oakum long enough to permit injection of fast-reacting chemicals around casings. Leaks were stopped and construction proceeded. (Photo by Structural Systems Inc.)

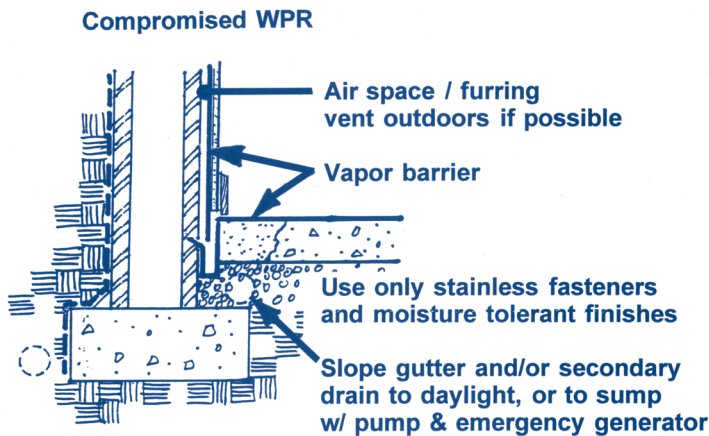
Cavity Wall drainage

Figure 15: As a last resort, a drained cavity wall can intercept leaks and direct water away from occupied spaces. Careful design, construction, and maintenance, along with appropriate selection of materials are needed to limit the potential for microbial growth in concealed spaces.

If leaks cannot be stopped, a drained cavity wall might be created by installing a new wall over the leaking below-grade wall with furring strips to provide space for drainage and a sloping gutter in the base of the wall cavity to direct water to drain (see Figure 15). If drainage is to a sump, an emergency generator should be incorporated to handle storm water during power outages. There are some serious risks assumed when taking this approach: Problems are not corrected but concealed. Microbial contamination may proliferate in cavities. Corrosion can eat away at the structure, wall supports, or drainage system with damage going unobserved. If attempted, be sure to:

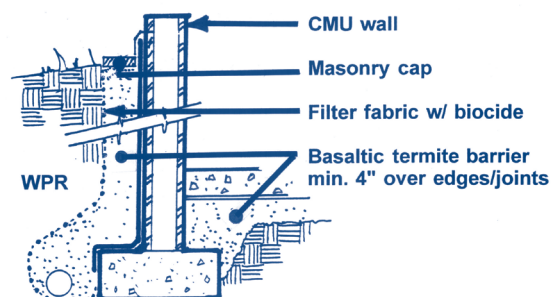
BTB Drainage Course

Figure 16: Subterranean termites can enter structures through, around, and behind waterproofing or foundation joints. Access can be blocked by use of Basaltic Termite Barrier as a backfill and drainage material, protecting both the waterproofing and the building.

A hillside Honolulu home suffered severe termite damage at upper-level wood framing and water intrusion to lower levels due to termite entry through CMU retaining walls. The upslope side of foundation walls was completely excavated, and a new, fluid-applied coating, drainage course, and protection board were applied down to the edge of footings. The excavation was back-filled with BTB to protect waterproofing and its edges below grade. It has been more than six years since work was completed without a sign of termites. See Figure 16 for an illustration of a typical BTB application to protect below-grade waterproofing.
