Cold Weather Considerations for Glass-reinforced Asphalt Shingles

By Raymond L. Corbin and L. D. Hogan

Glass-reinforced, asphalt shingles are designed for application in a wide range of weather conditions; however, care should always be exercised whenever approaching climate extremes. While there are also hot weather precautions, this article focuses on matters of cold weather application.

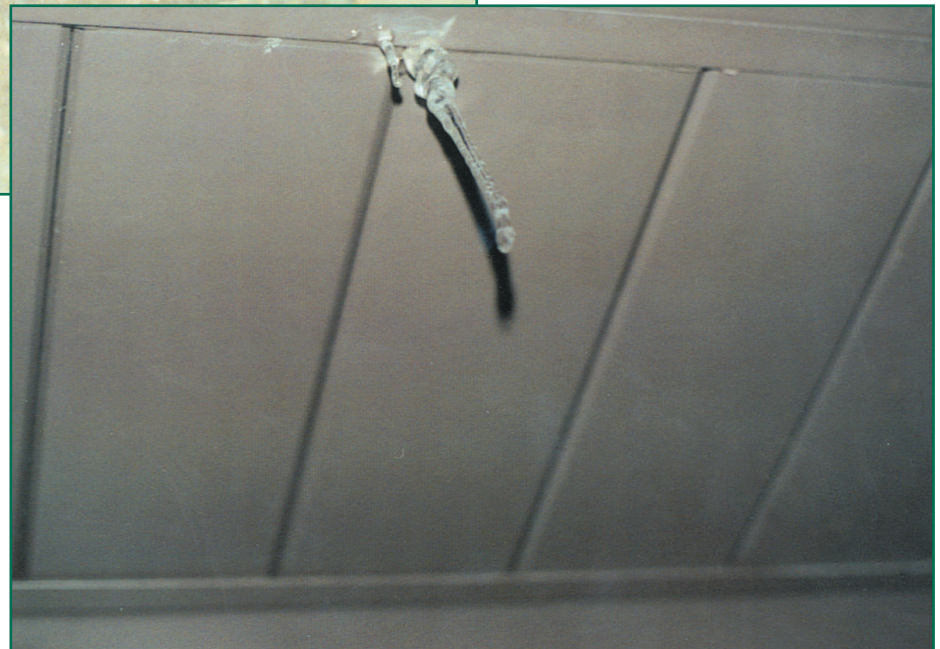
Figure 1A and 1B (below)—Ice damming on a roof where ice and water membrane was not provided.

Ice dams can form elsewhere on the roof, and waterproofing measures may be required on areas other than the eaves. Features giving off shadows (such as large roof projections, dormers, and higher roof levels) are prone to foster ice damming. These areas are blocked from the sun and can re-freeze, causing an ice dam and resultant leakage. *Figure 1* depicts ice damming on a roof where an ice and water membrane was not provided.

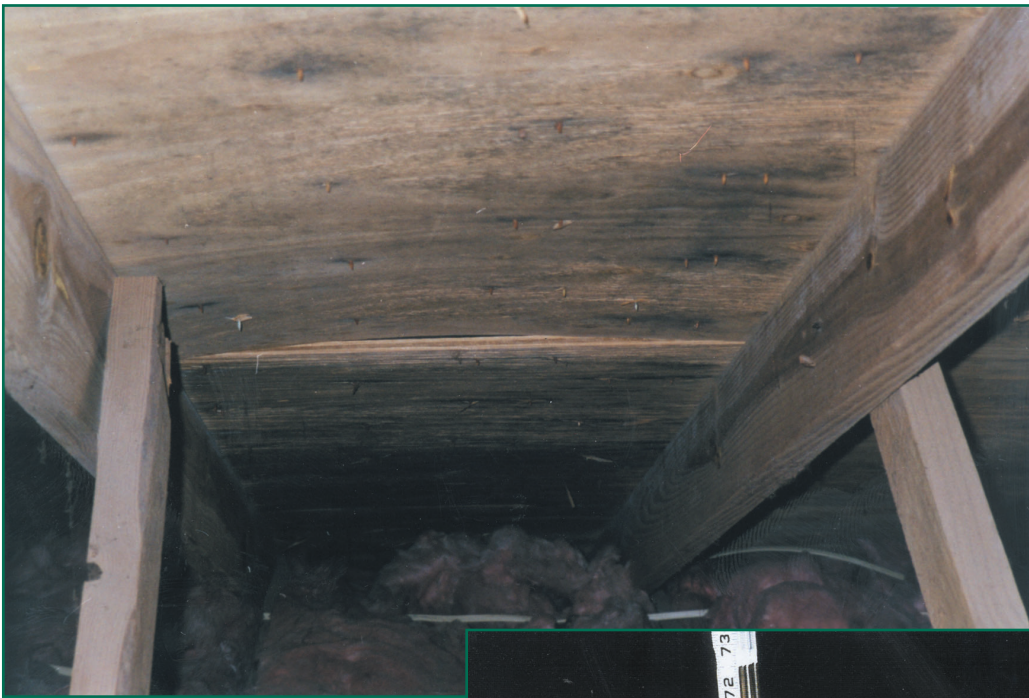
Figure 2—Moisture will accumulate in a wood deck long before water droplets are formed. Note the buckled plywood deck, mold formation, and soffit region blocked with glass fiber insulation

- decayed wood;
- expansion, warping, and buckling of the sheathing (Figure 2); and
- dripping into the building interior⁵

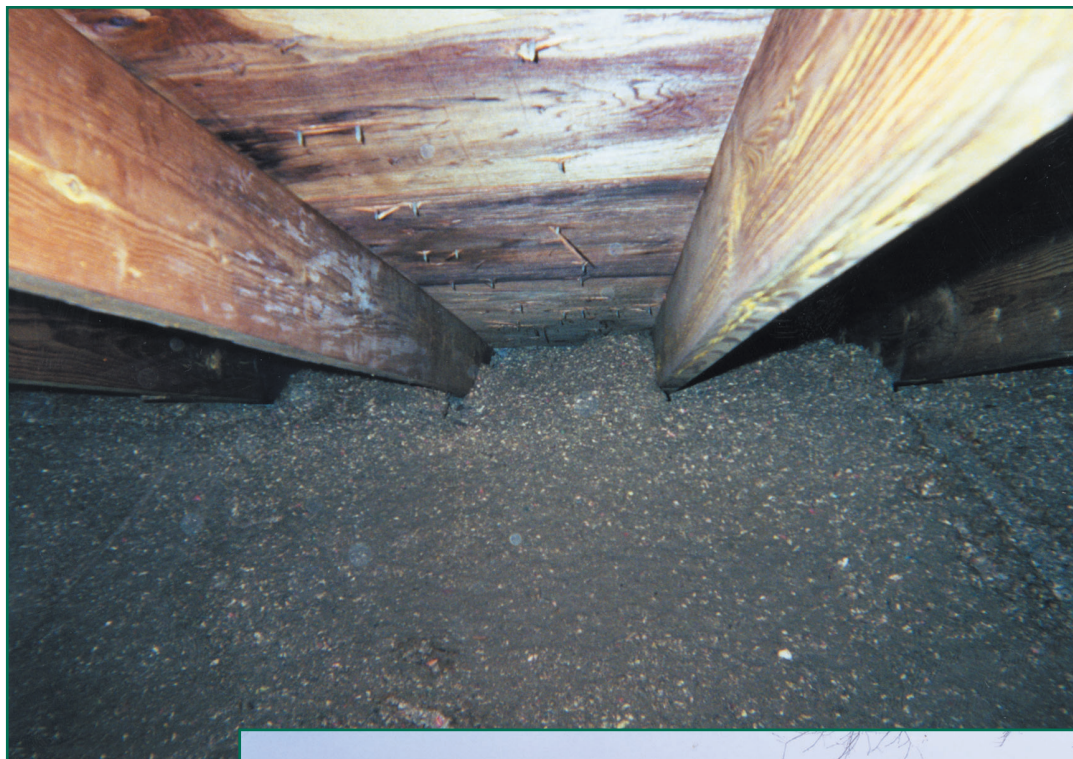
Figure 4—Attic insulation must be held back from the soffit region in order to serve as the intake port. A pre-manufactured baffle can be used to keep blown-in insulation from becoming a ventilation impediment.

Attic insulation must be held back from the soffit region in order to serve as the intake port (Figure 4), and blown-in insulation is routinely over-sprayed into the eaves. A tightly-installed air barrier can reduce the tendency of the insulation to fill the cathedral passageway. It also increases the net insulating ability of the fiberglass insulation by keeping airflow away from it. A pre-manufactured baffle can also be used to keep blown-in insulation from becoming a ventilation impediment.

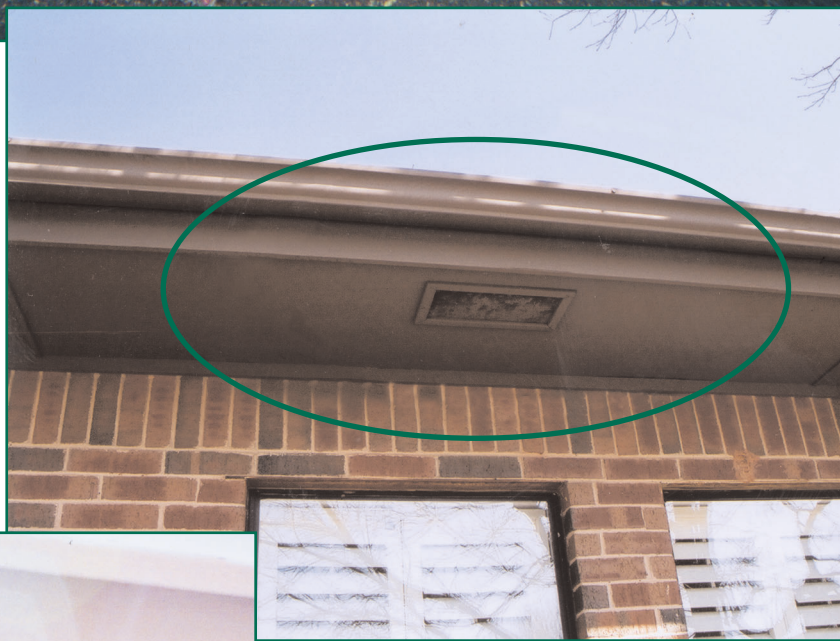
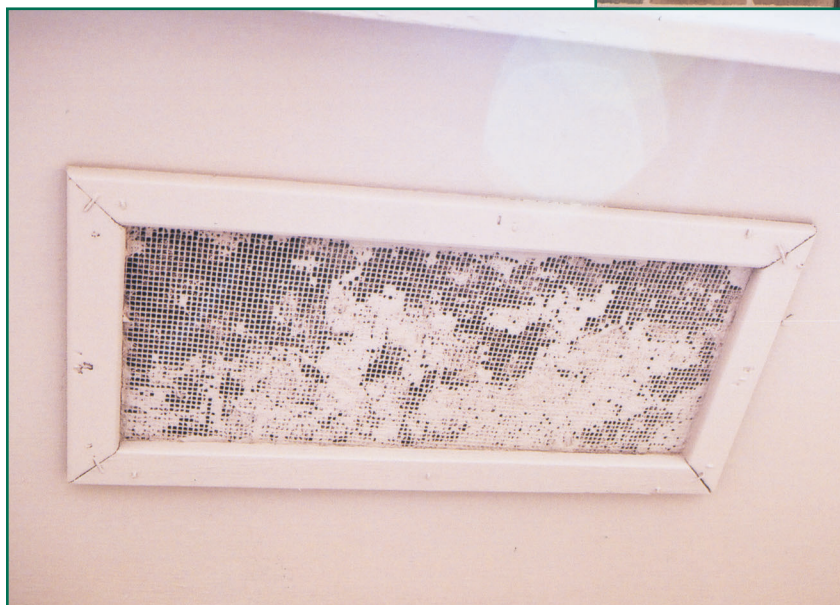
Figures 5a and 5b—Multiple coats of paint can render soffit openings virtually useless. Airways and vent openings should be slightly larger than would be implied in the sizing calculation.

It should be noted that screens and louvers placed over vents reduce the effective airflow. Similarly, multiple coats of paint can render soffit openings virtually useless (Figures 5a and 5b). Other

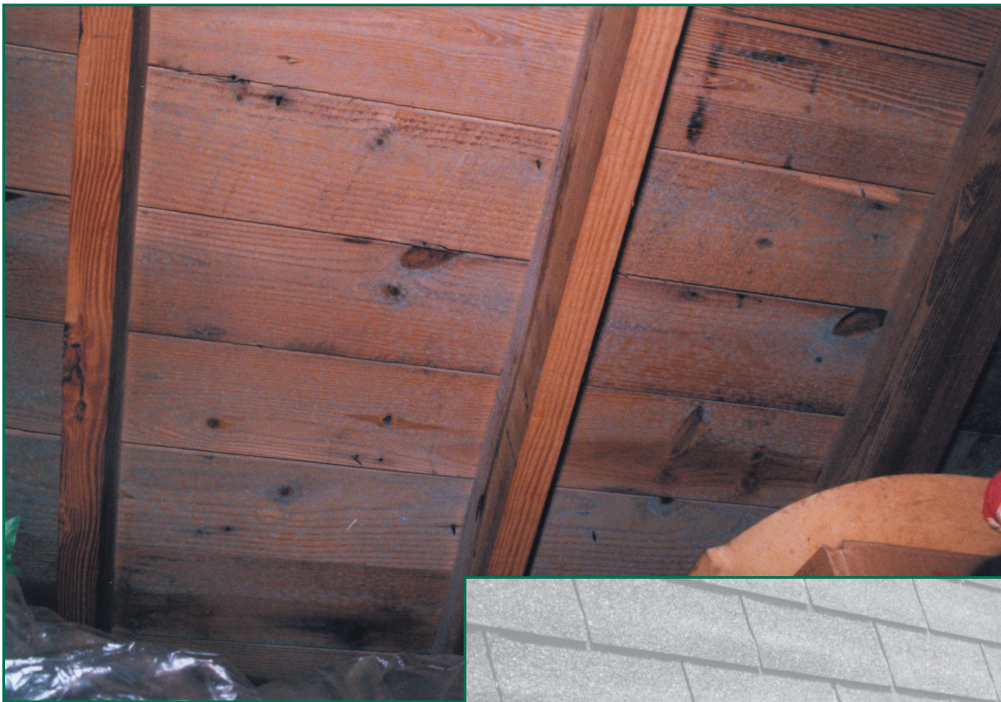
Figure 6—Mold/mildew in a humid southern climate. While attic insulation was properly held back at the edge and openings were present in the soffit cladding, the eaves carpentry was continuous along the entire perimeter. The mold/mildew colonies were fostered during a wintertime condensation scenario, drying to the powder during the hot season as shown.

conditions have impact on venting effectiveness. Figure 6 depicts a mold/mildew occurrence in a humid, southern climate (hot and dry at the time of the study). Attic insulation was properly held back at the edge, and the openings were present in the vinyl soffit cladding. However, carpentry was continuous along the eaves, so the soffit feature was completely useless. The mold/mildew colonies were fostered from a wintertime condensation scenario, drying to the powder shown during the hot season.
