# Cold Weather Considerations for Glass-reinforced Asphalt Shingles

By Raymond L. Corbin and L. D. Hogan

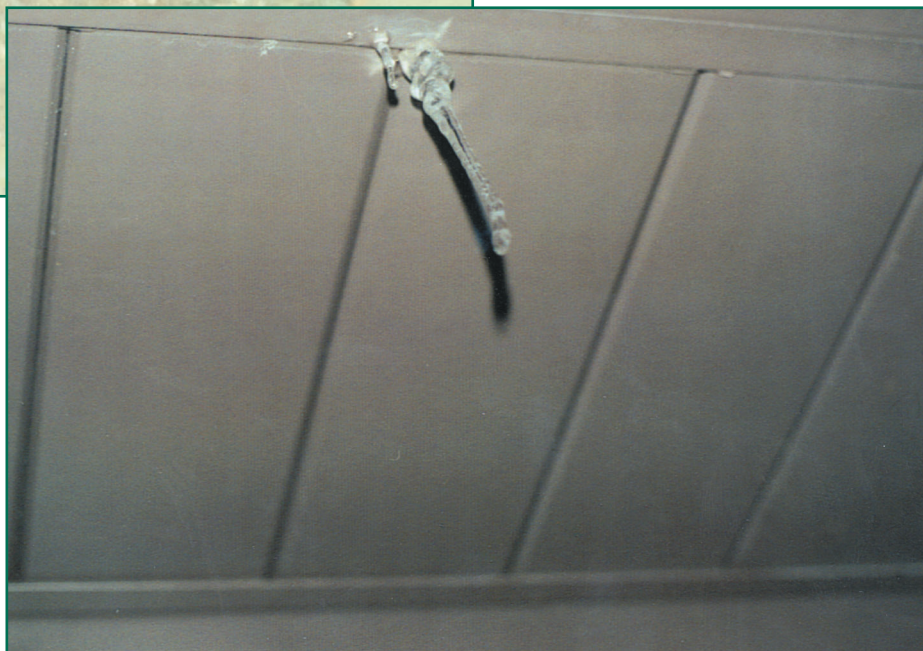
Figure 1A and 1B (below)—Ice damming on a roof where ice and water membrane was not provided.

Ice dams can form elsewhere on the roof, and waterproofing measures may be required on areas other than the eaves. Features giving off shadows (such as large roof projections, dormers, and higher roof levels) are prone to foster ice damming. These areas are blocked from the sun and can re-freeze, causing an ice dam and resultant leakage. *Figure 1* depicts ice damming on a roof where an ice and water membrane was not provided.

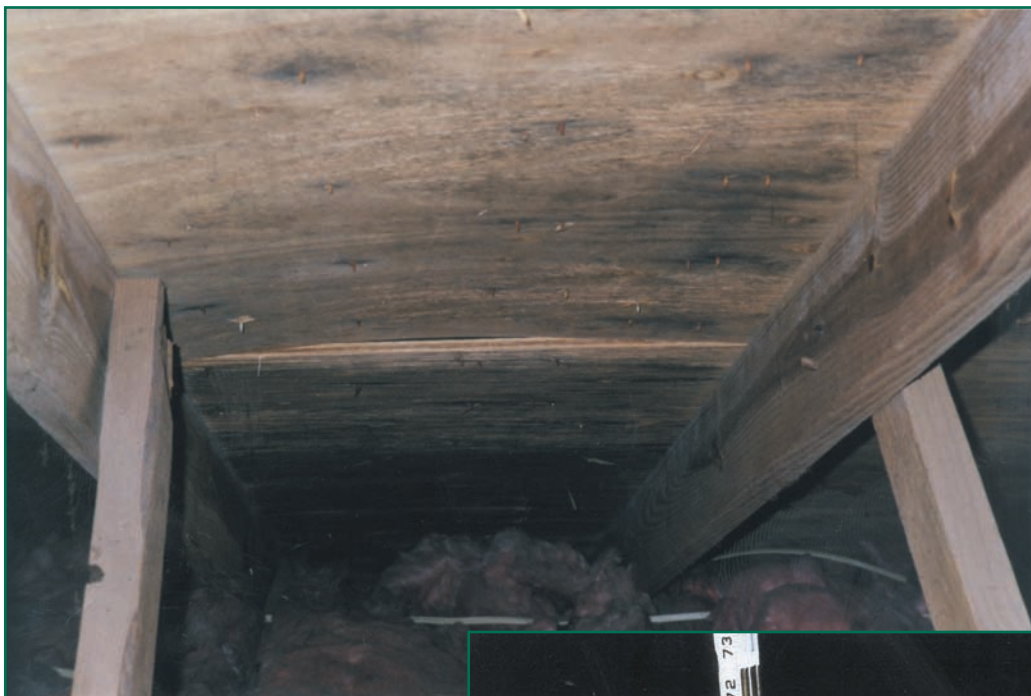
*Figure 2—Moisture will accumulate in a wood deck long before water droplets are formed. Note the buckled plywood deck, mold formation, and soffit region blocked with glass fiber insulation*

- decayed wood;
- expansion, warping, and buckling of the sheathing (Figure 2); and
- dripping into the building interior<sup>5</sup>

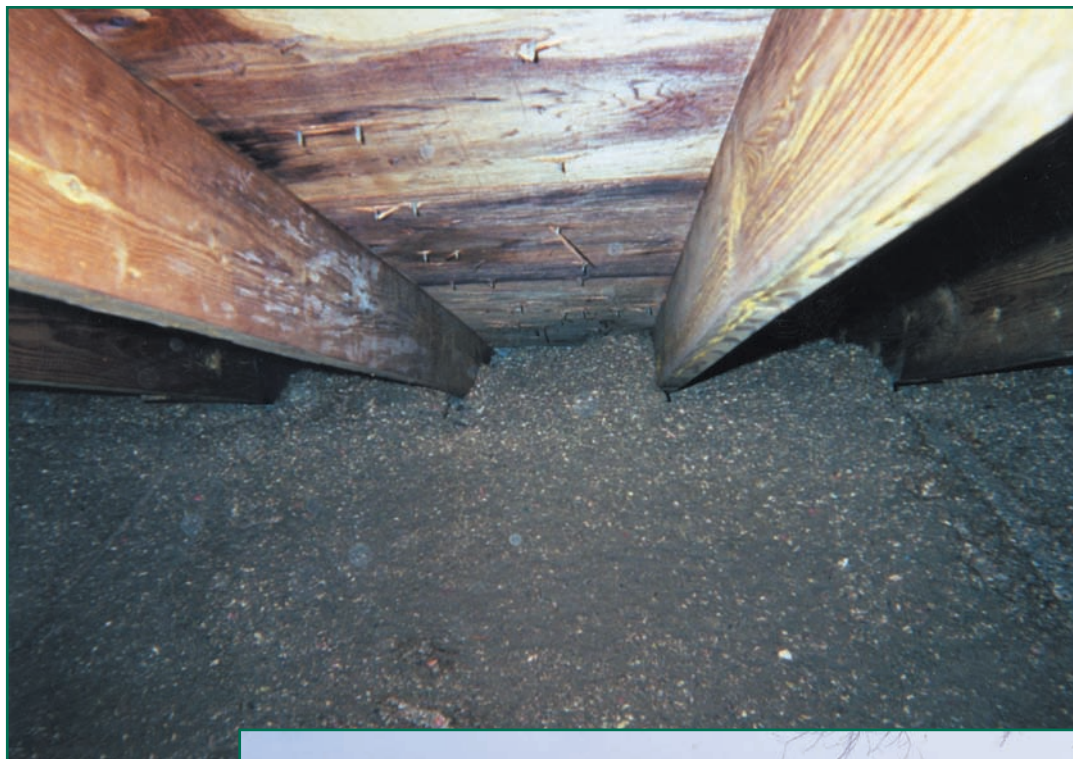
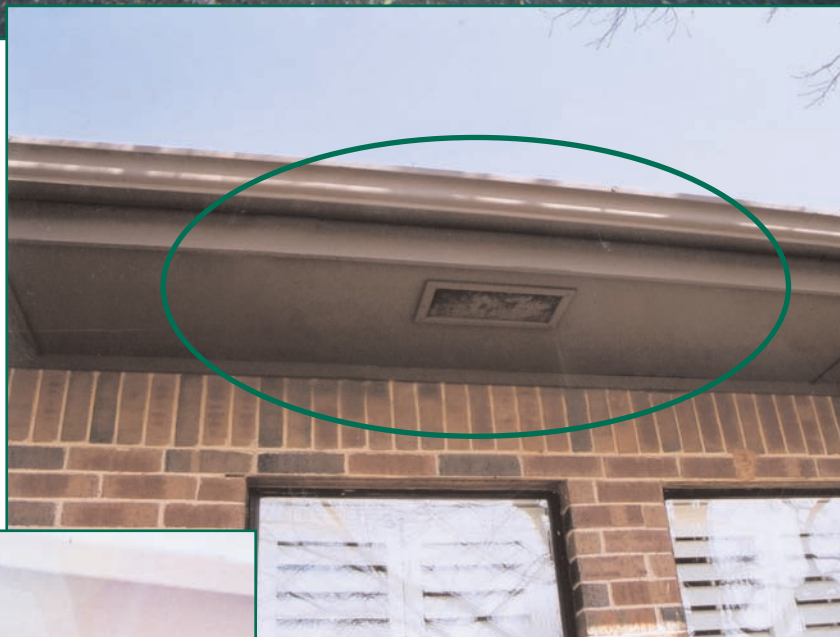
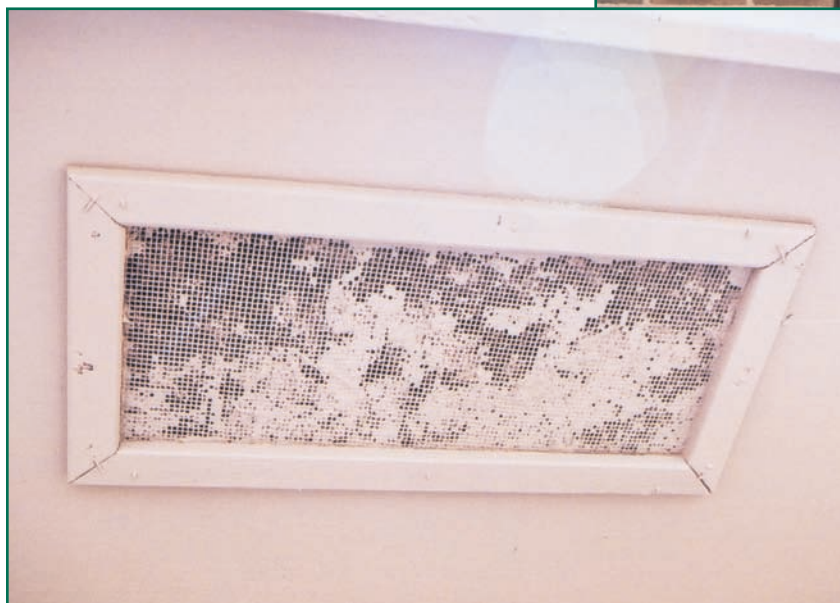
Figures 5a and 5b—Multiple coats of paint can render soffit openings virtually useless. Airways and vent openings should be slightly larger than would be implied in the sizing calculation.

It should be noted that screens and louvers placed over vents reduce the effective airflow. Similarly, multiple coats of paint can render soffit openings virtually useless (Figures 5a and 5b). Other

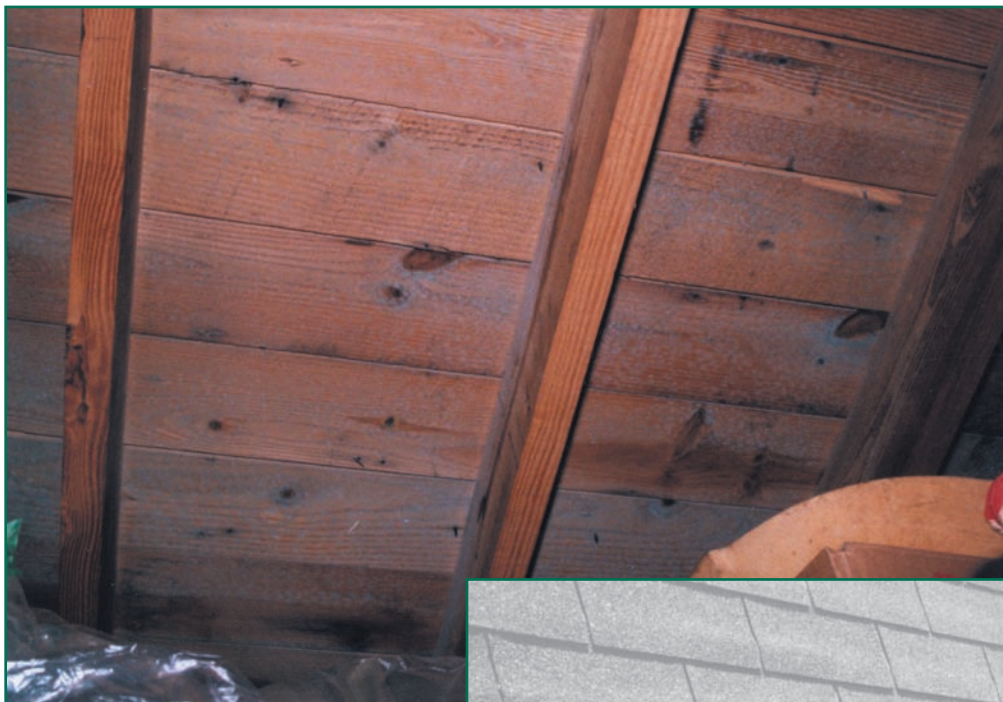
Figure 6—Mold/mildew in a humid southern climate. While attic insulation was properly held back at the edge and openings were present in the soffit cladding, the eaves carpentry was continuous along the entire perimeter. The mold/mildew colonies were fostered during a wintertime condensation scenario, drying to the powder during the hot season as shown.

conditions have impact on venting effectiveness. Figure 6 depicts a mold/mildew occurrence in a humid, southern climate (hot and dry at the time of the study). Attic insulation was properly held back at the edge, and the openings were present in the vinyl soffit cladding. However, carpentry was continuous along the eaves, so the soffit feature was completely useless. The mold/mildew colonies were fostered from a wintertime condensation scenario, drying to the powder shown during the hot season.
