THE PROBLEM IS NOT EIFS – IT'S THE DETAILS

By Derek A. Hodgin, PE, RRO, RRC

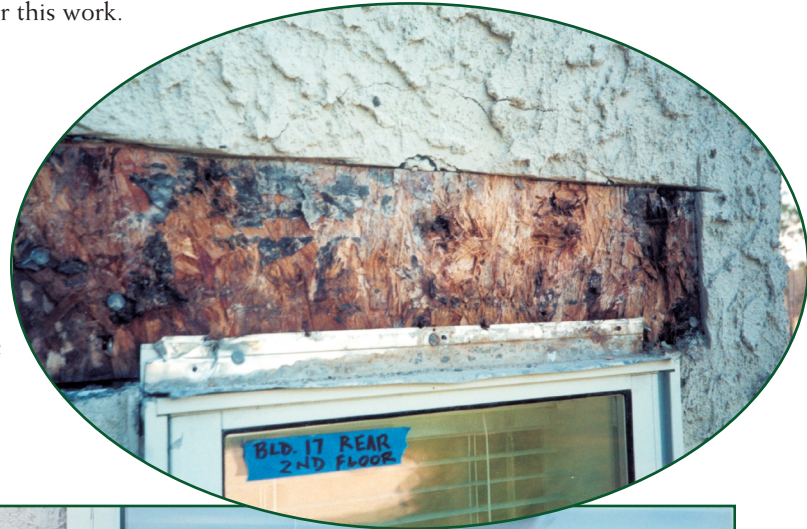
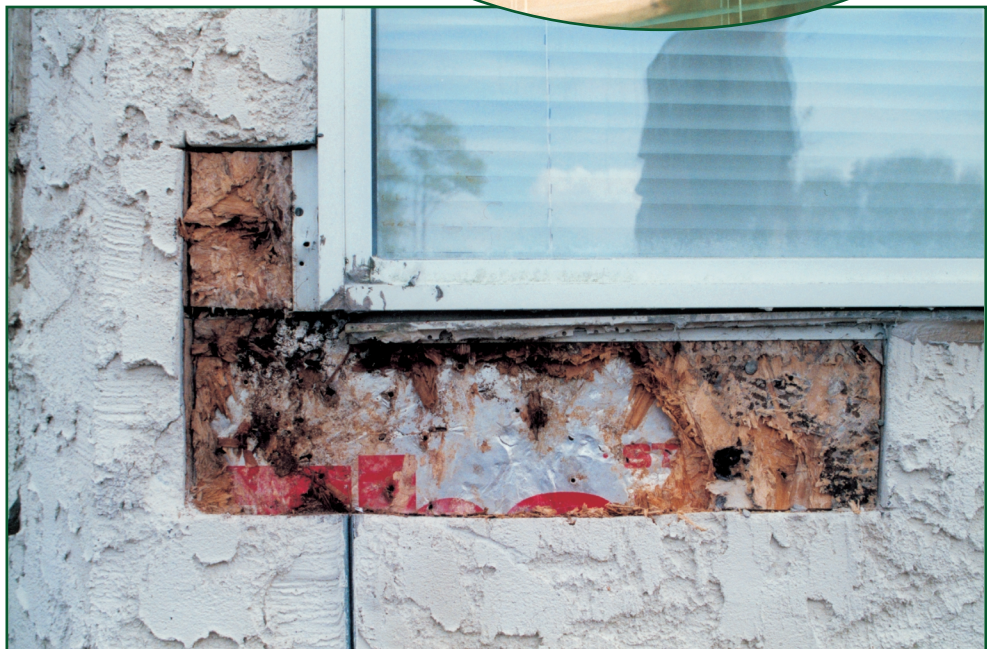
Water intrusion damages are frequently located adjacent to windows. The most common problems (which are often compounded by leaking windows) include improper wrapping of the rough opening and improper installation of head and sill flashing (*Photos 1 and 2*).

Photos 1 and 2: Views of damage above and below a window in a building with hard coat stucco.

Window rough openings should be properly wrapped. Head and sill flashing should be installed and properly integrated with adjacent building components (i.e., weather barrier). The American Society for Testing and Materials (ASTM) International Standard E 2112, issued in 2001, and the American Architectural Manufacturers Association (AAMA) *Installer Training Manual*, published in 2000, serve as excellent references for this work.

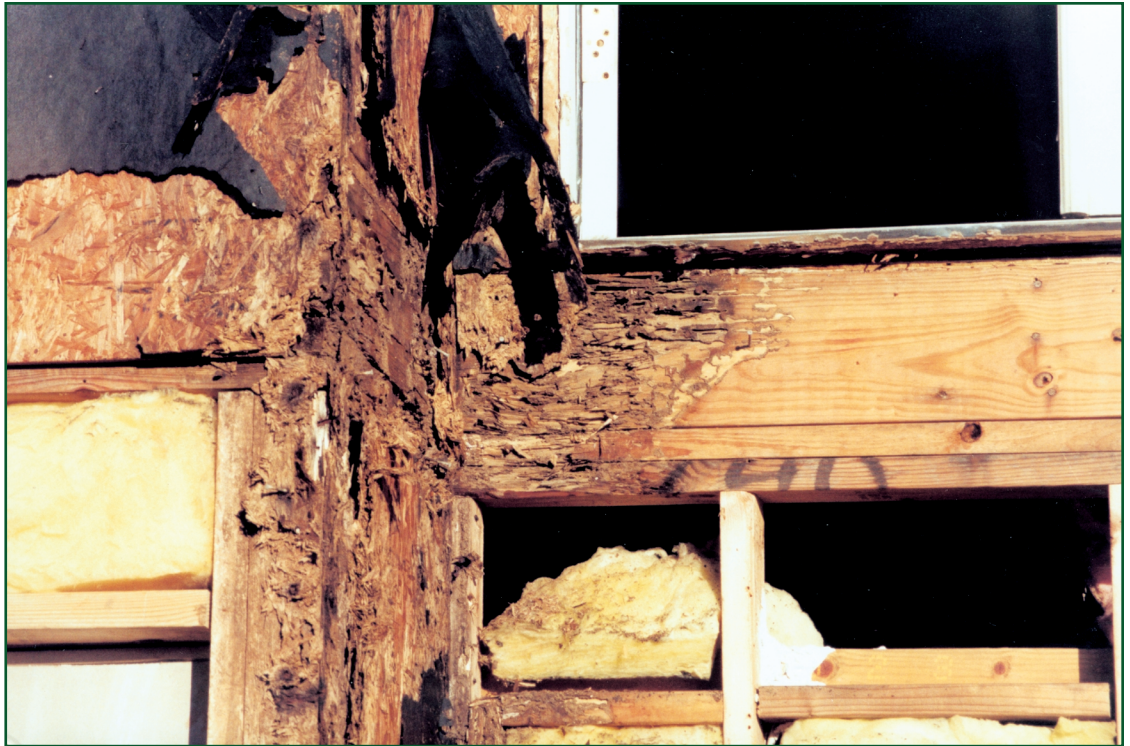
Entry doors and sliding glass doors can admit significant amounts of water behind a cladding system if proper waterproofing details are not present. The damages can be particularly devastating when large doors are used on walls with exposure to wind-driven rain. In these cases, the author has observed damages below the unsealed jamb/threshold intersection at the bottom corners of the door. This problem can be exacerbated when the door threshold is installed at the same elevation as an adjacent walkway, deck, balcony, or threshold if it is improperly integrated into the deck waterproofing system (Photo 3).

Photo 3: View of damages below a jamb/threshold intersection on a building clad with wood siding.

Door openings should be wrapped in the same manner as window openings. Additionally, a more significant waterproofing membrane, metal pan, or both should be installed below the threshold. All waterproofing materials should be properly integrated with adjacent building products to provide a continuous drainage path.

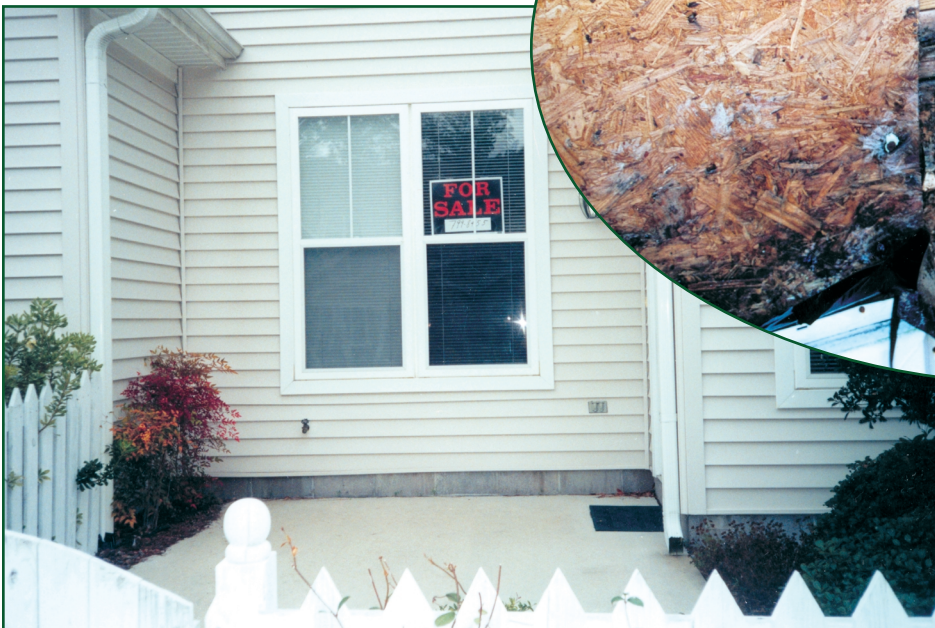
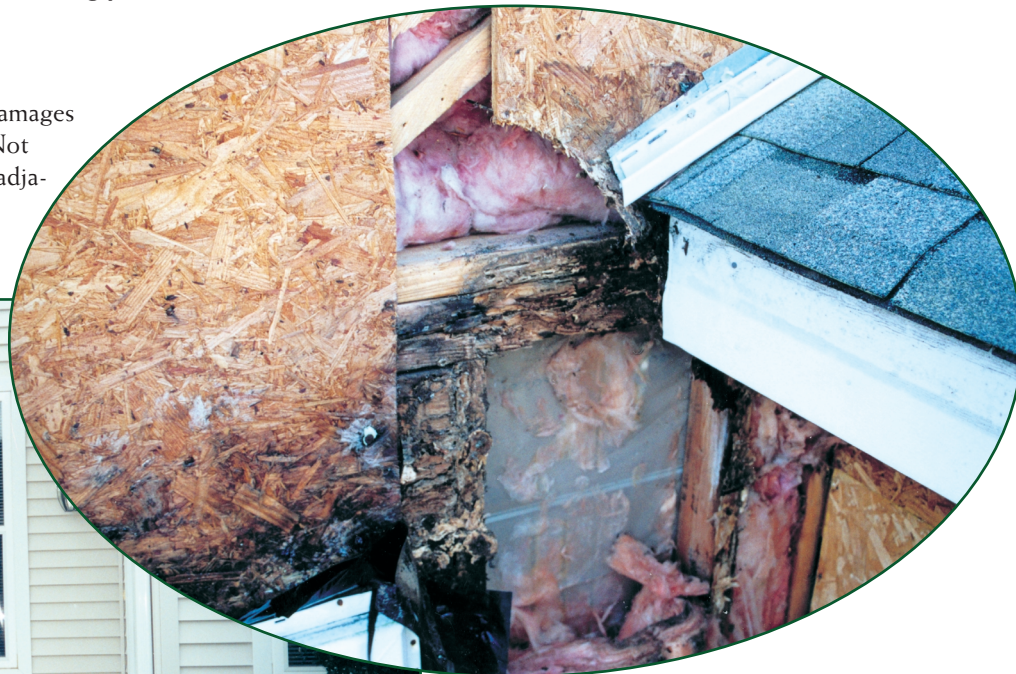
Some of the most significant water-related damages exist at roof/wall intersections (Photos 4 and 5). Not only does this area collect the most water from adjacent roof areas, it can distribute the water over great vertical distances with the help of gravity.

Photos 4 and 5: Views of significant damages below a roof/wall intersection on a building clad with vinyl siding.

Waterproofing at roof/wall intersections is somewhat dependent on the cladding type. However, the waterproofing concepts are all the same. The adjoining roof and wall areas must be protected using underlayment (typically asphalt-saturated felt or self-adhering membrane). Additionally, metal flashing should be used to prevent water penetration and to divert water away from the wall assembly. This flashing detail is commonly referred to as a "kickout."

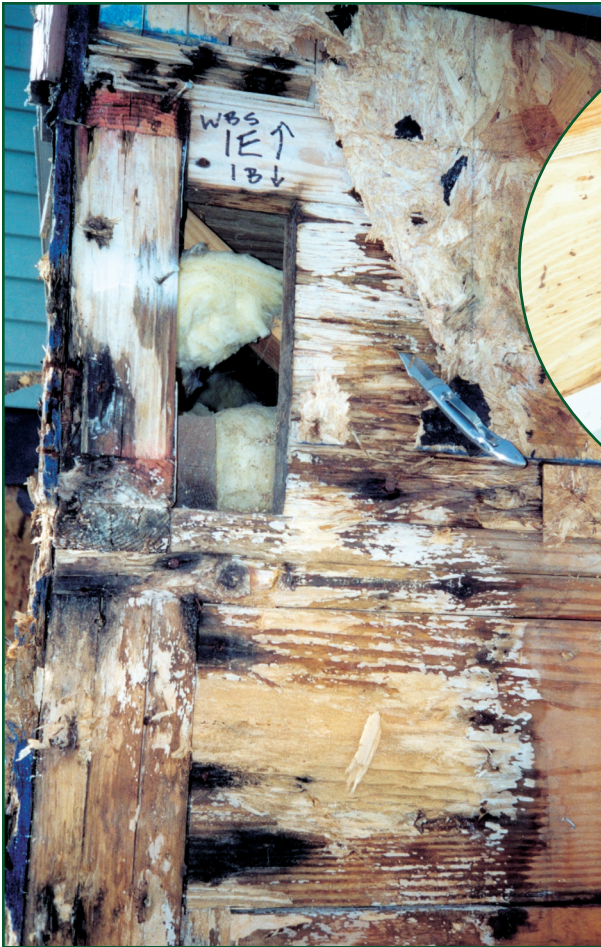
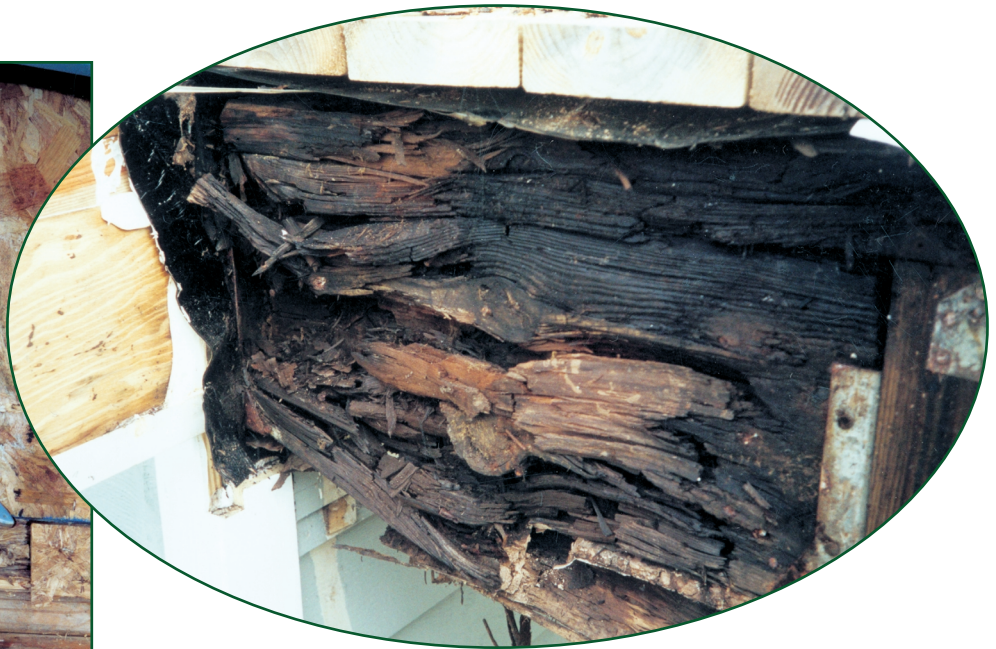
Photos 6 and 7 show water-damaged building components caused by improper waterproofing details at a deck. These buildings were clad with wood siding.

The drainage plane must not be interrupted. The building components in the area must be properly integrated (i.e., wall cladding components, wood deck members, metal flashing, weather barrier, waterproofing membrane, and doors). Adequate space between products must be provided such that water can flow along an uninterrupted and unrestricted path. These details should be considered in conjunction with other waterproofing details such as the door details described previously.
