MASONRY PARAPETS in FREQUENT FREEZE/THAW CLIMATES

By Robert W. Humbarger, RRC, CDT

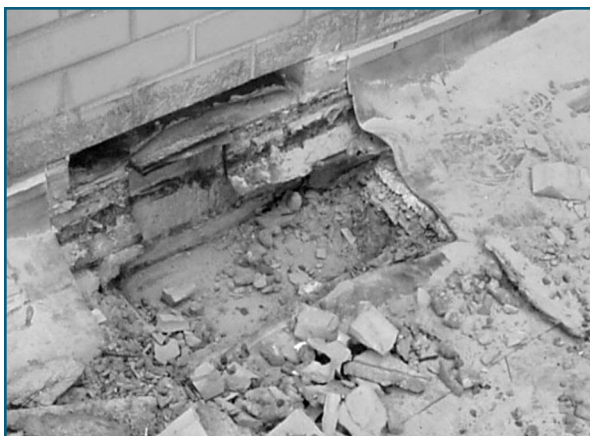
Photo 1 (above) and 2 (right) show roof flashing installed above through-wall flashing

Cavity walls are not expected to prevent water infiltration. That is why masonry cavity walls should have through-wall flashing and weep holes. It is "Basic Roofing 101" that the top termination of all roof flashings is to be below the height of the weep holes; yet, it is astounding how often this basic principle is ignored, even by some of the largest roofing contractors in the United States (see Photos 1 and 2). When (not if) the wall above the height of the weep holes leaks, it is highly probable that the water will eventually enter the room below the roof or, worse yet, the roof assembly. When counterflashing is used on cavity walls or parapets, it must be installed below the through-wall flashing and weep holes.

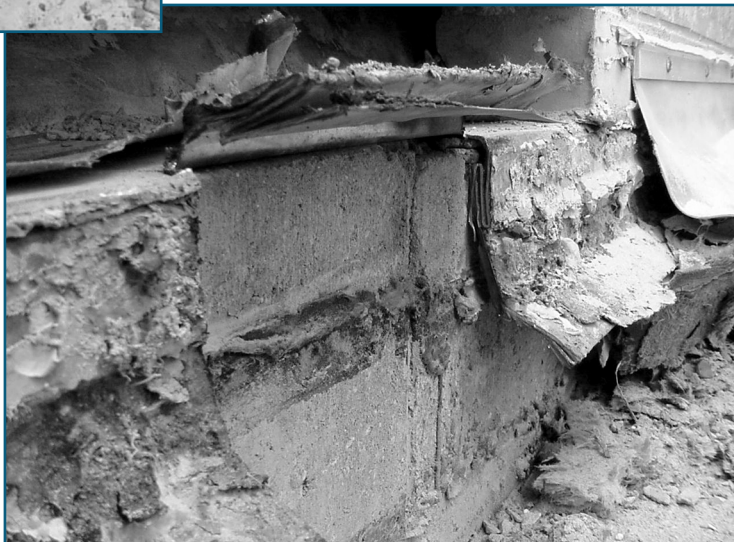
Photo 3: Parging with mortar coming off brick above metal counterflashing.

All deteriorated mortar joints should be re-pointed, with cracked masonry units replaced before re-roofing. Parging the backside of parapet walls with mortar or cementitious coatings is only a short-term solution (see Photo 3).

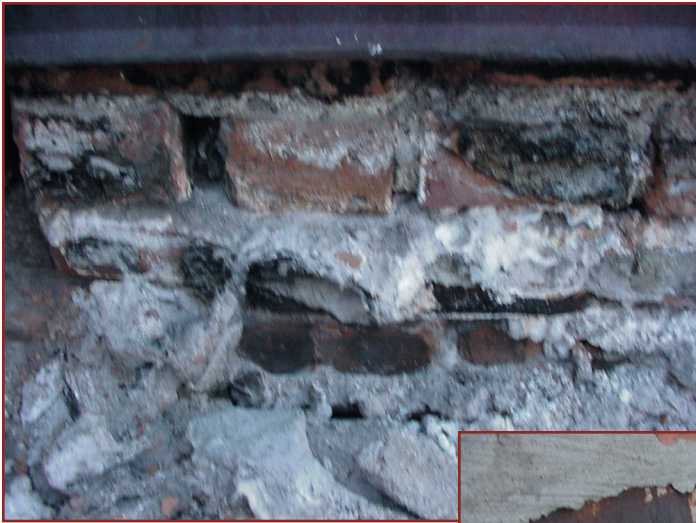
Photos 4 and 5: Moist air condensing behind roof base flashing and deteriorating brick.

Conditioned buildings in cold climates have a vapor drive from the inside to the outside exterior during the winter. Except for monolithic concrete roof decks, the gap between the edge of the deck and the parapet is seldom sealed (especially along the sides parallel to the structural supports.) Sometimes there is an open gap that allows warm, moisture-laden air to infiltrate from the inside, up behind the roof membrane flashing, where it condenses on the back side of the roof flashing and/or into the

upper portions of the parapet masonry (see Photo 4). The higher it migrates, the more likely it is to freeze and accelerate deterioration of the masonry. If the upper portion of the parapet is left exposed to breathe, the potential damage from freezing will be mitigated to some extent.

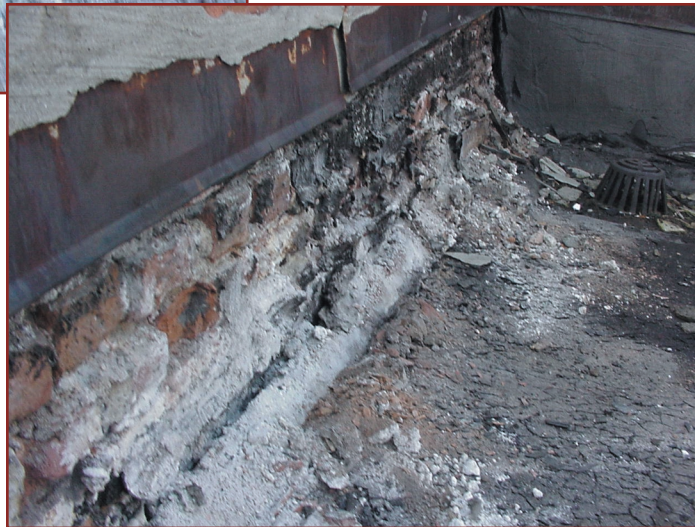
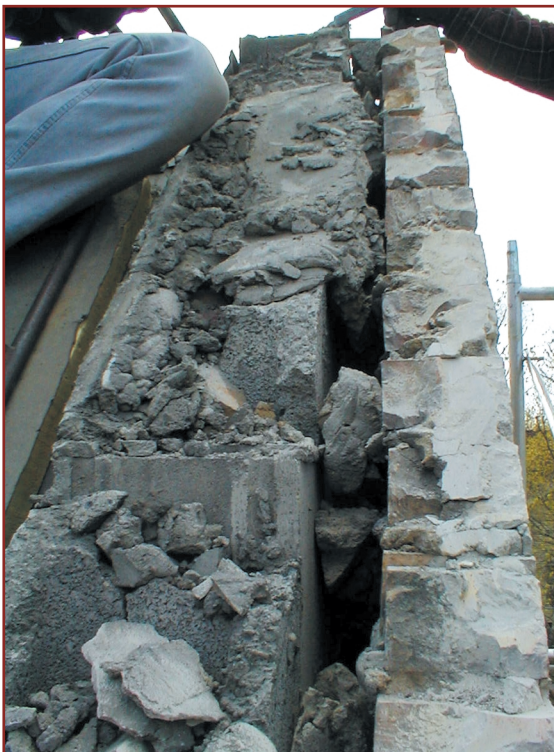
Photo 6: Cavity wall after limestone cap has been removed.

Cavity walls (see Photos 6 and 7) should be vented at the top and have weep holes at the bottom to allow the cavity to dry as soon as possible. The vent must be below the through-wall flashing on the exterior side of the building. Consequently, the cavity in the parapet above the through-wall flashing is not usually purposefully vented.

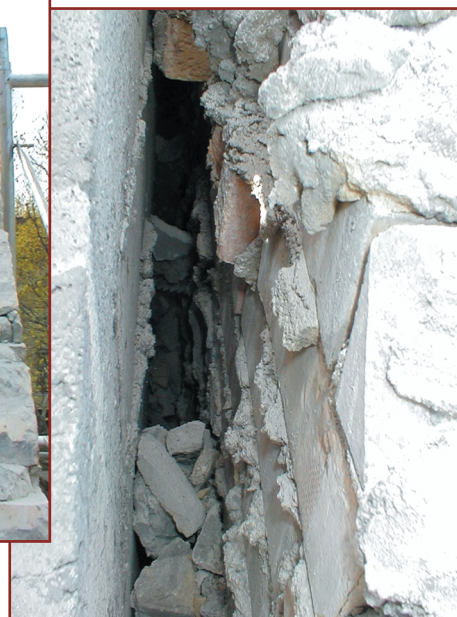
Photo 7: Closer view of cavity wall after limestone cap has been removed.
