VALUE ENGINEERING OF TRADITIONAL CLAY TILE DOME ROOFS

- Lessons Learned

By Kami Farahmandpour,
PE, RRC, CCS, CCCA

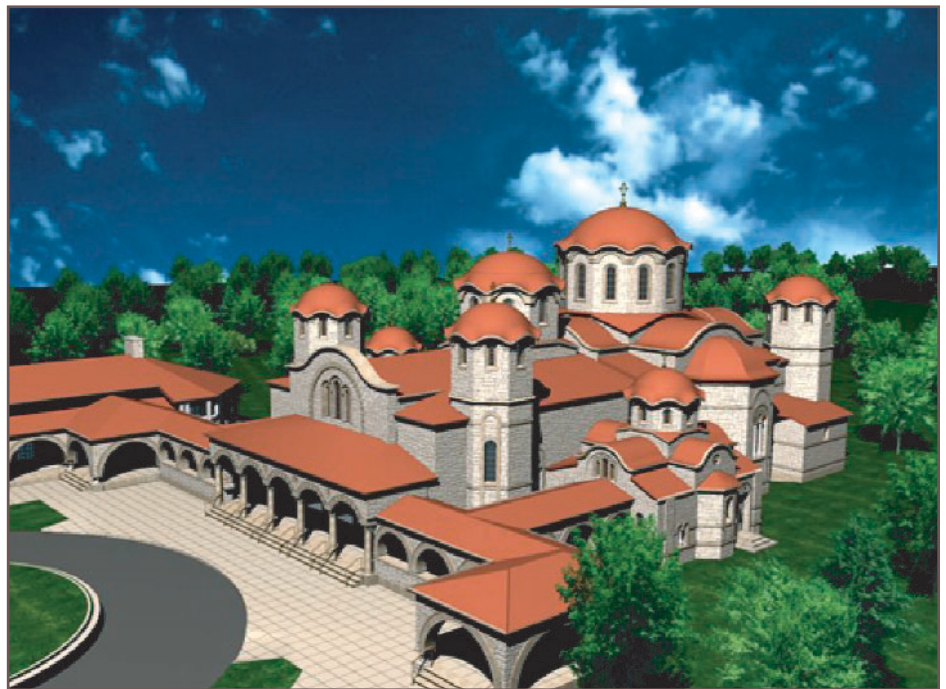
Figure 1 - The architect's original rendering of the church building at St. John Chrysostomos Monastery. The dormitory building behind the church is not shown.

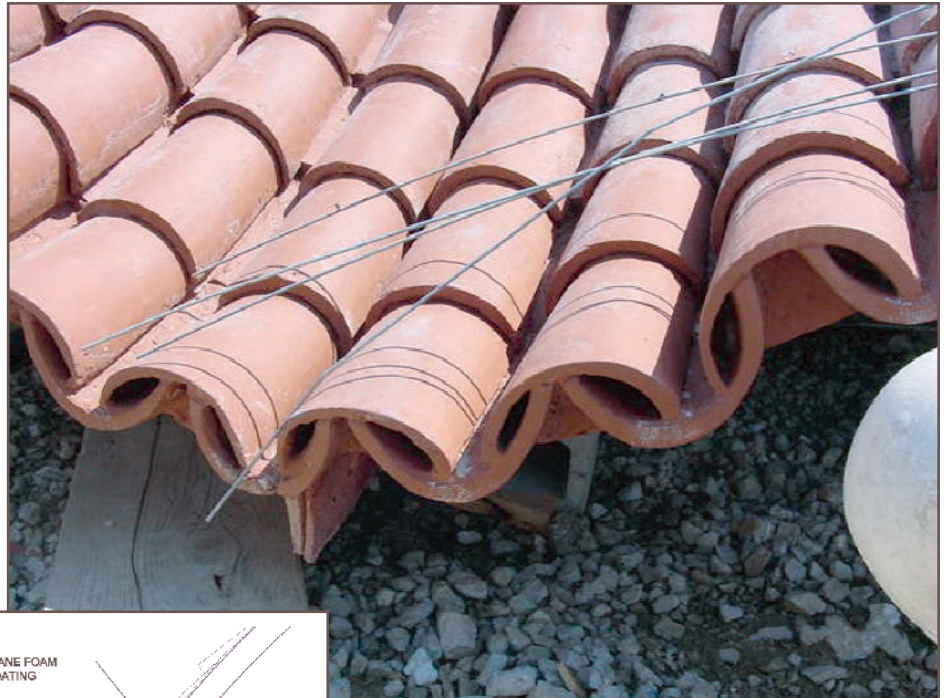
Above: Figure 6 - The crevices between the tiles were difficult to mold.

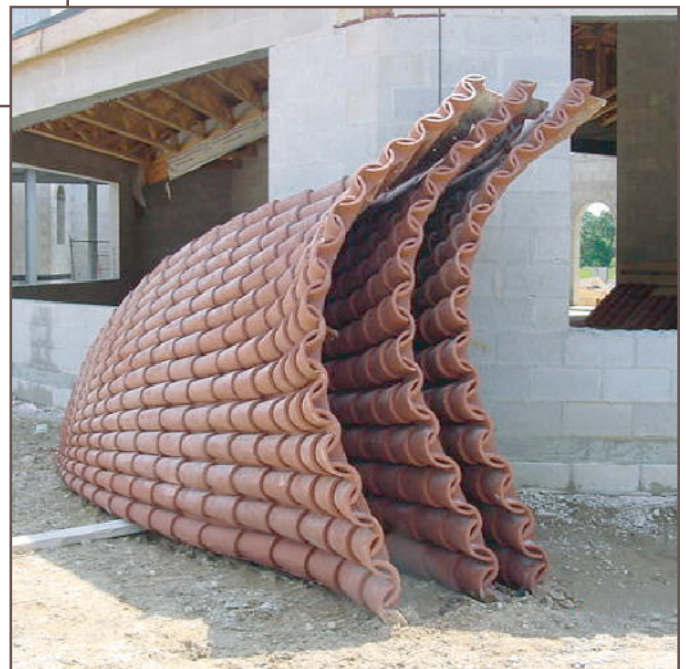
The domes were fabricated at the manufacturer's facility and brought to the site in pie-shaped segments (Figure 8). Depending on its size, each inner and outer dome was constructed of two to 12 segments. The segments were then joined in the field on the pre-fabricat-

Figure 8 - Outer domes were fabricated and delivered to the site in pie-shaped segments.

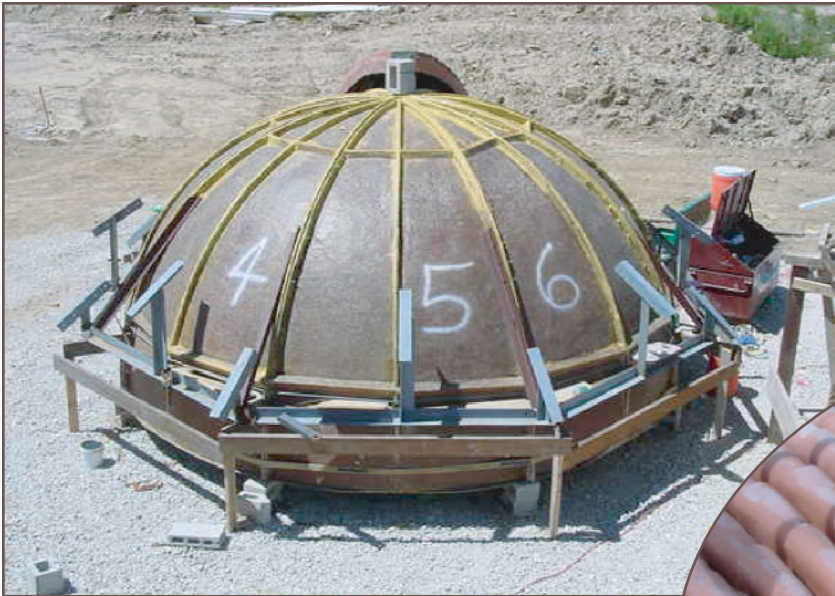
Above: Figure 9 - An inner dome being assembled on the structural steel skeleton.

ed structural steel skeleton (Figure 9). The seams between the pie segments were also sealed with fiberglass resin (Figure 10).

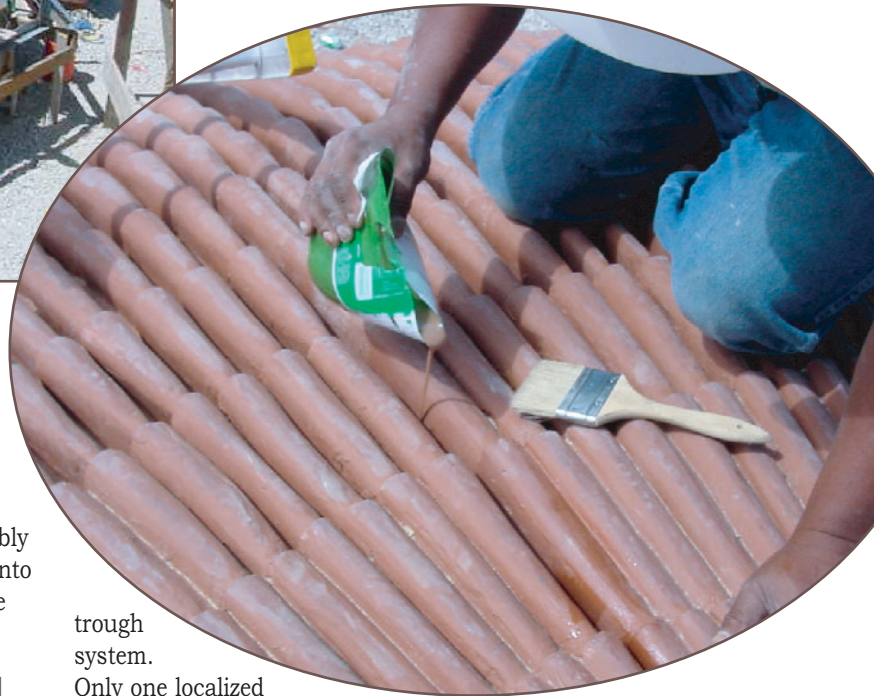
Below: Figure 10 - Sealing of the pie-shaped segment joints with pigmented resin.

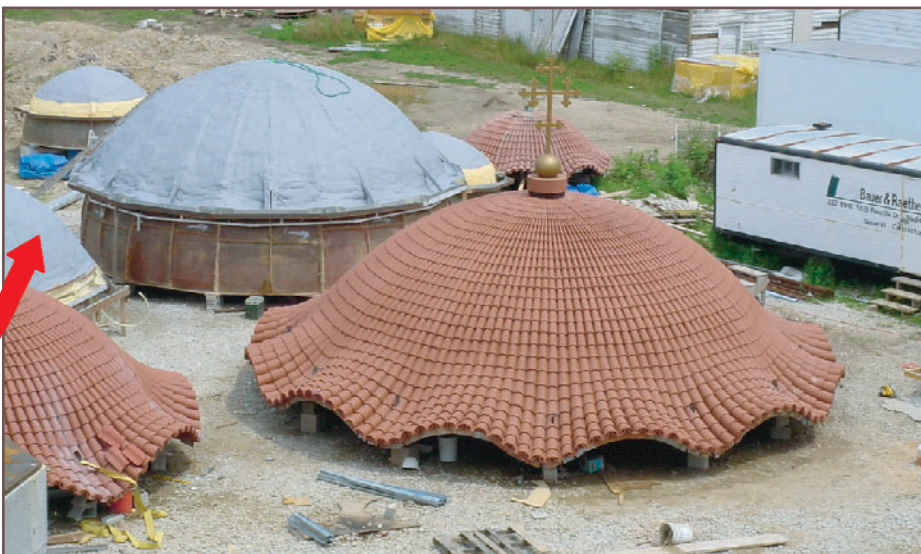
Once the inner domes were constructed, the spray polyurethane foam system was applied, and the perimeter drainage trough was constructed (Figure 11). The entire assembly was water tested on the ground and then lifted and installed onto the structure. The perimeter trough drains were directed to the building exterior using flexible tubing (Figure 12).

Above: Figure 11 - Assembled inner and outer dome. Note the gray spray polyurethane foam system and the perimeter drain pipes (red arrow).

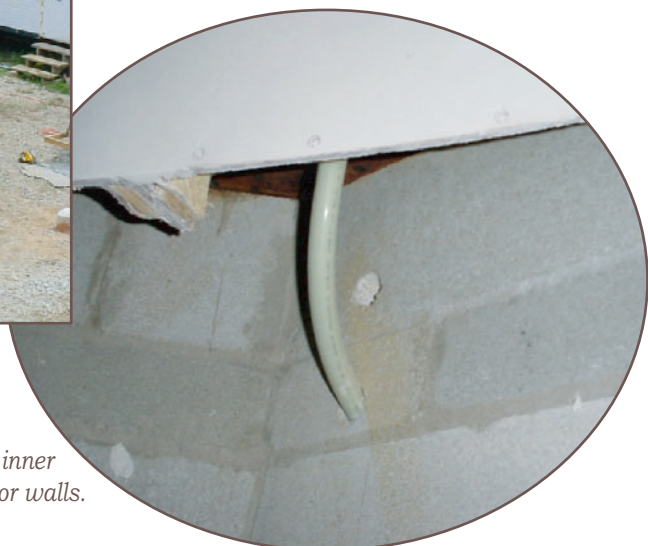
Right: Figure 12 - A flexible drain tube carried the water from the inner dome's perimeter drainage system to outside of the exterior walls.

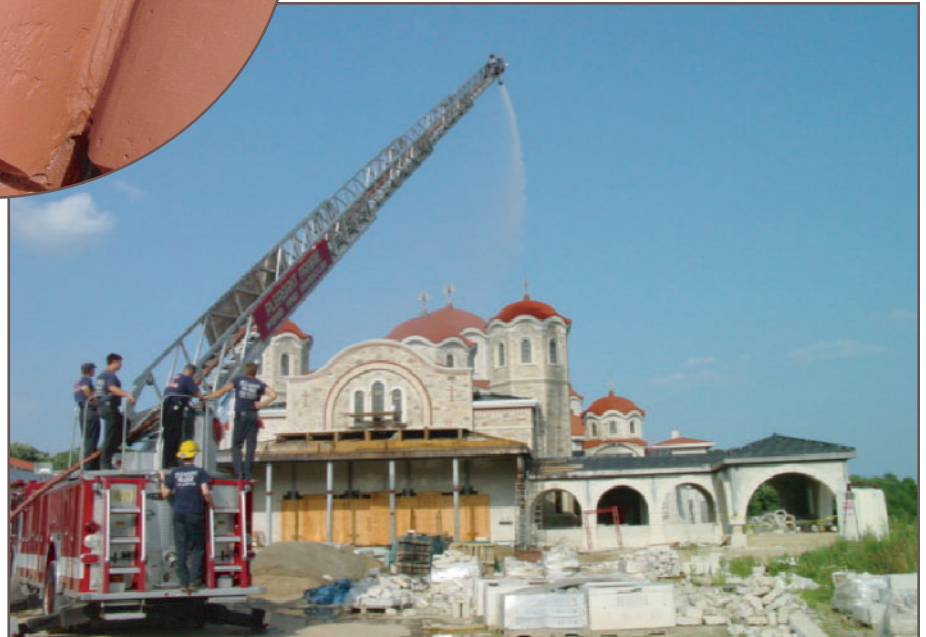
spray testing (performed by fire-fighting apparatus) confirmed significant leakage through the outer domes (Figure 14). While the redundant waterproofing system appeared to control the leakage, the owners and the design team were concerned that the cracking of the outer fiberglass domes might continue. Furthermore, the redundant waterproofing system was only designed to handle minute amounts of water, not the amount that was revealed during the water testing.

Below: Figure 14 - Water testing of the outer dome surfaces using fire fighting apparatus. The nozzle at the top of the ladder delivered 1000 gallons of water per minute.

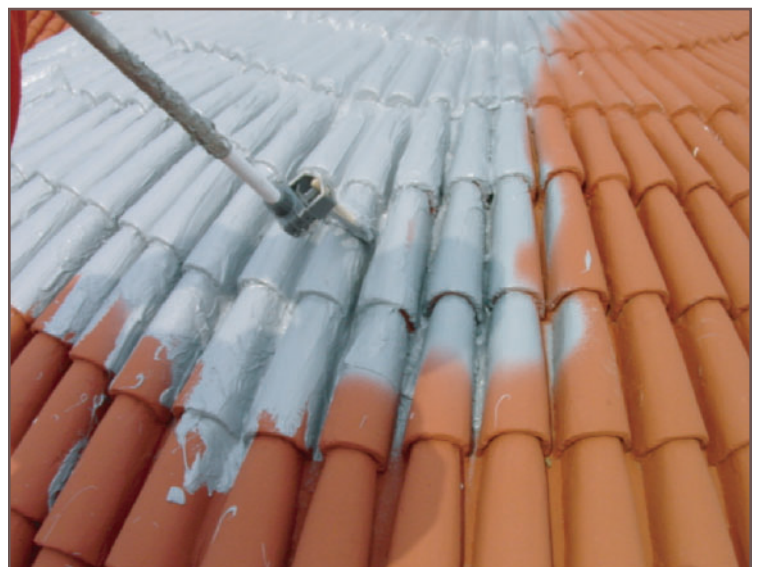
Figure 15 - Application of the elastomeric base coat in all the crevices with a brush.

After consultation with a reputable elastomeric coating manufacturer, the design team specified a urethane-based material with paste consistency as the base coat for the system. This base coat was to be applied using brushes to ensure that all crevices were filled with the material. The base coat was then topped with a spray-applied elastomeric color coating that was formulated to match the color of the adjacent clay tile roofs.

The application of the coating system also posed several challenges. Ensuring that all the surfaces and crevices were well coated was tedious work, performed from a large articulating boom (Figure 15). After completion of the coating application, no further evidence of water leakage was reported.

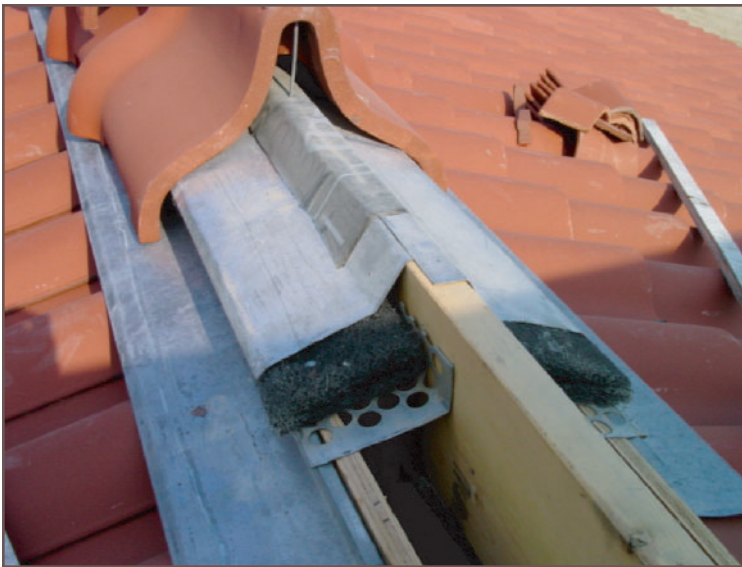
Aside from difficulties encountered with the fiberglass domes, remaining portions of the tile system on the hip, gable, and barrel roofs also proved challenging. Several details, including the ventilated ridges and attachment of lightning arrest system rods to the tile roofs, proved difficult and required special attention (Figures 16 and 17). Exacerbating some of these problems were construction tolerance issues that resulted in deviations from the original design details.

Figure 16 - Roof ridge configuration with ventilation provisions and a lightning arrest rod.
