SLIDING ICE AND SNOW CAUSE ROOF AND PROPERTY DAMAGE

Arrowhead condominiums in Big Sky, Montana.

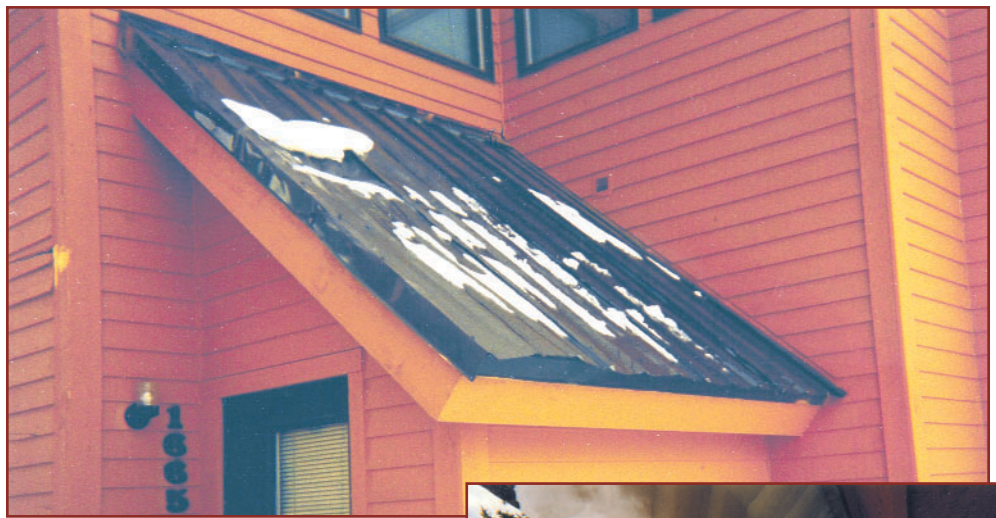
Located in Big Sky, Montana, the Arrowhead Condominium Association consists of 24 units with metal standing seam roofs on a 12/12 slope. The homes are only 10 to 15 feet apart, and each is a ski-in, ski-out unit on a hillside. During harsh winters, snow, ice dams, and icicles were sliding off the units and damaging neighboring homes. The front door of one unit collapsed three different times from sliding snow. The decks on the buildings had to be closed for the winter, since many rails and decks had been torn off by snow and ice. On lower shed roofs, not only was the metal roofing torn and bent, but the 3/4" plywood sheathing was crushed between the roof's rafters.

Damage to metal roof and sheathing from snow and ice falling from the roof above.

"The consultant [Terry E. Anderson of Anderson Assoc. Consulting Inc.] recommended an engineered snow retention system," Ryan continued, "and a good ventilation system that, once installed, would stop most of the ice dam and icicle problems. He

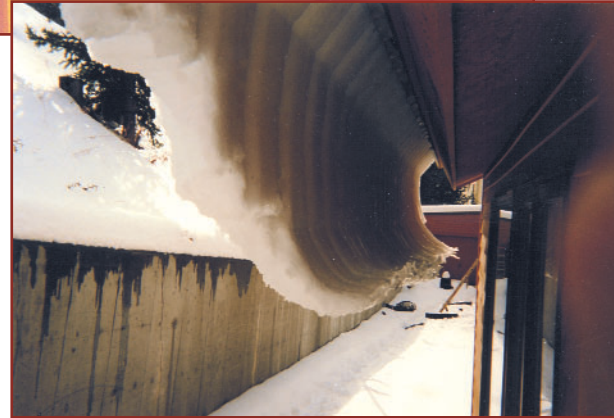
Snow and ice sliding off metal roof and curling into window.

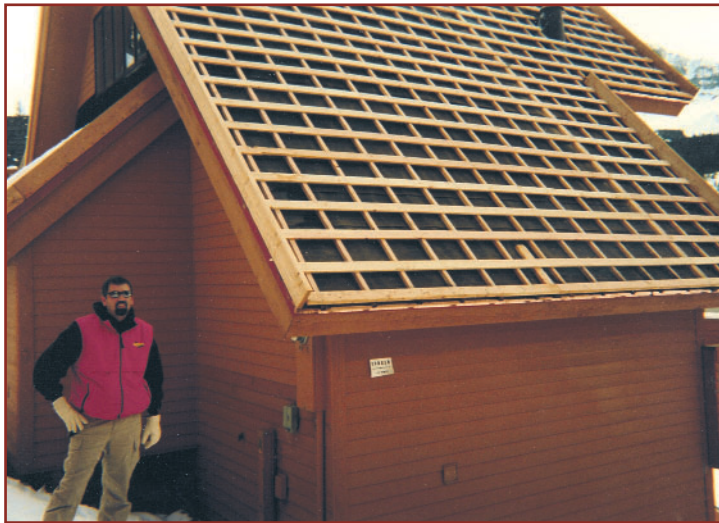
Above: New cold-roof system framework for concrete tile roof.

The cold roof system stops ice dams and icicles by venting air outside below the roof tile and above the sheathing from the eave to the ridge. The equalized temperature minimizes thawing and refreezing of the snow on the roof by venting away heat from the living space. The system is based on the Roof Tile Institute and Western States Roofing Contractors' Association's *Cold Roof Manual* and air ventilation charts from Europe.

Since adequate ventilation was critical to the success of the roof system, calculating the air openings needed from eave to ridge was essential. The designed air intake system at the eave and the ridge exhaust system at the raised-ridge vent were to work in tandem to achieve the major difference between the old and new systems. This was immediately apparent when icicles were eliminated and snow was retained on the roof.

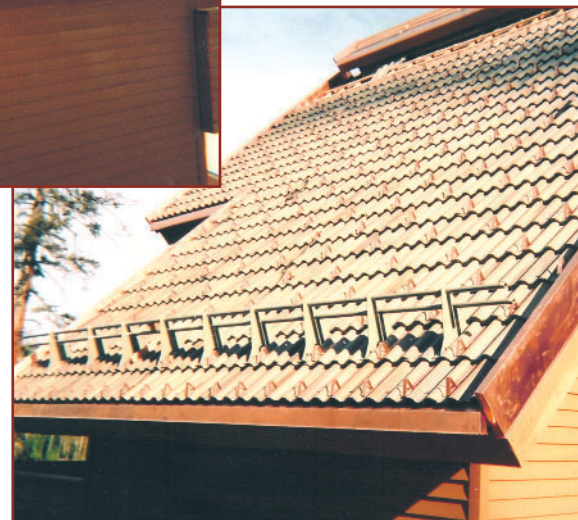
Right: New concrete tile roof with snow retention brackets.

12/12 slope. However, with proper engineering of fences and brackets, the system retains the snow and ice on the roof. The system was designed using a fully engineered snow retention system with TRA Snow Brackets and a "Cold Roof System."

designed cold roof system allows the snow to compact naturally with ice in the bottom three inches. This ice freezes around the triangular portion of the snow bracket and permits run-off between the ice and the tile when the outside temperature is above freezing.

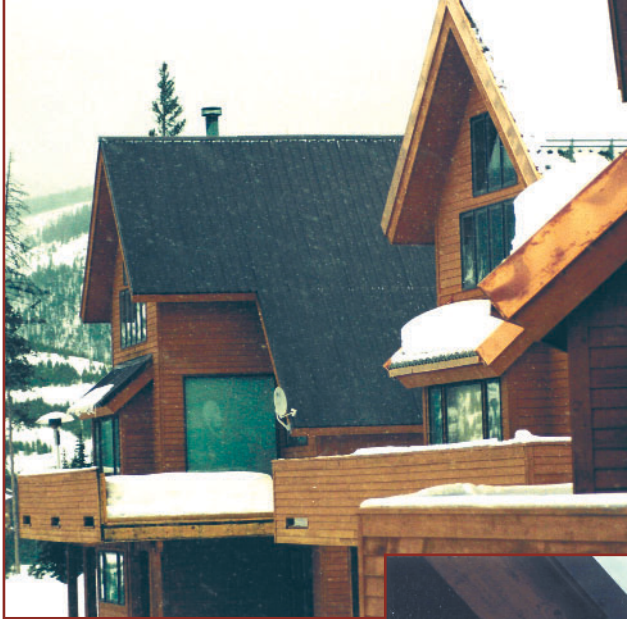
Left: Note difference in snow retention. Middle building with new tiling and snow guards is providing safe snow and ice retention. Far building with old metal roof had its deck torn off from sliding snow and ice.

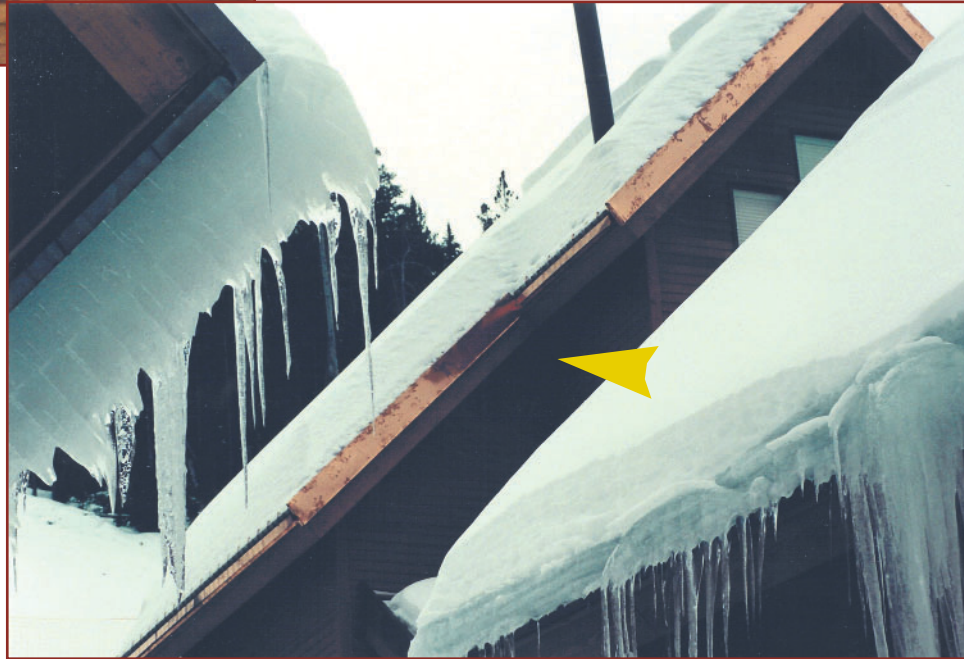
Below: Note the contrasts between the old and new systems. The roofs to the left and the right still have the old system – metal with no snow retention devices, causing ice dams and hazardous conditions. The center slope is a cold-roof system with concrete tiles and a snow retention system at work. It is safe, attractive, and insurable.
