RICOWI INVESTIGATES

Hurri

By Patty Wood-Shields and Kristen Ammerman

cane Charley

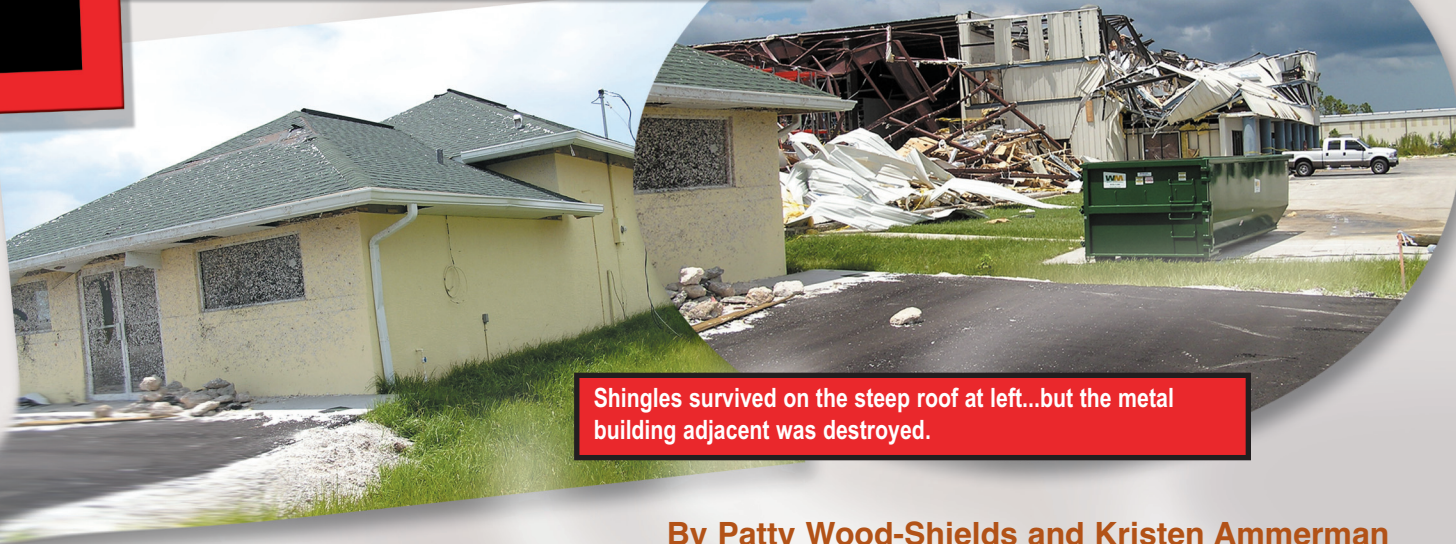
Shingles survived on the steep roof at left...but the metal building adjacent was destroyed.

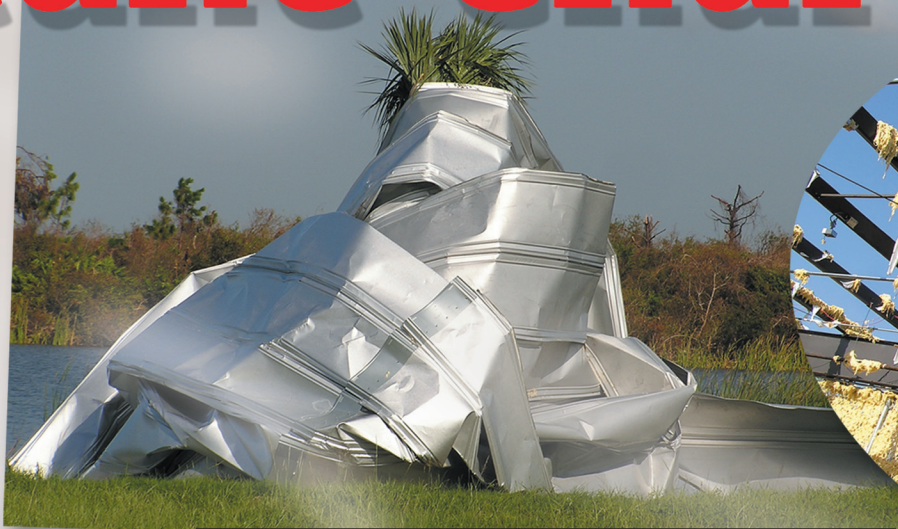
Above: Structural metal roof panels were wrapped around a palm tree. Right: This structural metal roof system was blown off.

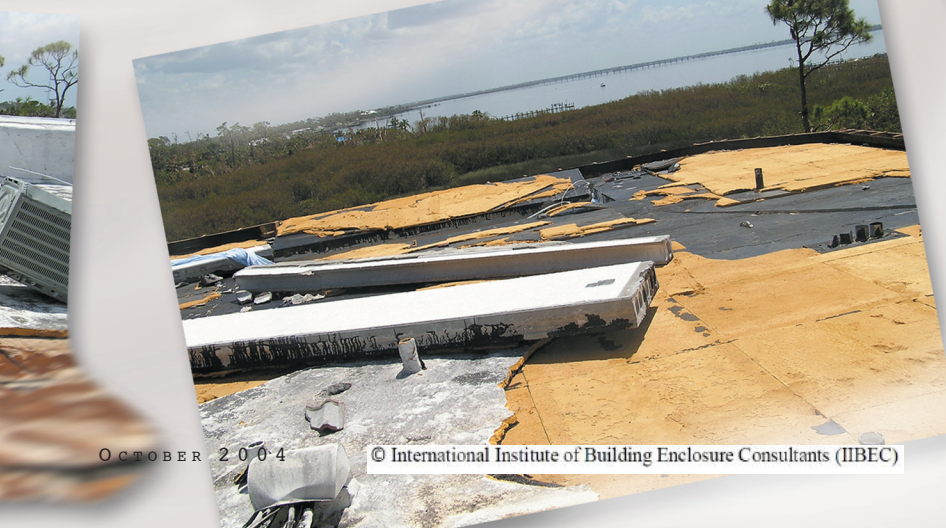
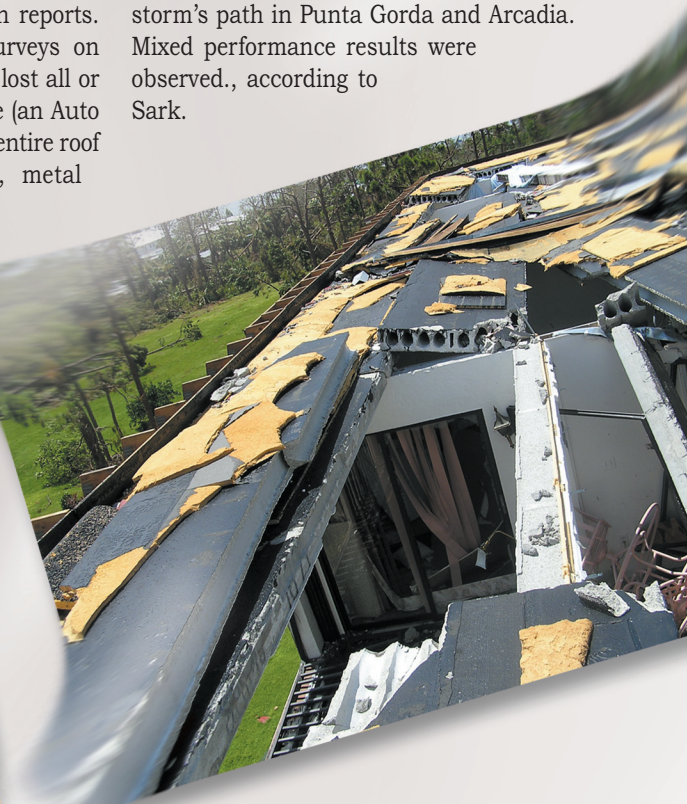
All from the same location—Below left: BUR and SPF blown off phenolic foam insulation. Directly below: BUR with SPF surface blow off. Below right: Hollow core concrete deck blow off.

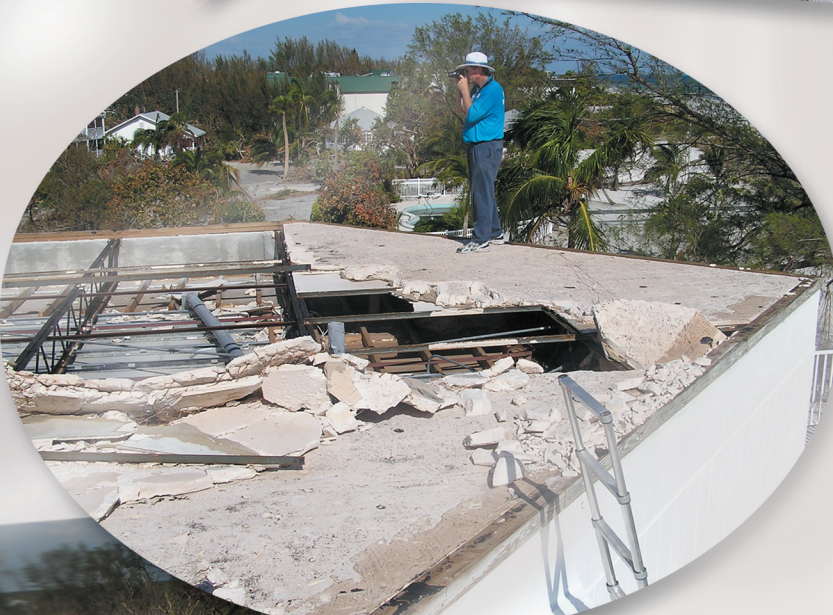
Above: Sanibel Island BUR blow off. Left: This single-ply, only 500 yards from the photo above, survived.
