# COPPER IN TODAY'S ATMOSPHERE

BY DAVID L. HUNT

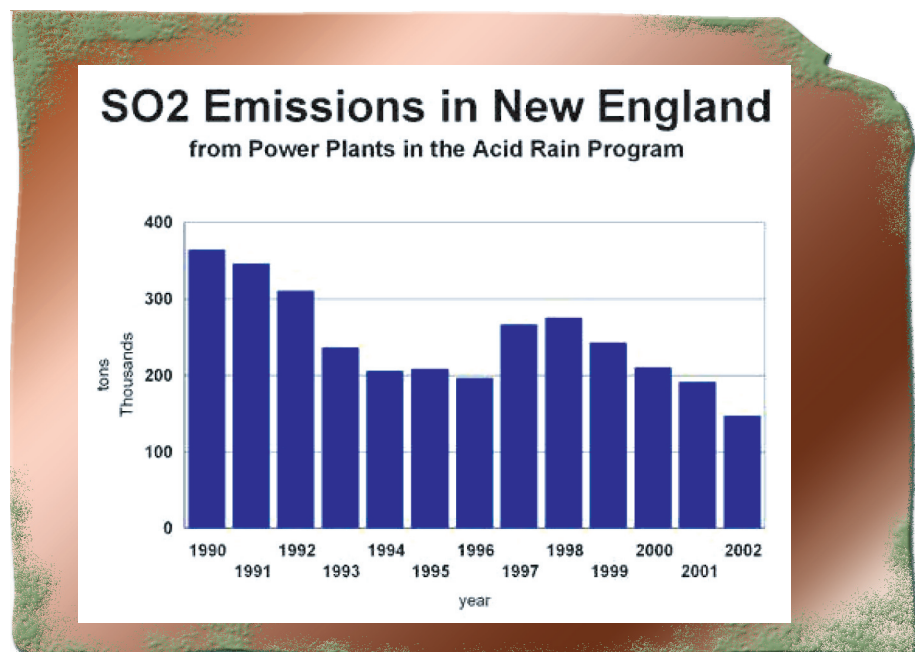
Figure 1: SO<sub>2</sub> emission in New England from power plants in the acid rain program. Source: U.S. EPA.

Visit the U.S. Environmental Protection Agency website at [http://www.epa.gov/region01/eco/acid\\_rain/trends.html](http://www.epa.gov/region01/eco/acid_rain/trends.html). There, one can find the statement, “SO<sub>2</sub> and NO<sub>x</sub> emissions from power plants in New England have decreased since 1990.” (See Figure 1.) Charts on the website also plot the reduction.

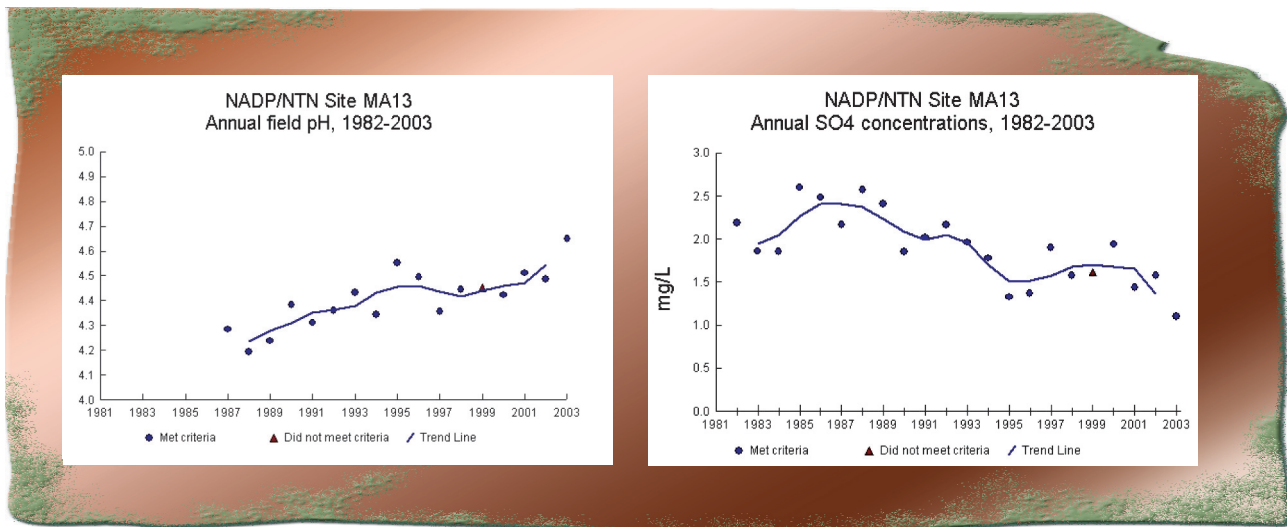
Figures 3 and 4: The pH of precipitation has risen. The concentration of SO<sub>4</sub> has decreased.

Site MA13, located at the State Agricultural Experimental Station, has collected rainfall data since 1982. Over the past 22 years, the pH of the precipitation has risen while the concentration of SO<sub>4</sub> has decreased (Figures 3 and 4).

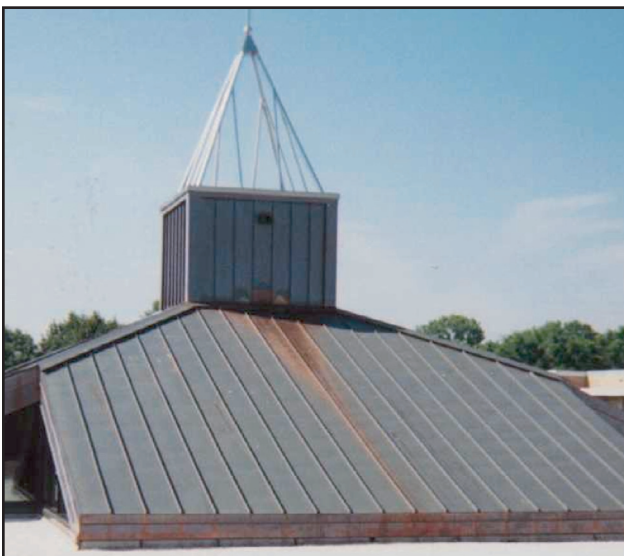
*Figure 5: Uneven weathering caused by the flow of rainwater from an asphaltic-based roof covering onto standing seam copper.*

A caveat, however, is that the flow shown in *Figure 5* is through a scupper and it impinges on the copper. As will be discussed later, impingement can cause problems. This roof should be monitored regularly and corrective action taken if thinning is noted.

*Figure 5* shows uneven weathering that is caused by the flow of rainwater from an asphaltic-based roof covering onto standing seam copper. This is typical of the appearance of copper subjected to mild, surface corrosion.

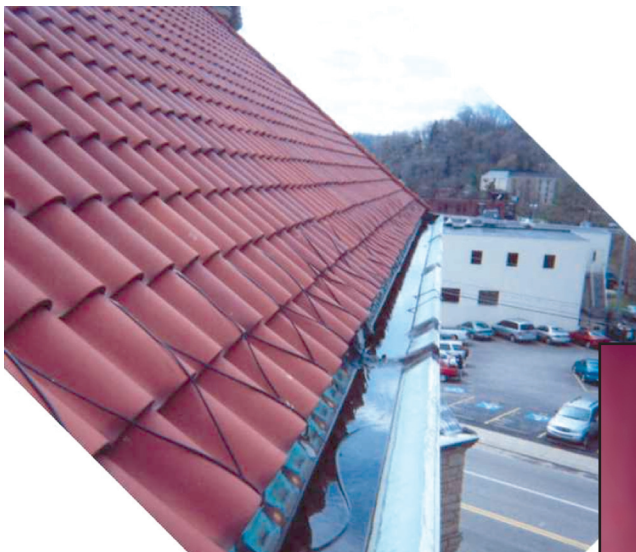
Figures 7 and 8: Runoff from clay tiles can be corrosive to copper, causing "erosion-corrosion."

occur with Spanish clay tile. The low points (valleys) of the tiles not only are the point of concentrated flow, but also the channel for moisture from heavy dewfalls and mists. Depending upon the type and amount of pollutants that accumulate on the tile before they are washed off, these small amounts of water may be very corrosive to copper.

Bright orange "icicles" or spots can occur when copper's protective oxide is mechanically removed by high-velocity, turbulent rainwater. It can also be removed by the flow of abrasive water over copper. This type of attack on copper is generally referred to as "erosion-corrosion" or impingement attack.

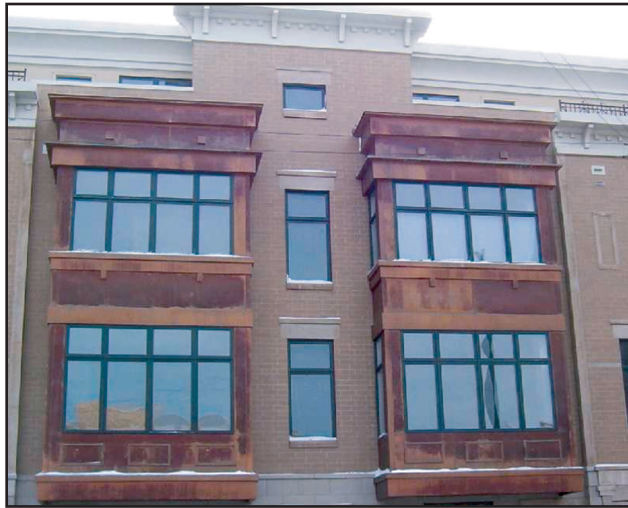
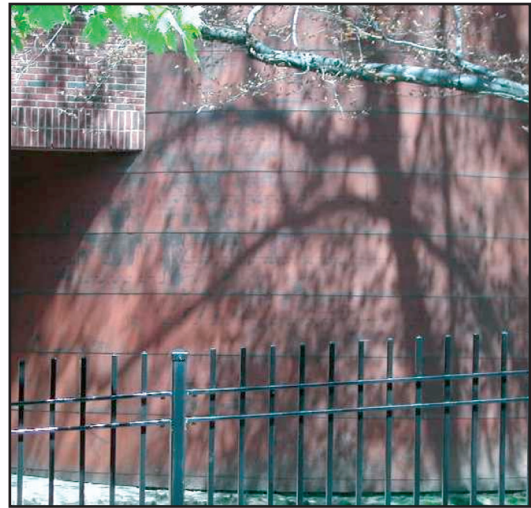
Figures 9 and 10: Only the initial aesthetics are affected by this natural but unusual weathering. With time, the copper should take on a uniform brown, bronze, and eventually blue-green color of natural patina.

Although the owners of the properties in Figures 9 and 10 may not be especially pleased with the appearance of the copper wall cladding, only the initial aesthetics are affected. The coloration is simply the result of natural – if somewhat unusual – weathering. With time and additional weathering, there is every reason to believe the copper will take on a uniform brown or bronze tone and eventually the blue-green color of natural patina. However, since the air quality in the United States is considerably better now than it was 25 years ago, they may have to wait many years.
