# THE PECULIARITIES OF HISTORIC SLATE ROOFS WITH EXAMPLES OF WRONGFUL CONDEMNATIONS

BY JOSEPH JENKINS

The following are some examples of slate roofs that illustrate these, and other peculiarities.

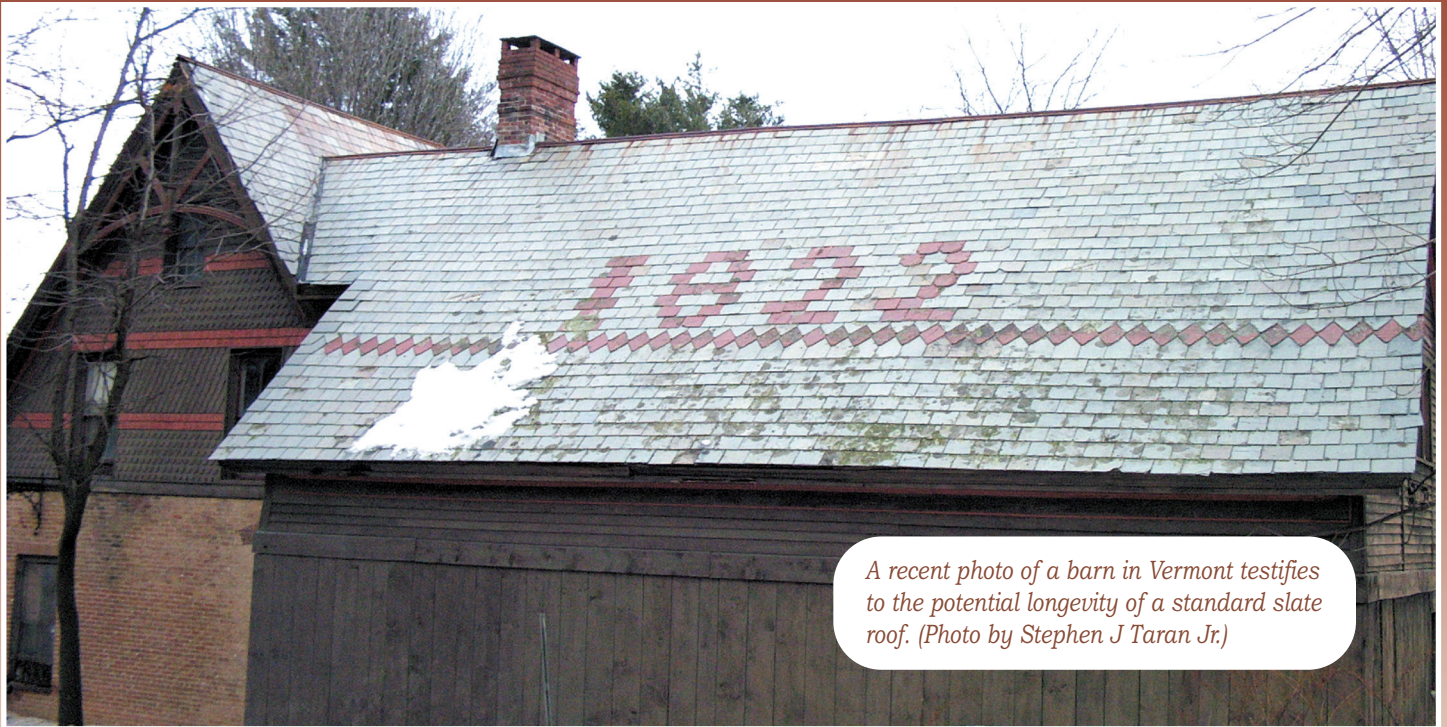
*A recent photo of a barn in Vermont testifies to the potential longevity of a standard slate roof. (Photo by Stephen J Taran Jr.)*

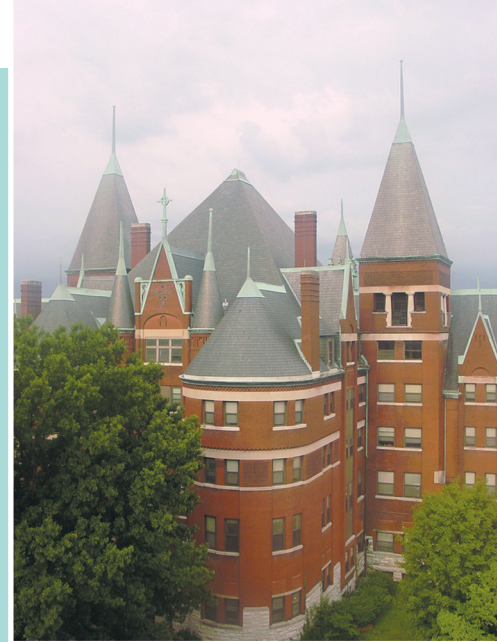
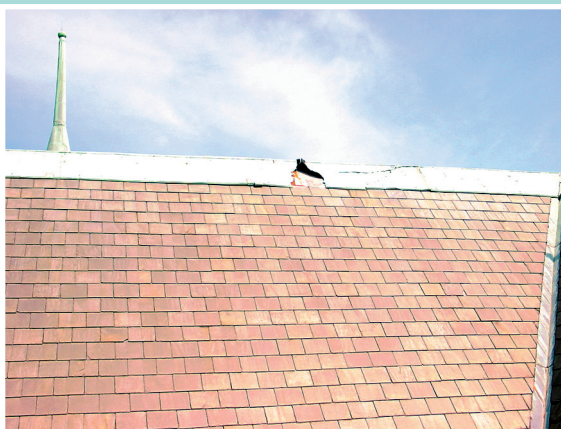
An inspection by the author revealed that the slates were a Buckingham or Peach

Bottom variety of exceptional quality. There was essentially no wear visible on the slates after 120 years. The very steep slopes and the semi-dry conditions of the area had helped preserve the copper, most of which was original. The wind and hail damage on the roof was quite limited and all of it was repairable for less than 3% of the replacement cost. The slates themselves could be expected to last another century, although the copper flashings would have to be replaced eventually. The main leak was in a copper valley and was unrelated to the storm damage. Although this beautiful slate could last at least another century, contractors were earnestly attempting to permanently destroy it.

*The photo at right is only the entranceway to Castle Park, which has large wings emanating in three directions. The slate, at 120 years of age, is in excellent condition. Roofing contractors, however, would love to tear it off. Left: Minimal wind damage does not justify replacing the entire roof when the slate is still in good shape. (Photos by Joseph Jenkins.)*

The Castle Park building, near St. Louis, is a huge, sprawling, five-story building with an 850 square slate roof built in 1882. The roof suffered hail and wind damage in the early 2000s and was subsequently condemned by contractors who offered to replace the roof with asphalt shingles for \$10 million. The entire roof was original – flashings and all – and some leaking was occurring.

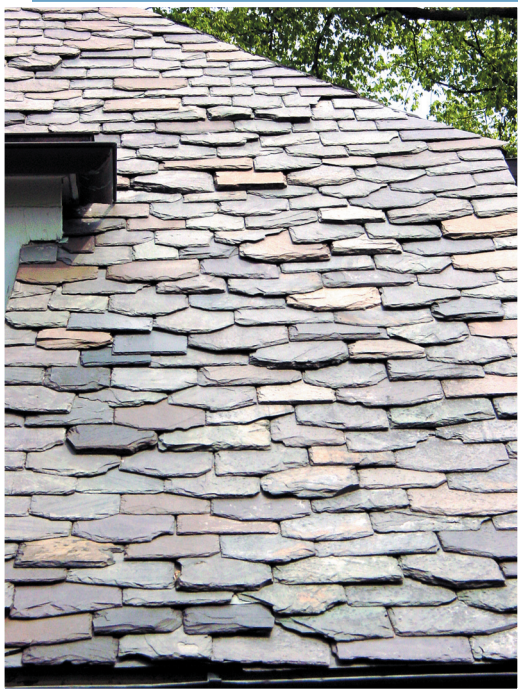
*Chicago area home with beautiful 75-year-old "ragged butt" slate roof condemned by three roofing contractors. (Photo by Joseph Jenkins.)*

A residence in an upscale Chicago neighborhood suffered hail damage to its unique "ragged butt" style 75-year-old slate roof. Three firms looked at the roof and all three condemned it before the owner contacted the author for an impartial inspection. Hail damage to the mixed Vermont and Buckingham slate was certainly evident, but it was limited and all readily repairable by any contractor with a minimum of slate roof restoration experience. The inspection revealed about 150 slates needing to be replaced – a couple days' work for experienced professionals.

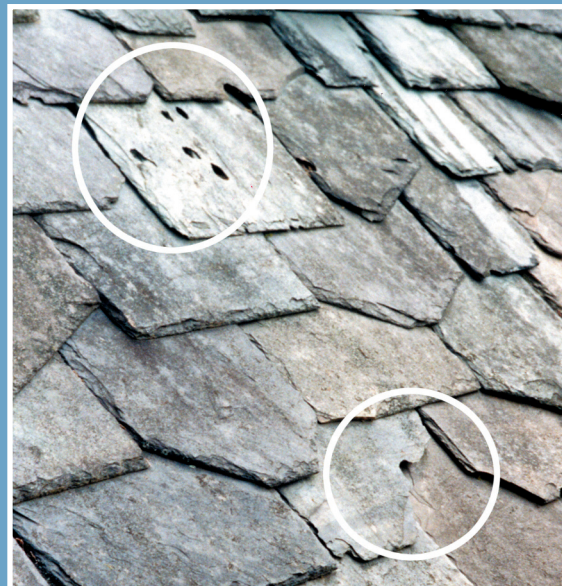
*Hail damage of this nature, as seen on Chicago area "ragged butt" slate roof, is repairable by simply removing the damaged slates and replacing them. Most of the slates are undamaged. (Photo by Joseph Jenkins.)*

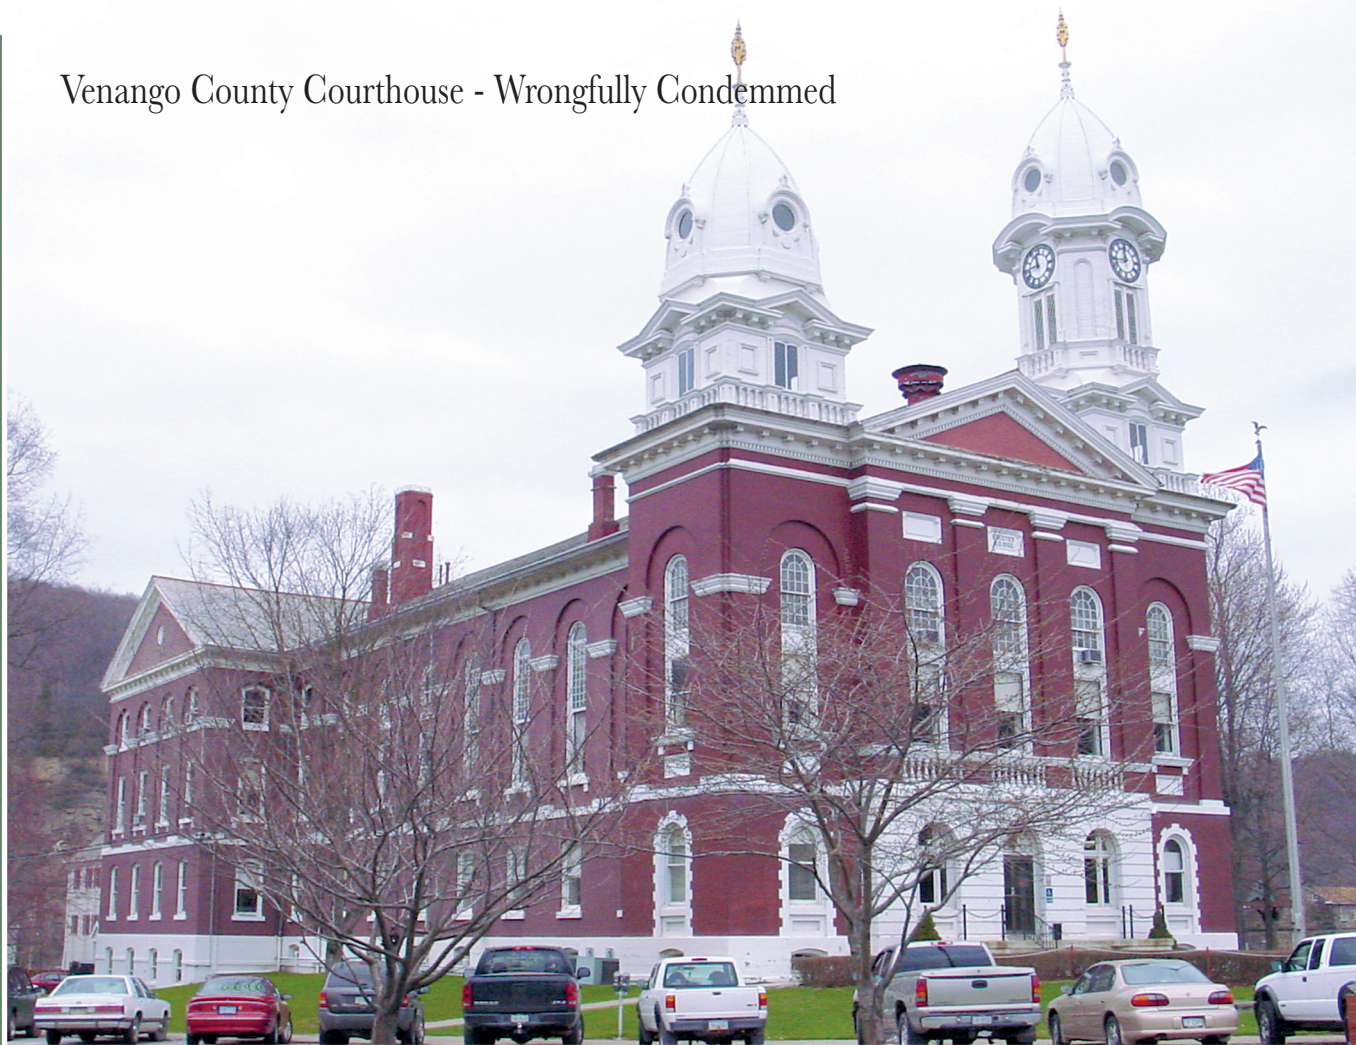
*This courthouse roof was unnecessarily condemned and scheduled for replacement. The Vermont “sea green” slate roof is only 72 years old – about halfway through its life. Comprehensive restoration work on this roof will only cost 10% of the cost for total replacement because the slates and fasteners are still in good condition. Most of the flashings, however, need to be replaced. (Photo by Joseph Jenkins.)*

In 2004, the author was called to consult on the replacement of a Pennsylvania courthouse roof. The 130-square Vermont “sea green” slate roof was approximately 72 years old. A county engineer insisted that the roof was beyond repair and was “absolutely certain” it had to be completely replaced. The author’s inspection revealed that most of the problems with the roof were related to bad repairs in the past, all reversible. The slate itself was still good and could be expected to last at least another 50 years if not 75 or more. Replacement costs of \$358,451 were reduced to restoration costs of \$35,000, which included replacement of virtually all flashings with stainless steel – a savings to the cash-strapped county of over \$300,000.

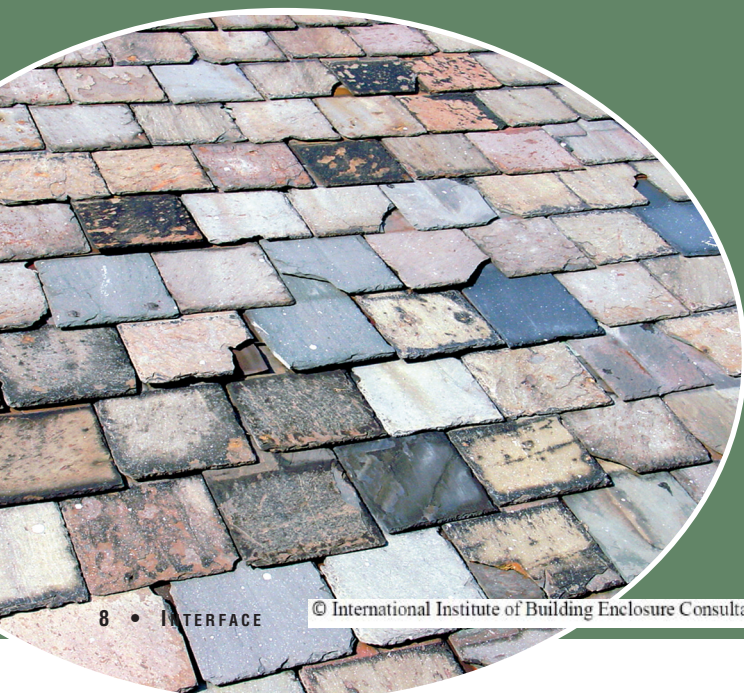
*Most of the problems associated with the Venango County Courthouse roof were caused by bad repair work over the years, an example of which is shown at left. The wrong type and color of slates were used to repair this roof, indicating the repair contractor didn’t understand proper restoration techniques. These will all need to be removed and replaced with slates that match the original roof. The author counted approximately 700 slates like this on the courthouse roof. (Photo by Joseph Jenkins.)*

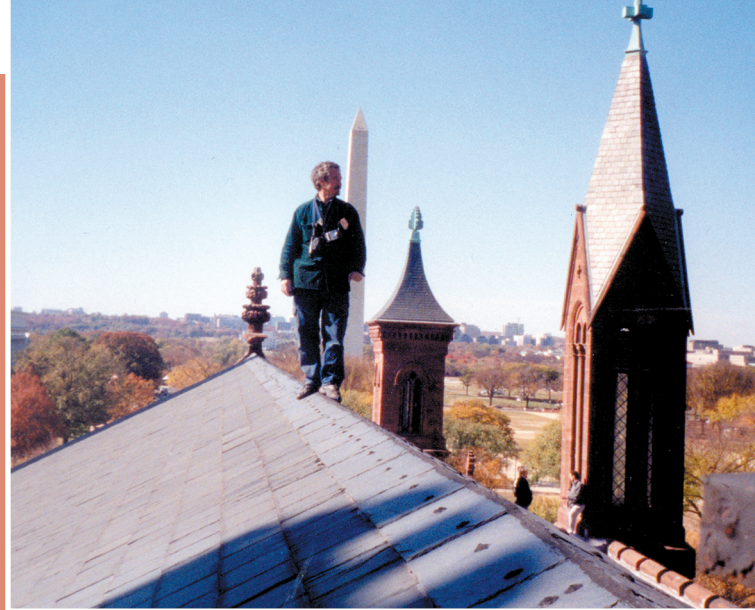
refurbished around the time of the bicentennial in 1976. At about that time, the Castle got a new roof. For some unknown reason, however, not all of the Castle's flashings had been replaced. Four main central valleys and the flashings along two parapet walls had been left as original, and they now leaked. Furthermore, the maintenance crew had the habit of tromping on the slate roof in what appeared to be combat boots, crunching the slates underfoot, breaking them, and adding to the roof problems. The solutions were simple and relatively inexpensive: replace the old flashings with new copper and keep people off the roof who don't belong there.

*The Smithsonian Institute Building known as "The Castle" had already been replaced with new slate, but some of the original flashings had been left in place, and they leaked. The author is inspecting the roof in the photo above. (Photographer unknown.)*

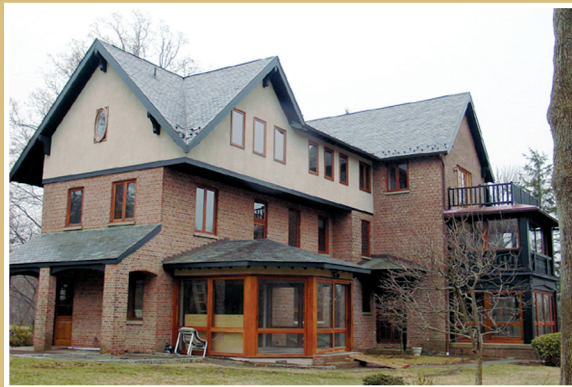
*Ten-year-old slate roof on a private residence condemned by roofing contractors. The nominal snow guard damage, however, was covered by homeowner's insurance; the roof did not need to be replaced at all. (Photo by Joseph Jenkins.)*

The author's inspection revealed that the snow guards had let loose due to severe weather that winter, combined with an inadequate number of snow guards for the size and slope of the roof. Each snow guard was hooked onto a slating nail, causing a slate to be pulled out with the snow guard. The damages amounted to a maximum of \$10,000 and all of it was covered by homeowner's insurance. Otherwise, the roof was fine. So much for "experts."

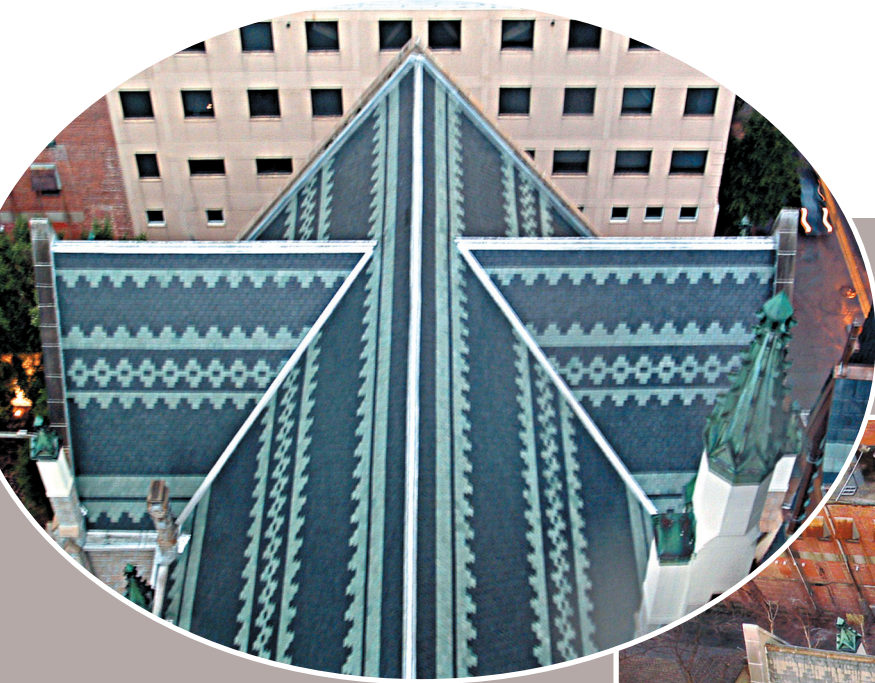
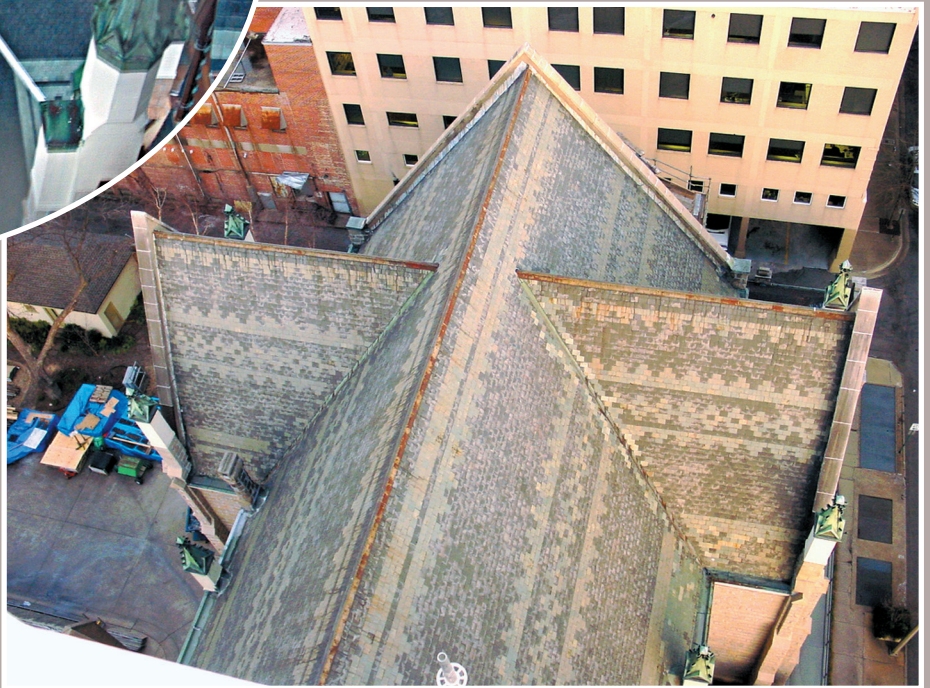
The Cathedral of St. Andrew in Little Rock, Arkansas, had worn out its black Pennsylvania slate after 120 years (below). The cathedral's new roof, left, installed by Midland Engineering in 2003, is likely to last 150 years. Vermont unfading green slate mixed with Welsh black slate and terne-coated stainless steel flashings should outperform the original roof. (Photo below by Joseph Jenkins; left photo by Lyle Bandurski.)

A slate roof will wear out, of course, and at the end of its life, nothing can save it. This was the case with the Cathedral of St. Andrew in Arkansas. The cathedral roof was made up of Pennsylvania black slates and Vermont unfading green slates mixed in an ornate pattern. At 120 years of age, the PA black slate had simply worn out – become soft, flaky, and falling apart – especially on the southern exposure and on the main body of the church. The Vermont unfading green slates showed almost no wear at all, despite their age of 120 years.

The original roof was inspected by the author to determine its condition and to draw up specifications for replacement. The new slate roof was subsequently installed by Midland Engineering of South Bend, Indiana, to match the original roof. This time, however, Vermont unfading green slates were mixed with Welsh black slates from Cwt-y-Bugail. All of the copper flashings were replaced with terne-coated stainless steel (some 4-lb. sheet lead was also used). The new slate roof is expected to last at least 150 years.
