WATERPROOFING UNDER GREEN (GARDEN) ROOFS

Part 2 of 2

By Justin Henshell, FAIA, CSI, FASTM

This is part two of a two-part series on waterproofing membranes under green (garden) roofs. The first part, published last month, traced the history of waterproofing membranes under plazas and earth-covered, below-grade spaces, and discussed the various types of waterproofing systems currently marketed and their advantages and disadvantages for use under green roof systems. This part covers the attributes of candidate membranes and offers a list of minimum physical properties proposed to satisfy the specific needs for those membranes exposed to continuous moist environments, aggressive chemicals, root invasion, and abusive maintenance. Additionally, it discusses failures and offers case studies to illustrate them.

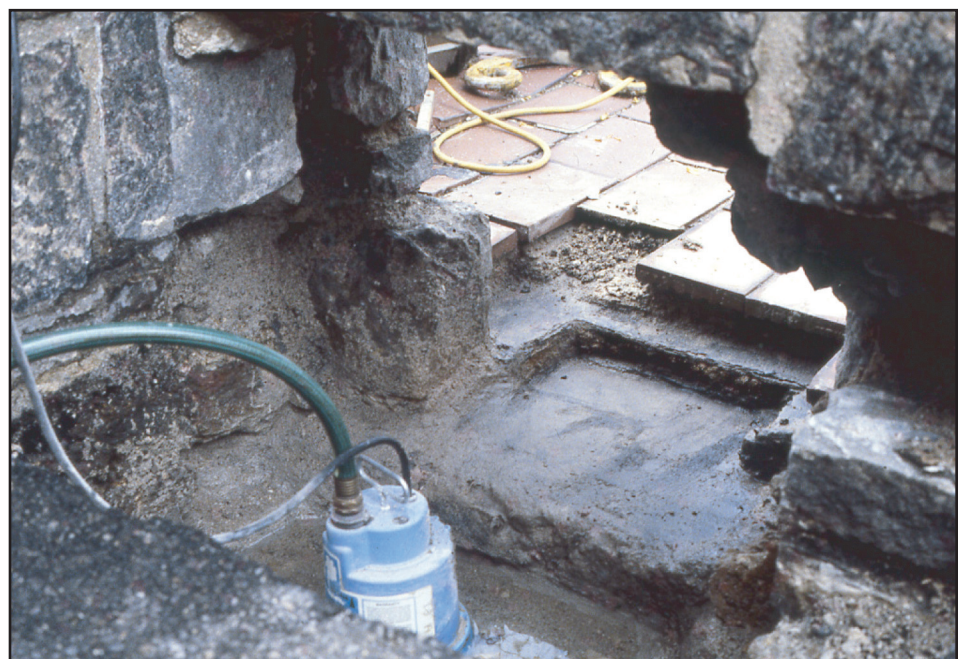
Figure 1: Exposing membrane for repair.

In selecting a waterproofing membrane under a GRS, the designer should exercise the same prudence as he or she would use when selecting a membrane under a wearing course that is to be installed in a mortar setting bed – the maintenance and repair are difficult and costly (Figure 1).

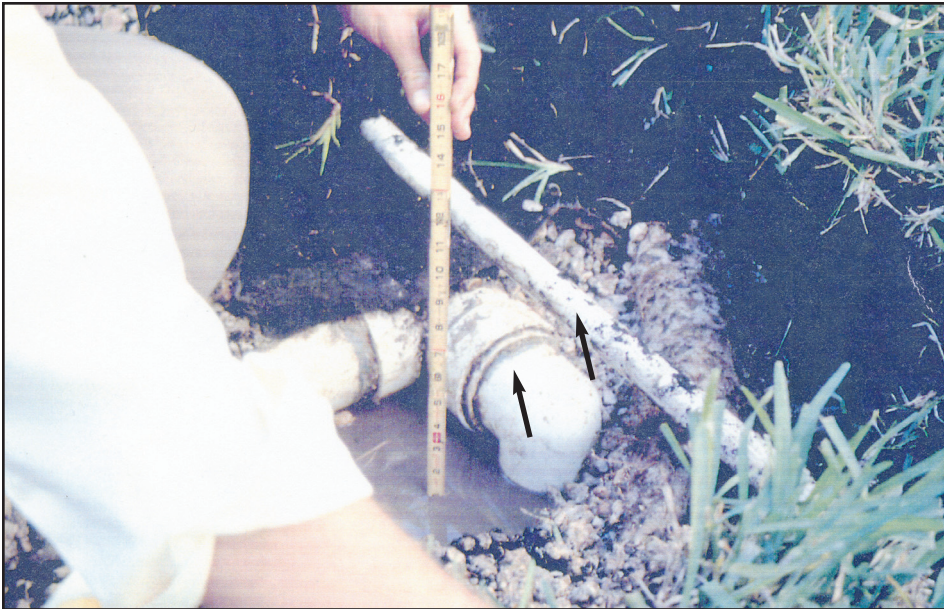
Figure 4: Elevated drainage pipes.

conceived drainage system. The planted areas were drained by perforated pipes extending from leaders through the slab. There were no conventional drains. Because the hubs on the pipe fittings and the radius of the elbow connecting the lateral pipes to the leaders raised the pipes above the slab, there was a reservoir of standing water more than an inch deep (Figure 4). Sheet rubber expansion joint covers had been installed flush with the waterproofed slab. The rubber was bonded to the liquid-applied membrane, creating a plane of weakness that was exploited by the hydrostatic head. The inadequate drainage and failure to elevate the expansion joint cover caused the joint to leak.
