# SOLVING DIFFICULT ROOF PROBLEMS

## PART I

By Ray Heisey, PE, RRC

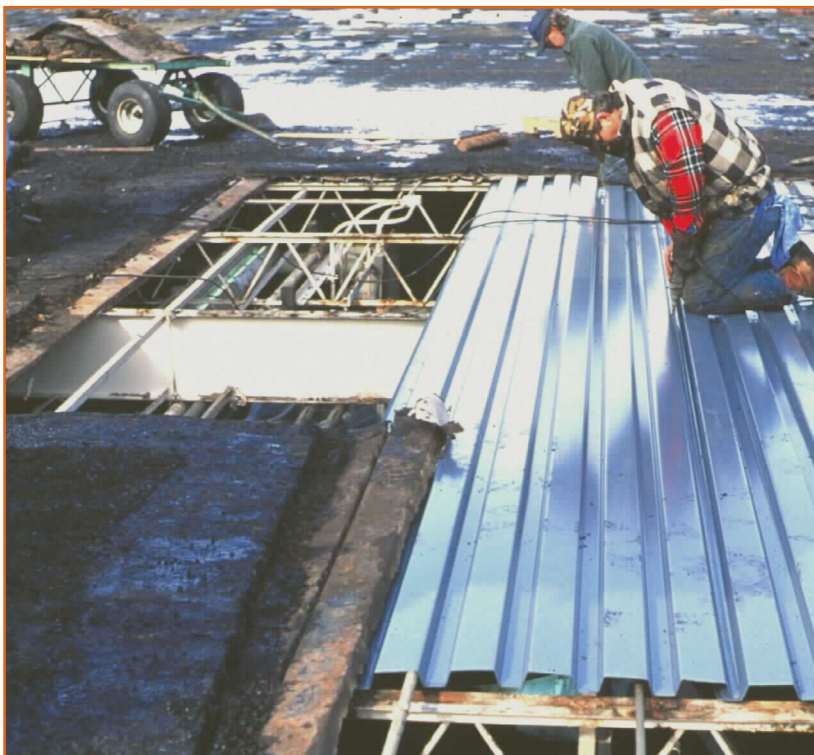
Portions of this steel roof deck are being replaced.

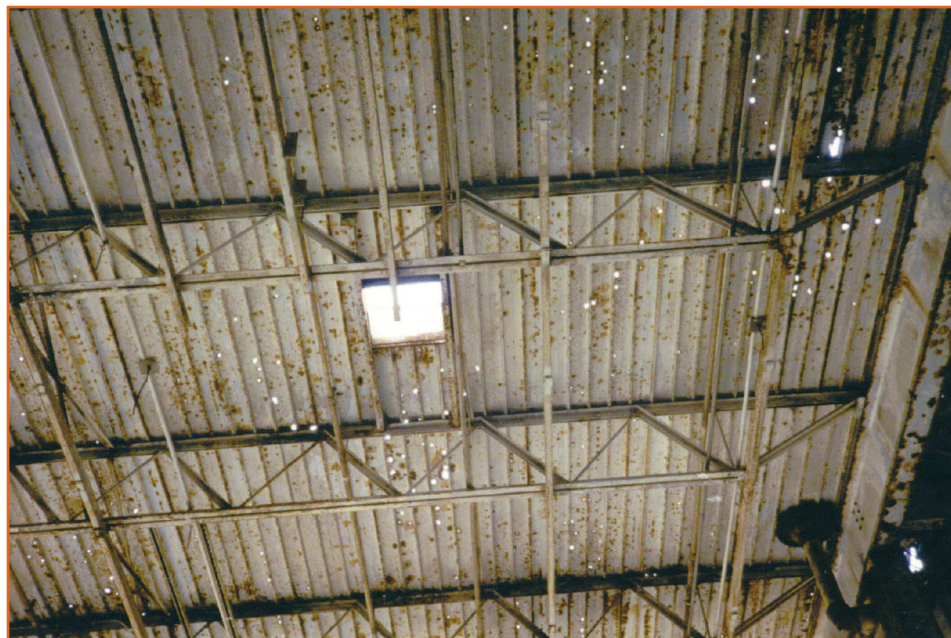
*This steel roof deck has numerous holes created by severe corrosion.*

problems because the deck is no longer able to carry the intended vertical and diaphragm loads. The majority of roof deck problems are caused by moisture infiltration.

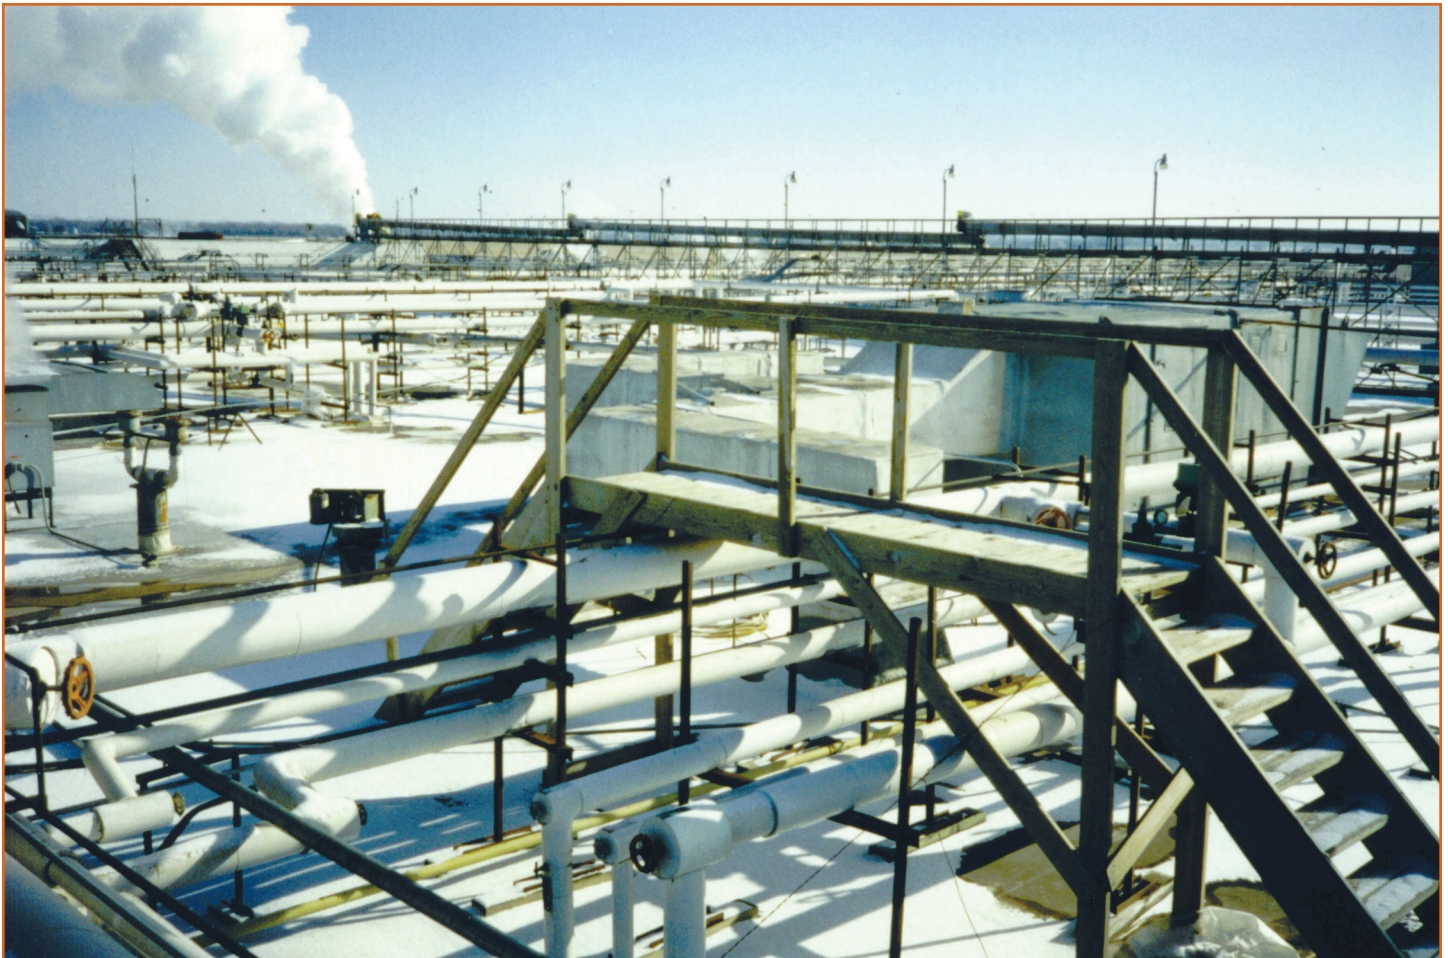
*The roof of a beef processing plant with numerous roof penetrations and obstructions.*

Roof penetrations can cause installation and weathertightness problems for any type of roof. When penetrations become numerous and close together, it becomes difficult, if not impossible, for even experienced crews to successfully install any roof system. Some industrial plants have equipment, piping, and other obstructions so numerous that proper installation techniques are very difficult to follow.

It logically follows that these same industrial plants with extraordinary quantities of rooftop equipment are the most intolerant to roof leaks. The ongoing challenge is that rooftop equipment, piping, etc., are moved, added, or eliminated frequently.

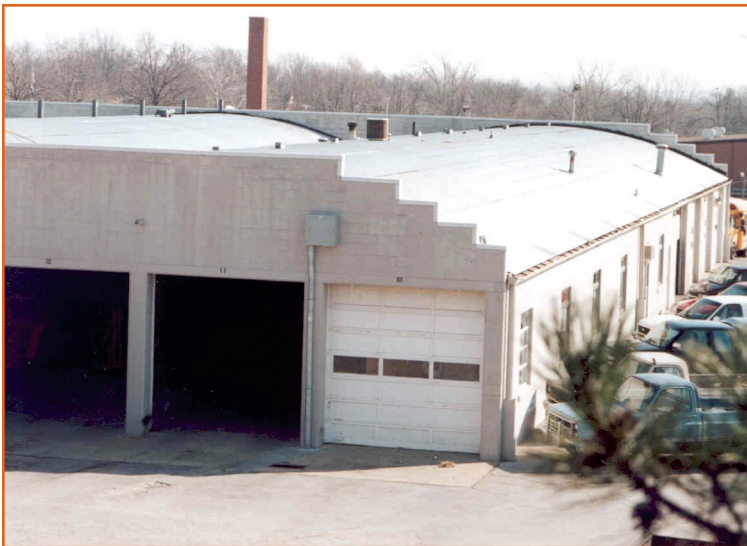
Adjacent curved roofs create valleys for moisture infiltration and parapet wall problems.

Curved roofs present a unique challenge. The slope varies from dead flat at the highest point to, in many cases, a very steep slope at the low edge. Few roof materials can be used on non-linear surfaces and both steep and low slopes. Curved roofs can also present appearance issues, which further limits the choice in systems. Multiple, adjacent, curved roofs create large valleys where snow, ice, and water can infiltrate, causing long-term roof, wall, and structural problems. These problems can be expensive to correct and disruptive to occupants.

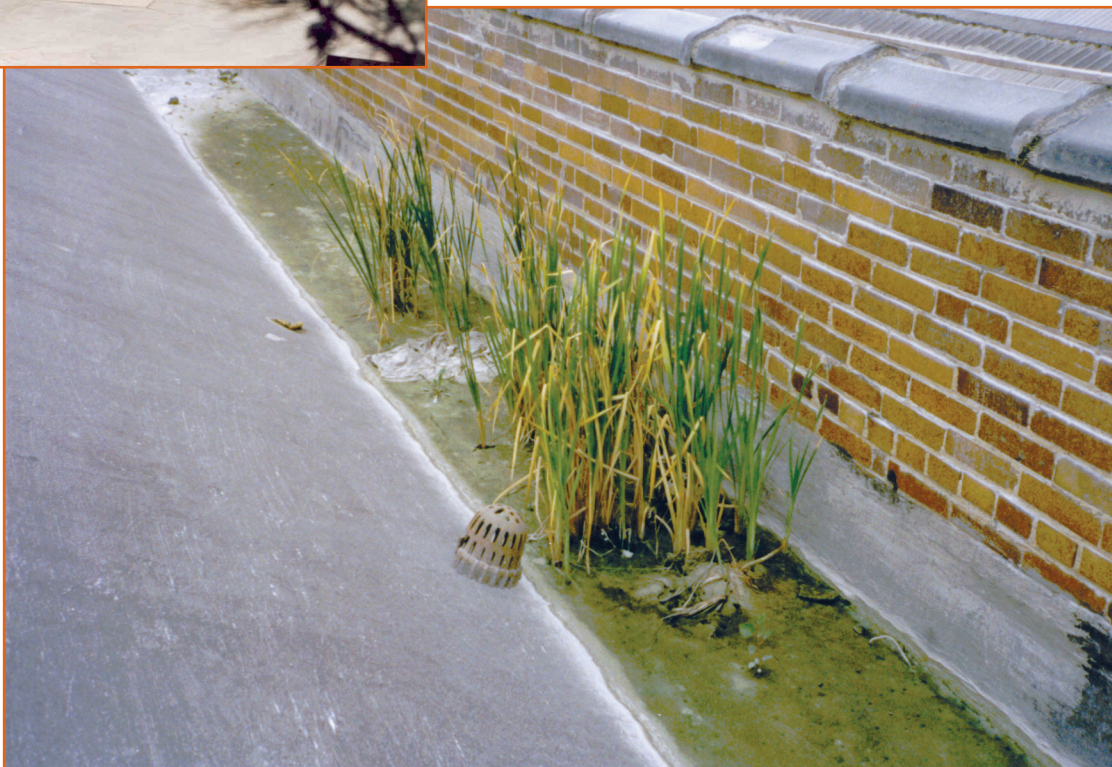
This roof drain is blocked with plant growth and sediment.

In some cases, the original drainage design for a building becomes non-functional, disabled, undesirable, or the cause of roof problems. This could happen for many reasons. A new building on an adjacent property, particularly with a zero lot line setback, can cause an existing property to restrict runoff to that property. Interior drains can become islands as the roof areas around the drains sag, settle, and deflect. Problems with interior drains and plumbing can create a desire to eliminate this type of system. Interior drainage systems in combination with parapet walls can create the potential for structural overload when drains become blocked. Interior drain piping can leak, causing interior finish damage, mold growth, and structural damage.

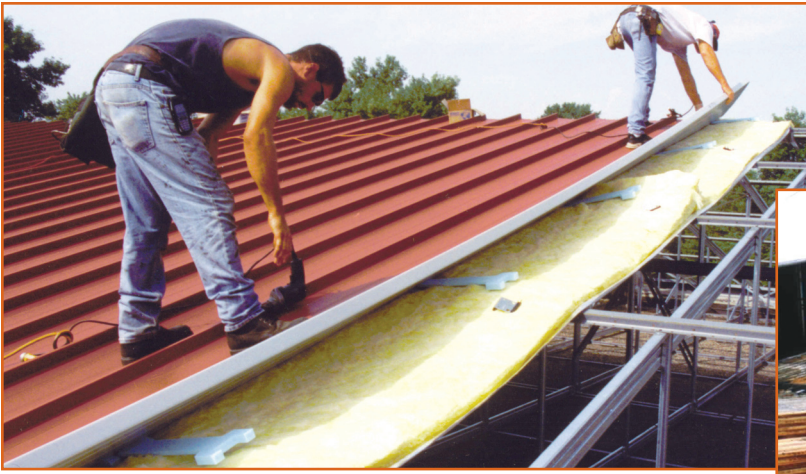
Flat roof being retrofitted with a sloped standing seam metal roof.

roof is created. This update serves multiple purposes. The steep roof creates curb appeal for the business and also eliminates a problem low-slope roof with interior drains.

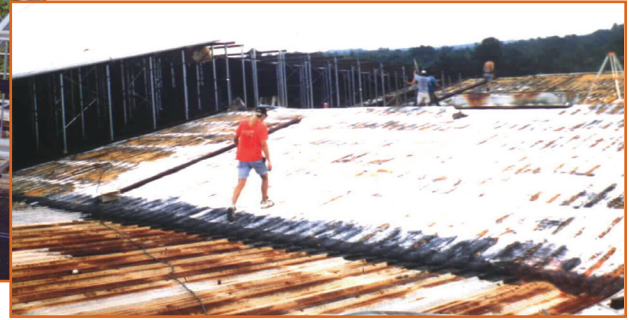
Below: These multiple adjacent metal buildings created leaking valley problems.

When building additions are constructed, consideration is rarely given to good drainage or flashing design. Roof problem areas are sometimes created, such as valleys between buildings, steps in elevation, and different adjacent roof materials.
