The Challenges of Retrofit Plaza Deck Waterproofing

By Gary W. Whittemore, CDT

A Case Study – John F. Kennedy Presidential Library and Museum

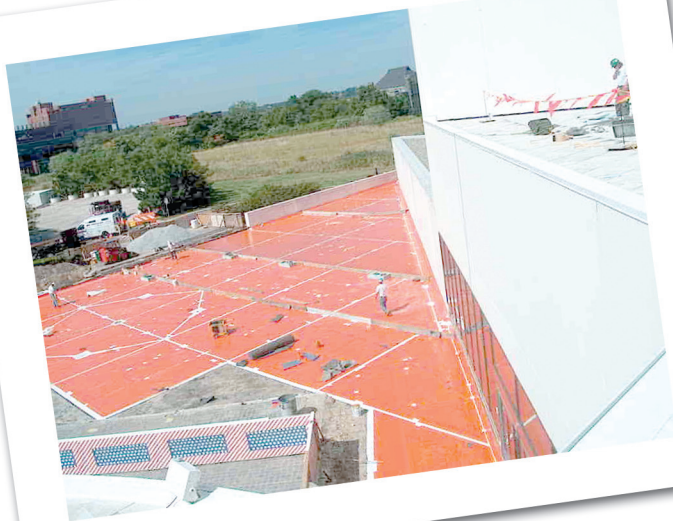
Photo 2 – The reinforced PVC waterproofing system was installed in a containment grid configuration to isolate any water that might breach the system.

The existing waterproofing membrane was completely removed only in areas where the 300-mm (12 in.) containment grid strip was installed. The grid strip was set in a two-part liquid urethane

adhesive and allowed to cure overnight. The open area was covered with membrane at the end of each day with the edges hot-air welded to the grid strip to maintain a watertight seal. Membrane overlaps were also hot-air welded to achieve a reliable watertight seam between the sheets (see *Photo 2*).

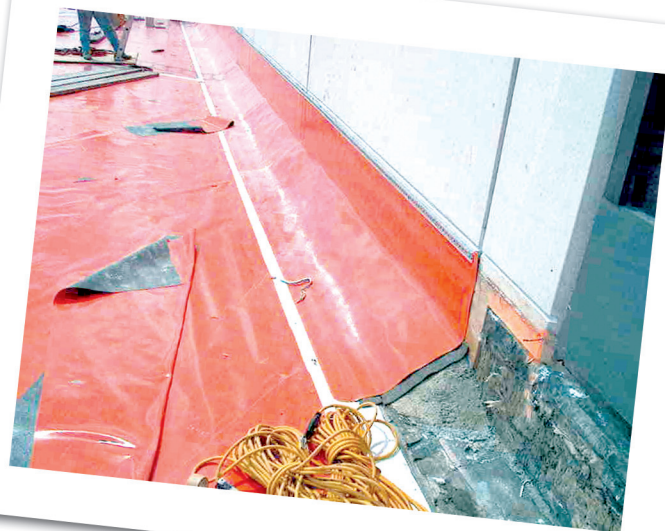
Photo 3 – A reglet was cut into the existing custom pre-cast concrete panels to terminate the waterproofing membrane and allow water to weep from the vertical caulk joints.

The existing waterproofing membrane was terminated behind the exterior, custom-manufactured, pre-cast concrete wall panels along the perimeter of the deck. This presented a significant challenge because the concrete panels could not be removed or cut. Since the quarry that provided the aggregates was no longer in operation, replacement panels could not be obtained should a panel be damaged. A detail was developed that allowed the new waterproofing membrane to be terminated on the panels. A reglet was cut to receive a metal counterflashing, which was designed to weep water that ran down the vertical caulk joints between each panel (see *Photo 3*). Custom stone pavers were installed to conceal the metal counterflashing, retaining the original appearance of the plaza.

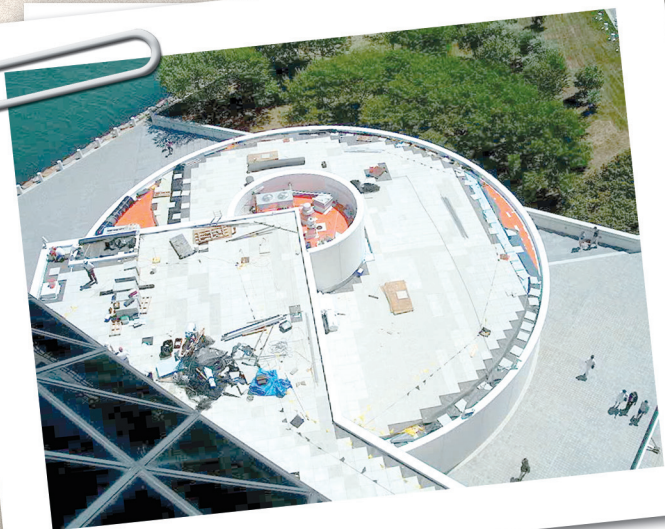
Photo 4 – Granite pavers were installed to complete the installation on the complexly-shaped elevated blue decks.

The contractor also replaced the waterproofing systems on four elevated roof decks utilizing the same design. The building's shape and deck locations proved challenging at times (see *Photo 4*). On one deck, the equipment, materials, and construction debris had to be hoisted over a 4.3-m (14 ft.) high parapet. Another deck was accessible only from a 12-story high external stair tower.

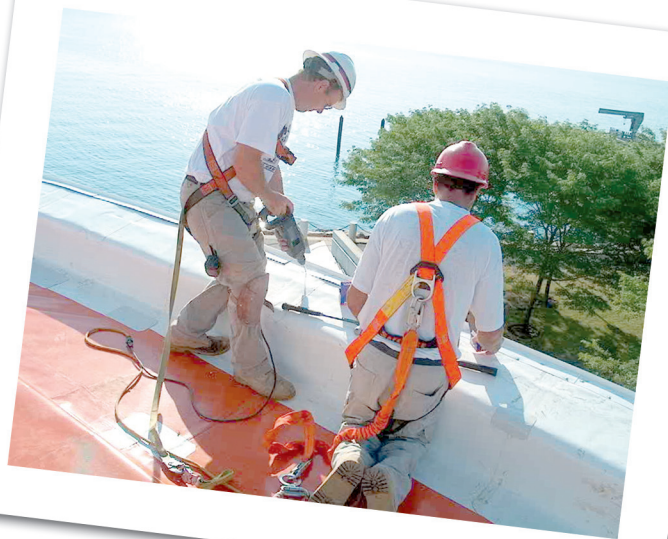
Photo 5 – Custom fabricated, PVC-coated metal is installed to complete the parapet wall detail.

Parapet walls were another source of leakage. The original flashing was terminated on top of the parapet wall and was not covered with metal. NARA was very concerned about the aesthetic impact of metal along the parapet wall. The design team was faced with developing a detail that provided watertight protection yet did not disrupt the look of the building.

White reinforced PVC membrane was used on all exposed flashings. The flashing membrane covered the top of the parapet wall and was terminated 50 mm (2 in.) down the exterior wall to

ensure watertightness. Metal edging was custom fabricated from PVC-coated metal to complete the detail. The library staff was consulted to select the color of the PVC-coated metal to best match the exterior walls (see *Photo 5*). A flashing strip of membrane was hot-air welded to the PVC metal to complete the detail.
