TILE ROOF SYSTEMS:

Analysis and Inspection Techniques for Roof Consultants

By Robert L. Fulmer

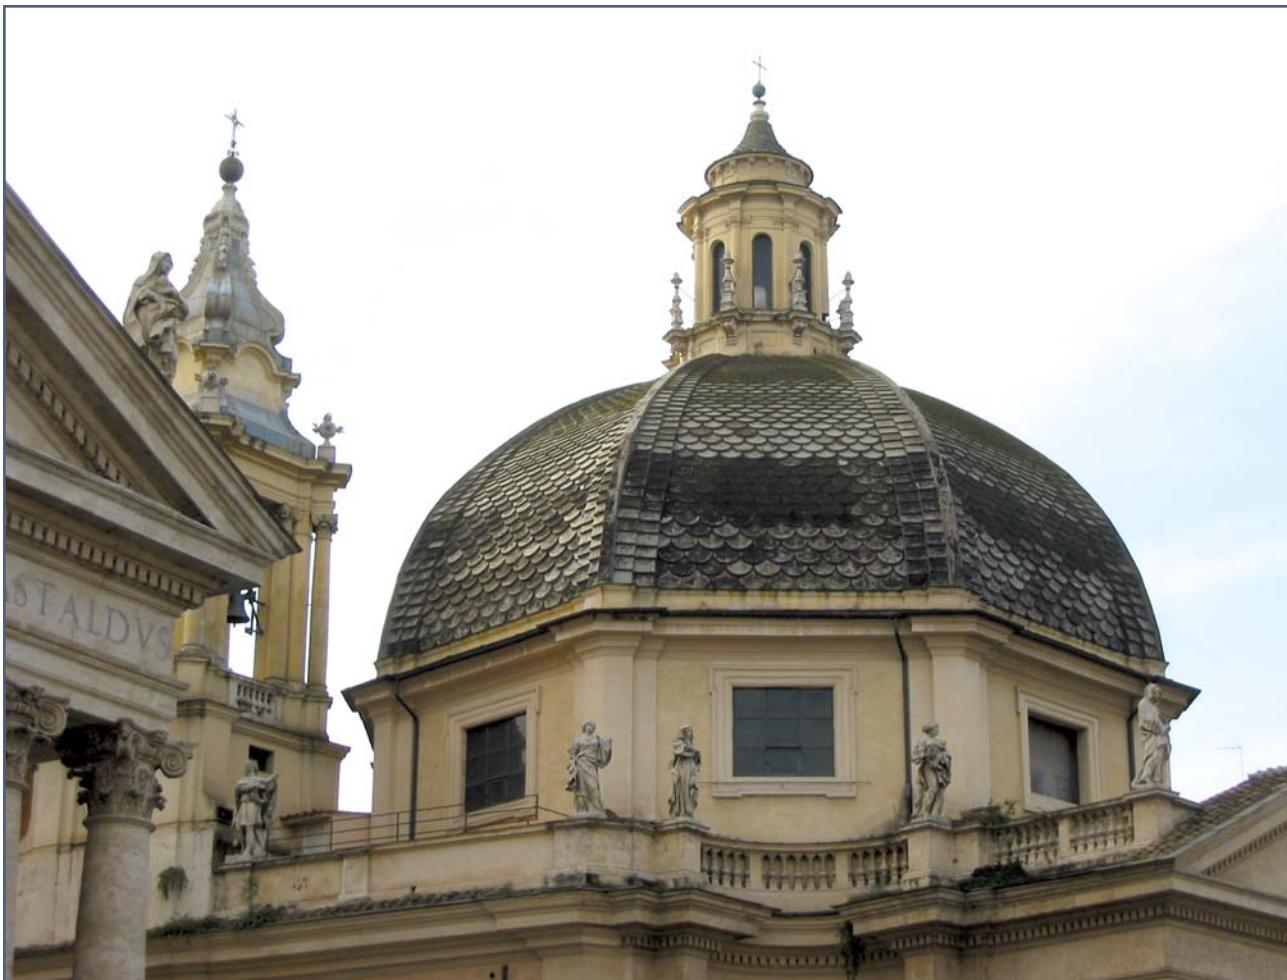
Photo 1 - Flat clay tile on a dome at the Pantheon, Rome, Italy. Photo by Robert L. Fulmer.

While some basic elements of tile roofing have been a part of the world's architectural legacy for thousands of years, our more recent past has seen significant growth and change within the industry (*Photo 1*).

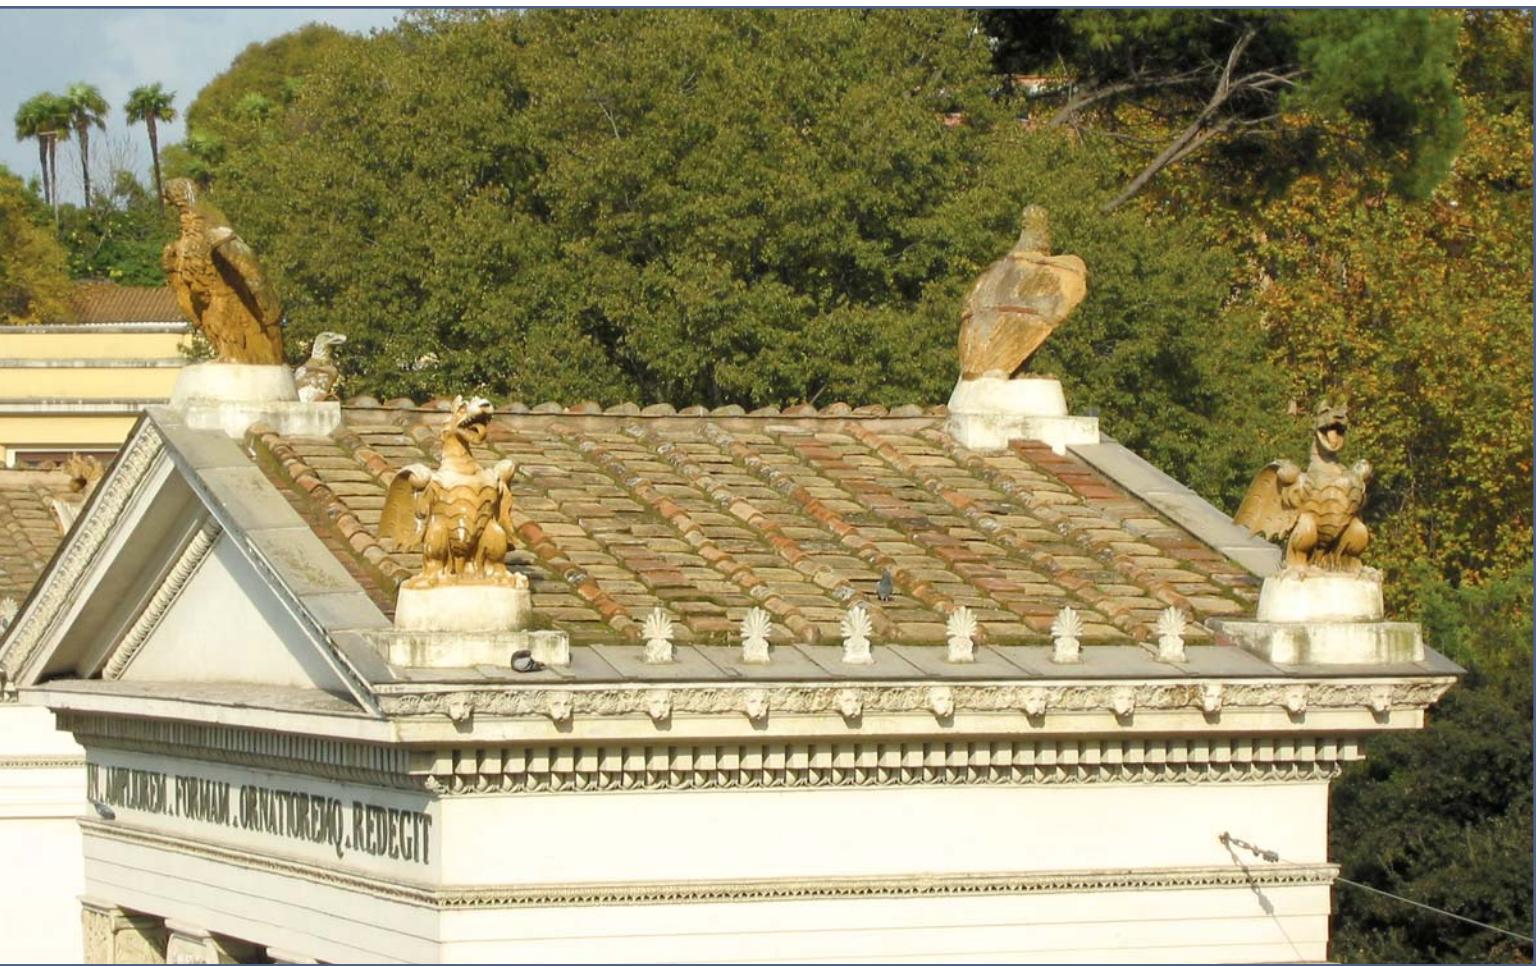
Photo 2 – Flat clay tile in the Piazza del Popolo, Rome, Italy. Photo courtesy of Robert L. Fulmer.

From China and the Middle East, the use of clay tile spread throughout Asia and Europe. Although tile roofs were used by the Assyrians, Egyptians, and Babylonians, it was the Greek and Roman civilizations that elevated roofing tiles (known as Tegula) from crude, hand-made objects in clay to an art form (Photo 2).

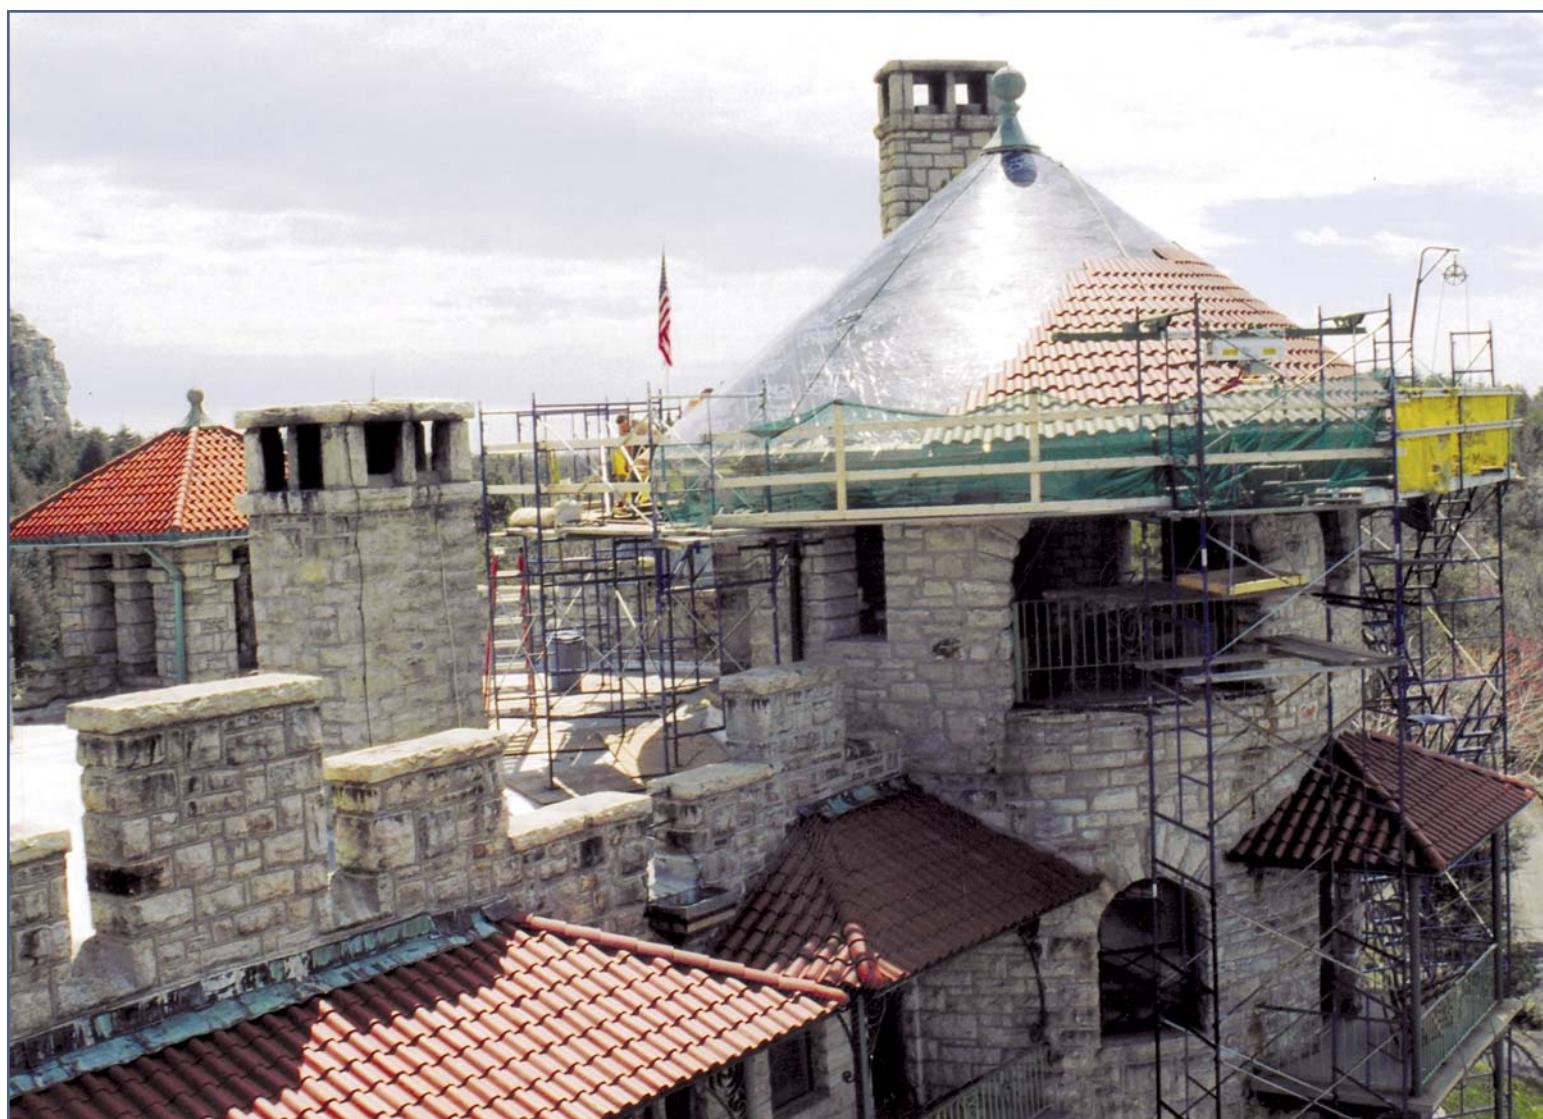
Photo 3 – Process of replacing original Ludowici Celadon clay Spanish tile (initially installed at the turn of the 20th century) with new tile by the same manufacturer on an historic hotel in upstate New York (the original tile came from Celadon's plant in Alfred, NY). Photo by Robert L. Fulmer.

In Colonial America, tile was popular for the same reasons that were relevant during the Neolithic period. The materials were readily available and they were fire-proof. The latter helped address a near hysteria about fire in colonial American cities. After devastating fires in London in 1666 and Boston in 1679, the first building and fire codes were established in New York and Boston. These codes encouraged the use of tile roofs and remained in effect for almost two hundred years. By the 1830s, however, clay tile was temporarily out of fashion. Competition with slate along the east coast and new metal products that looked like tile became significant (*Photo 3*).

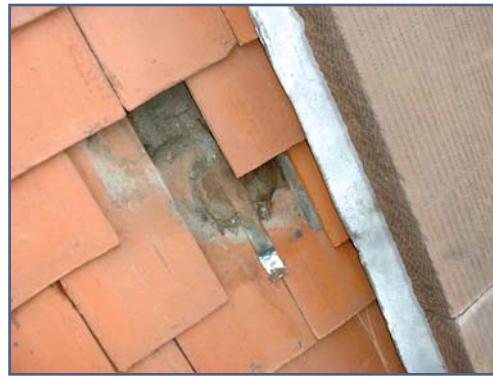
Photo 4 – Clay overlapping (flat shingle) tile exhibiting signs of water absorption. Photo by Robert L. Fulmer.

Predominantly, there are two types of roofing tiles – overlapping and interlocking. Interlocking tiles are designed to be installed in pairs with an extrusion on one tile that is designed to "lock" over the other tile, securing both. Overlapping tiles don't have a locking side and are generally nailed in place. There are a number of tile shapes and profiles, but most fall into two categories – pantiles and flat tiles. Pantiles consist of two half cylinders, where one is attached to the roof deck or battens and the second is inverted and overlaps the upturned edge of the first. These comprise the most common profiles associated with tile roofing – i.e., Spanish, mission, or barrel tile. Flat tile can be either completely flat (no extrusion or lock), or it can be interlocking on the top and one side (*Photo 4*).

Clay tiles also absorb water; however, porosity is a function of the density of the clay used and the vitrification process. Vitrification is the process that turns clay to glass by applying heat (firing). Clay tiles that are not thoroughly vitrified are softer and consequently possess a shorter service life. Freeze/thaw cycles in colder climates cause spalling when moisture expands as it freezes. Spalling and flaking are the result of normal water absorption and wear process. Flaking begins on the surface of the tile and continues throughout the life of the tile until the flaking wears completely through. The presence of these elements is sometimes incorrectly diagnosed as tile failure. During examination of a representative number of tiles, the flaking should be dislodged. If algae or lichen are present under the flaking, the process is a slow, natural one. If bright, clean clay is exposed, the process is accelerated and newer. This could be the result of environmental factors (i.e., hail damage, excessive hot and cold temperature variation), or it could indicate premature tile failure.

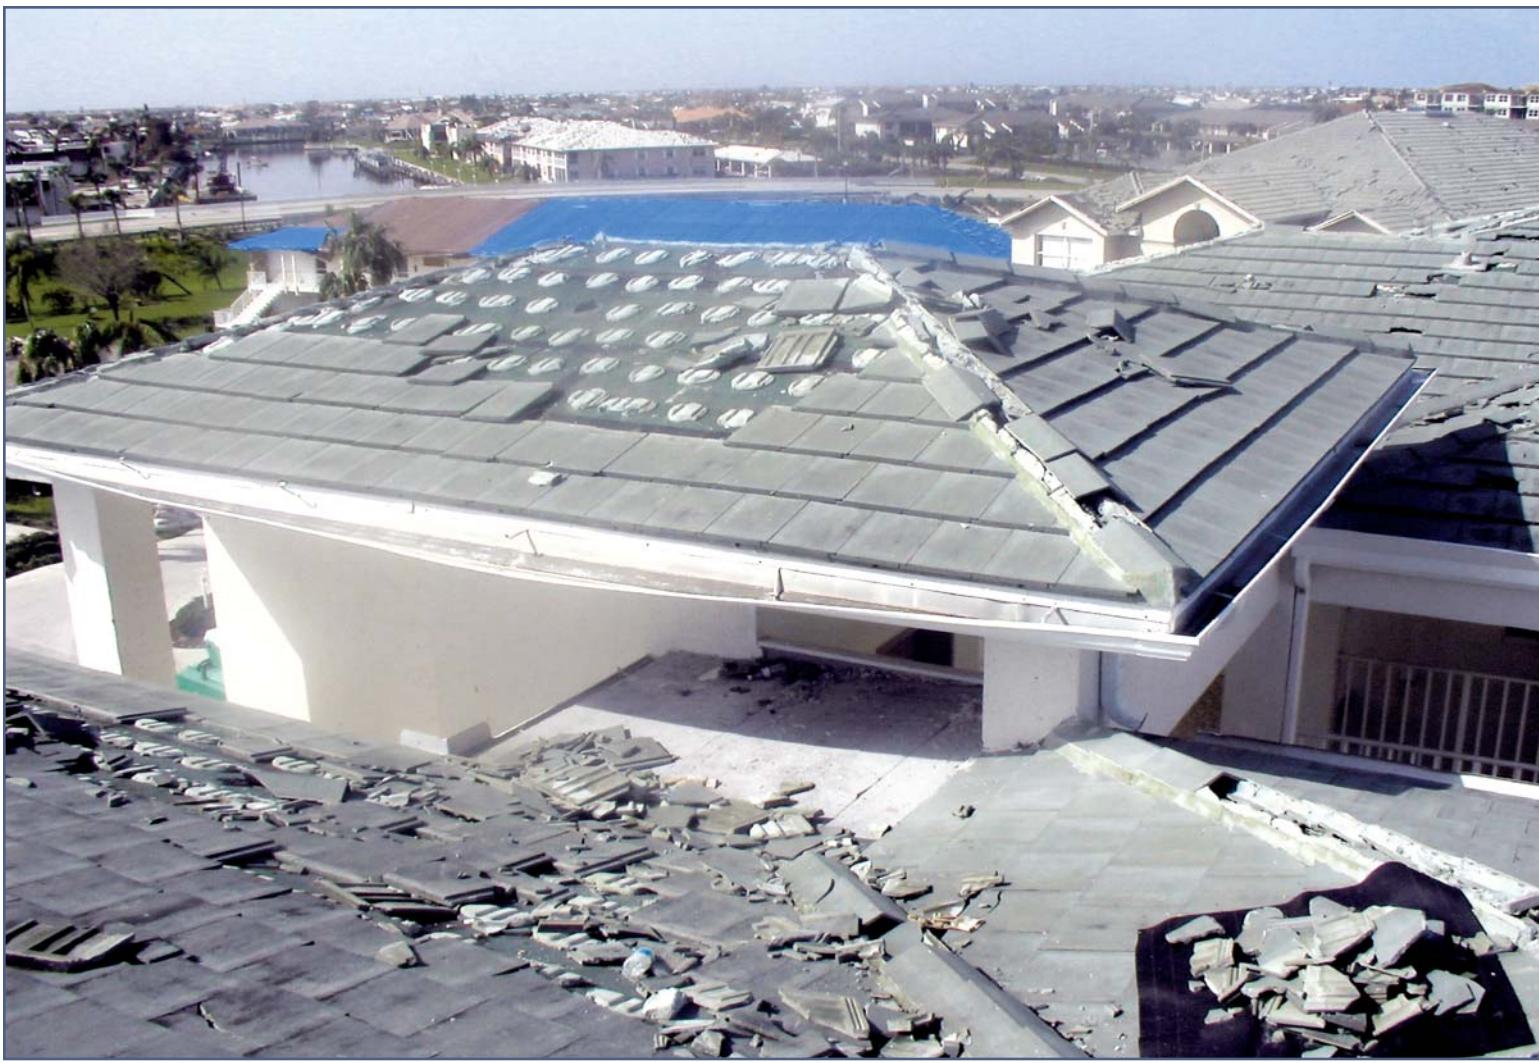
Photo 5 – Example of a ridge tile failure in a concrete tile roof system. Photo courtesy of Warren French.

severe wind event. Because Punta Gorda is an older community, most tile roofs were older, mortar-set concrete tile. Overall, system performance of the older, mortar-set tiles was the poorest. Mortar deterioration and subsequent loss of adhesion resulted in either substantial numbers of tile blown from the roof deck, or completely missing rakes and ridges (Photo 5).

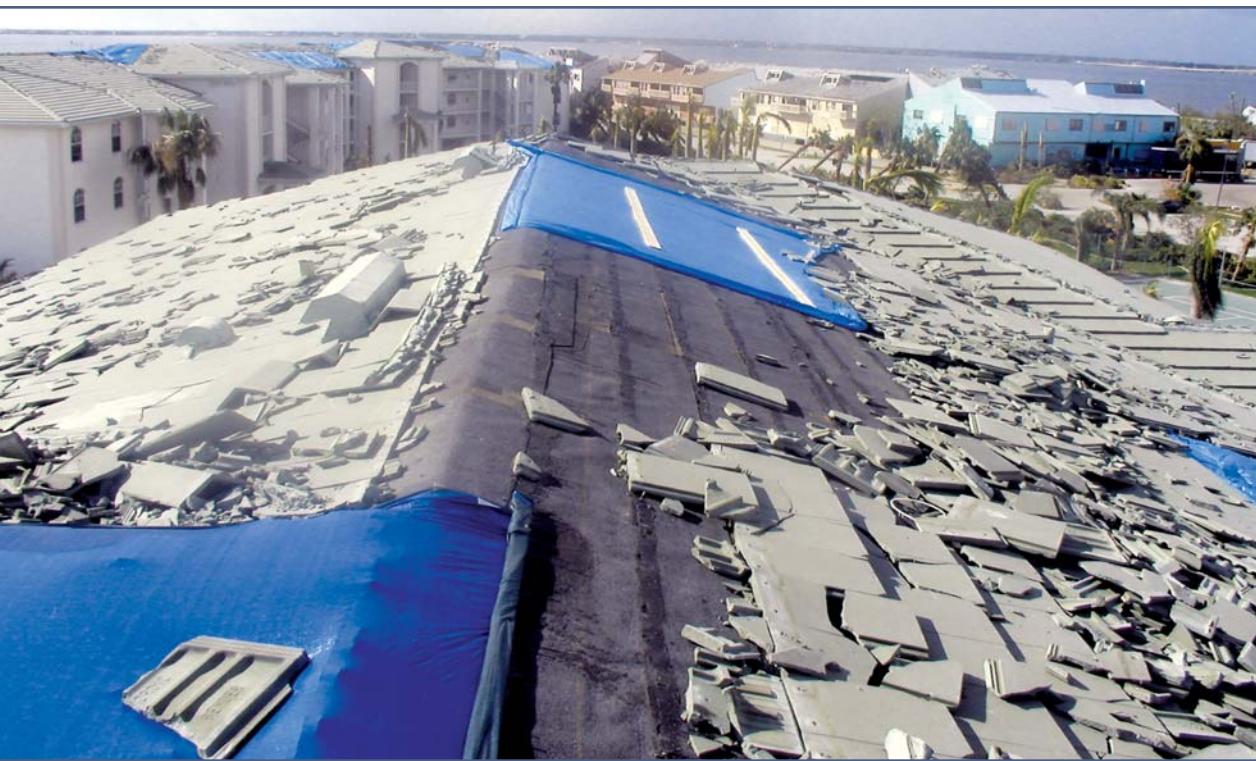
Photo 6 – Upper concrete tile roof exhibiting partial failure of the “foam-set” system, possibly due to an improper foam mix. Lower roof exhibiting damage from flying debris. Photo courtesy of Warren French.

1. Failure of the ridge tile occurred on roofs that did not use a ridge nailer board, but relied on mortar without fasteners.
2. The second failure source was an installation error occurring when the two-part foam mix was improperly mixed, resulting in the foam being either “part A rich” or “part B rich” (Photo 6).
