Restoration and Repair of Historic and Contemporary Brick Masonry

Douglas R. Stieve, RRC, AIA
Wiss, Janey Elstner Associates, Inc.
New York, NY

Roof Consultants Institute

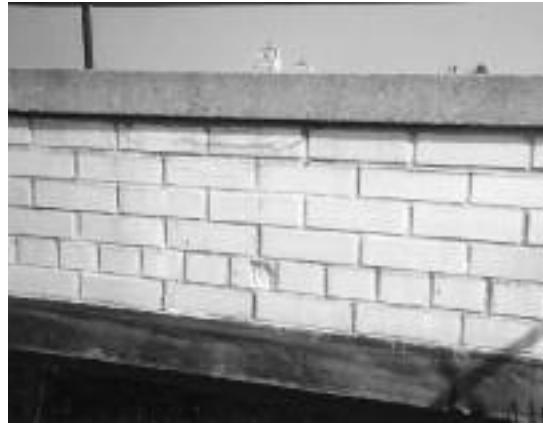
absorbs water and when it is saturated, these pores become filled with water. If the masonry freezes while it is saturated, the ice will expand as it changes from a liquid to a solid. If the pores on the brick and/or mortar are well interconnected, there is enough room to accommodate the expanding ice. If there is not enough room, stress

is produced within the material and distress can occur (*Figure 2*).

Figure 2 – Freeze-thaw distress at parapet.

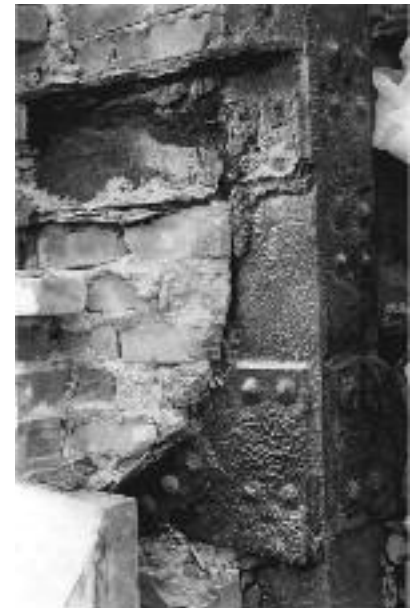
Rust Jacking: Masonry is often placed in intimate contact with structural steel lintels, outriggers, and spandrel beams. Steel will expand as it corrodes, often to volumes several times greater than that of the original steel. The expanding rust produces large stresses, which can exceed the tensile strength of the masonry. Cracks, deflection, and spalling of the brick can all occur due to rust jacking (*Figure 3*).

Figure 3 – Rust scale on structural steel.

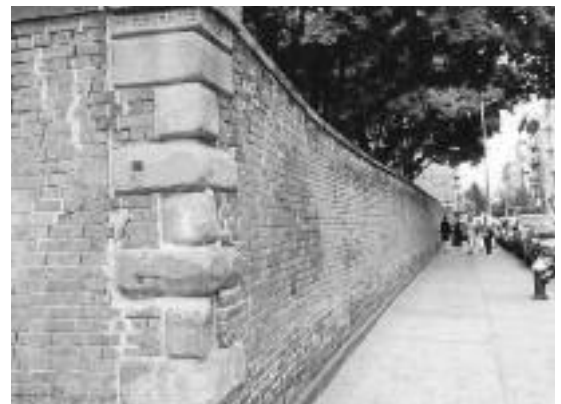
Temperature differences affect all materials. New construction standards require expansion and control joints. Older buildings with multi-wythe masonry walls and steel skeleton structural frames are also affected by differential thermal movement between the outer wythe of brick and the steel structure, which is better protected from temperature swings by the mass of the wall (*Figure 4*).

Figure 4 – Bowing due to restrained thermal movement.

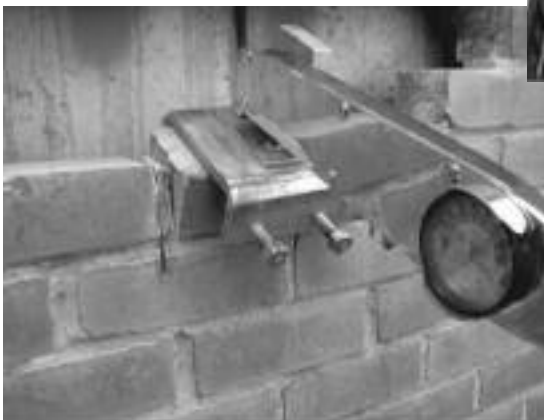
Bond Wrench Test. Based on a modified field application of ASTM C1072, *Standard Test Method for Measurement of Masonry Flexural Bond Strength*.³ This can help determine the flexural bond strength of the masonry. Masonry is removed from around the test specimen and a large calibrated wrench is used to break the brick from the bed joint while recording the peak load (Figure 6).

Figure 6 – Bond wrench test.

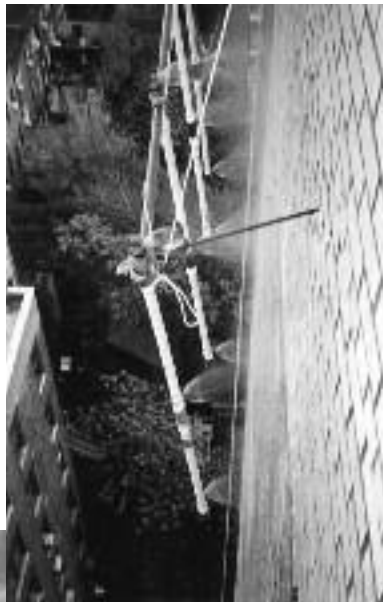
Water Spray Rack. Water is sprayed on the wall surface area via a water spray rack. The size of

the spray rack can be adjusted to suit field conditions. Portions of the wall can be masked off with plastic sheathing to limit the testing to just the masonry or to eliminate other variables such as windows and/or mechanical louvers. The flow of water and spray nozzle sizes are based on ASTM E1105, *Standard Test Method for Field Determination of Water Penetration of Installed Exterior Windows, Skylights, Doors, and Curtain Walls by Uniform or Cyclic Static Air Pressure Difference*² (Figure 7).

Figure 7 – Spray rack.

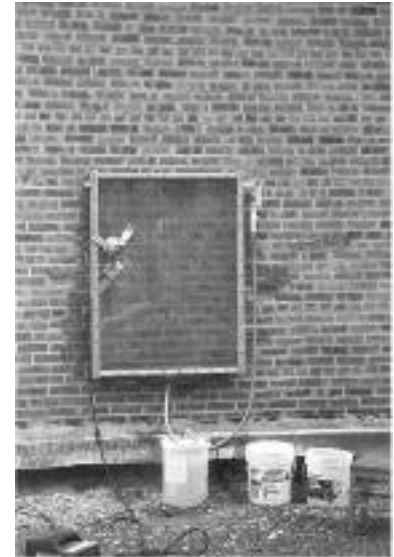
This test conducted per ASTM C1601, *Standard Test Method for Field Determination of Water Penetration of Masonry Wall Surfaces*, can be performed to determine the amount of water that penetrates into a masonry surface (Figure 8). A chamber is

Figure 8 – Water penetration test in progress.

mounted to the brick and a film of water is created within the chamber that flows down the face of the brick. The water is collected at the bottom of the chamber and recirculated. Air pressure is introduced to mimic a wind-driven rain. The amount of water lost from the chamber is recorded as the amount of water that penetrates into the masonry. This is a very useful tool to evaluate various repairs to resist water penetration, such as re-pointing and masonry sealers. Base line values for the existing wall can be compared to mock-ups of different repair methods.

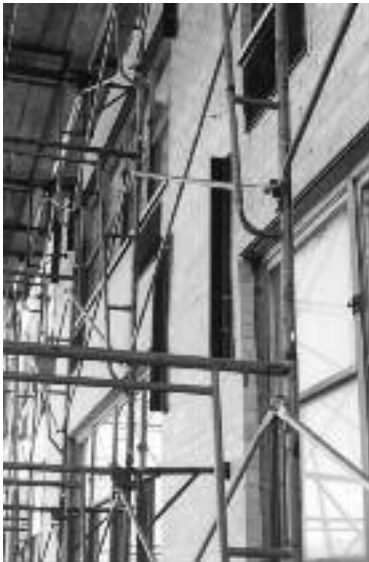
Sometimes temporary repairs are required to stabilize the masonry until long-term repairs can be performed. Masonry distress to walls over sidewalks, driveways, and other areas accessible to pedestrians and/or vehicles are of particular concern. Access into these areas should be prevented or adequate sidewalk protection should be installed. Temporary repairs are often performed before the investigation concludes. These can involve pinning, the installation of braces (Figure 9), and/or netting to catch loose fragments before they can fall to the ground.

Figure 9 – Temporary bracing angles used to prevent bulged masonry between windows from falling.

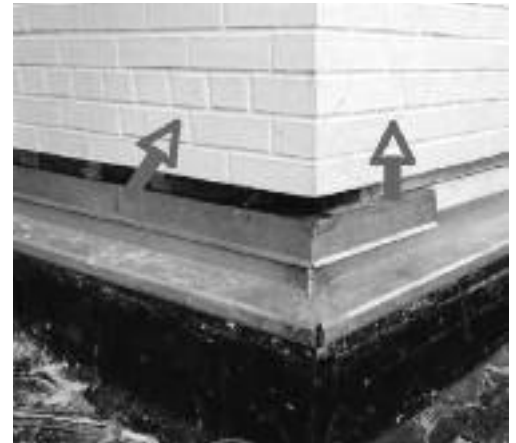
Shoring is a critical component during construction and can be provided with wood blocking or the use of steel angles inserted below the remaining brick. These angles are supported off of the lower remaining brick or connected back to the structure of the building. Masonry veneers are usually tied back to the remainder of the wall with metal ties, which have no vertical load resistance capabilities. Older multi-wythe masonry walls are usually tied together with brick header courses. These headers transfer some of the weight of the outside wythe of brick to the inside wythe(s). Often during flashing repairs, small amounts of masonry are removed, the flashing installed, and the brick is replaced before the mason proceeds to the next small section of masonry. A metal flashing that can be soldered in the field such as copper, lead-coated copper or stainless steel should be used. This will allow the small sections of flashing to be

soldered together so that the end result is a complete watertight flashing system. Shoring is often a means and methods issue and will vary, depending on the repair and wall type. The existing wall should be reviewed and shoring should be designed by a licensed engineer engaged by the contractor (Figure 10).

Figure 10 – New through-wall flashing at setback wall. Note header brick course (arrows).

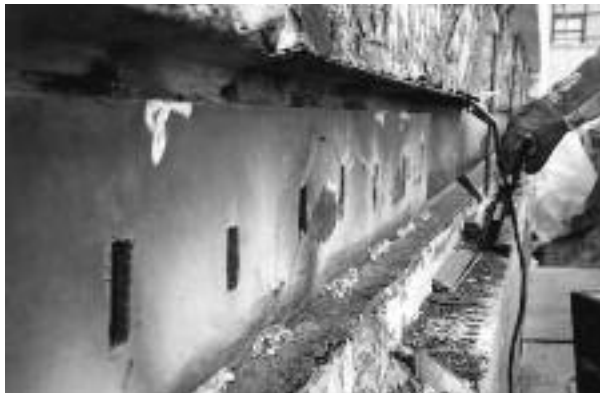
Masonry reconstruction often includes structural steel repairs. Long-term corrosion can reduce the size and strength of the remaining steel. Supplemental sections such as plates, angles, and channels can be welded or bolted to the remaining steel to strengthen deteriorated portions of the structure. Repairs at connections – particularly where older rivets occur – present challenges. Structural steel repairs should be designed by a licensed engineer (*Figure 11*).

Figure 11 – New steel plate being welded to existing beam.
