PERFORMANCE ATTRIBUTES OF FIBERGLASS SHINGLES

By Jim D. Koontz, RRC, PE

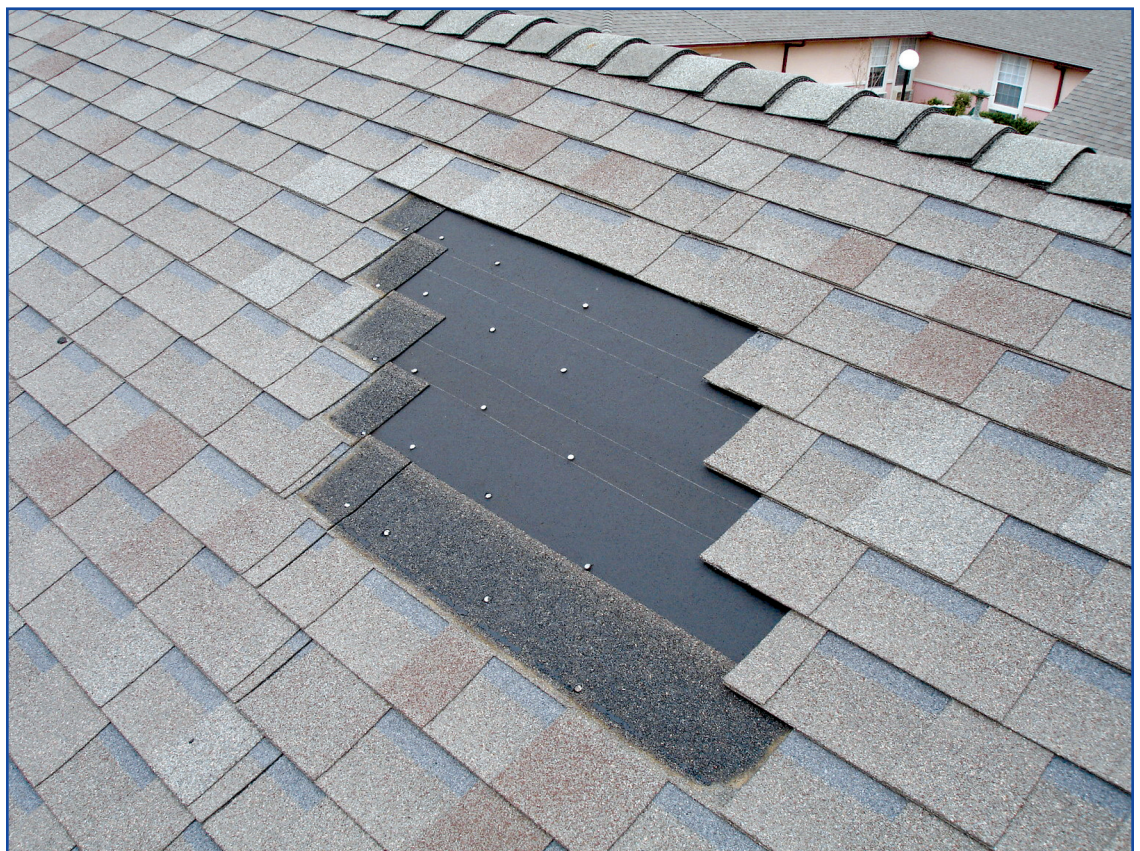
Photo 1 – Shingle failure. Note high placement of nails.

The past 30 years have presented many opportunities to examine numerous shingle losses due to wind events. For the most part, fiberglass shingles have performed well. In many cases, however, it is clear that improperly manufactured or installed shingles have prematurely failed (*Photo 1*). Some shingles, even when properly manufactured or installed, have failed at relatively low wind speeds.

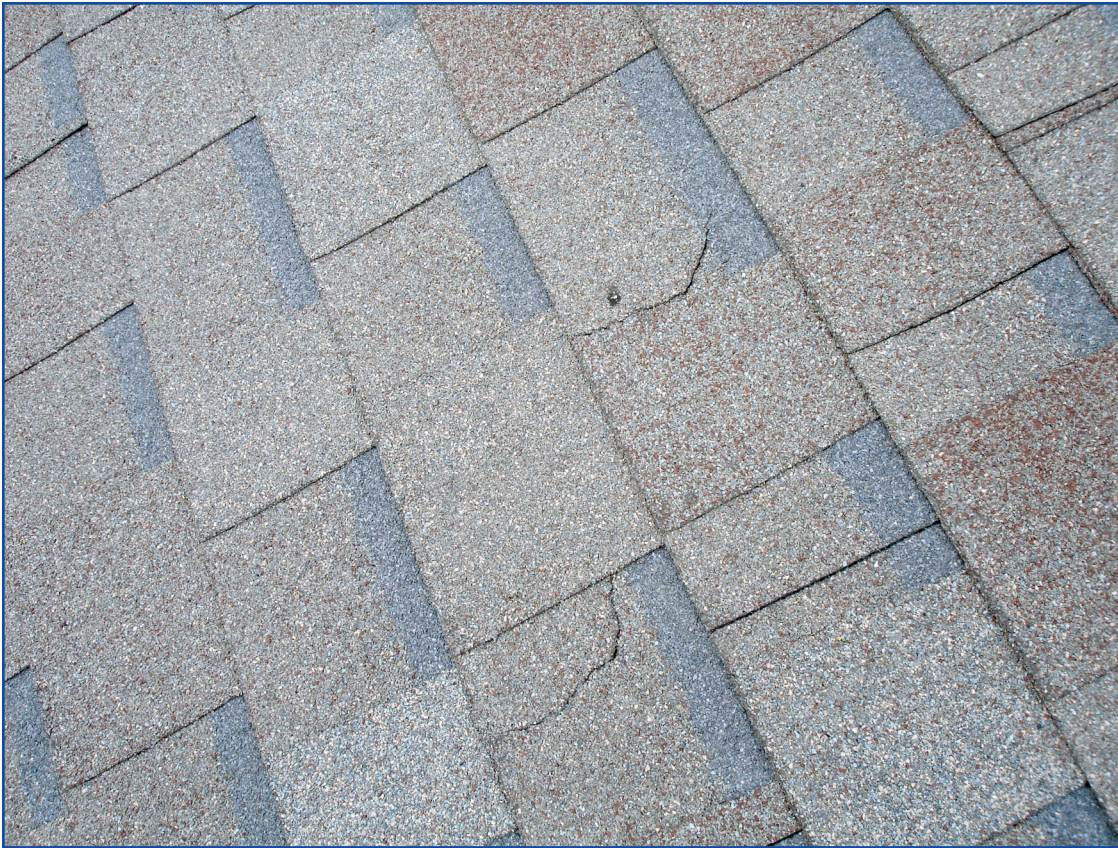
Photo 2 – Shingle splitting.

Numerous cases of fiberglass shingles splitting, independent of external factors, were reported (*Photo 2*). The shingles would split on the exposed face of the roof in both horizontal and vertical directions. Splitting occurred predominantly on western and southern exposures.

numerous technical articles on the subject. The causes of the splitting were attributed to poor ventilation, workmanship, and in some cases, poor quality of manufacture. Eventually, through research, splitting was found to be related to thermal cycling and the physical properties of the shingles. The earliest article on this subject was published in *Western Roofing*, May/June 1990.¹

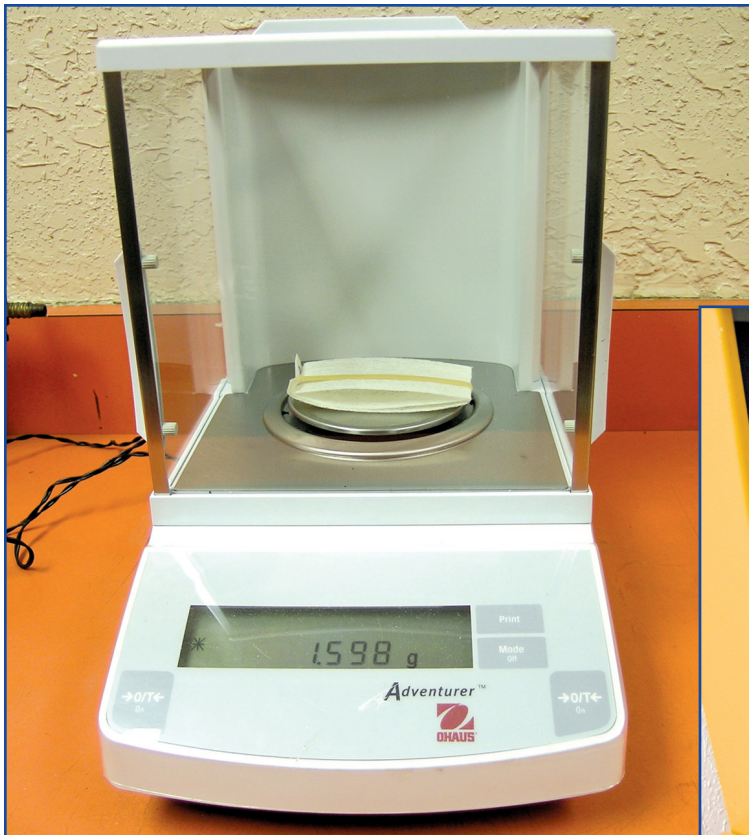
Photo 4 – Desaturated mat weight.

extracted from each sample until a clean fiberglass mat was obtained (Photo 4). The fiberglass mat samples were dried and weighed. The desaturated, dry, fiberglass mat weights ranged from a low of 1.67 lbs/100 ft² to a high of 2.17 lbs/100 ft². All of the samples tested contained fiberglass mats that exceeded the ASTM D 3462 minimum requirement of 1.35 lbs/100 ft².

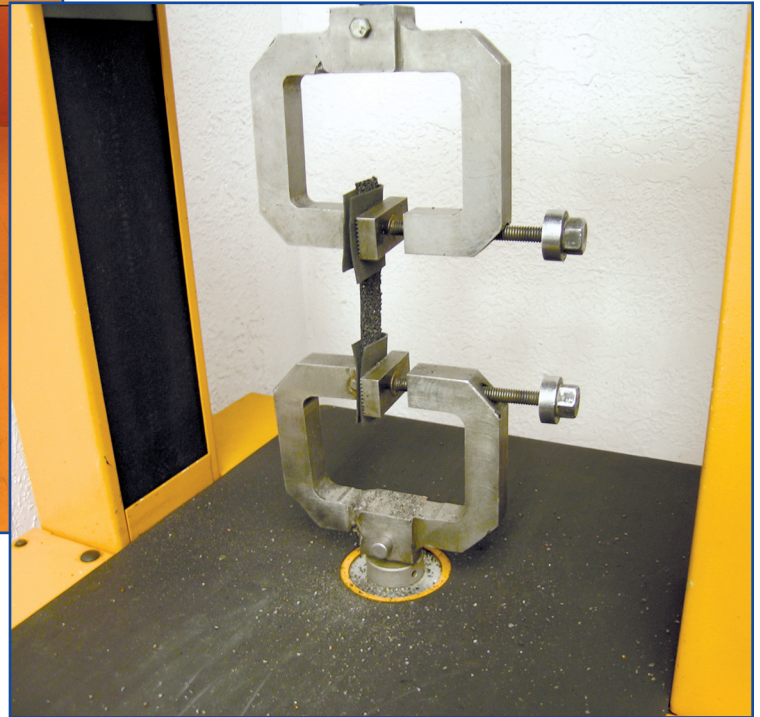
Photo 5 – Tensile strength.

The shingles were also tested for tensile strength (Photo 5). Tensile strength is not listed as a requirement under ASTM D 3462, but was performed for informational and comparison purposes. The tensile strength ranged from a low of 82.0 lbf to a high of 119.0 lbf.

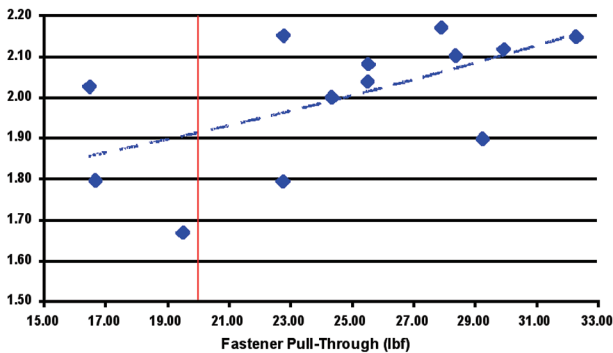
Graph C

Fastener Pull-Through & Desaturated Mat Weight

A vertical line within *Graph C* and a horizontal line within *Graph D* have been inserted at 20.0 lbf to indicate those samples that fell below the ASTM D 3462 minimum requirement for fastener pull-

In reviewing *Graphs A - D*, clear correlations exist between tear strength and tensile strength, tear strength and desaturated mat weight, fastener pull-through and desaturated mat weight, and tear strength and fastener pull-through.
