# DETERIORATION OF REINFORCED CONCRETE ELEMENTS

By Matthew D. Pritzl, EIT

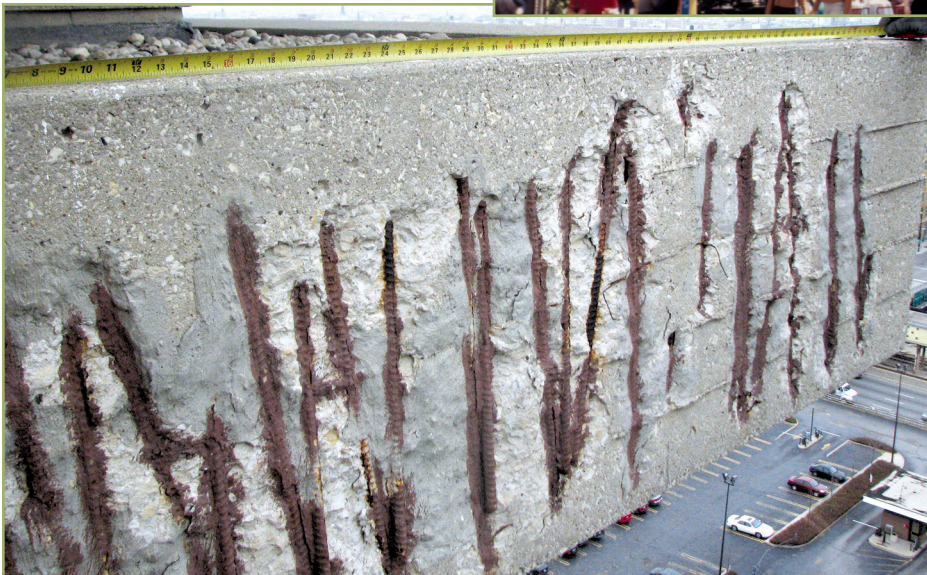
*Figure 2 - Deterioration of reinforced concrete beam element constructed in the 1960s.*

Why is it that buildings constructed with concrete thousands of years ago (*Figure 1*) have withstood the test of time, while buildings constructed with reinforced concrete within the last 100 years have deteriorated rapidly (*Figure 2*)?

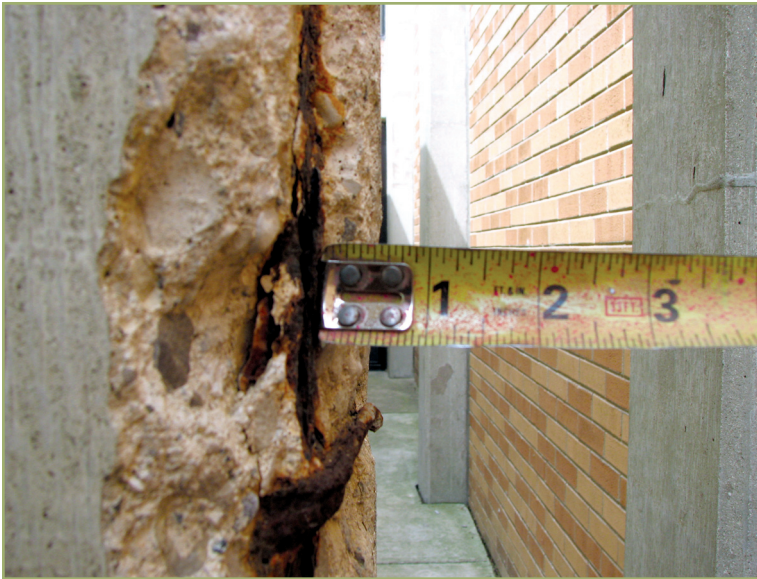
**Figure 3 – Lack of concrete cover.**

include failure to provide the design concrete cover (Figure 3), inadequate compaction, improper placement techniques, and lack of cold joints.<sup>5</sup>

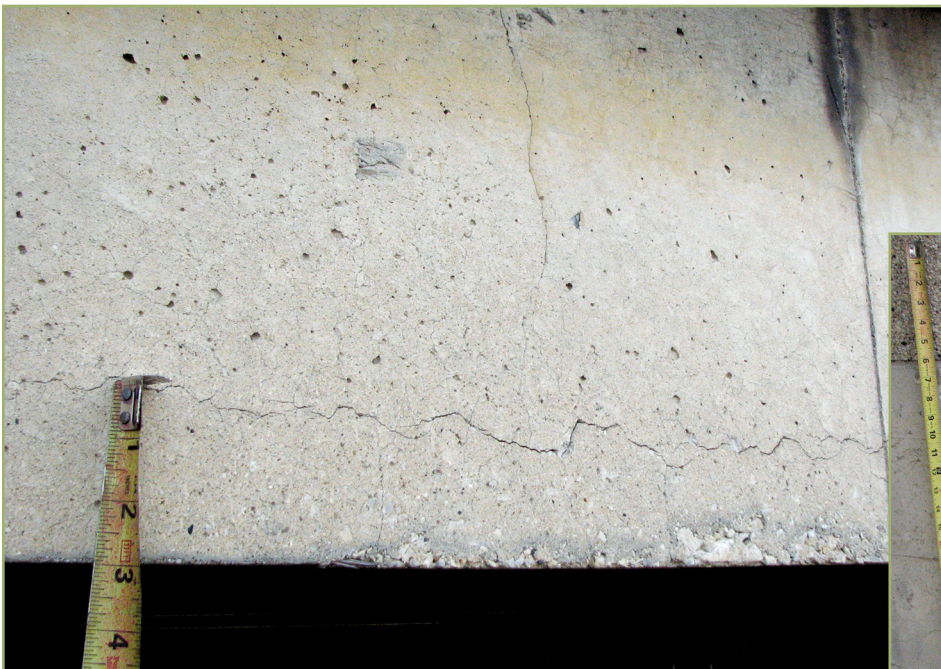
**Figure 4 – Cracks in concrete.**

These stresses are relieved in the form of cracks (Figure 4), delaminations (planes of cracking within the concrete), and spalls (Figure 5).

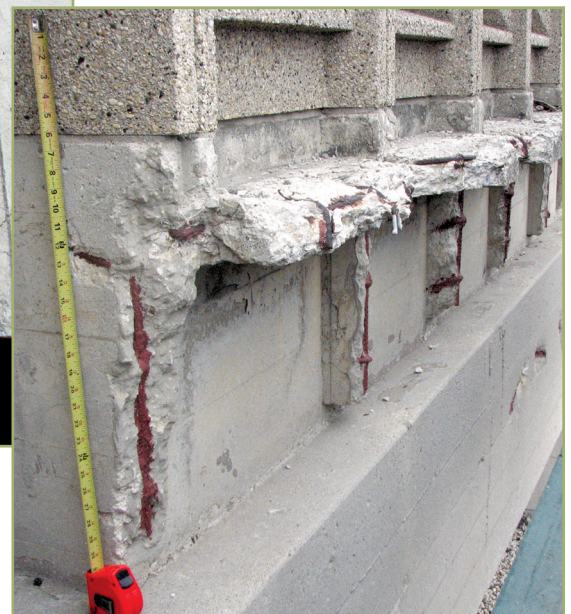
**Figure 5 – Spalls in concrete.**

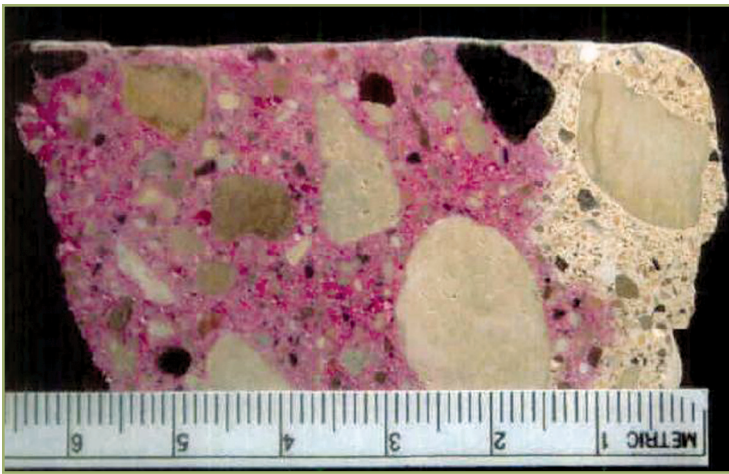
Figure 6 - Depth of carbonation sample.

To determine the depth of carbonation, a phenolphthalein solution is applied to a concrete sample. The solution is colorless at and below a pH of 8.2 and pink at pH levels above 10.0 (Figure 6).<sup>2</sup> A common problem occurs when the depth of carbonation is greater than the concrete cover provided for the reinforcing steel. When this occurs, the protective layer is destroyed and the reinforcing steel no longer has protection against moisture and oxygen.

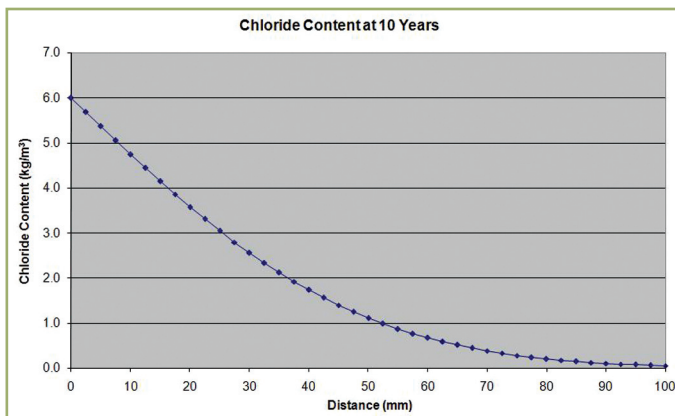
Figure 7 - Profile of service chloride content vs. depth.

ride contamination, a profile of chloride content vs. depth can be made by taking samples at regular intervals of depth (Figure 7).

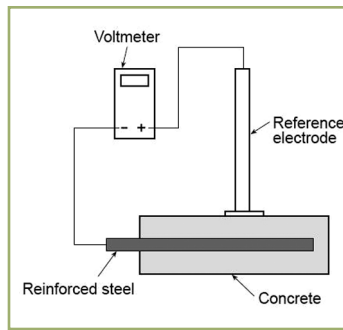
Figure 8 - Schematic of half-cell potential test.<sup>1</sup>

of the reinforcing steel. Half-cell potentials measure the difference in potential between a reference electrode (copper-copper sulfate) and the reinforcing steel (Figure 8). Potential readings more negative than -350 mV indicate a 90% probability of corrosion activity, readings between -200 mV and -350 mV indicate an unknown probability of corrosion activity, and readings more positive than -200 mV indicate a 90% probability of no corrosion activity.<sup>1</sup>

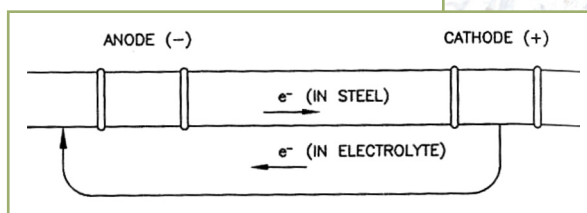
Figure 10 - Corrosion cell.<sup>4</sup>

Corrosion is electrochemical in nature; it is essentially a battery in which electrical current flows between an anode and a cathode (Figure 10). The anode is the site where corrosion occurs.

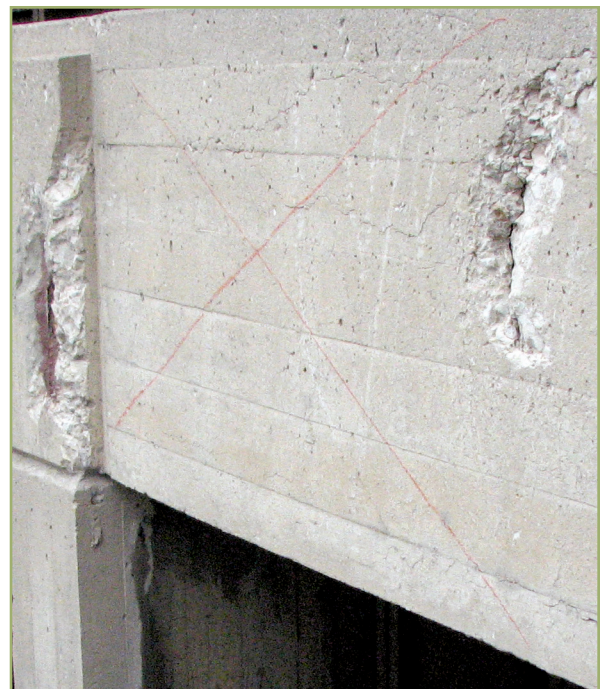
Figure 9 - Area of distress discovered by sounding.

sounds “hollow” can be heard. Even though the area appears to be in good condition, the difference in tone reveals that areas of distress lie below the concrete surface (Figure 9).<sup>2</sup>

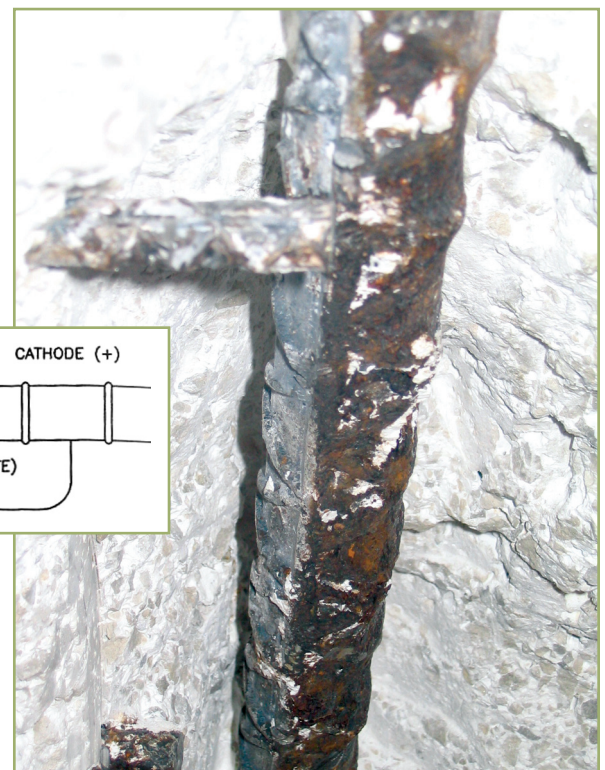
Figure 11 - Corrosion on same piece of reinforcing steel.

Differing electric potentials may be located on the same piece of reinforcing steel (Figure 11) because of the heterogeneous nature of steel (it is created from iron ore), depth of carbonation, chloride content, concrete imperfections, cracks, etc. The pore water in the concrete is the electrolyte that conducts the electricity.<sup>4</sup>

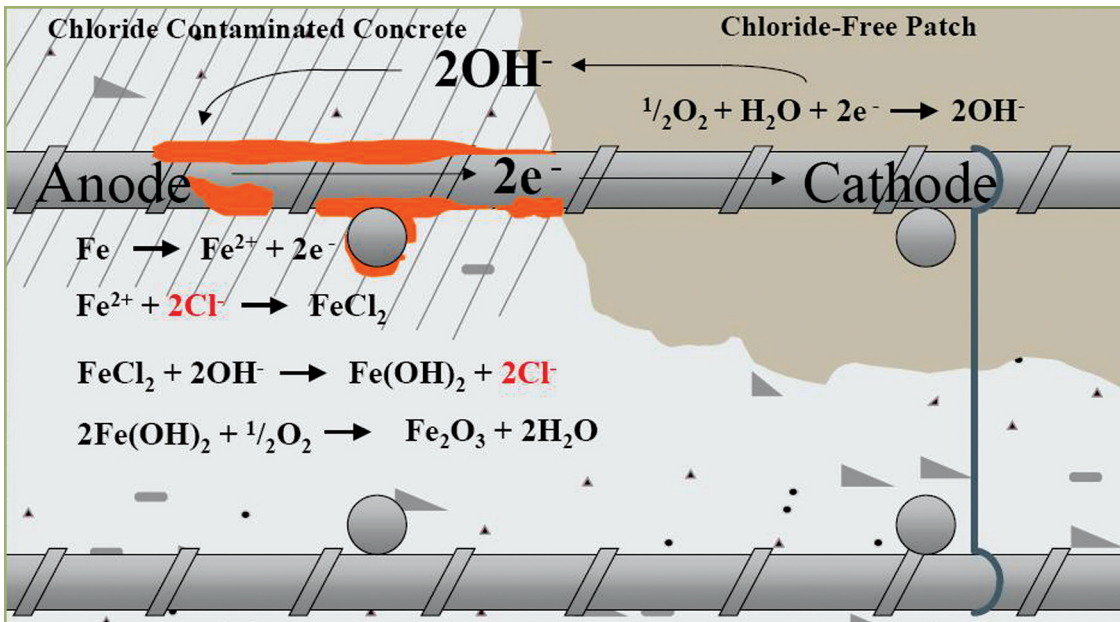
Figure 12 - Patch accelerated corrosion.<sup>3</sup>

In a patch repair with chloride-contaminated concrete, the newly repaired (chloride-free) area has a drastically different electrical potential than the nonrepaired (chloride-contaminated) area. (On a side note, another problem with chloride contamination is that the chloride ions are not consumed and that they continue to fuel the corrosion cell.) The newly repaired area acts as a noncorroding cathode, while the old area becomes a corroding anode (Figure 12). This results in an accelerated corrosion cell near the patch. The “ring-anode” or “halo” effect can be seen when spalls appear next to previously patched areas. It is not uncommon for additional repairs to be made at these

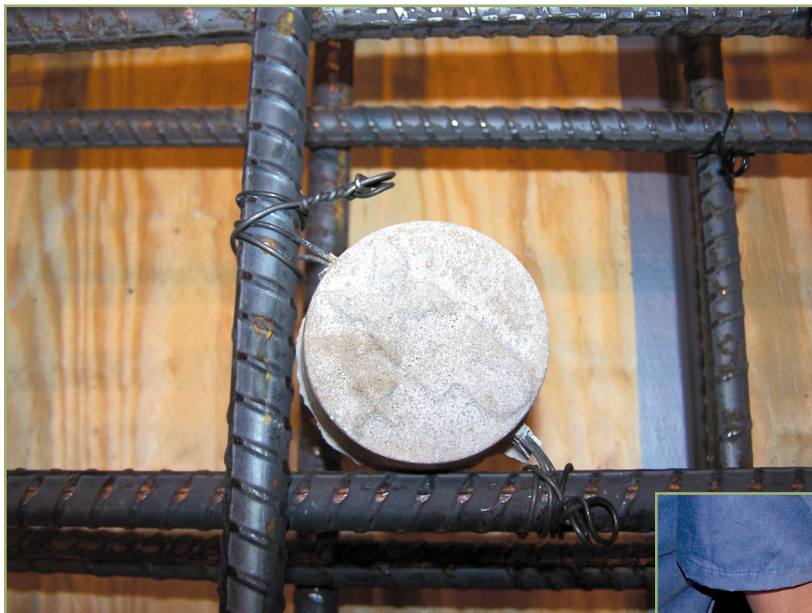
Figure 13 - Installation of an embedded sacrificial anode.

cial metal, such as zinc, to create a current flow from itself to the rebar. When attached to the reinforcing steel, the anode supplies an electric current and protects the reinforcing steel by sacrificing itself. Galvanic anodes can be attached to the rebar and embedded in the concrete (Figure 13) or sprayed on the concrete surface (Figure 14). In the latter case, a connection is made between the sprayed metal and the rebar.

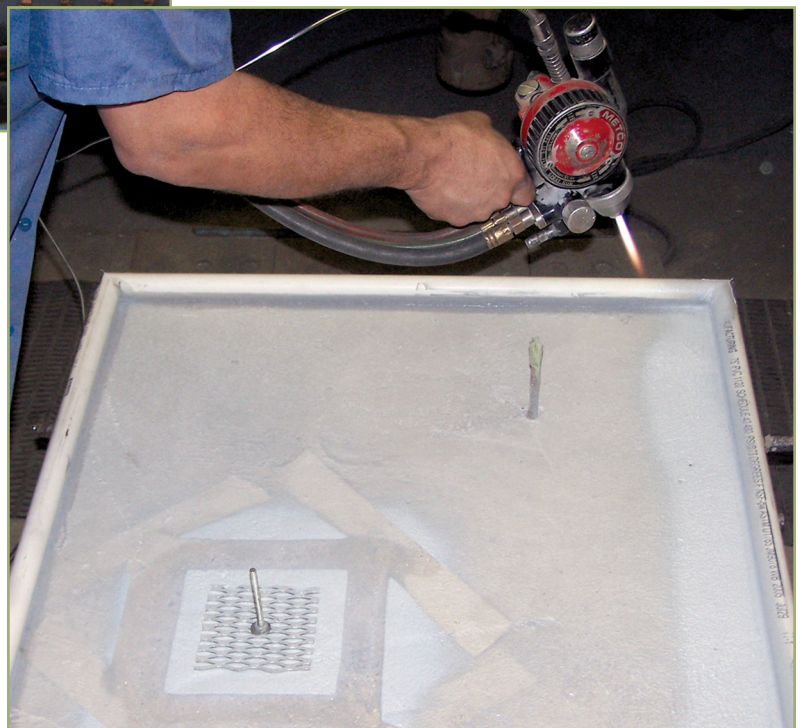
Figure 14 - Application of a thermal sprayed sacrificial anode

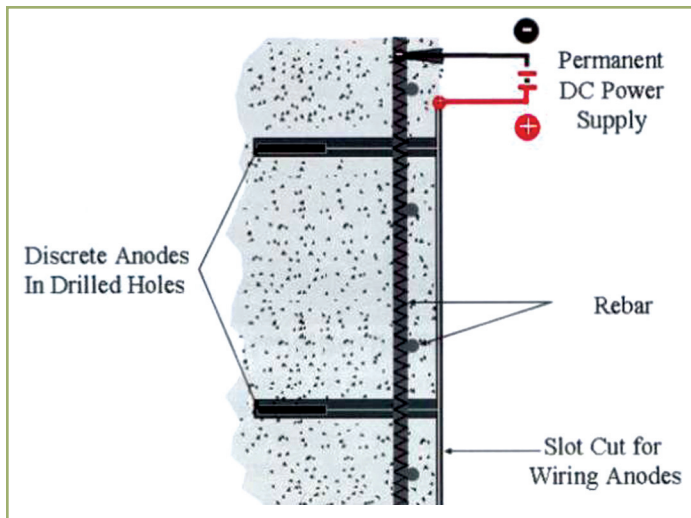
Figure 15 - Schematic of an ICCP system.<sup>3</sup>

ICCP systems (Figure 15) utilize anodes connected to an external DC power source that supply the necessary current to

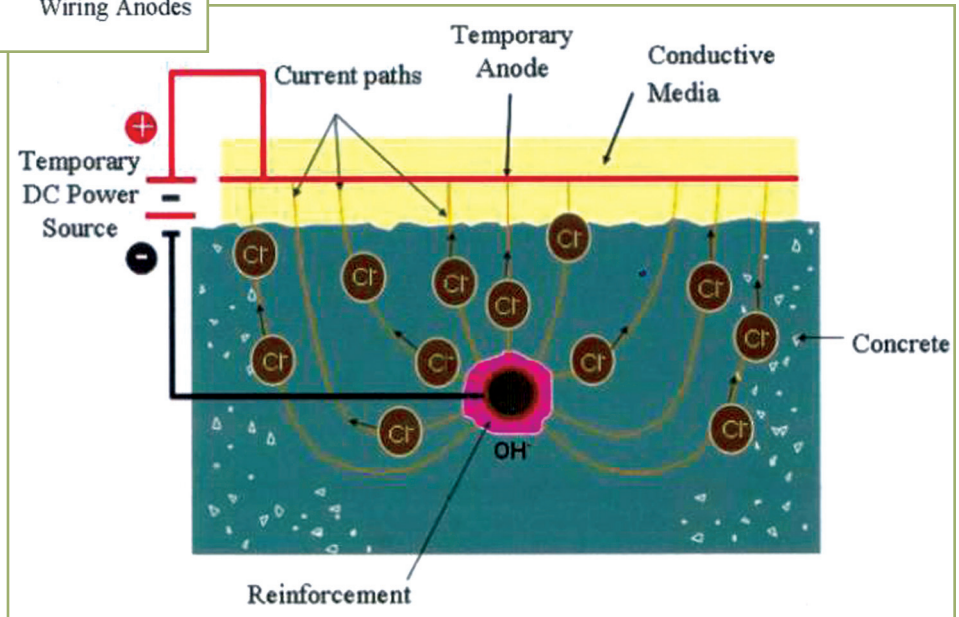
Figure 16 - Schematic of an ECE system.<sup>3</sup>

Another method is to use electrochemical chloride extraction (ECE) (Figure 16). This procedure applies an electric field between the reinforcing steel and an externally mounted mesh. During this short duration treatment, the chloride ions migrate away from the reinforcing steel and toward the mesh. This mesh is removed
