# Problems With Code-Compliant Brick Veneer in Residential Construction

By Derek A. Hodgin, PE, RRO, RRC, RWC, CDT

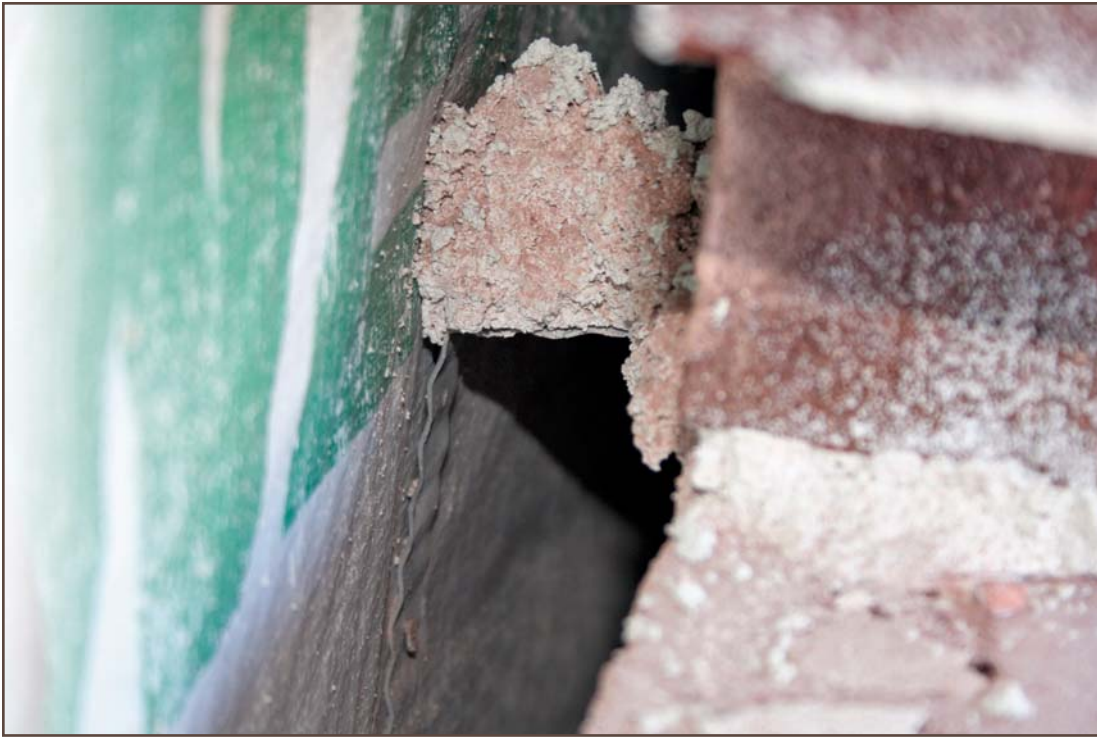
Photo 1 – Mortar droppings collect on top of metal brick ties and bridge across the 1-inch air space, coming into direct contact with a highly permeable weather-resistant membrane.

one or all of the following: wall framing, foundation, and brick laying. The air space will also include mortar slop and droppings that collect at the base of the wall and on top of wall ties (Photo 1). The mortar will bridge across the airspace, touching the

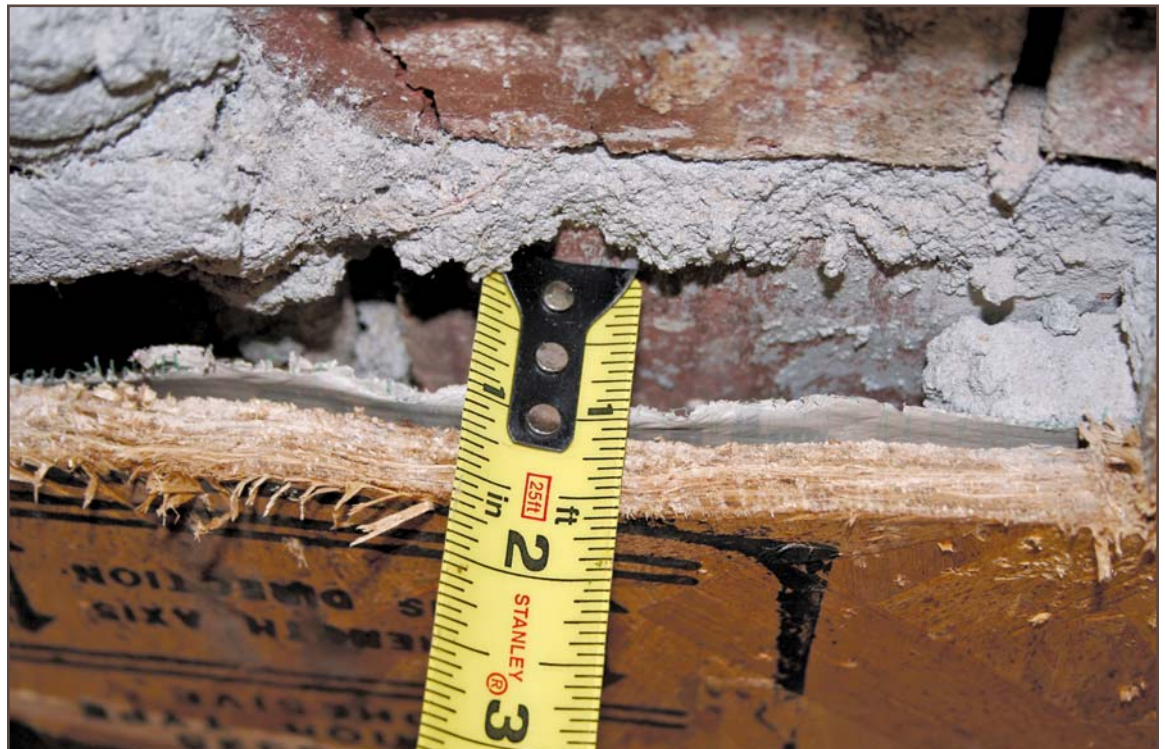
Photo 2 – A typical 1-inch air space ends up being reduced due to the presence of mortar and variations in wall framing and brick alignment.

unprotected wall sheathing. Therefore, even when the required 1-inch air space is planned for, it is rarely achieved (Photo 2). Additionally, the author has observed garbage (i.e., food wrappers and containers, construction debris, soda and beer cans, etc.) in the air space on numerous occasions.

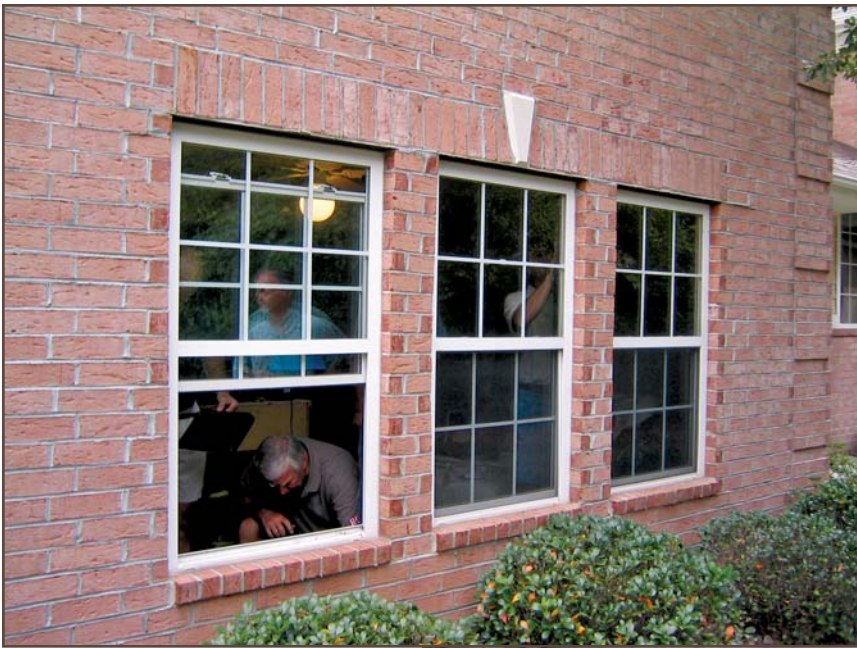
Photo 3 – Exterior view of a residential building with no obvious damage.

This problem is made much worse when significant moisture is present in the wall assembly after a summer rain shower. The rain serves to saturate the brick veneer and the mortar slop that is in contact with the highly permeable, weather-resistant membrane. When the sun comes out, some of the moisture is evaporated on the exterior wall surface. Unfortunately, most of the moisture (approximately two-thirds) is driven toward the interior (see Figure 1). Add one more problem to the mix (an interior-side vapor barrier that is also allowed by the building code), and you have the potential for a disaster (Photos

3 and 4), yet the entire wall assembly was built in accordance with building code requirements!

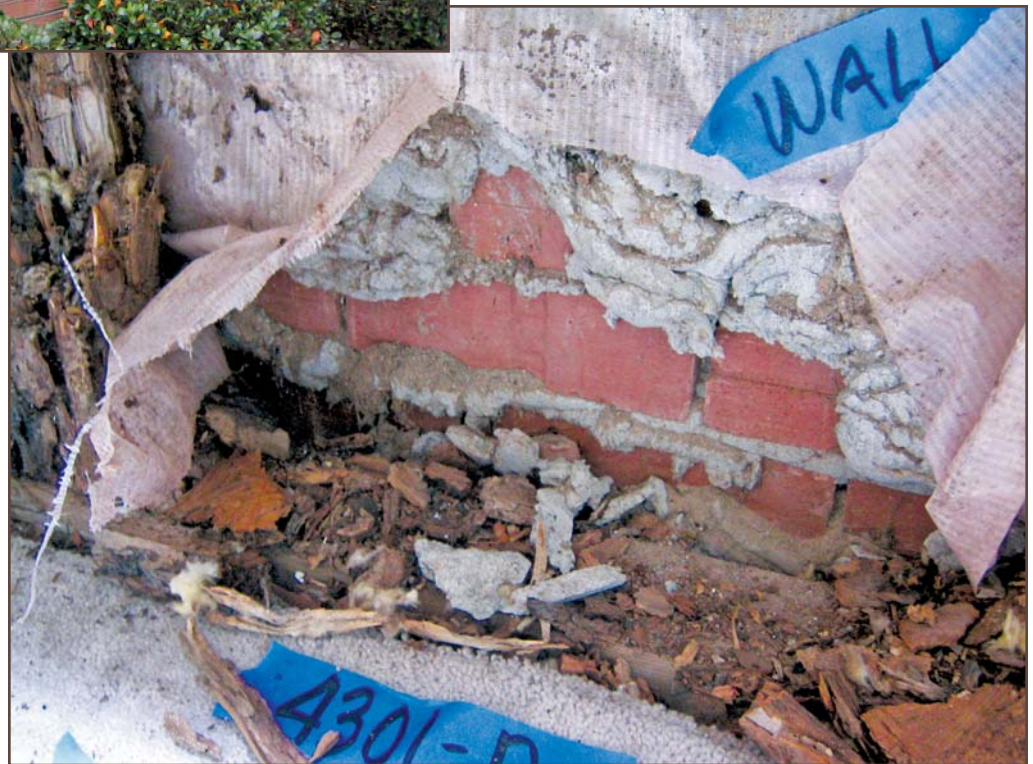
Photo 4 – View of the interior side of the wall shown in Photo 3 that was exposed during destructive testing. Both the exterior wall sheathing and dimensional wood framing members were rotten. An interior-side vapor barrier was placed behind the interior drywall.
