Problems With Code-Compliant Brick Veneer in Residential Construction

By Derek A. Hodgin, PE, RRO, RRC, RWC, CDT

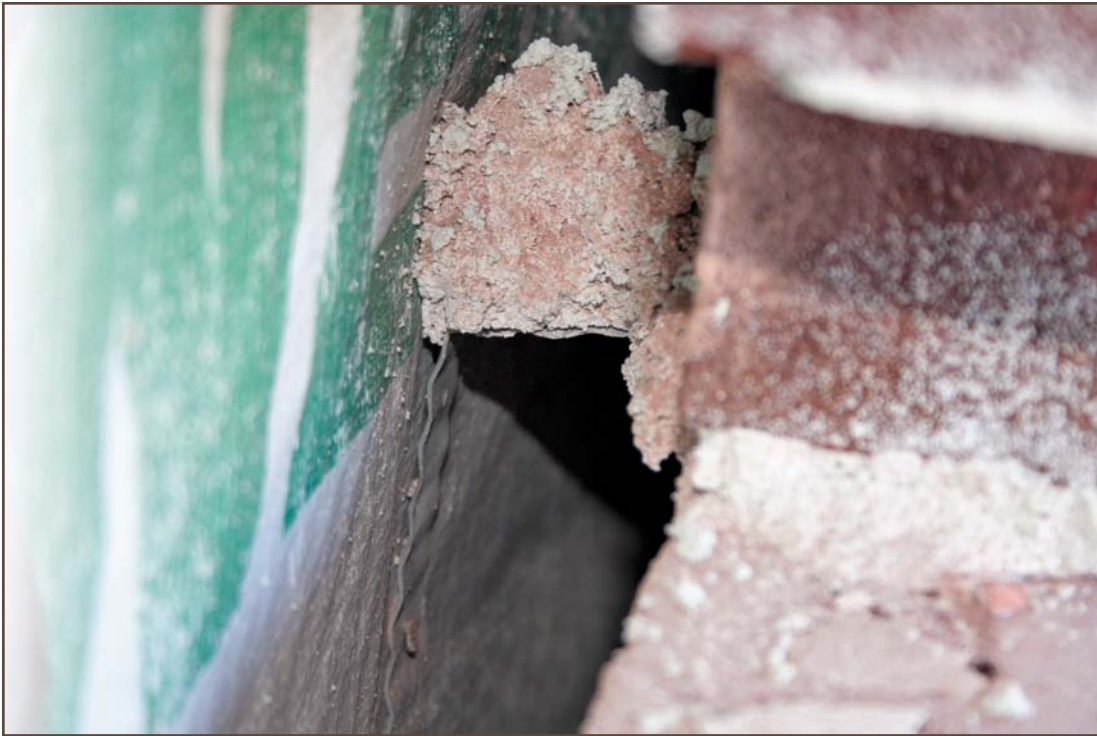
Photo 1 – Mortar droppings collect on top of metal brick ties and bridge across the 1-inch air space, coming into direct contact with a highly permeable weather-resistant membrane.

one or all of the following: wall framing, foundation, and brick laying. The air space will also include mortar slop and droppings that collect at the base of the wall and on top of wall ties (Photo 1). The mortar will bridge across the airspace, touching the
