BUILDING ENVELOPE  
TECHNOLOGY  
SYMPOSIUM

**THE HISTORY OF FLASHING AND ITS IMPORTANCE IN  
BOTH MODERN AND HISTORIC MASONRY CONSTRUCTION**

**JEFFREY L. ERDLY AND GREGG M. BEKELJA**

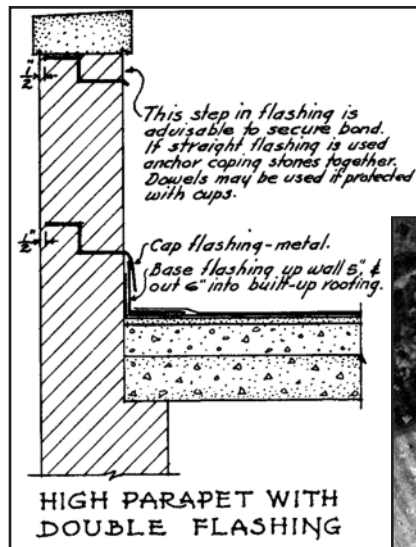
Figure 1 - Recommended flashing detail from architectural graphic standards. Facsimile of original edition.

Numerous technical manuals published during the early 20th century included detailing at masonry parapets requiring through-wall flashing at two levels. This detailing, contained in both of the most widely respected standards of the day, *Architectural Graphic Standards*<sup>1</sup> and *Brick Engineering Handbook of Design*,<sup>2</sup> required through-wall flashing at both the roof base flashing level and beneath copings (Figure 1). Further extensive detailing was also included in these manuals regarding the use of copper cups (thimbles) to be used when flashing or roofing was pierced by pinning that was required to secure copings or reinforce parapets (Figure 2). Additional flashing details for terra cotta assemblies were also recommended as best practice. The terra cotta industry as a whole ignored these recommendations, which eventually became a contributing factor to its near demise.

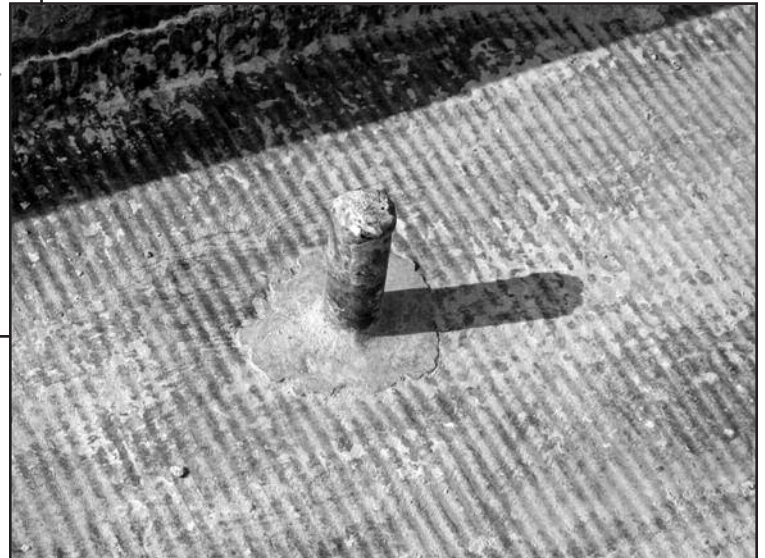
Figure 2 - Copper cup (thimble) from a circa-1930s project.

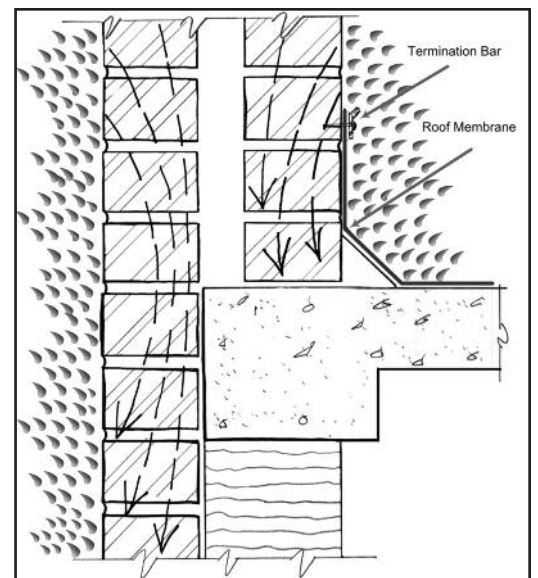
Figure 3 - Water penetration circumventing surface-mounted roofing termination.

Many modern roof termination standards in use today violate these original principles by allowing the use of a termination bar surface-mounted onto masonry or other materials. These widely used flashing terminations fail to preclude moisture from circumventing the surface-mounted roofing termination and lead to leakage and accelerated roof and masonry failures (Figure 3). Other detailing errors commonly observed include: 1) improper use of EPDM membranes as parapet covering; and 2) the extension of base flashing above existing flashing necessitated by the addition of roof insulation.

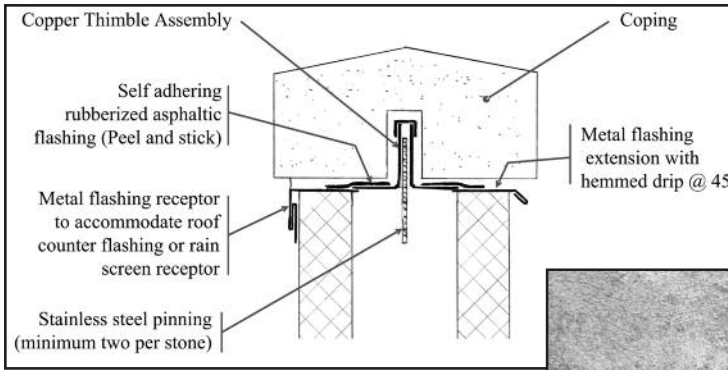
Figure 4 – Proper flashing beneath copings.

To protect parapets, through-wall flashing beneath copings is critical. Proper flashing should: 1) protect pinning with a thimble assembly; 2) integrate a flashing extension outboard that both daylight and includes a drip; 3) integrate a flashing extension inboard, including a receptor to accommodate roof counter flashing or rain screen; and 4) be permanently sealed with rubberized asphaltic flashing. See Figure 4 for a detail

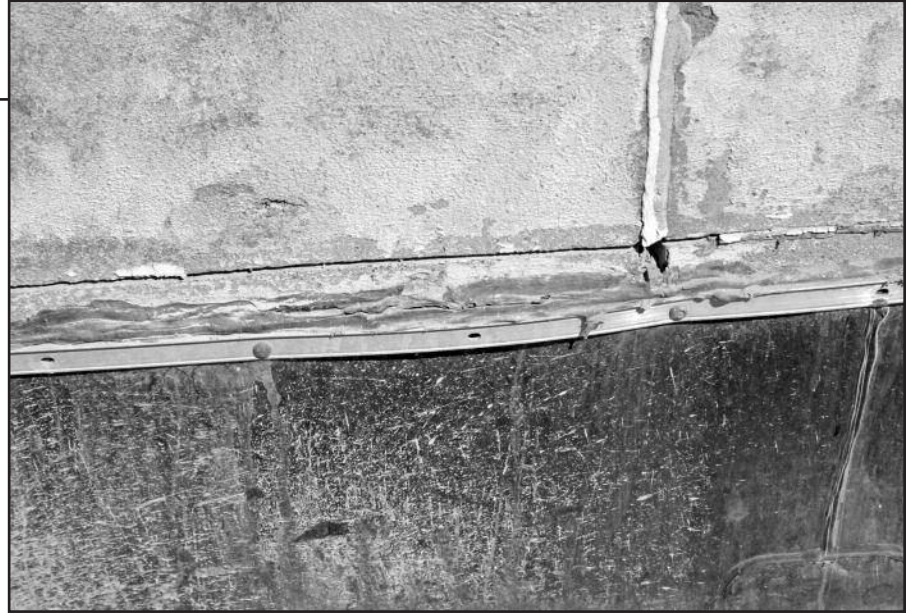
Figure 5 – EPDM roof membrane terminated at cast stone parapet.

This academic building was constructed in the early 1920s and included multiwythe mass masonry walls with cast stone copings and trim, and a center tower composed of solid cast stone components. The masonry was constructed without through-wall flashing. The center tower, composed of solid cast stone, was reroofed using EPDM as a replacement roof, installed with a surface-mounted termination bar (Figure 5). The new roof termination leaked, and to repair this assembly, the copings were removed and pinned, and through-wall flashing was installed and the copings reset. On the inboard face, a receptor was installed to accommodate a rain screen panel, which also oversails the counter flashing, thereby protecting the deficient

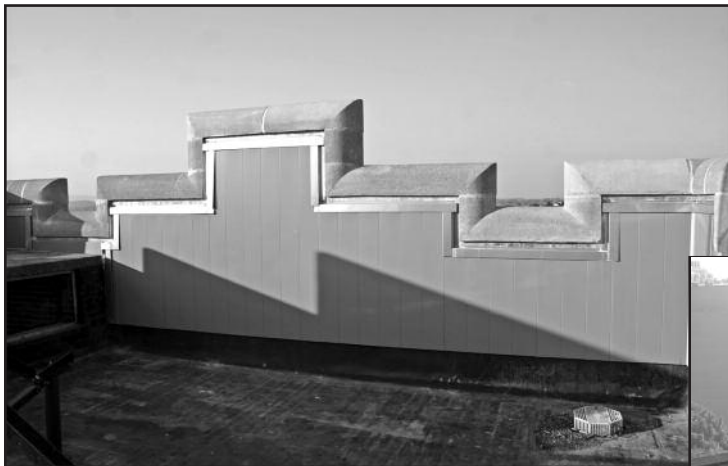
Figure 6 – Rain screen panel system interfaced with coping flashing and extending down over EPDM roofing termination.

EPDM roof termination below (Figure 6).

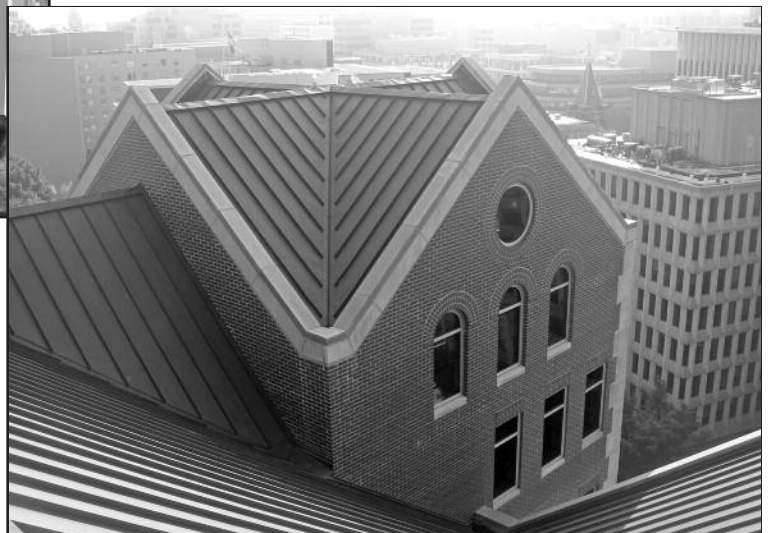
Figure 7 – Copper roofing improperly terminated at raked masonry rising wall.

detailed or constructed. The most labor-intensive and difficult masonry flashing interface detailing occurs when a raked roof adjoins a vertical masonry rising wall (Figure 7). Proper detailing at these interfaces requires 1) a through-wall stepped-pan-above-pan installation (Figure 8); 2) provisions to accommodate stepped surface counterflashing down the rake; and 3) detailing to accommodate sufficient wind clips and weeps. The proper installation of this detail requires a combination of masonry, sheet-metal, and roofing skills. This type of repair can become even more complicat-

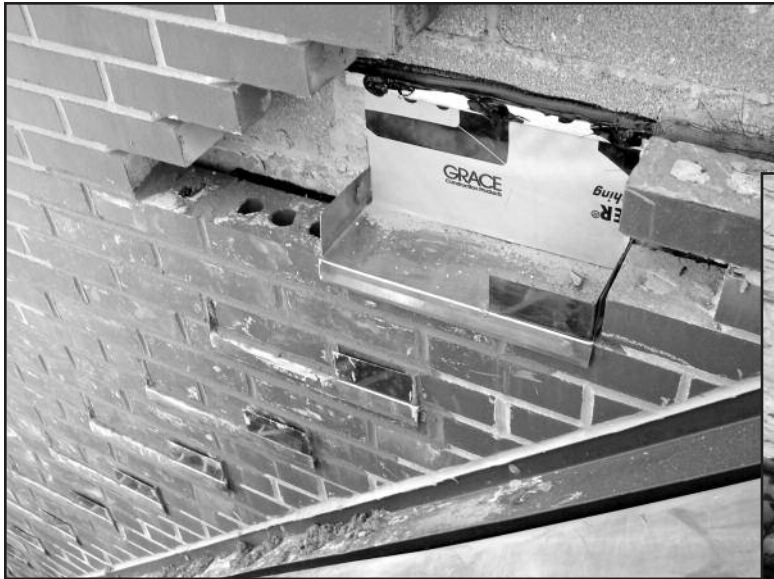
**Figure 8 – Installation of copper stepped-pan flashing at raked rising wall.**

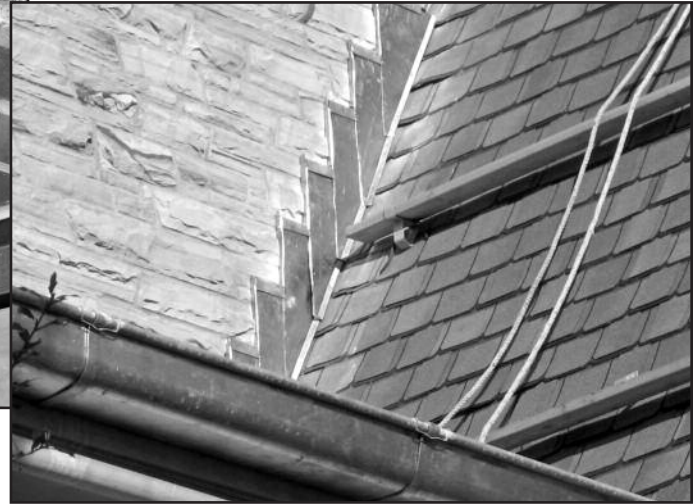
**Figure 9 – Stepped pan flashing at raked stone rising wall.**

ed when natural stone masonry varying in coursing height and length requires a stepped-pan flashing installation (Figure 9).

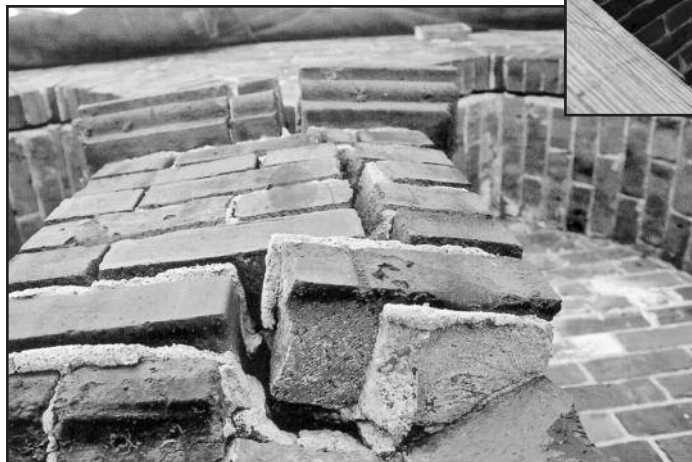
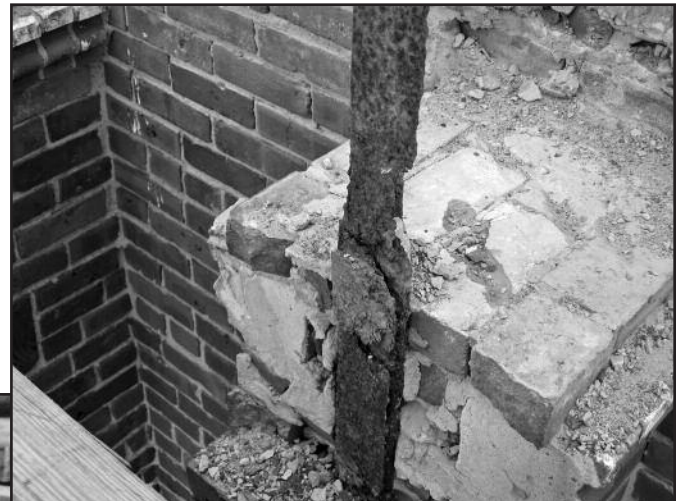
**Figures 10a (left) and 10b (above) – Displaced brick masonry caused by oxide jacking of embedded steel hangers.**

This landmark structure was modeled after the Italian Renaissance style and is rich in corbels, Gothic arches, and ornate brick and terra cotta. The 200-ft-tall smokestack tower, located within a federal penitentiary, was constructed as a mass masonry wall with embedded carbon-steel hanger assemblies. The steel hangers, in

direct contact with brick and mortar, corroded in the presence of moisture over time, and the volume change created by the exfoliating rust (oxide jacking) caused the masonry to split and become unstable (Figures 10a and 10b). Rebuilding these details without provisions to protect new steel (including the introduction of through-wall flashing) fails to address the original cause of the deterioration. For this project, the parapet was reconstructed to include new through-wall, lead-coated copper flashing above new steel hangers (Figure 11) and extended inboard to interface with new roofing, thereby providing a unified roof/flashing interface that extends through the historic masonry

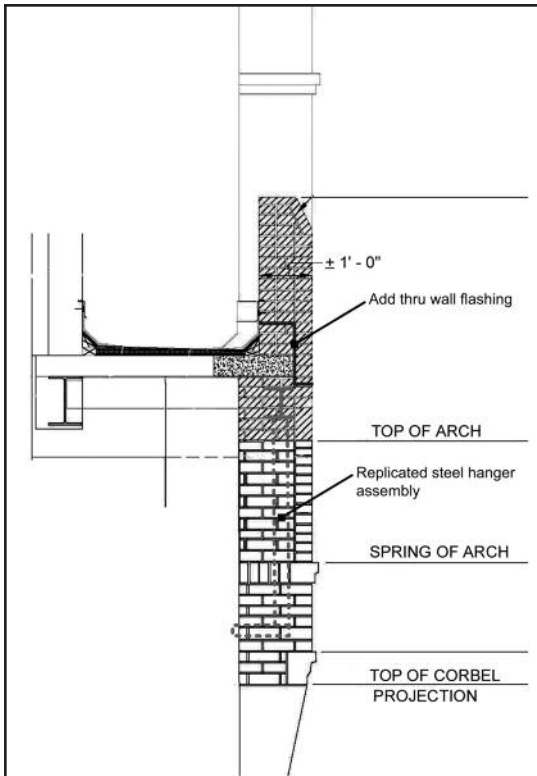
**Figure 11 – Detailing of tower parapet with through-wall flashing added.**

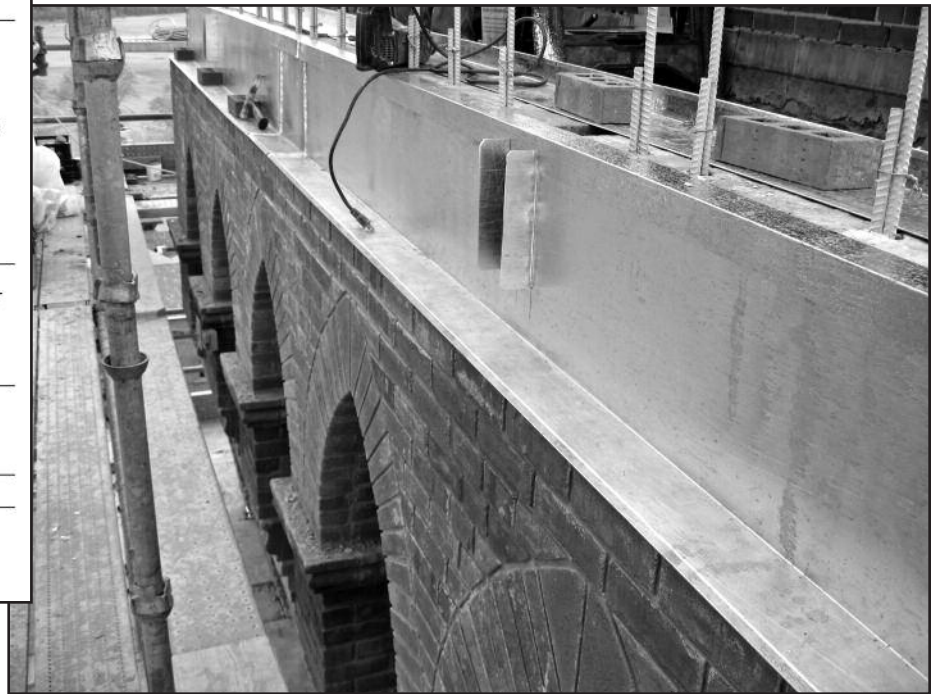
**Figure 12 – Lead-coated copper flashing added to protect embedded steel.**

assembly (Figure 12).

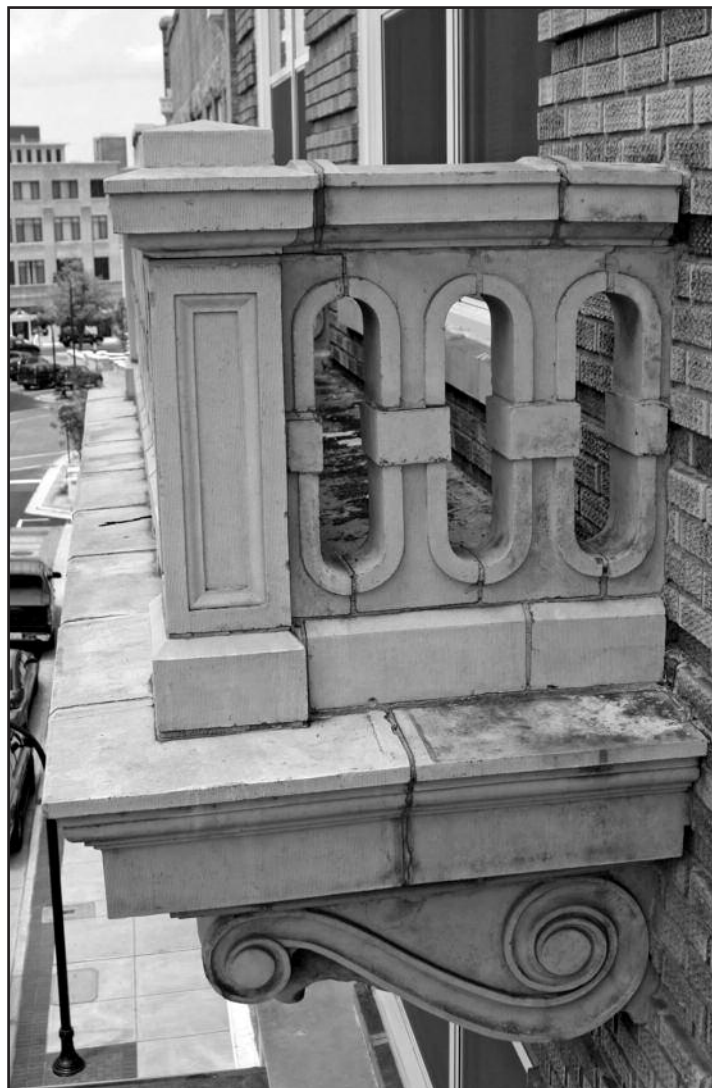
**Figure 13 – Terra cotta balcony assembly.**

This historic structure, located in the Piedmont region of North Carolina, was constructed in 1921. The building used architectural terra cotta to form projecting balconies at two intermediate floors (*Figure 13*). The original construction did not incorporate any flashing and/or noncorrosive anchors consistent with the 1914 standard. After approximately 80 years of service, expansion (oxide jacking) of steel components has compromised the stability of the entire assembly (*Figure 14*). The authors of this paper partici-

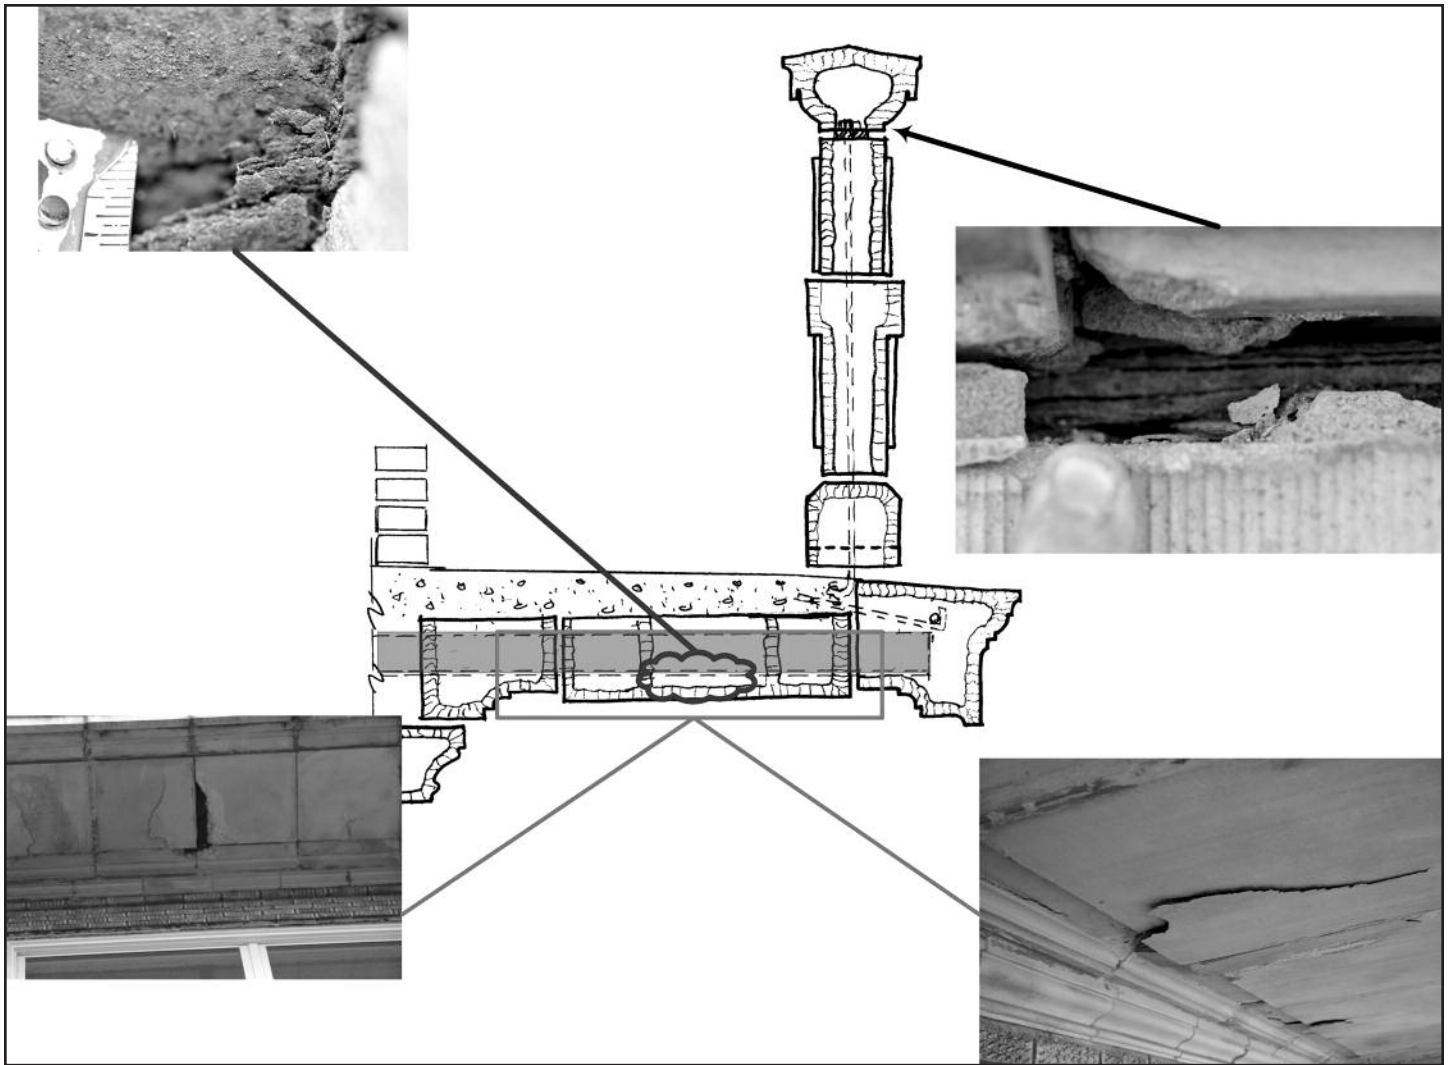
Figure 14 – Terra cotta components damaged by oxide jacking.
