# BUILDING ENVELOPE TECHNOLOGY SYMPOSIUM

## STRUCTURAL CHALLENGES OF BRICK MASONRY RECLADDING PROJECTS

**CHRISTINA M. TERPELUK, NIKLAS W. VIGENER, AND CHARLES J. RUSSO**  
*SIMPSON GUMPERTZ & HEGER, INC., ROCKVILLE, MD, AND WASHINGTON, DC*

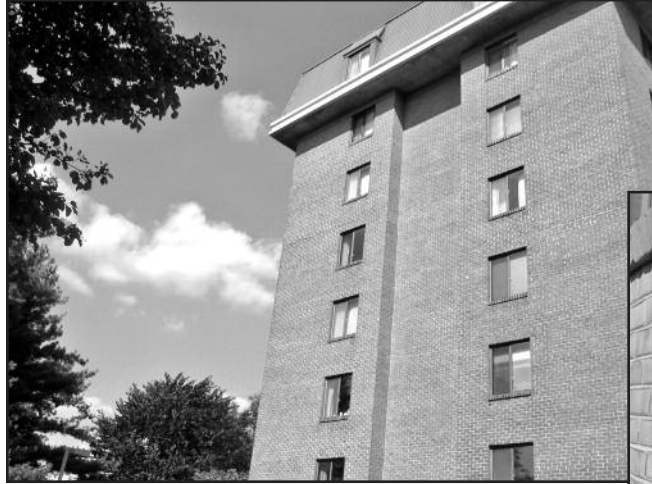
*Photo 1 - Multistory brick-masonry-clad building with punched windows.*

crete floor slab and spans floor to floor. Windows are usually set in "punched" (discontinuous) openings that interrupt the continuity of the backup wall (*Photo 1*). The concrete masonry backup frequently is not covered with waterproofing. The backup sometimes incorporates vertical steel reinforcement grouted in the cells of concrete masonry, but more typically we have seen unreinforced backup walls. The exterior brick masonry is typically tied to the backup with continuous horizontal steel wire truss reinforcement set into masonry bed joints. In wall assemblies with punched openings, the weight of the brick masonry is typically supported on continuous steel shelf angles attached to the edge of the con-

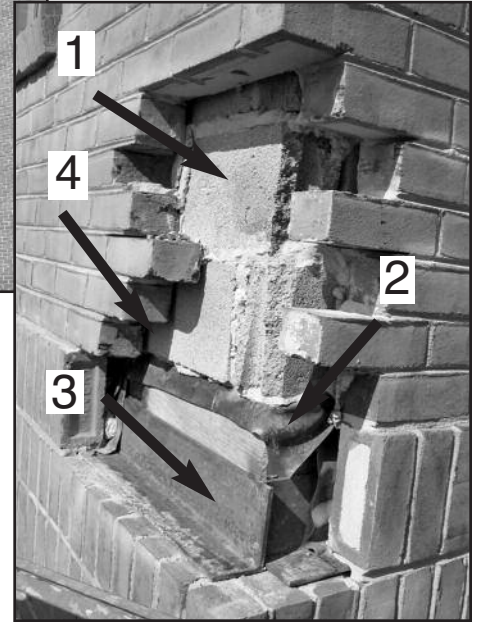
*Photo 2 - Wall Assembly 1 is composed of (from interior to exterior): 1) concrete masonry backup, (not shown) truss reinforcement, 2) PVC flashing, 3) steel shelf angle, and 4) brick masonry cladding. Note lack of waterproofing membrane over the concrete masonry backup.*

crete floor slab (Photo 2). Brick masonry above window openings is supported by steel lintels. This arrangement is shown in Sketch 1.

- **Missing or defective flashing.** Brick-clad systems frequently incorporate unreinforced sheet membranes (e.g., PVC) as through-wall flashing (Photos 2 and 4). These materials cannot be reliably sealed watertight at membrane joints, cannot be exposed to form a drip, and are susceptible to mechanical damage. Appropriate rehabilitation options include copper and stainless steel flashing.

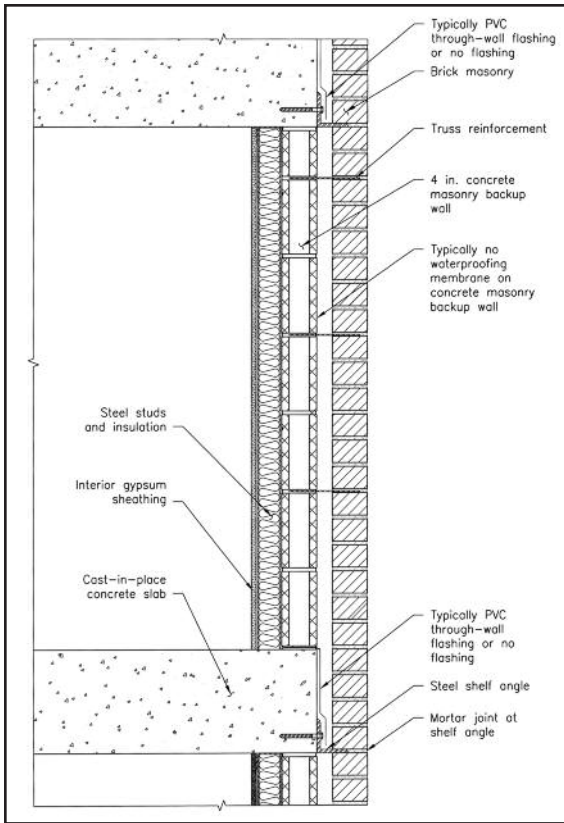
**Sketch 1 - Wall Assembly 1: wall section.**

A common construction from the 1950s to the 1970s for Wall Assembly 1 consists of a 4-in-thick unreinforced concrete masonry backup and a 4-in-thick brick masonry cladding tied together with horizontal truss reinforcement. Original designers of this wall assembly relied upon empirical rules to establish the required thicknesses of the

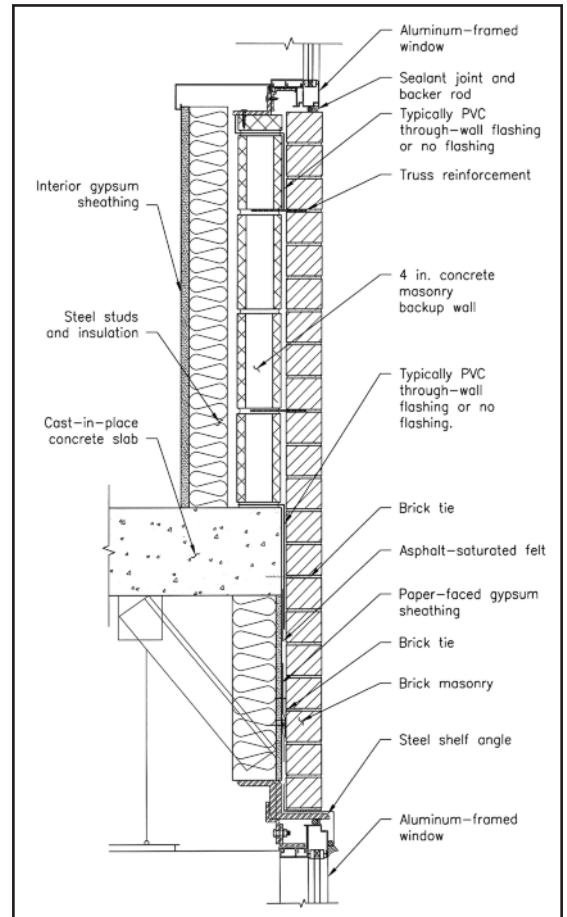
**Sketch 2 - Wall Assembly 2: wall section.**

In many buildings, windows are installed in continuous strips or ribbons (Photos 3 and 4), rather than in punched openings. In wall assemblies with ribbon windows (Wall Assembly 2) the weight of the concrete masonry backup is supported on the floor slab, and the weight of the brick masonry is supported on shelf angles that are suspended from hanger assemblies attached to the floor slab and positioned above the head of the

window below. This arrangement is shown in Sketch 2. Original designers of this wall assembly either relied upon empirical rules to establish the required thicknesses of the concrete masonry backup or utilized a rational design methodology using engineering analysis to determine the required thickness and the need for reinforcement of the backup. The former method considers that both the

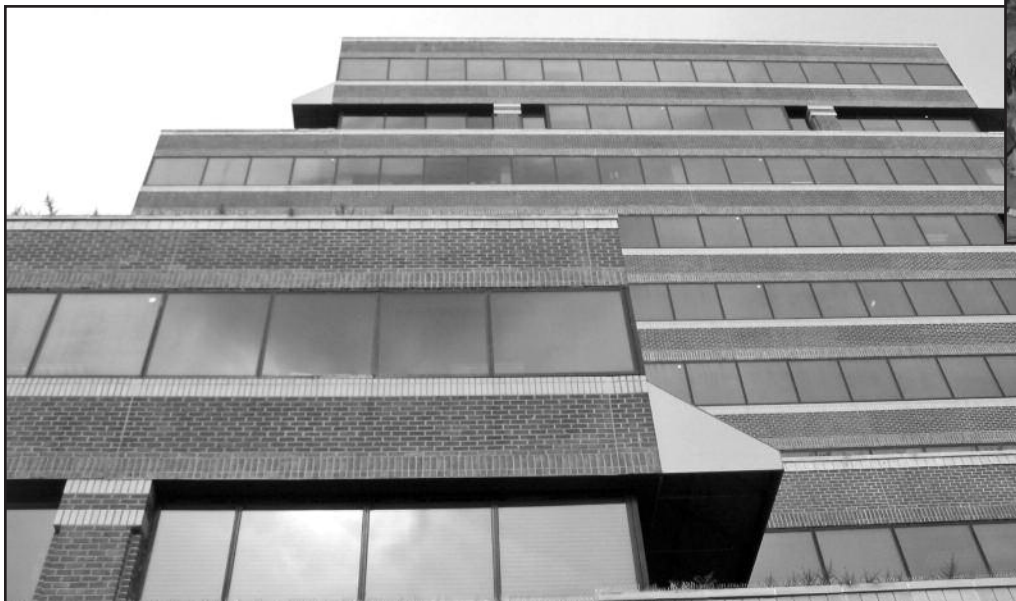
**Photo 3 - Multistory brick masonry-clad building with ribbon windows.**

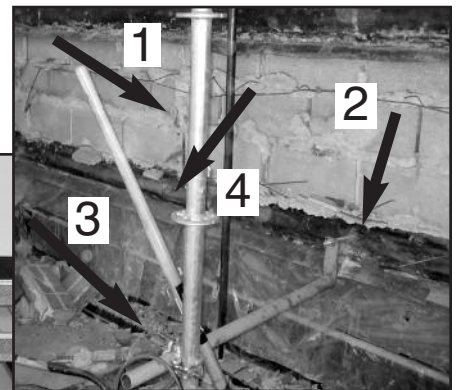
**Photo 4 - Wall Assembly 2 is composed of (from interior to exterior): 1) concrete masonry backup, 2) truss reinforcement, 3) steel shelf angle, 4) PVC through-wall flashing, and (not shown) brick masonry cladding.**

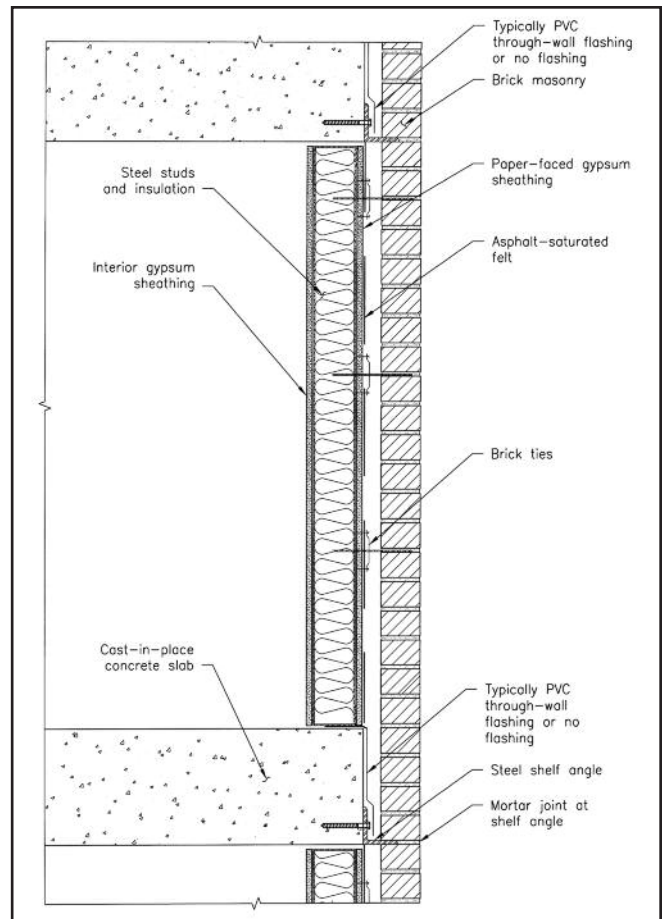
*Sketch 3 - Wall Assembly 3: wall section.*

In Wall Assembly 3, the backup consists of cold-formed steel studs that span floor to floor. Windows are set in either punched openings or continuous ribbons. In most buildings we have seen, the steel studs are covered with gypsum sheathing and asphalt-saturated felt waterproofing. Similar to the wall assemblies with concrete masonry backup, the exterior brick masonry is supported on steel shelf angles attached either directly to the floor slab edge (punched windows) or suspended from hangers attached to the floor slab (ribbon windows). The brick masonry is tied to the steel stud backup with individual adjustable steel wire ties. This assembly is shown in *Sketch 3*. Unlike the concrete masonry backup configurations discussed above, designers of Wall Assembly 3 use an engineered analysis to select the steel studs for strength and deflection limitations. In the analysis, the brick masonry does not participate in the load-resisting capacity of the wall assembly.

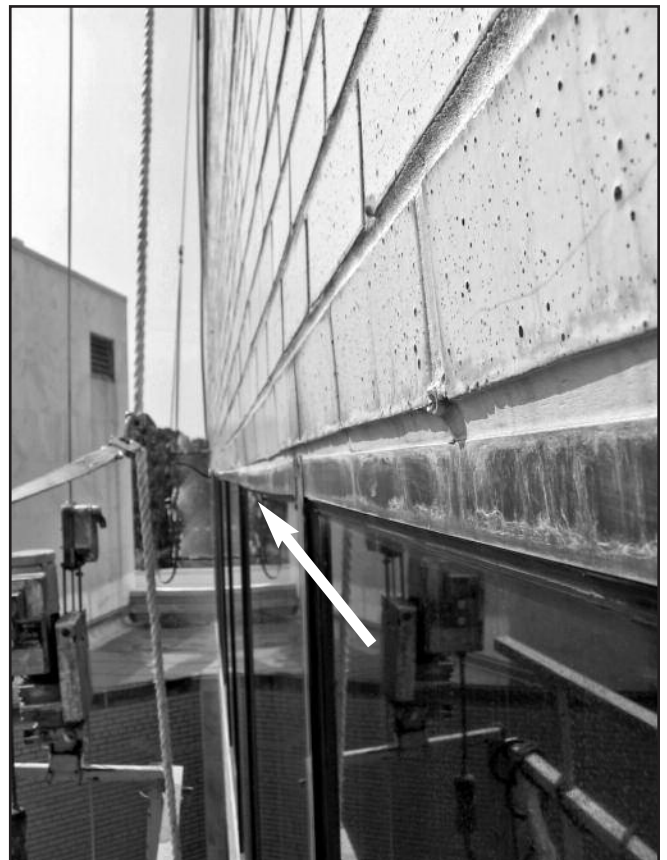
*Photo 5 - Window sagging (arrow) as result of the downward deflection of the shelf angle.*

- **Original construction sequence and detailing.** Good construction practice requires the provision of soft joints below shelf angles to accommodate the immediate downward deflection of the shelf angles under gravity load when the brick is placed as well as the long-term or seasonal movements of the building frame and the façade elements below the shelf angle. In some instances, shelf angles were originally installed tight against the brick masonry below them. During construction, the downward movement of the shelf angle was resisted by the brick in the floor below, and a portion of the self-weight of the brick masonry above is supported by the brick masonry below rather than the slab edge. Similarly, we have seen instances where shelf angles were installed tightly on top of window heads, causing a portion of the brick masonry weight to be supported by the window frame (*Photo 5*).

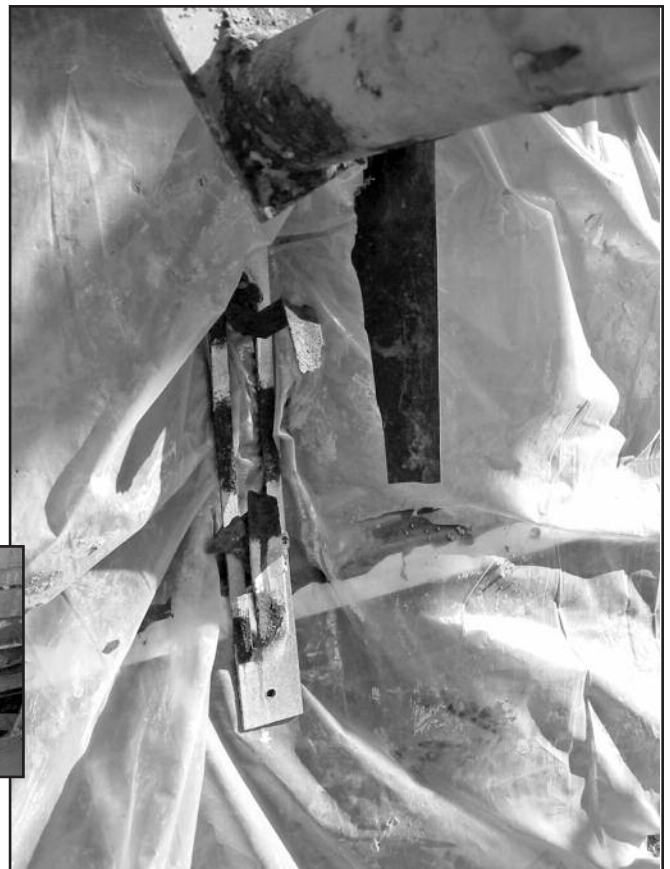
**Photo 7 – Corroded adjustable brick tie over plastic sheathing. Note brick tie is attached through plastic sheathing and exterior sheathing to steel stud.**

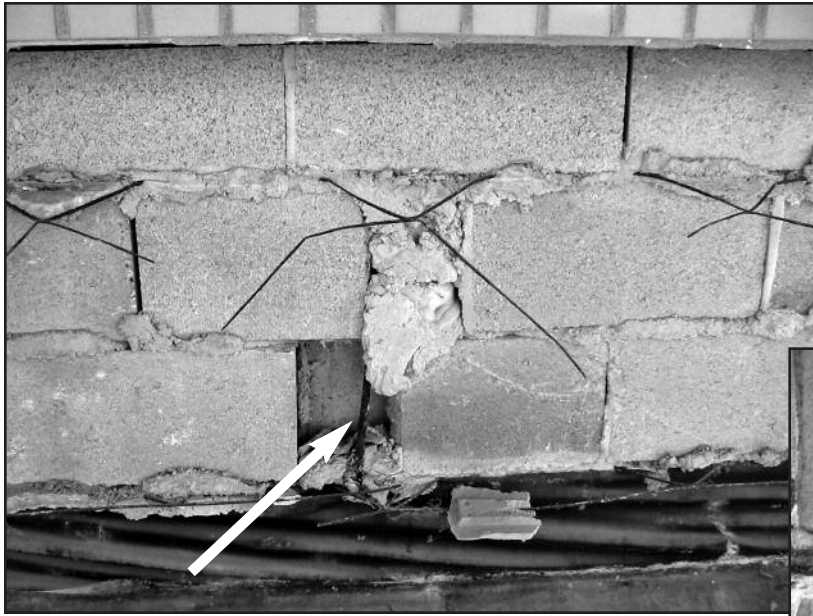
**Photo 8 – Corroded steel reinforcement (arrow) and truss reinforcement in a concrete masonry backup wall. Also note incompletely filled head joints, exposed reinforcement, and lack of waterproofing membrane on backup.**

movements between cladding and building frame. For example, in addition to cyclical daily and seasonal thermal movements, brick and other clay-based building materials undergo irreversible expansion often referred to as “brick growth.” Most brick growth takes place soon after brick production, and the rate of brick growth diminishes with age. Similar to structural frame movements, cladding movements must be accommodated with vertical and horizontal control joints and with sliding connection details. Unintended load distribution into the cladding will result if these are not provided (Photo 8).

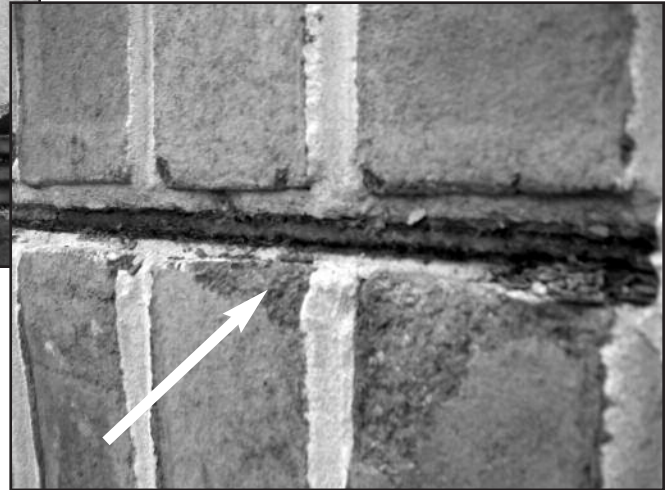
**Photo 9 – Spalled brick masonry below a corroded shelf angle (arrow). Note lack of soft joint below the shelf angle.**

- **Brick masonry damage caused by restrained movement.** Restrained frame and cladding movements discussed in the previous section can damage the brick masonry. Typical damage includes spalled brick below shelf angles (Photo 9). Repairs generally entail reconstruction of the affected masonry and installation of masonry expansion joints to accommodate differential movement.

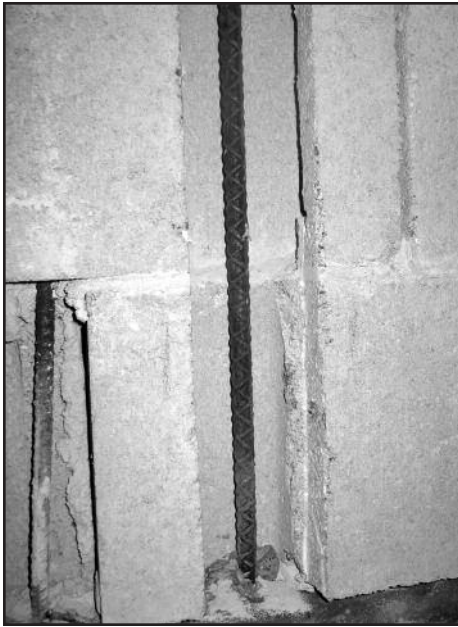
**Photo 10 – Installation of steel reinforcement into cavities cut into the concrete masonry backup wall as part of remedial work.**

stroyed by the removal of the horizontal wire to remain within the provisions of empirical design or strengthen the concrete masonry backup using an engineered analysis. Options for strengthening include the installation of steel reinforcing bars grouted into cavities cut into the concrete masonry backup (Photos 10 and 11) and installation of supplemental steel framing on the interior side of the backup wall (Photo 12).

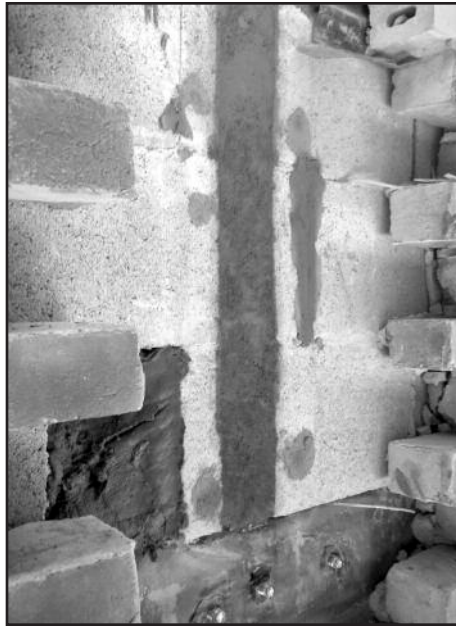
**Photo 11 – Installation of grout around steel reinforcement in concrete masonry backup wall.**

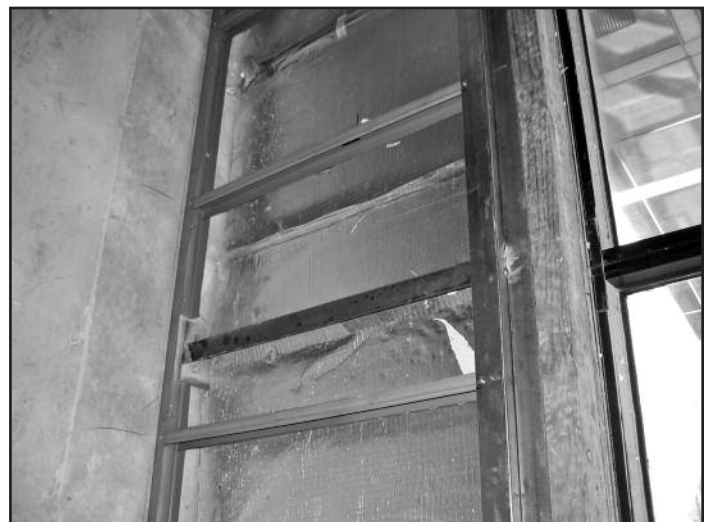
**Photo 12 – Installation of supplementary steel framing at the interior side of a concrete masonry backup wall.**
