# **Building Envelope Condition Assessment and Commissioning**

**William Hicks  
*Acuity Façade Inspection, LLC  
Hermitage, Illinois***

# Building Envelope Condition Assessment and Commissioning

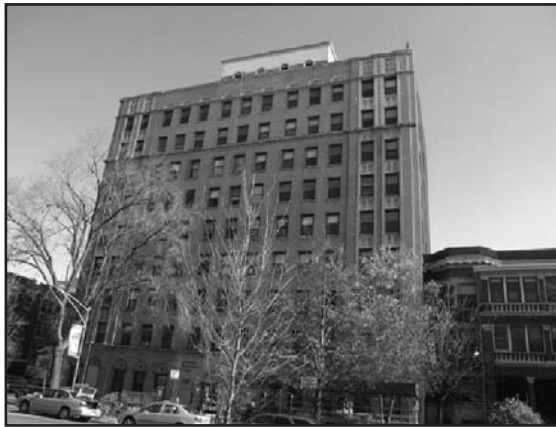
**Photo 1 – This circa 1920 building has a reinforced concrete structural frame and masonry/terra cotta façade supported with steel shelf angles.**

The author's firm was retained to prepare a Critical Exam Report (as per city of Chicago Façade Ordinance, Section 13-196 of the Chicago Building Code) for a ten-story building (circa 1920) with a reinforced concrete structural frame and masonry/terra cotta façade supported with steel shelf angles.

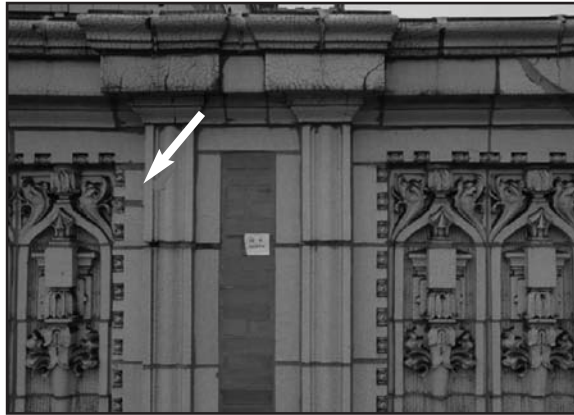
**Photo 2A – Full image area 8 ft x 6 ft (reduced to 12.5% original).**

Large-format (8 ft x 6 ft), high-resolution (16.7 mega pixel) digital images were collected for 100% of the inspected areas of the façade after the tape marks had been applied. These images could then be easily referenced via computer to assess and document the distress. Because of the high-res-

olution at which the photos were taken, there was no loss in quality due to pixilation and distresses were accurately represented and documented with respect to exact location and size. See *Photos 2A-2C* and *3A-3C*.

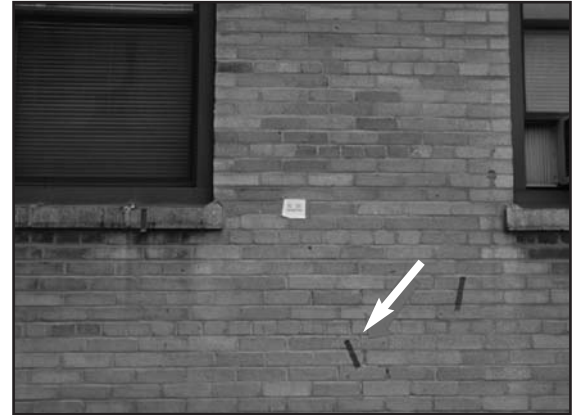
**Photo 3A – Full image area 8 ft x 6 ft (reduced to 12.5% original).**

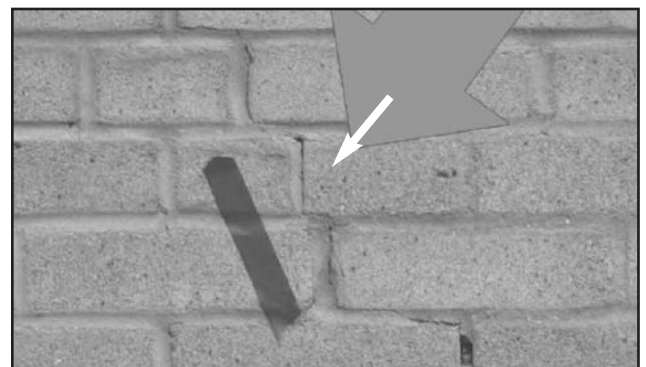
**Photo 3C – Image (partial) at 100% original.**

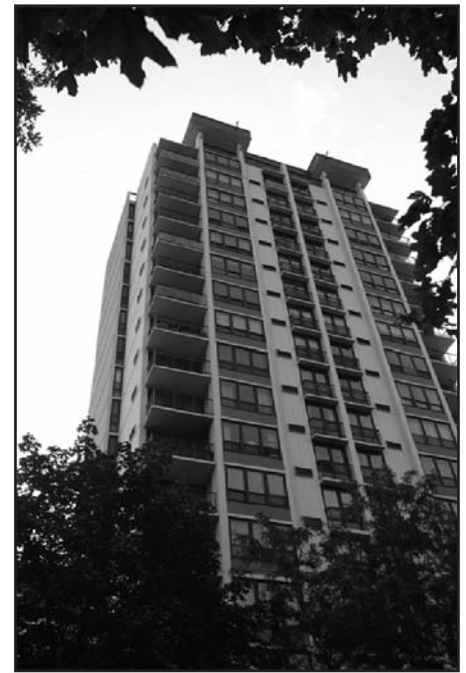
***Photo 4 - This 24-story reinforced concrete high-rise had floor-to-ceiling window/spandrel panel assemblies and concrete shear walls.***

The author's firm was retained to prepare a condition assessment report regarding the quality of façade mitigation repairs completed on a 24-story, reinforced-concrete, residential high-rise with floor-to-ceiling window/spandrel panel assemblies and concrete shear walls.

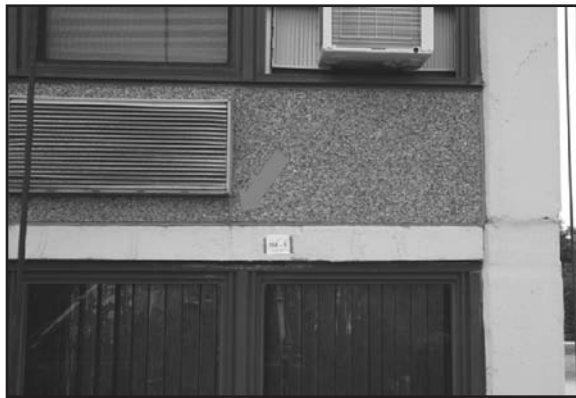
**Photo 5A – Full image area 8 ft x 6 ft (reduced to 12.5% original).**

The large-format high-resolution digital image of 100% of the façade captured the location of thousands of flat-head stainless steel screws that anchored the exposed aggregate panels to the

façade and thousands of linear feet of spandrel panel sealants. A traditional inspection methodology of note taking, sketch making, and localized photos to record screw locations and sealants would have increased the time on the job by 500%, would not have quantified details as accurately, and would have been much more expensive.

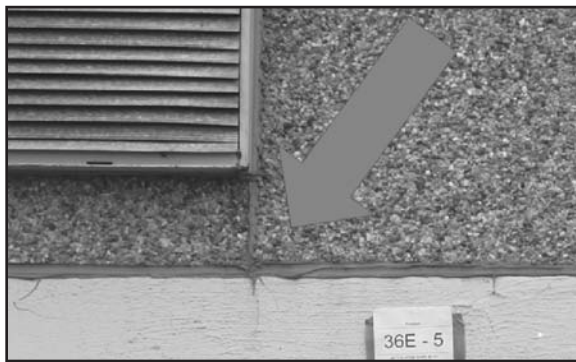
**Photo 5B – Image (partial) reduced to 50% original.**

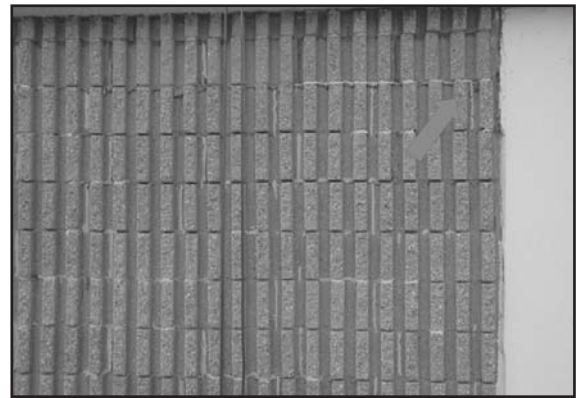
**Photo 6A – Full image area 8 ft x 6 ft (reduced to 12.5% original).**
