HISTORIC ROOF DECKS:

[ROOF DESIGN ISSUES AND CONSIDERATIONS]

By Richard S. Koziol, AIA, NCARB; and Christopher W. Giffin, AIA, NCARB

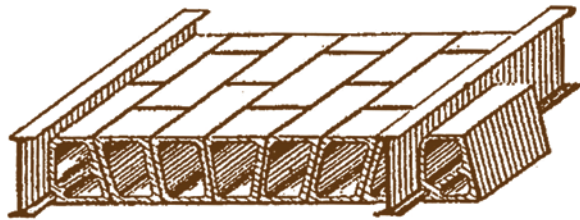
View of 12½-in tile arch between 15-in I beams.
Weight, 45 lbs per sq ft.

Figure 1 – Typical assembly of flat and segmental clay tile systems.

Flat-arch and segmental-arch systems rely upon arch action for strength and rigidity. For these arches, tiles are placed between steel beams, forming a flat arch. Figure 1 illustrates both of these.

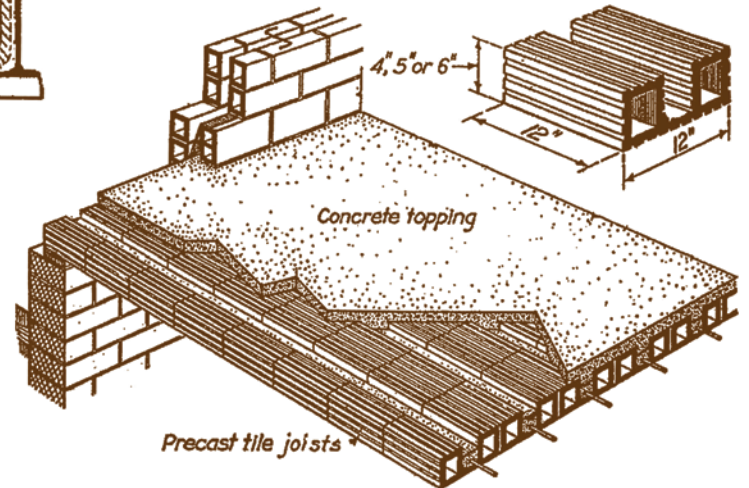
Figure 2 – Typical combination clay tile and integral concrete topping roof-deck system.

Combination systems rely upon the composite interaction of clay tile units, concrete, and steel reinforcing bars to carry tensile and bending stresses, as shown in Figure 2. These decks often utilized a 2-inch-thick plain or cinder concrete topping over the clay tile as a composite component of the roof-deck system. The combination system is analogous to a modern-day concrete pan joist or waffle slab structural system.

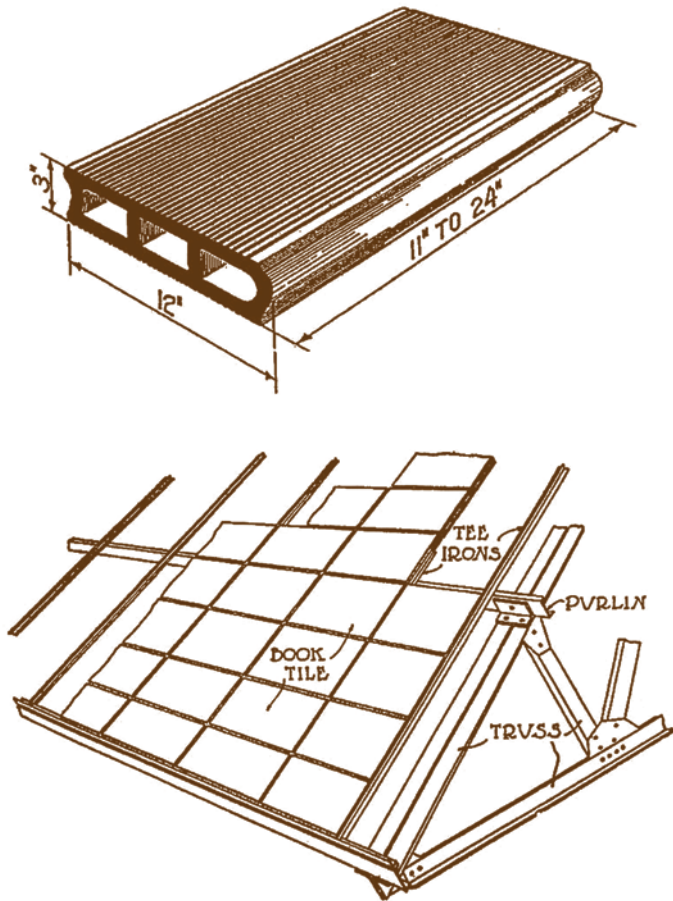
Figure 3 – Typical steep-slope application of clay book tiles.

tile units that are supported by steel purlins with the sides held in place with steel T-bracing, as shown in Figure 3. Book tile was primarily intended for use on steep roofs, but they may be found on flat roofs, also. The name “book tile” refers to the shape of the tile, in that it resembles a closed book. The strength of the tile unit resists tensile and bending stresses.

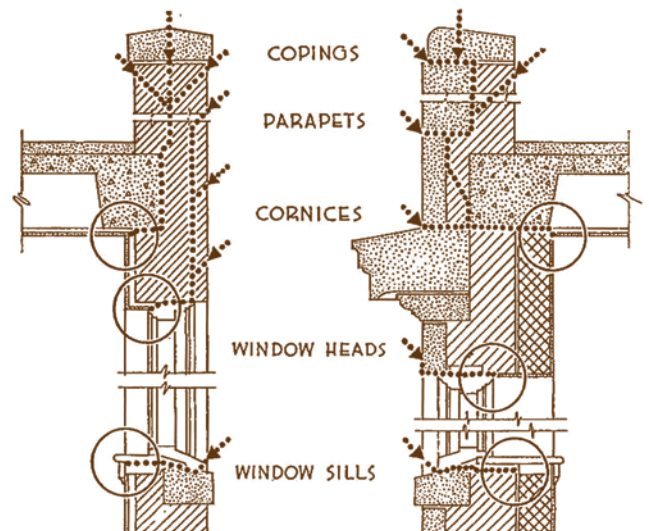
Figure 5 – Some of the paths water can follow before leakage is discovered in the interior spaces.

condensation. Often, because of the type of construction, water leakage into the building may go unnoticed for an extended period of time. Figure 5 highlights the many paths water can travel before it leaks into the interior spaces.

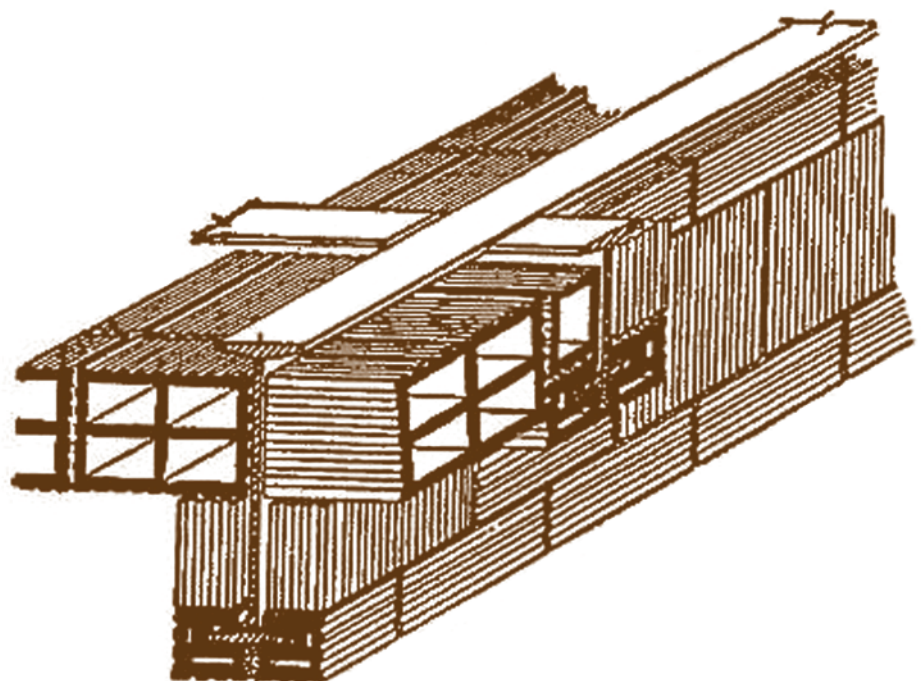
Figure 6 – How clay tile was used to cover structural steel members to provide fire protection.

Clay tile provides an excellent source of fire protection for steel framing. Figure 6 shows how the clay tile typically protected structural steel members. If there is significant deterioration of the existing clay tile deck and selected removal and replacement of tile units is necessary, the replacement materials need to provide the same or better fire protection of structural steel, should
