# EVALUATION OF HAIL-STRIKE DAMAGE TO ASPHALT SHINGLES BASED ON

## HAILSTONE SIZE, ROOF PITCH, DIRECTION OF INCOMING STORM, AND FACING ROOF ELEVATION

BY STEPHEN PETTY, PE, CIH, MARK PETTY, AND TIM KASBERG

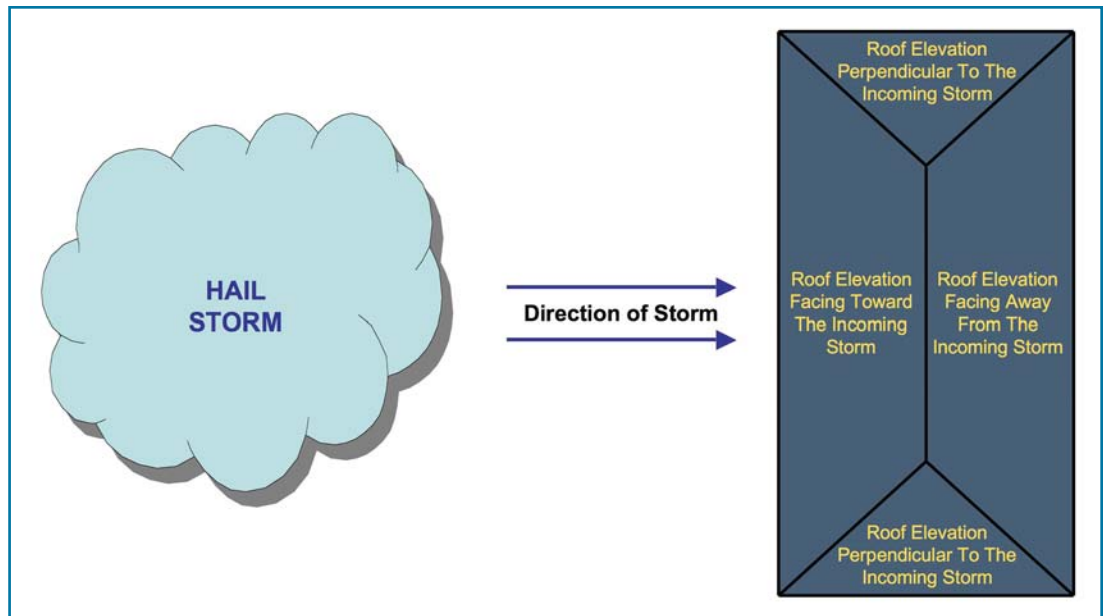
Figure 1- Direction of arriving hailstorm vs. roof elevation.

Note that the last two correlations (see Figure 1) may be useful to degraded roof surfaces not suitable for bruise counts, which, according to our study, often face south and west into the direction of arriving hailstorms.

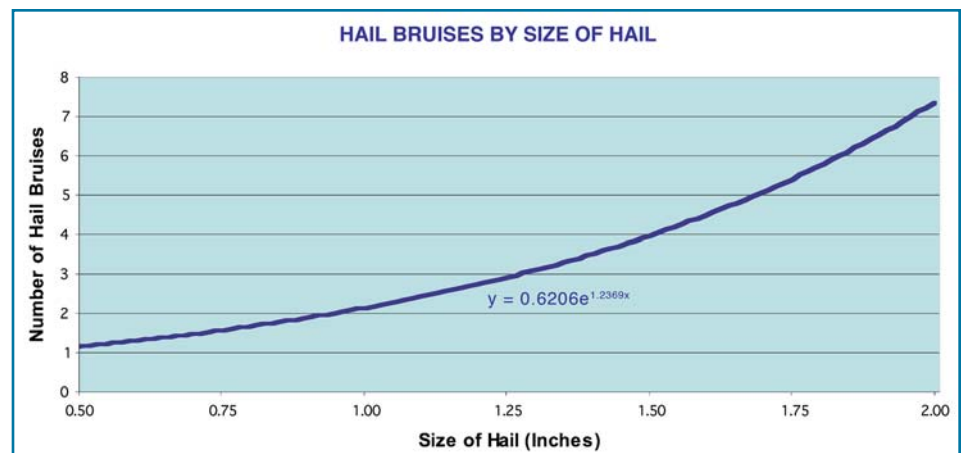
Figure 2 - Hail bruises by size of hail.

Remaining data sets were broken down into hail-size subgroups of 1/8 in to 3/4 in, 7/8 in to 1 in, 1-1/8 in to 1 1/2 in, 1-5/8 in to 2 in, and greater than 2 in. Similarly, the bruise counts per 100 sq ft were collected from measured field values. Using this information, a scatter plot graph was created by placing the mean hail size for each subgroup on the x-axis and the mean number of bruise counts on the y-axis. Using this data, the number of hail bruises was found to increase exponentially as the size of the hail increases (Figure 2).

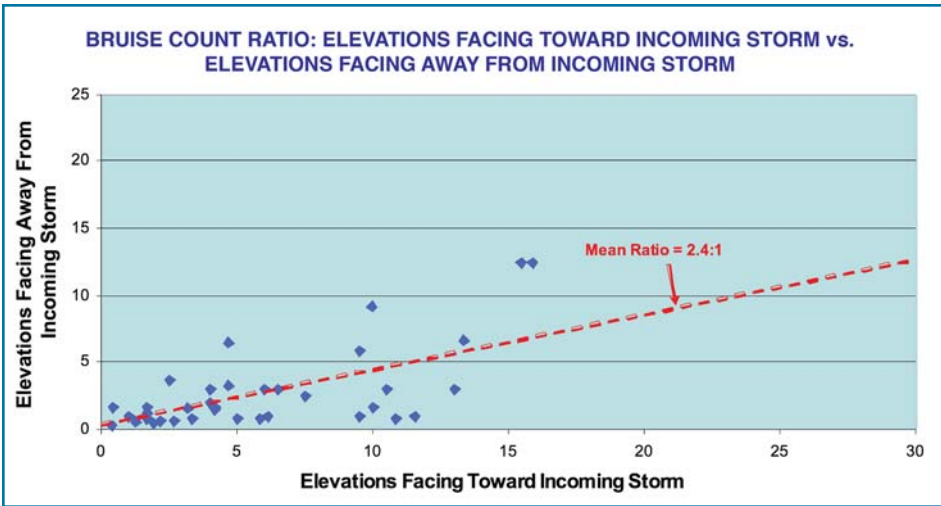
Figure 5 – Bruise count comparisons between roof elevations facing an incoming storm and roof elevations facing away from an incoming storm.

the incoming storm was then compared to the number of bruises on the roof elevations facing away from the storm and turned into a ratio. Using results from 51 site inspections, the study found this ratio to be 2.4:1

(see *Figure 5* and *Table 2*). Thus, a roof facing the incoming storm had bruise counts nearly two and a half times that of the roof elevation facing away from the incoming storm.

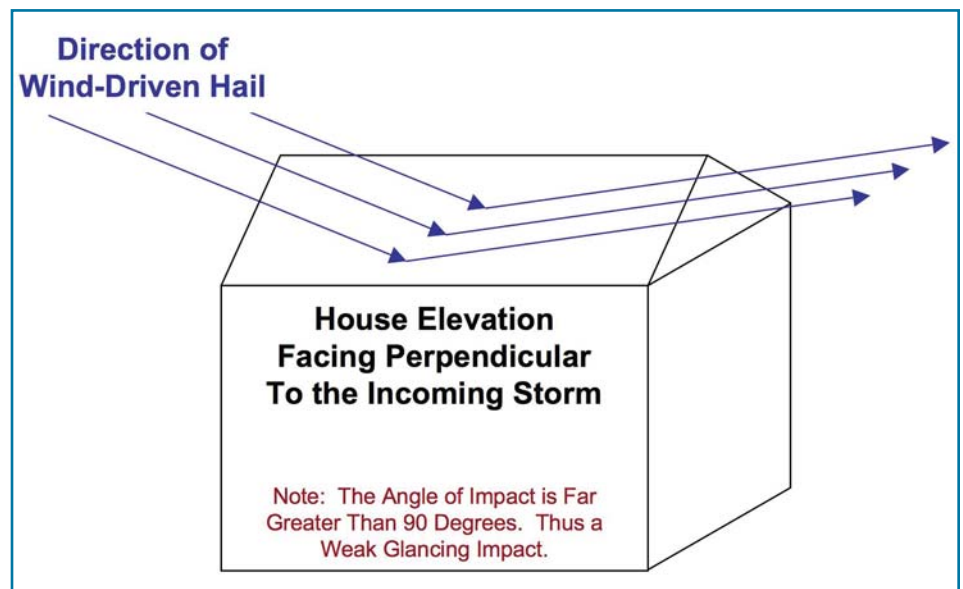
Figure 6 – Hail impact on roof elevations facing perpendicular to an incoming storm.

For this correlation, the database was manipulated to include only roof elevations that were finished with asphalt shingles. This correlation focused on comparing the bruise counts received by roof elevations facing the incoming hailstorm versus the roof elevations perpendicular (see Figure 6) to the incoming hailstorm. This correlation used data gathered during the hail-damage inspections performed by EES regarding the direction each elevation faced and the direction that the storm traveled. This information was then separated into two categories: 1) elevations that were facing into the incoming storm and 2) elevations that were perpendicular to the incoming storm.

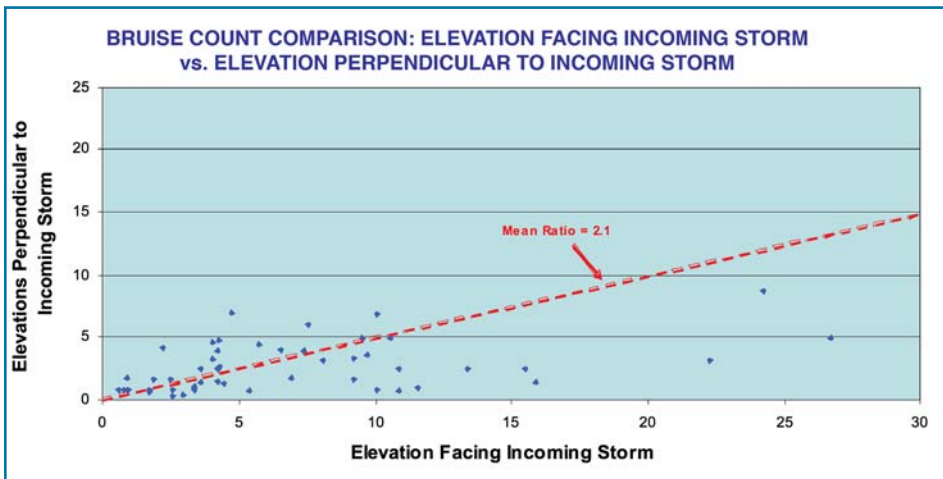
Figure 7 – Bruise count comparisons between roof elevations facing an incoming storm and roof elevations perpendicular to an incoming storm.

the number of bruises on the roof elevations perpendicular to the incoming storm and turned into a ratio. Using data from 100 site inspections, the study found this ratio to be 2.1:1 (see Figure 7 and Table 3). Thus, a roof facing the incoming storm had bruise counts just over two times that for roof elevations perpendicular to the incoming storm.
