# BUILDING ENVELOPE TECHNOLOGY SYMPOSIUM

## DUAL-SEALED MOVEMENT JOINTS IN ROOFING AND WATERPROOFING APPLICATIONS

**ROCCO ROMERO, AIA**

*WISS, JANNEY, ELSTNER ASSOCIATES, INC.*

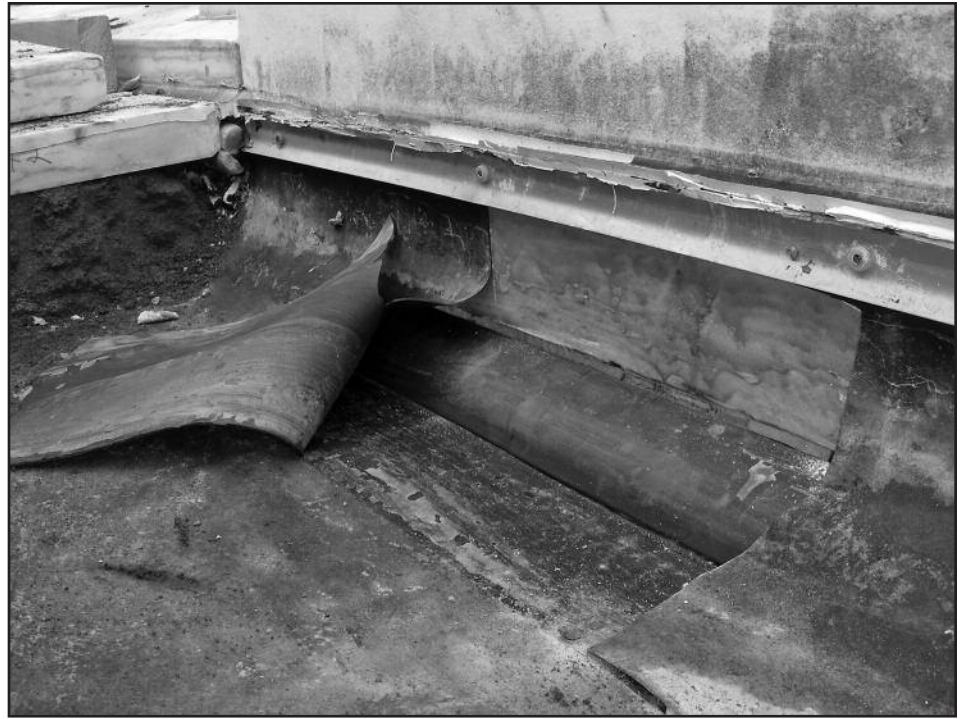
In 2008, as a part of the building renovation, the terrace-level waterproofing system was removed and replaced. The new waterproofing membrane system consisted

of a reinforced, hot-applied, rubberized-asphalt membrane system applied to the top of the structural slab, a protection layer, drainage mat, and patterned architectural concrete topping slab sloped to trench drains. In the area of the waterproofing membrane replacement work, all existing gaskets and mem-

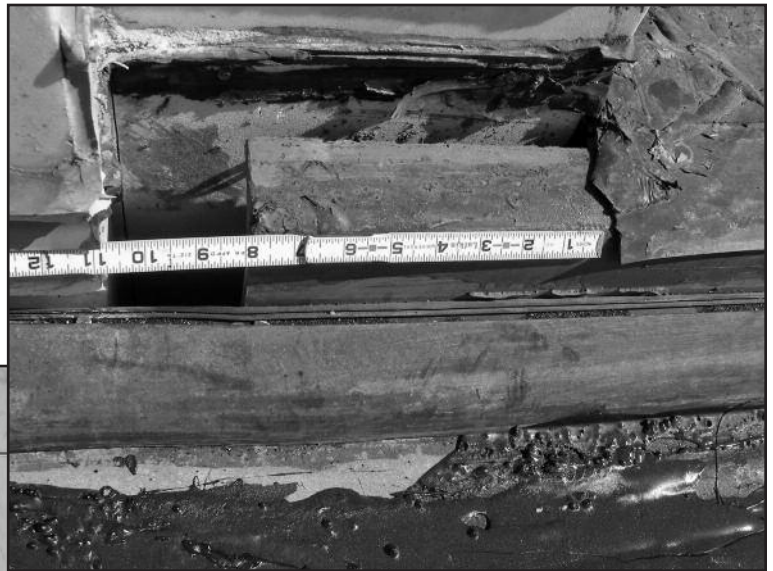
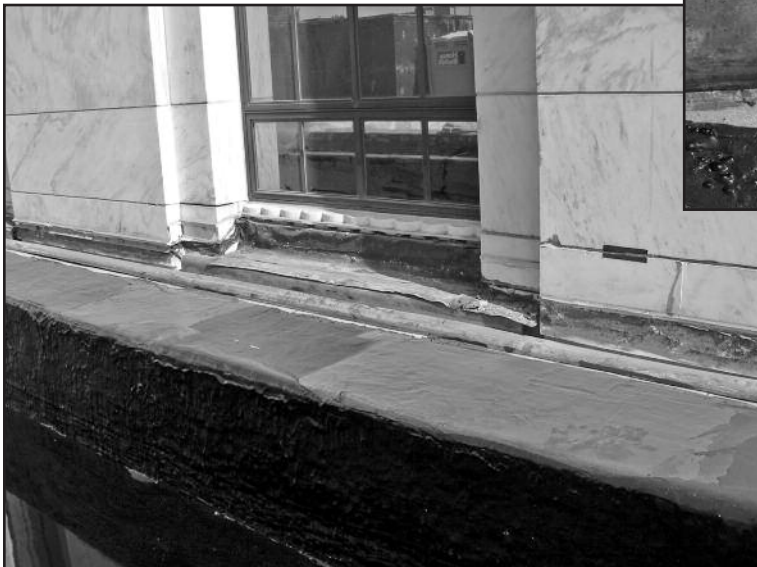
The new topping slab would limit future access to the waterproofing membrane at the seismic joint; therefore, a dual-seal

movement-joint approach was used. The design utilized a preformed, acrylic-impregnated expanding foam seal that expands to fill and seal the gap in the joint. This preformed seal was considered to be the second seal or backup line of defense against water intrusion into the seismic joint. The primary seal utilized a flexible gland embedded in a layer of hot-applied rubberized asphalt. Both the waterproofing membrane manufacturer and foam seal manufacturer confirmed prior to installation that the components were compatible with each other.

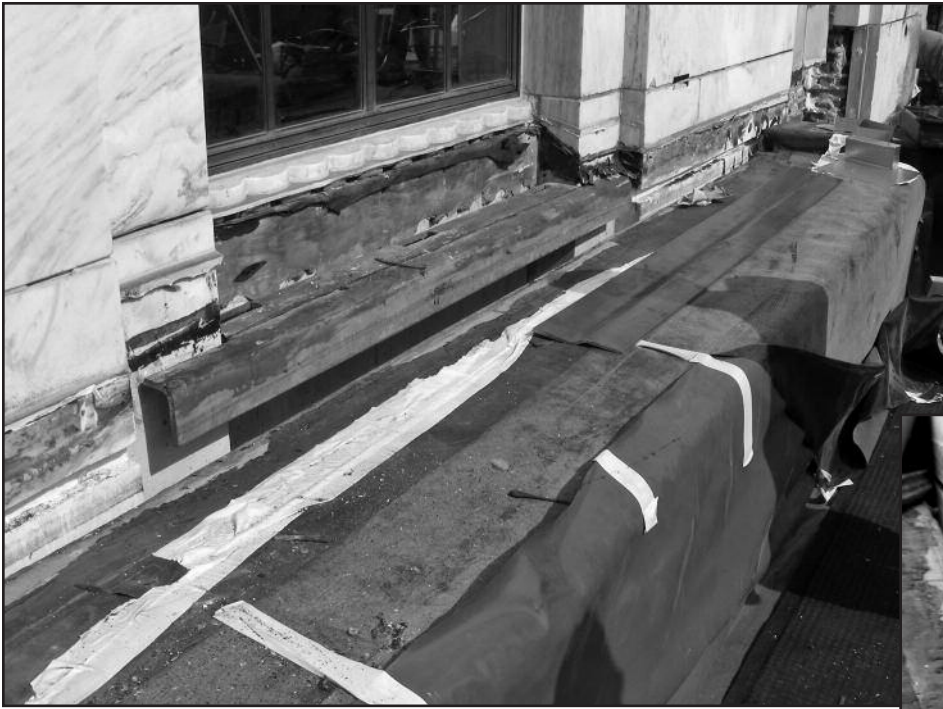
As with many retrofit projects, unique transitions between buildings required specialized movement-joint waterproofing design. For example, at the north-perimeter planter walls, a seismic joint was located directly below windowsills, with gaps between the existing steel bent-plate marble sill support and existing joint gasket (*Figures 3 and 4*). Removal of the gasket revealed a gap between the lowest edge of the steel bent-plate sill support and the top of the planter wall (*Figure 5*).

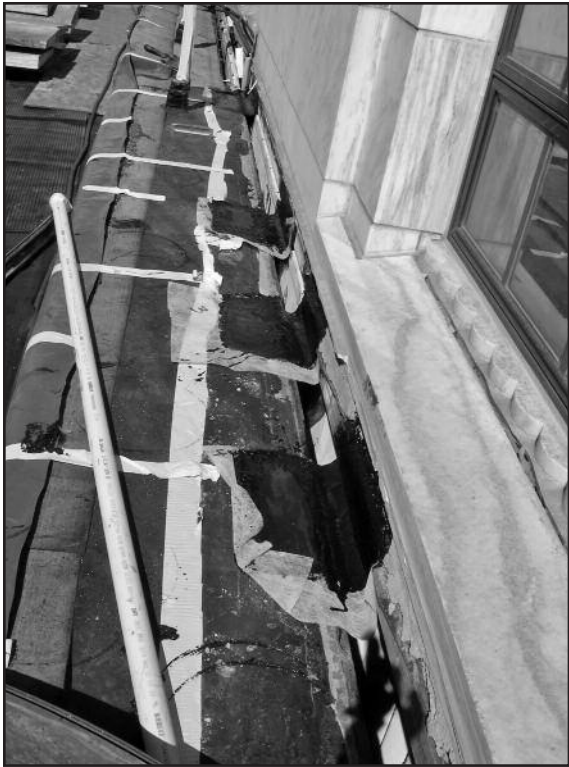
ing membrane system to the various substrates (which included marble, concrete, and steel), the substrates were prepared and primed where applicable, and membrane patches were installed and evaluated (*Figure 8*).

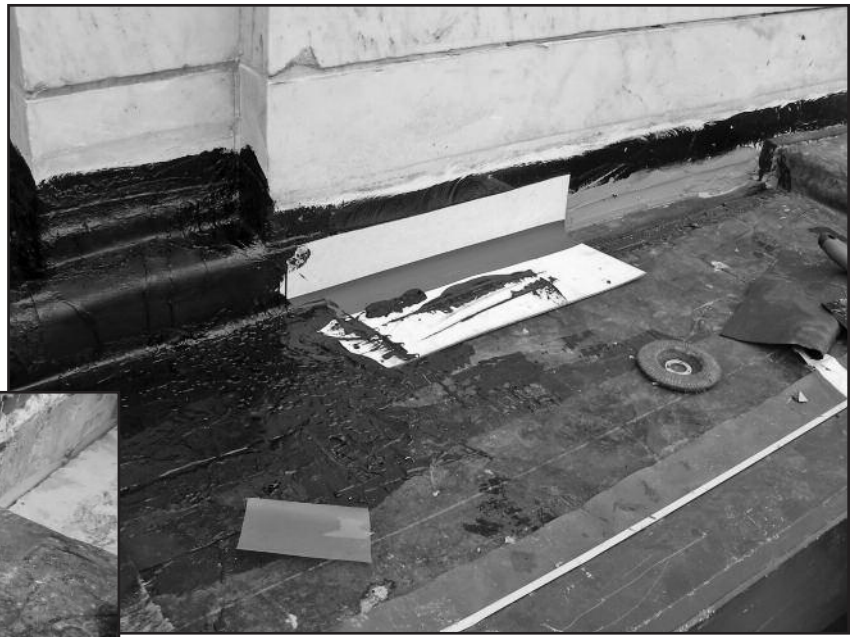
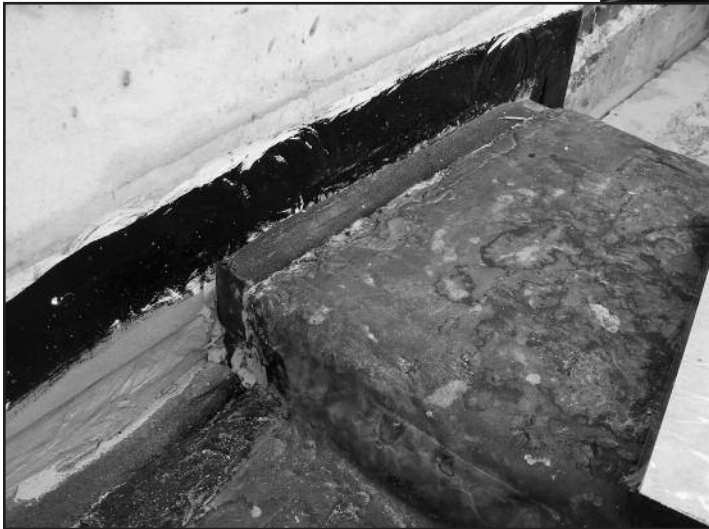
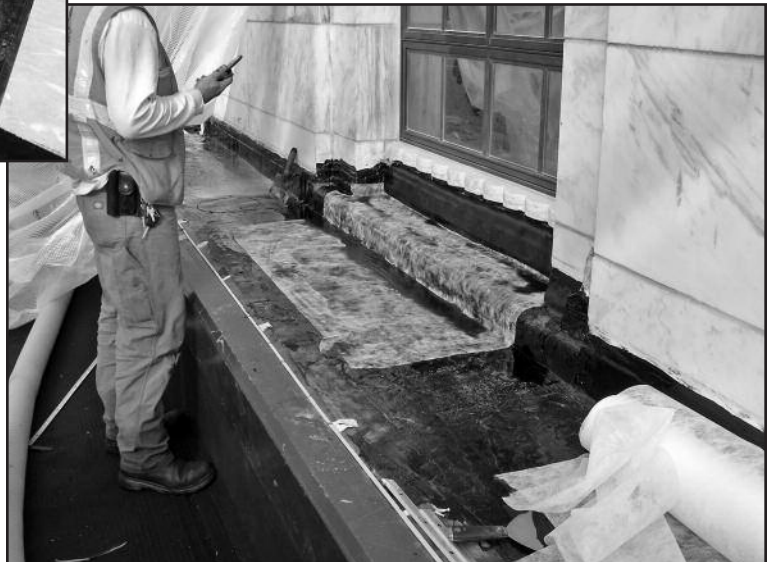
Transitions from horizontal to vertical components required special detailing in order to maintain the watertight integrity of the joint. At the preformed acrylic-impregnated expanding-foam seal, portions of the ends of the vertical and horizontal components were miter-cut at a 45-degree angle and keyed together. The top of the expanding foam was set level with the top edge of the joint to eliminate creation of a trough that could potentially collect infiltrating water. Flexible gland was then installed over the preformed acrylic-impregnated expanding-foam seal in a layer of hot-rubberized asphalt. As a part of the waterproofing membrane system, a membrane flashing was installed directly over the flexible gland in a layer of hot-rubberized asphalt waterproofing. The reinforced waterproofing membrane system was then installed, integrated with the membrane flashing (*Figures 9, 10, and 11*).

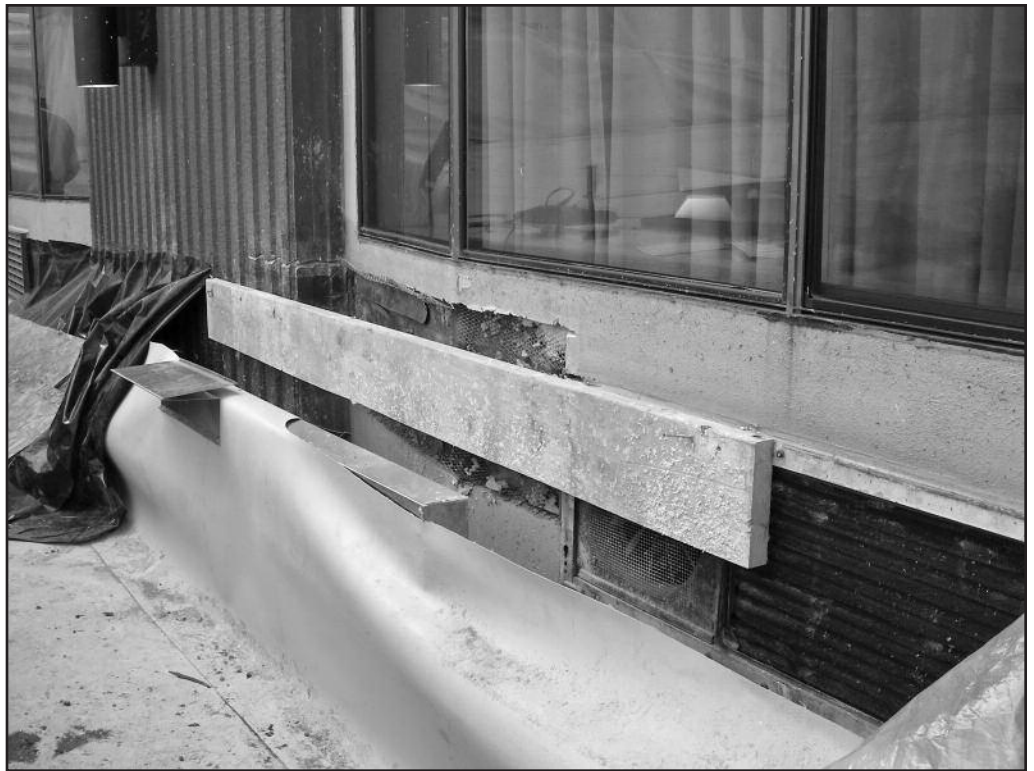
In order to address the gap created by the stucco setback at the fluted concrete piers, continuous wood blocking was added to establish a datum line for the termination point of the roofing membrane and provide a substrate to attach components required for the movement joint (*Figure 12*).

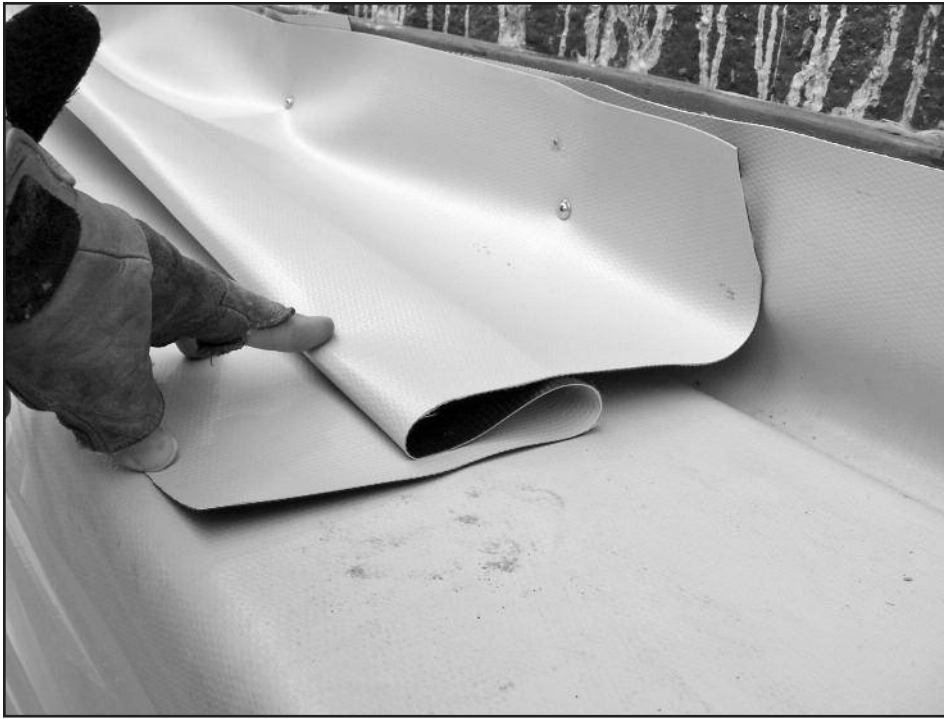
The single-ply TPO roofing membrane was utilized as the primary waterproofing component for the movement joint. While the TPO membrane thickness was typically 60 mils in the field of the roof, membrane thickness was reduced to 45 mils at the joint in order to fold the membrane and create slack to accommodate anticipated movement (*Figure 13*).

The folded TPO membrane was terminated vertically at the new blocking. The membrane was installed with a slope-to-drain toward the outside roof edge and into the roof drainage trough.

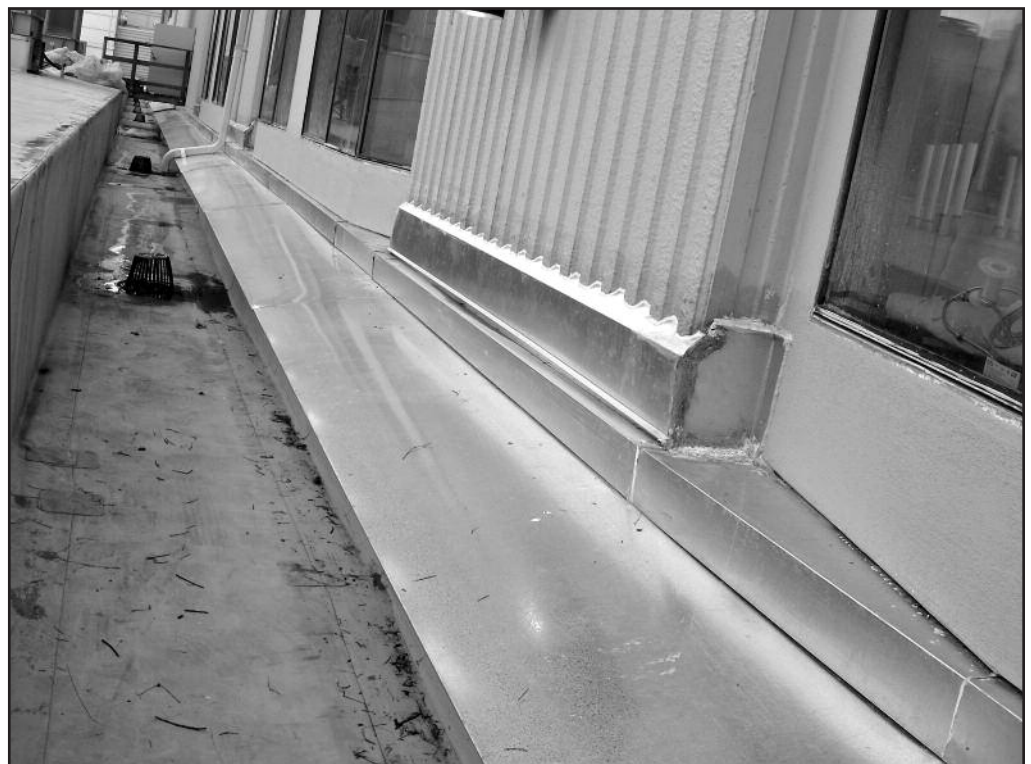
A view of the completed system is shown in *Figure 14*. Several field mock-ups were performed to determine the constructibility of the design and implement changes to accommodate as-built substrate conditions.
