TURN UP THE HEAT!
CONSTRUCTION ADMINISTRATION
OF A HOT-FLUID-APPLIED,
RUBBERIZED ASPHALT
WATERPROOFING MEMBRANE

Nicholas A. Piteo
Christina M. Terpeluk
Simpson Gumpertz & Heger Inc.
Rockville, MD

THE PROJECT

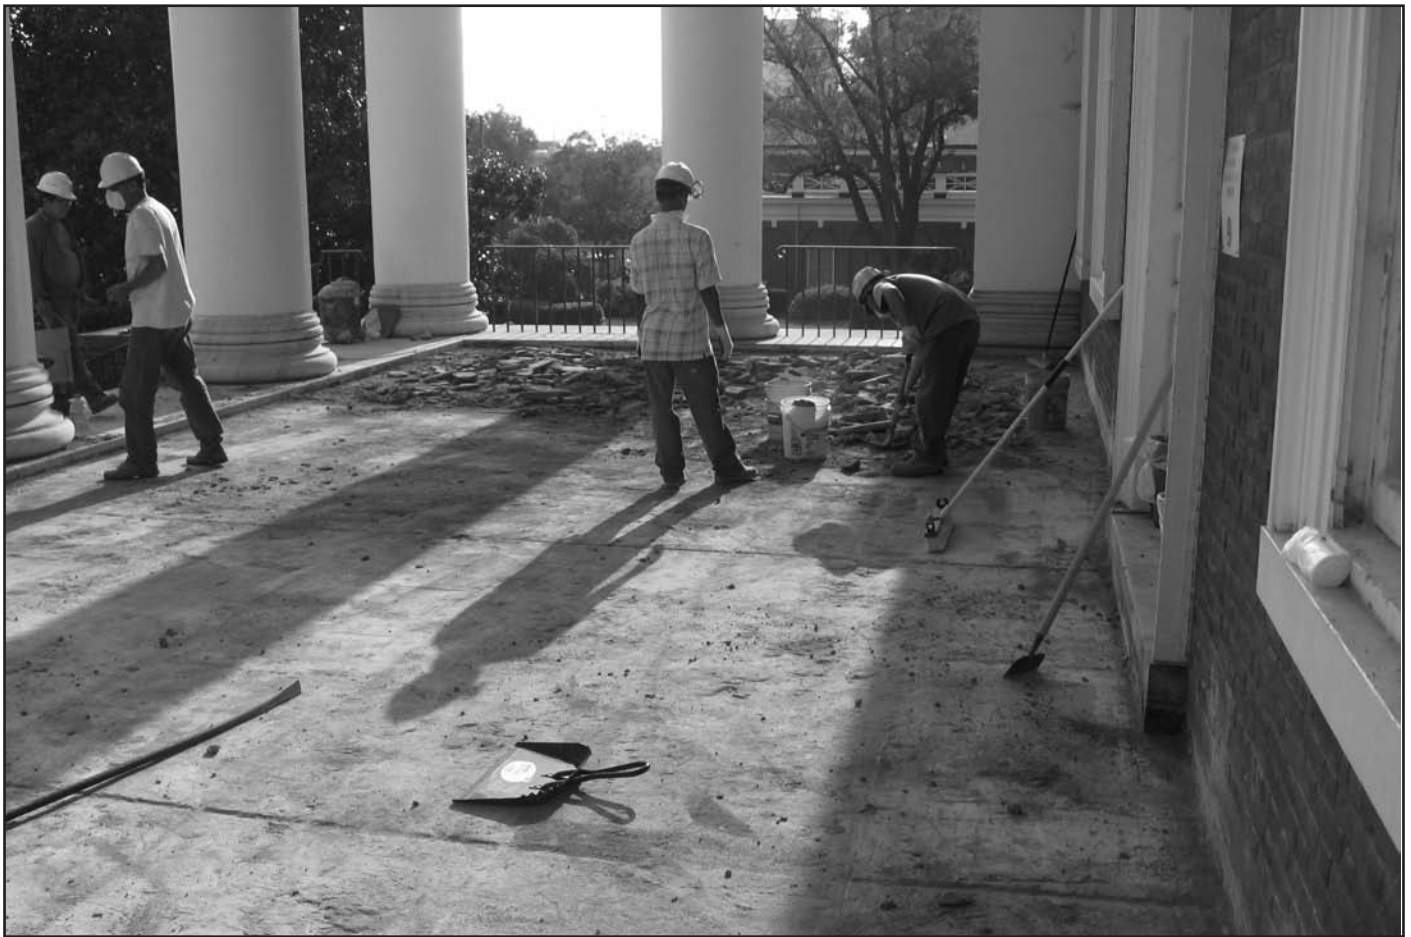
Photo 1 – Removal of concrete topping over concrete substrate. Note the existing roofing system consisted of (from interior to exterior): concrete deck, existing waterproofing membrane, concrete topping slab, mortar setting bed, and overburden (not shown).

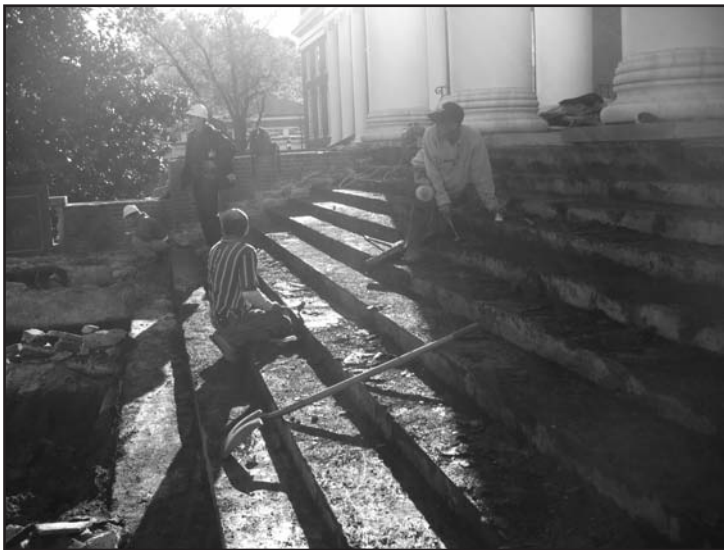
Photo 2 – Removal of existing waterproofing membrane on stairs using handheld-scrappers.

existing hot-applied asphalt, can be difficult. Workers often try creative solutions to remove hot-applied asphalt, but we have seen the greatest success with heavy scraping bars, shovels, chisels, and physical effort (*Photo 2*). Designs should not require the installation of a new membrane over existing membrane because the existing substrate remains concealed, and recovering an existing leaky membrane is likely to trap moisture, which reduces the durability of the waterproofing system.

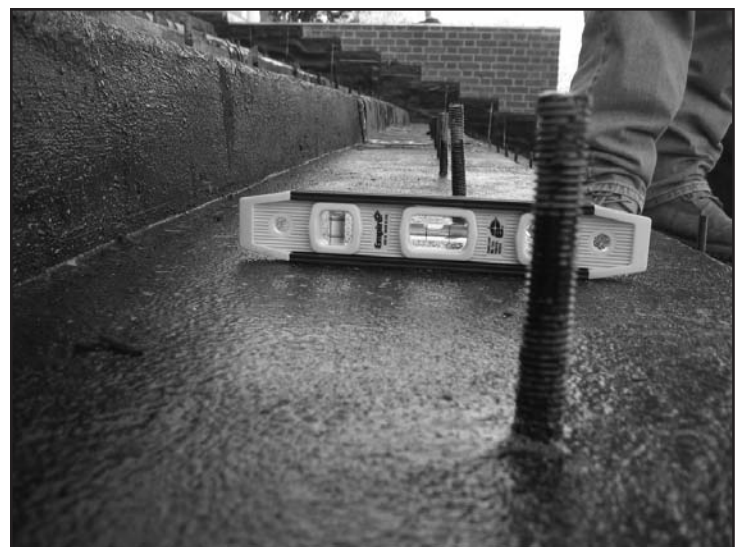
Photo 3 – Level showing sloped surface at a stair tread. We added slope with a concrete topping at the stair treads to promote drainage.

Waterproofing membranes should slope to direct water off of the membrane or to drains (*Photo 3*). Our project did not include drains, but existing drains (and overflow drains) should be reviewed for capacity based on rainfall data contained in the International Building Code or other locally applicable codes. Hot-fluid-applied, rubberized asphalt membranes bond directly to the substrate (i.e., tapered insulation is not appropriate), and therefore, the substrate must provide the membrane with slope. A durable, low-slope waterproofing system requires a slope of ¼ in/ft to provide reliable membrane level drainage. Slopes lower than ¼ in/ft provide little margin for error in concrete placement or long-term deflection, provide less reliable drainage, and thereby reduce the durability of the waterproofing assembly. Waterproofing slope can be provided by sloped structural framing with uniformly thick concrete, or with level formwork

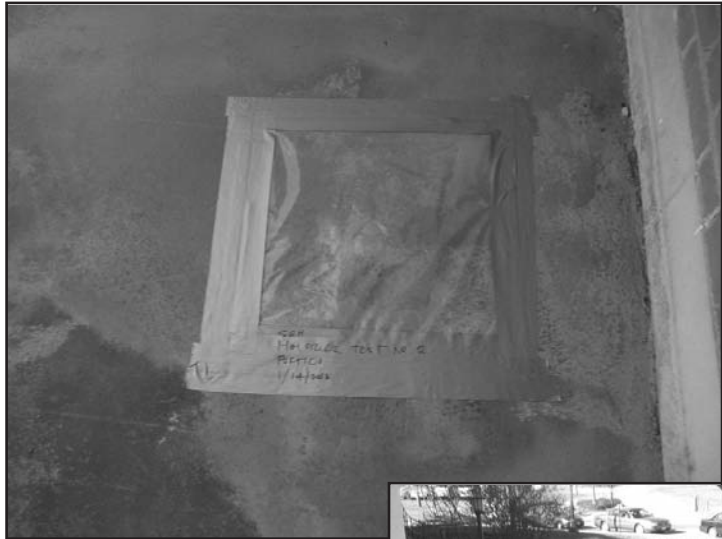
Photo 4 – Moisture test according to ASTM D 4263 – Standard Test Method for Indicating Moisture in Concrete by the Plastic Sheet Method.

the moisture levels in concrete. This test consists of sealing a piece of plastic sheeting (approximately 18 in. by 18 in.) to the concrete surface (Photo 4). After approximately 16 hours, the sheet is removed and both the sheet and concrete surface inspected. Moisture on either the plastic or concrete surface indicates wet concrete, which requires additional drying time prior to installation of a hot-fluid-applied, rubberized asphalt membrane.

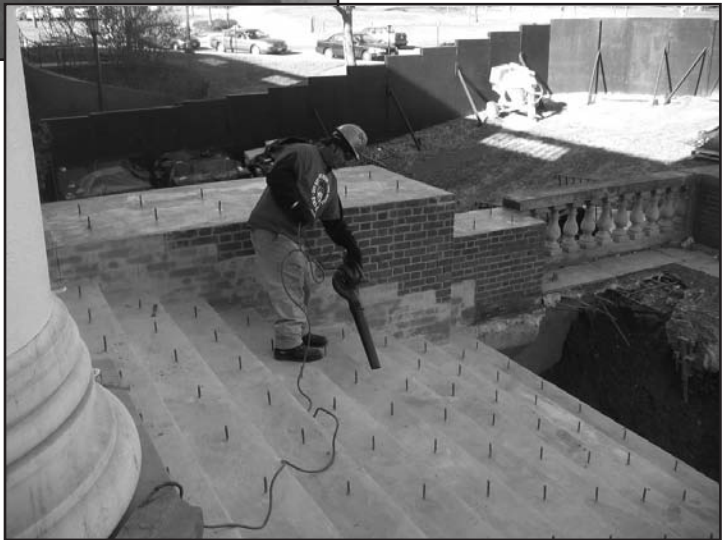
Photo 5 – Removal of dirt and debris from concrete surface using a hand-held blower.

During the construction process, debris and dirt will settle on the concrete substrate and interfere with the membrane bond. Debris and dirt must be removed from the substrate prior to the application of the membrane by sweeping and blowing the substrate clean with compressed air to (Photo 5).

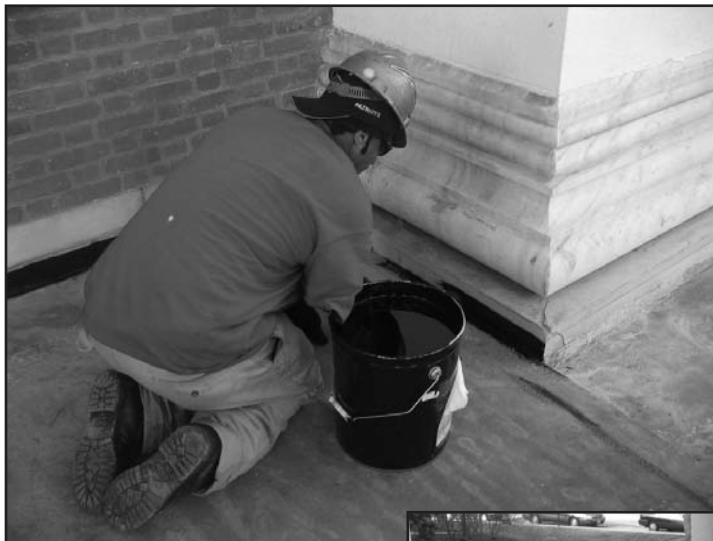
Photo 6 – Primer application with a brush.

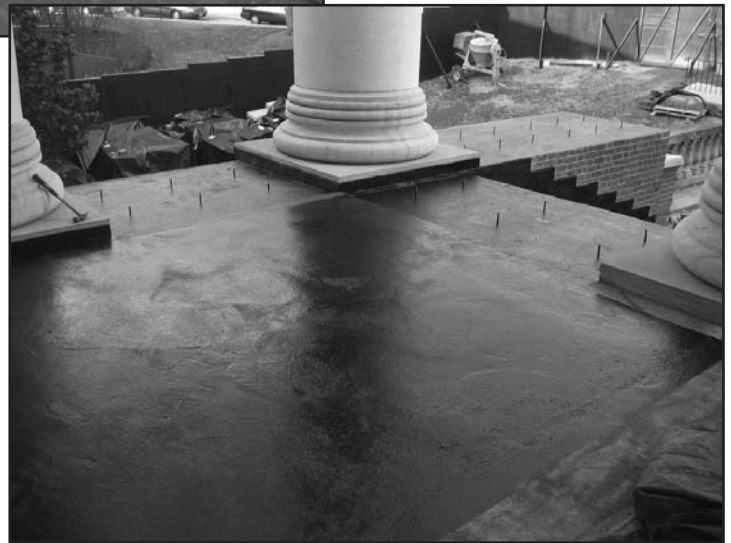
Photo 7 – Primer applied in field of the plaza. Note that the lighter-colored primer at the plaza perimeter is a water-based primer for locations that will receive self-adhered waterproofing membrane.

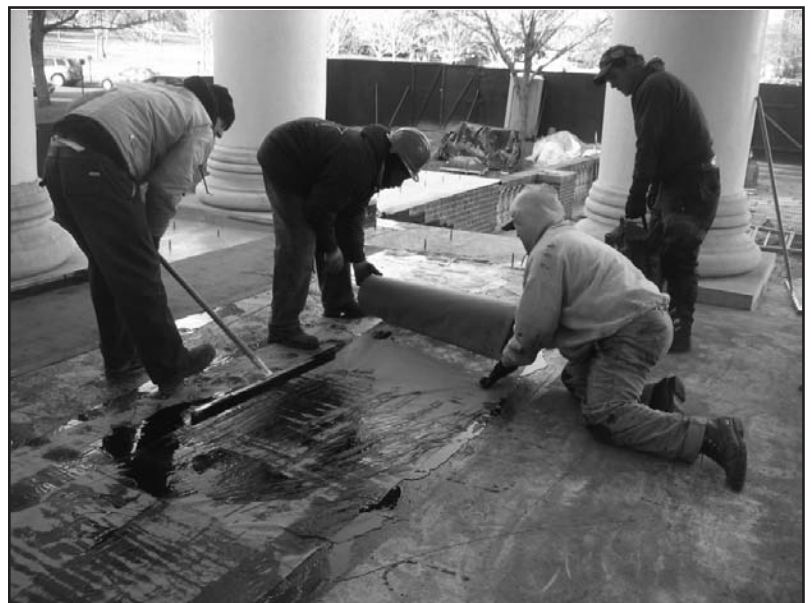
Photo 8 – Placement of fabric reinforcement on top of the first coat of membrane.

Hot-fluid-applied, rubberized asphalt membranes are constructed in one or two coats, reinforced and unreinforced. We consider reinforced membranes more durable because the reinforcement increases puncture resistance, decreases cold flow (e.g., under-concentrated load), improves crack bridging (i.e. cracks, construction joints, and changes in planes) and provides a thickness gauge for the second coat. We recommend that reinforcement be spread across the first layer of membrane after initial cooling (*Photo 8*). If the reinforcement is installed too quickly prior to initial cool, the fabric will melt.

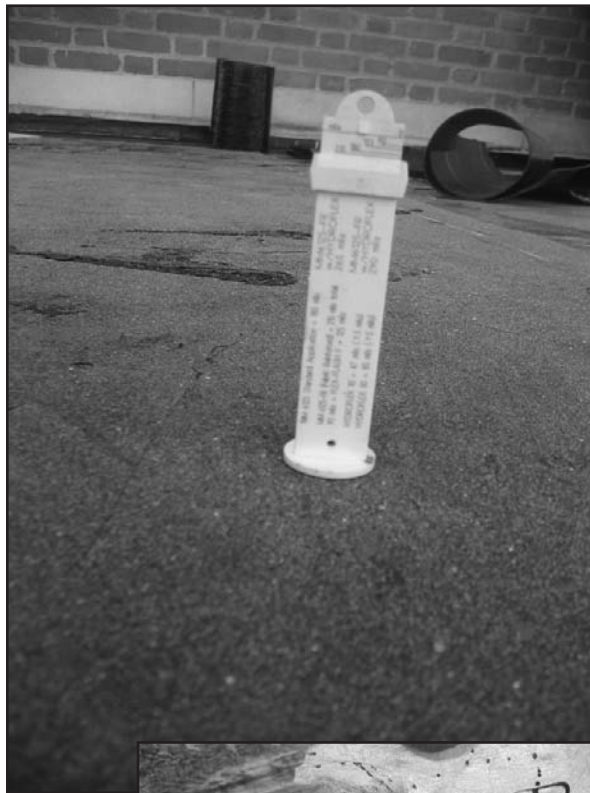
Photo 9 – Measurement of membrane thickness with pin tester. Note that the pin (not shown) is inserted into membrane and thickness is read off the top (arrow).

A typical completed reinforced hot-fluid-applied, rubberized asphalt membrane is an average of 215 mils thick. The installed thickness is important to membrane durability and the construction observer, contractor, or manufacturer's representative should measure the membrane thickness in several locations to verify acceptable thickness prior to installation of the protection sheet. Membrane thickness may be measured with a pin tester or at test cuts in the membrane. Pin testing must be performed in close coordination with the installer so that the test area is immediately recoated to seal the test hole. Consistent with most manufacturers, we recommend one measurement per 100 sq ft (*Photo 9*).

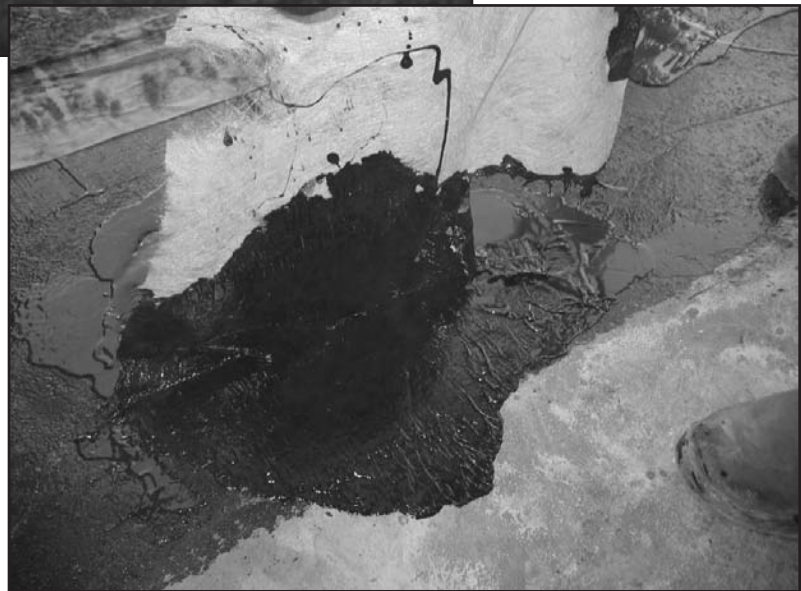
Photo 10 – Fabric embedded in membrane for adhesion test. After the membrane cured, workers pulled the fabric to observe the failure mechanism. The membrane failure occurred within the layers of the membrane.

At our project, the contractor successfully mocked up the membrane within the expected thickness range while we were on site. The mock-up also included an adhesion test that consisted of embedding a piece of fabric with an exposed pull tab within the membrane (*Photo 10*). The fabric is pulled until membrane failure

to examine the failure mode. Our mockup pull test failed cohesively within the membrane, which indicates that the adhesive bond to the deck is stronger than the cohesive bond between layers of the membrane, which is the desired result of the pull test. An adhesive failure between the membrane and substrate indicates insufficient bond that requires additional investigation to determine the source of poor adhesion. Different test methods

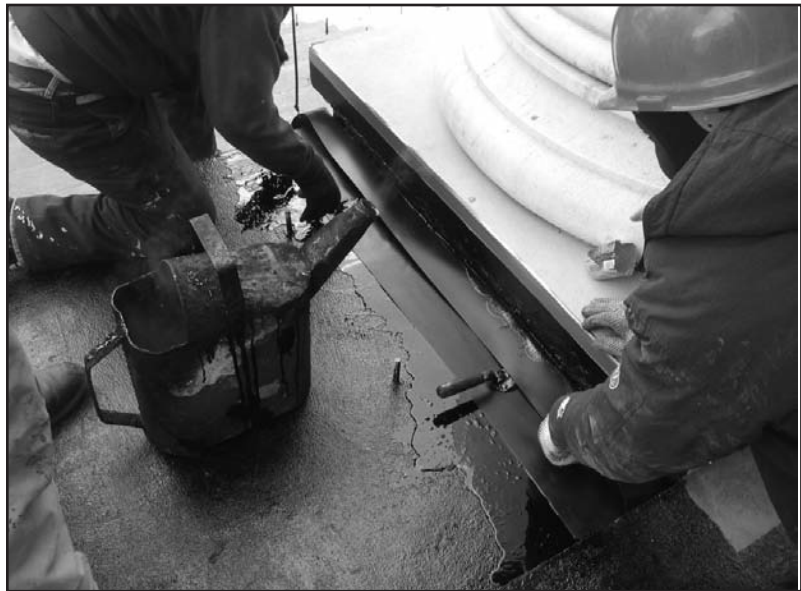
Photo 11 – Neoprene flashings installed at the base of a portico column prior to the application of waterproofing membrane.

Base flashings turn up and transition between the fluid-applied membrane and rising walls or other surfaces. Base flashings should be installed prior to wholesale deck membrane installation to facilitate seamless integration with the membrane. Base flashings may be installed with a manufacturer’s recommended adhesive, may be hot-fluid-applied asphalt, or may be torch-applied. They must be installed without wrinkles or fishmouths. The base flashing should extend a minimum of 8 inches above the top surface of the waterproofing assembly (e.g., pavers, stair treads, etc.) and requires termination bars to secure the top of the base flashing in place. Some climates may require higher base flashing extension above the top surface to better resist drifting snow. Metal skirts, masonry or other protection may be necessary to cover base flashings in locations where exposed flashings are nondurable or undesirable. We specified uncured Neoprene base flashings at our project and the workers

first attempted to adhere the base flashing with the membrane manufacturer’s recommended Neoprene adhesive. We easily removed the base flashings adhered with Neoprene adhesive by hand. As an alternative, workers set the base flashings in hot-fluid-applied, rubberized asphalt, which resulted in well-adhered base flashings that we could not remove by hand (*Photo 11*). We also secured the top of the Neoprene flashing in place with continuous hook strips that also fastened copper protection plates over the Neoprene flashings.

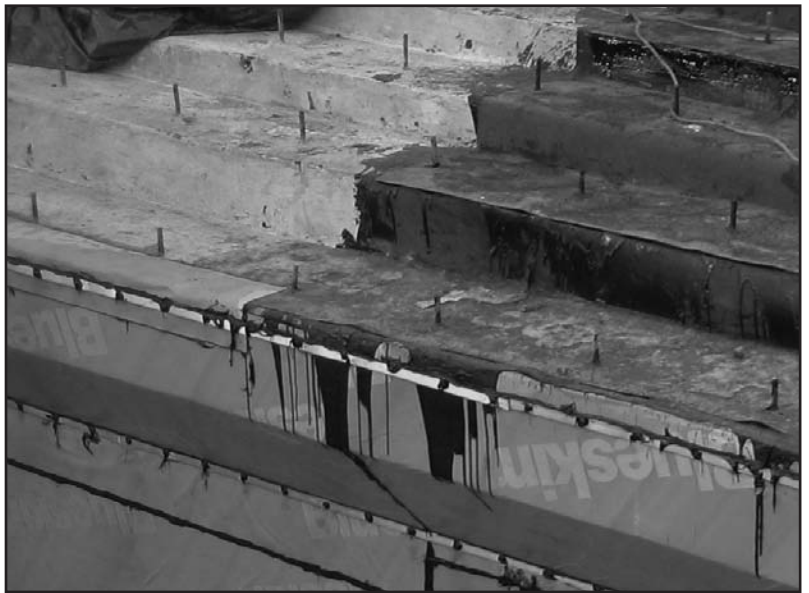
Photo 12 (above) – Hot-fluid-applied, asphalt waterproofing membrane lapped over self-adhered waterproofing membrane at the vertical foundation wall.

Workers removed the polyethylene carrier sheet from the surface of the self-adhered membrane to prevent bond interference between the hot-fluid-applied asphalt and self-adhered membrane.

At our project, the integration of the hot-fluid-applied, rubberized asphalt membrane with the self-adhered membrane applied to the below-grade wall at the bottom of the stairs was a significant challenge. Although the fluid-applied rubberized asphalt membrane and the asphalt in the self-adhered membrane are compatible, we learned on previous projects that the polyethylene facer on the self-adhered membrane inhibits bond between the hot

rubber and the self-adhered sheet membrane. We worked with the membrane manufacturer and the contractor to extend the self-adhered membrane on the wall and approximately 6 inches onto the horizontal surface of the bottom stair tread. The contractor removed the polyethylene carrier sheet from the top surface of the self-adhered membrane with a torch and then applied the hot-applied rubberized asphalt over the self-adhered membrane (Photo 12). In doing so, we avoided the interference of the polyethylene layer with the bond between the hot-fluid-applied, asphalt and the self-adhered membrane.

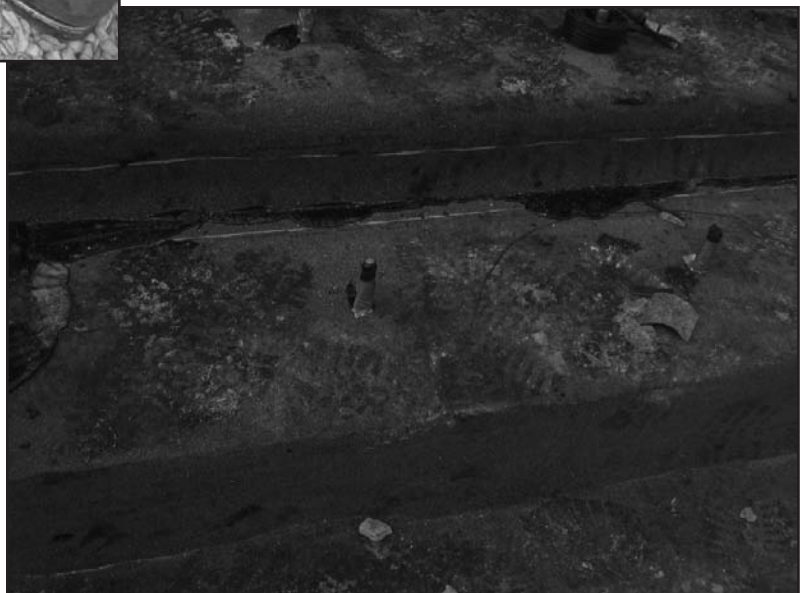
Photo 14 (below) – Neoprene sleeve flashing wrapped around dowel and secured with duct tape to prevent the membrane from unwrapping during placement of the hot-fluid-applied, rubberized asphalt.

to the dowel with the manufacturer’s recommended adhesive prior to pouring hot-applied asphalt over the dowel, but the adhesive did not hold the sleeve together. We successfully secured the Neoprene wrap with tie wire and duct tape to prevent the membrane from unwrapping while workers installed the hot rubber at the dowels (Photo 14).

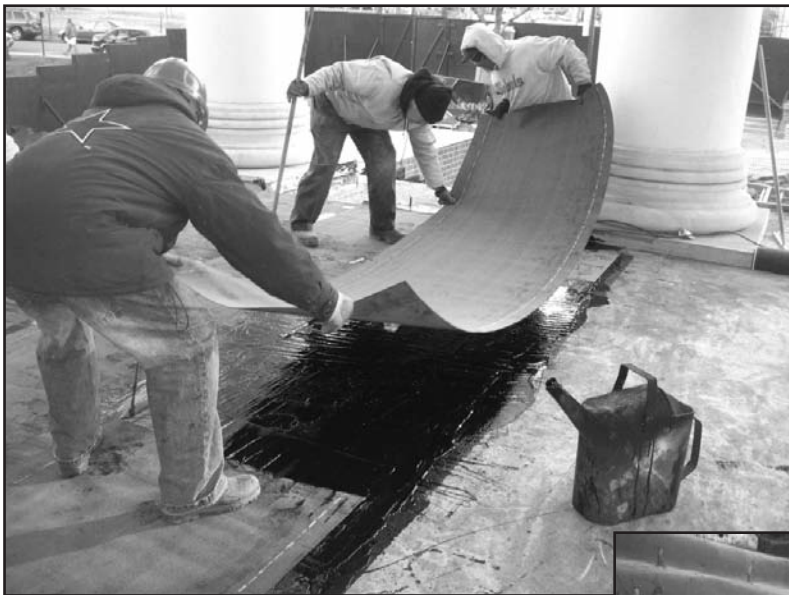
Photo 15 – Placement of protection board over reinforced hot-fluid-applied, rubberized asphalt membrane.

A protection sheet is required by most manufacturers and is placed over and bonded to the membrane while it is still aggressively tacky to complete the membrane application (Photo 15). Seams in the protection layer are lapped to provide continuity. We found that workers had difficulty applying the protection layer at some details, such as

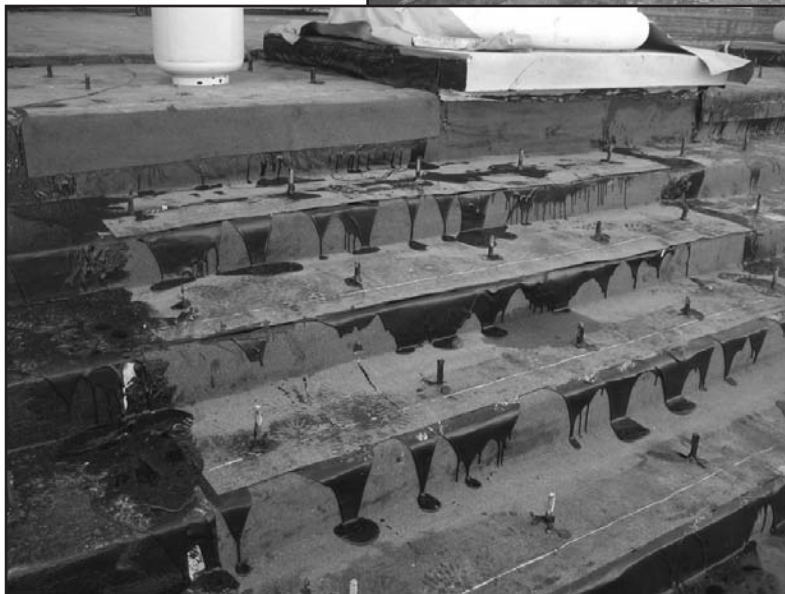
Photo 17 – Protection board cut into smaller and more manageable pieces that lap several inches onto each tread near the nose of the stair, over the vertical riser, and over the majority of the tread below the riser. Note that the protection board conforms to the shape of the stairs.

stair risers and treads. The ¼-in thick protection sheet is too stiff to bend and conform to the shape of the stairs (Photo 16). To solve the problem, the contractor cut the protection sheets into smaller and more manageable strips that covered several inches of the horizontal tread near the nose of the stair, the vertical riser below the tread, and the subsequent tread below the riser (Photo 17). We found that these smaller protection sheet strips were less susceptible to bowing at the vertical risers. We also made sure to shingle lap seams in the protection sheets and maintain slope to drain at each stair tread.

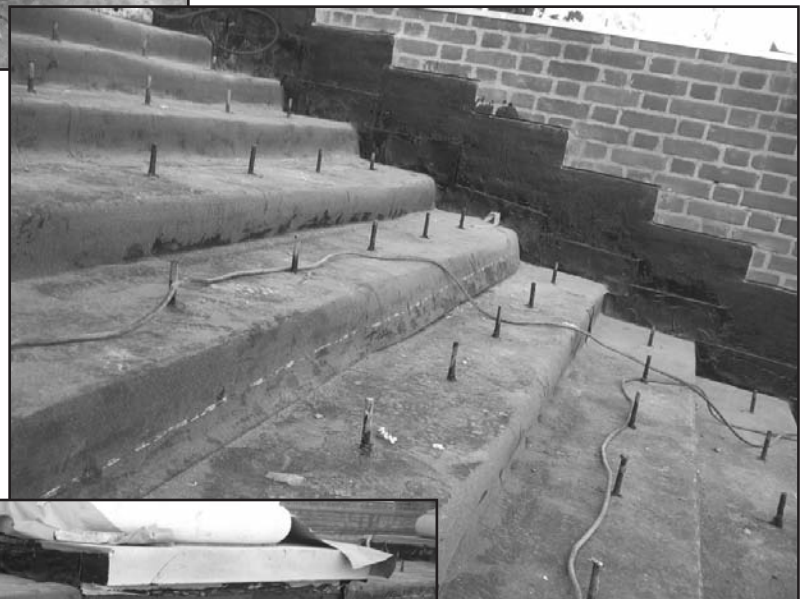
Photo 16 – Uncut protection board lapped over entire portion of stairs. Note that the protection board bulges at stair risers and does not conform to the shape of the stairs.

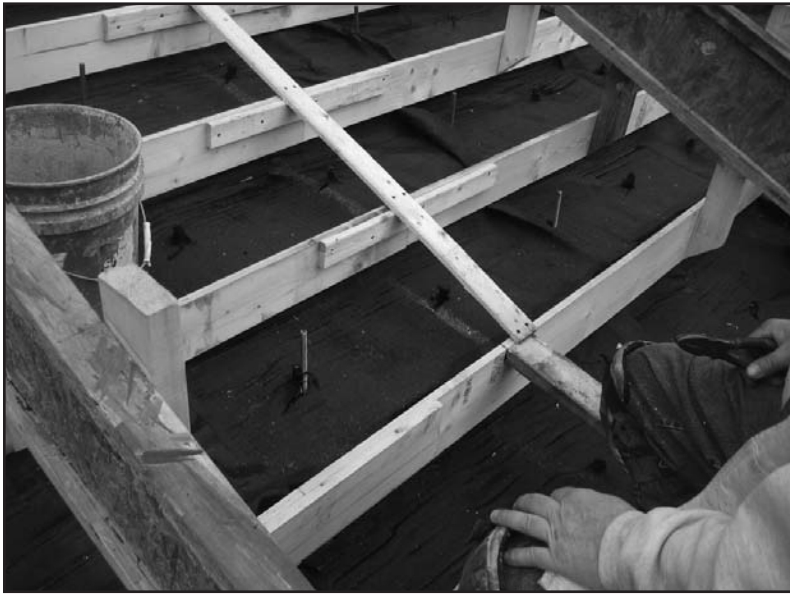
Photo 18 – Continuous layer of drainage board that conforms to the shape of the stairs.

As described earlier, the stair treads and risers are a difficult waterproofing detail. The substrate below stair treads must slope to drain water and include a drainage layer to provide space for water to flow below the stairs. The dimpled drainage layer installed at our project was flexible enough to conform to the nose and heel of the stairs and provide a continuous drainage plane (*Photo 18*). However, the drainage layer must also integrate with the waterproofing above and below the stairs to conduct water into the intended drainage plane and resist unsightly stains and efflorescence at poorly integrated or missing drainage layers (*Photo 19*). In addition to the stair

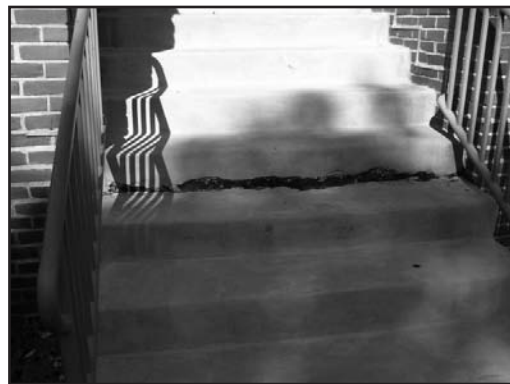
Photo 19 – Stain at stairs installed over hot-fluid-applied, rubberized asphalt waterproofing with no drainage layer at a waterproofing project.

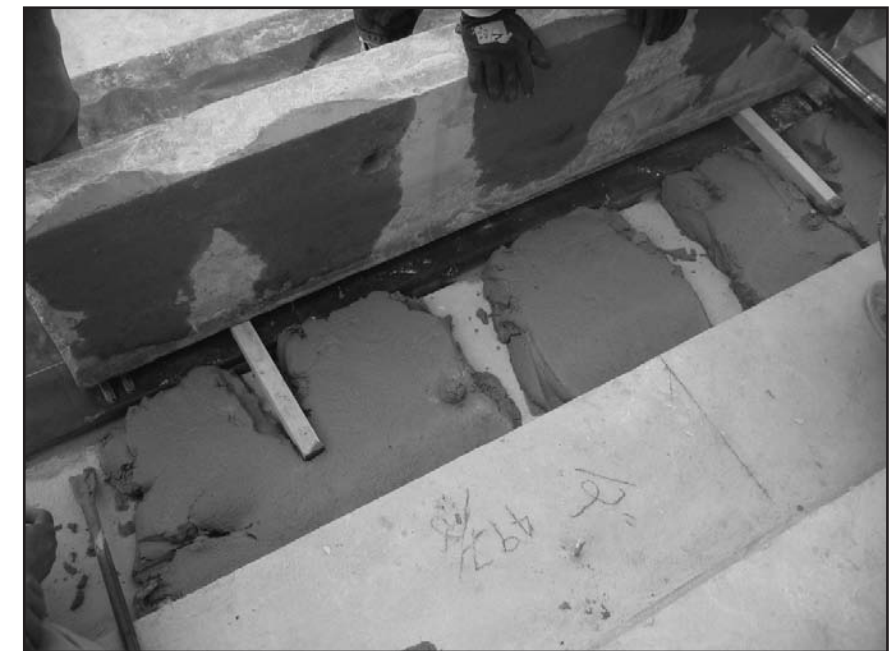
Photo 20 – Alternating mortar-setting beds and drainage space installed below limestone stair treads.

drainage layer, we installed the limestone stair treads on top of alternating 6-in-wide mortar-setting beds, spaced at 12 inches on center (*Photo 20*). The openings between the mortar setting beds promote drainage below the stairs.
