# USING GPS TECHNOLOGY AND WEB IMAGERY IN ROOF CONSULTING

BY REMO CAPOLINO, RRC, PE

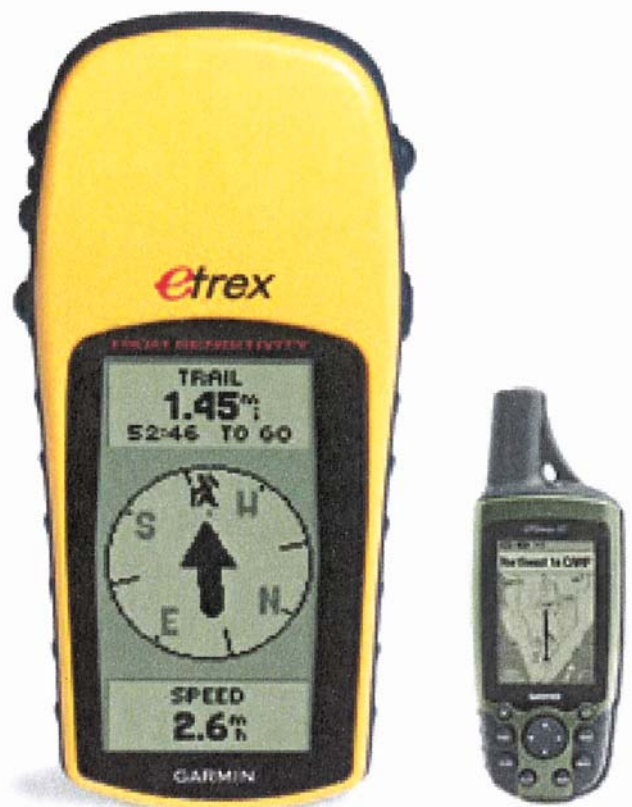
Photo 1 – Handheld GPS units.

used by hikers or other outdoor enthusiasts (Photo 1). The cost of this equipment was anywhere from \$200 to \$400. In-house testing revealed the latitudinal and longitudinal accuracy and repeatability to be about 16 ft. While this degree of accuracy may be acceptable for hiking – if trying to find a circle of orange paint on the roof indicating the presence of a pinhole-sized breach in the membrane, or if attempting to create a roof plan with over 100 of these locations – this degree of accuracy is not sufficiently precise.

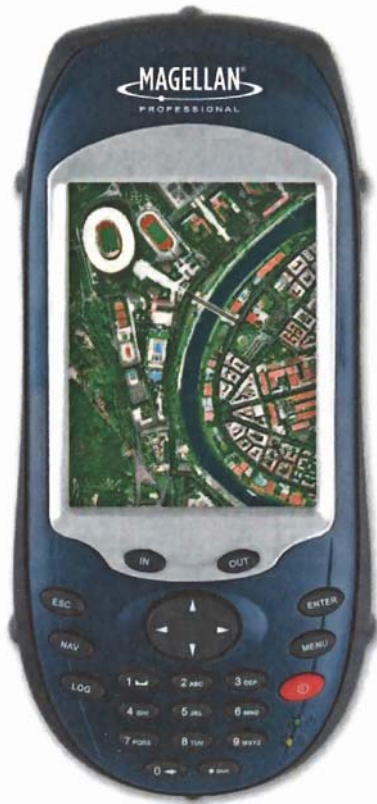
Photo 2 – Sub-meter GPS device.

The GPS devices with the next degree of increased accuracy (typically called “sub-meter” equipment due to their ability to provide location accuracy of less than 3 ft was then tested in house. It was found that to get this degree of accuracy, “post processing” of the data was typically required. The cost of these types of “toys” was in the \$4,000 to \$7,000 range and varied with software interfaces and other features. Some available software packages allow users to import Google Maps or other Internet mapping data and will display color satellite images of the points of interest (Photo 2).

When tested on the top deck of WJE’s parking garage, the accuracy of these “sub-meter” GPS devices was found to be between 3 and 5 ft prior to post processing. This is not as good as the advertisements lead one to believe, but it is precise enough for our purposes.

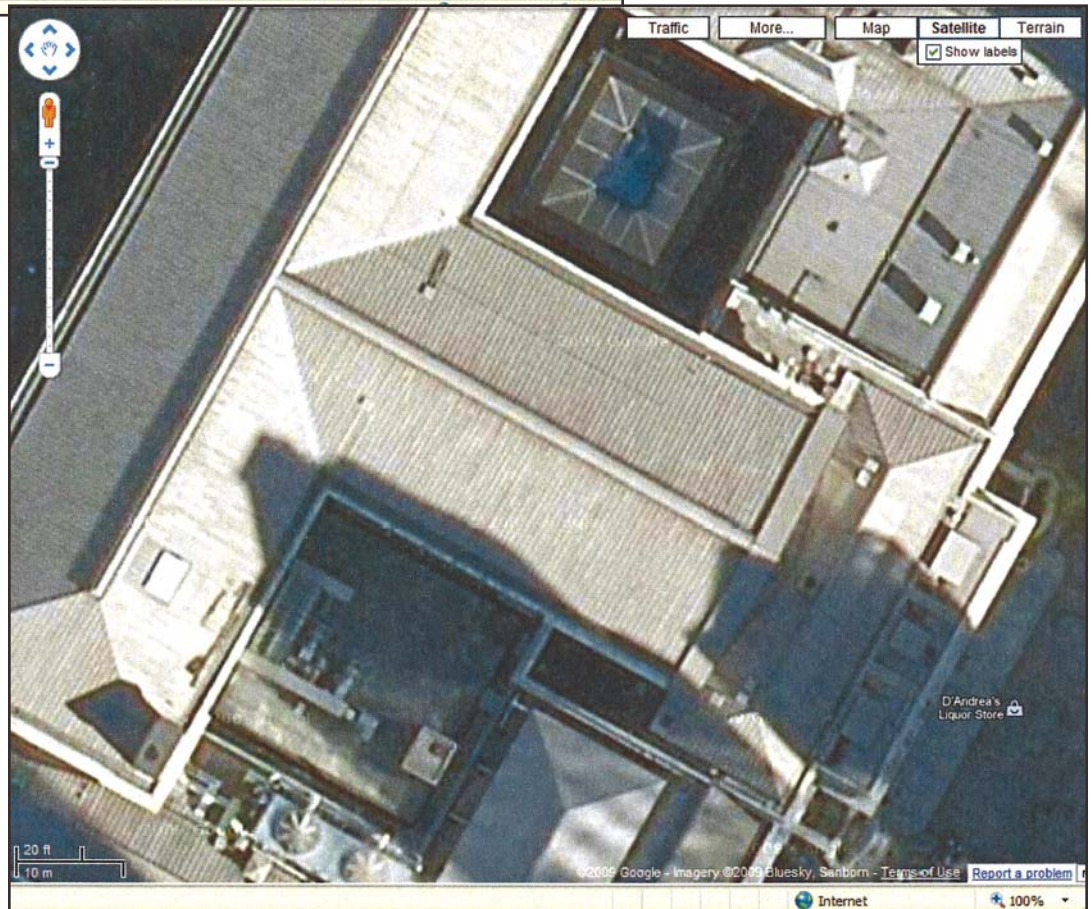
Photo 5 – Close-up view of portions of the roof at scale of 1 in = 30 ft.

were checked and sometimes augmented by the close-up satellite imagery (Photo 5) that was sometimes used to count the number of batten seams at a particular section of the metal roof and compare them to the original plans and our site notes.

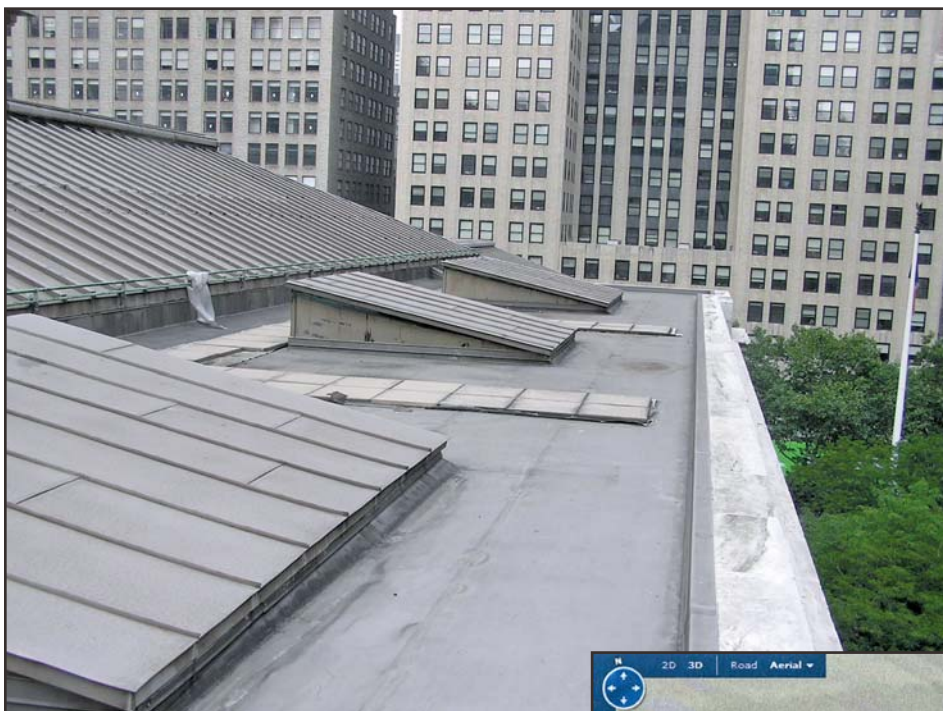
Photo 7 – Photo taken from the roof above the 5th Avenue entrance to the library.

The resolution of the imagery available for cities such as New York City is astounding. The roof above the 5th Avenue main entrance is shown in a screen capture of an aerial photo from Bing Maps in Photo 6. Photos taken from the roof, as well as one obtained from Bing Maps, are provided in Photos 7 and 8, respectively. The detail pro-

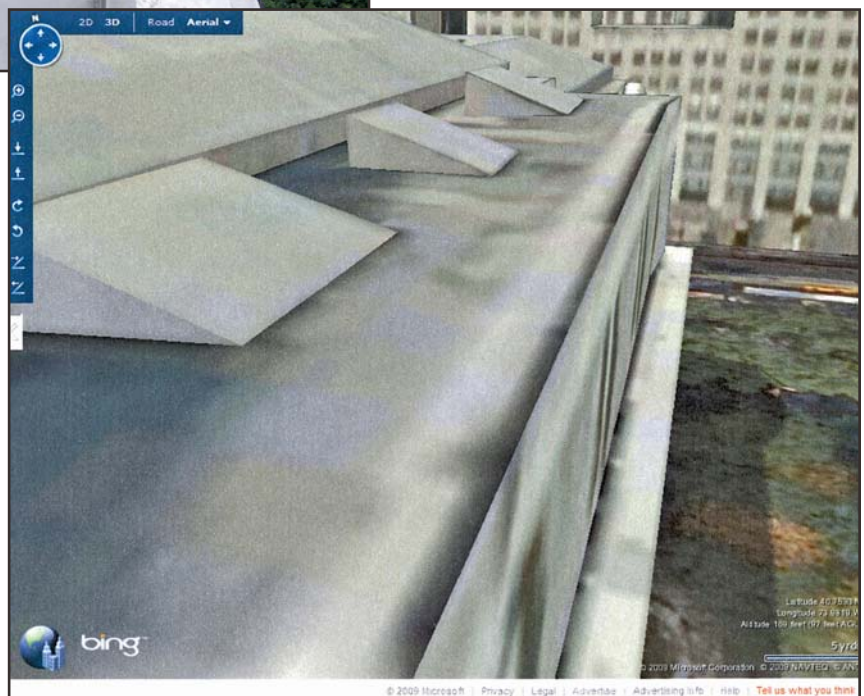
Photo 8 – Image from Bing Maps of the same location shown in Photo 7. Only the flagpole is missing!

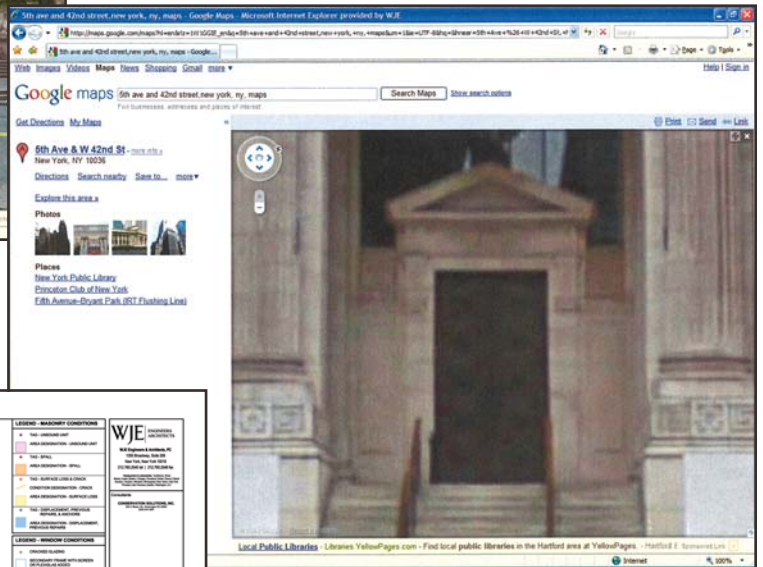
Photo 11 – Building elevation.

entrance elevation (Photo 9) and a zoomed-in photo of the center entry door (Photo 10), when compared to the very detailed drawings available of the building (Photo 11).
