# CORROSION

## The Use of Metal Within Masonry Wall Systems and Associated Life-Cycle Issues

By Edward Gerns, RA, LEED AP

This article is reprinted from the Proceedings of RCI's 2009 Building Envelope Technology Symposium in San Diego, CA.

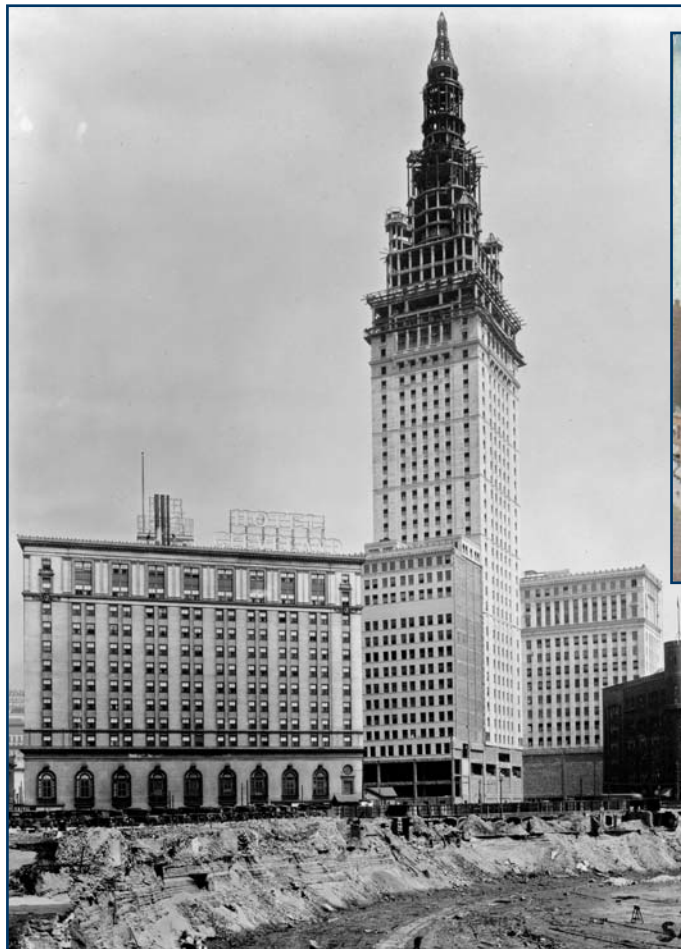
Figure 1 – Skeleton-frame building under construction (image from [www.skyscrapercity.com](http://www.skyscrapercity.com)).

The industrial revolution of the late 19th century produced a dramatic change in building construction. The ability to economically manufacture steel shapes led to the development of the skeleton-frame building system. This system enabled the exterior wall to be used as a nonload-bearing component of the building. The façade could be treated as a skin that wrapped the skeletal frame. The skin was still needed to transfer wind loads to the frame and provide weather protection, but it no longer had to support interior floor loads. (See Figure 1.)

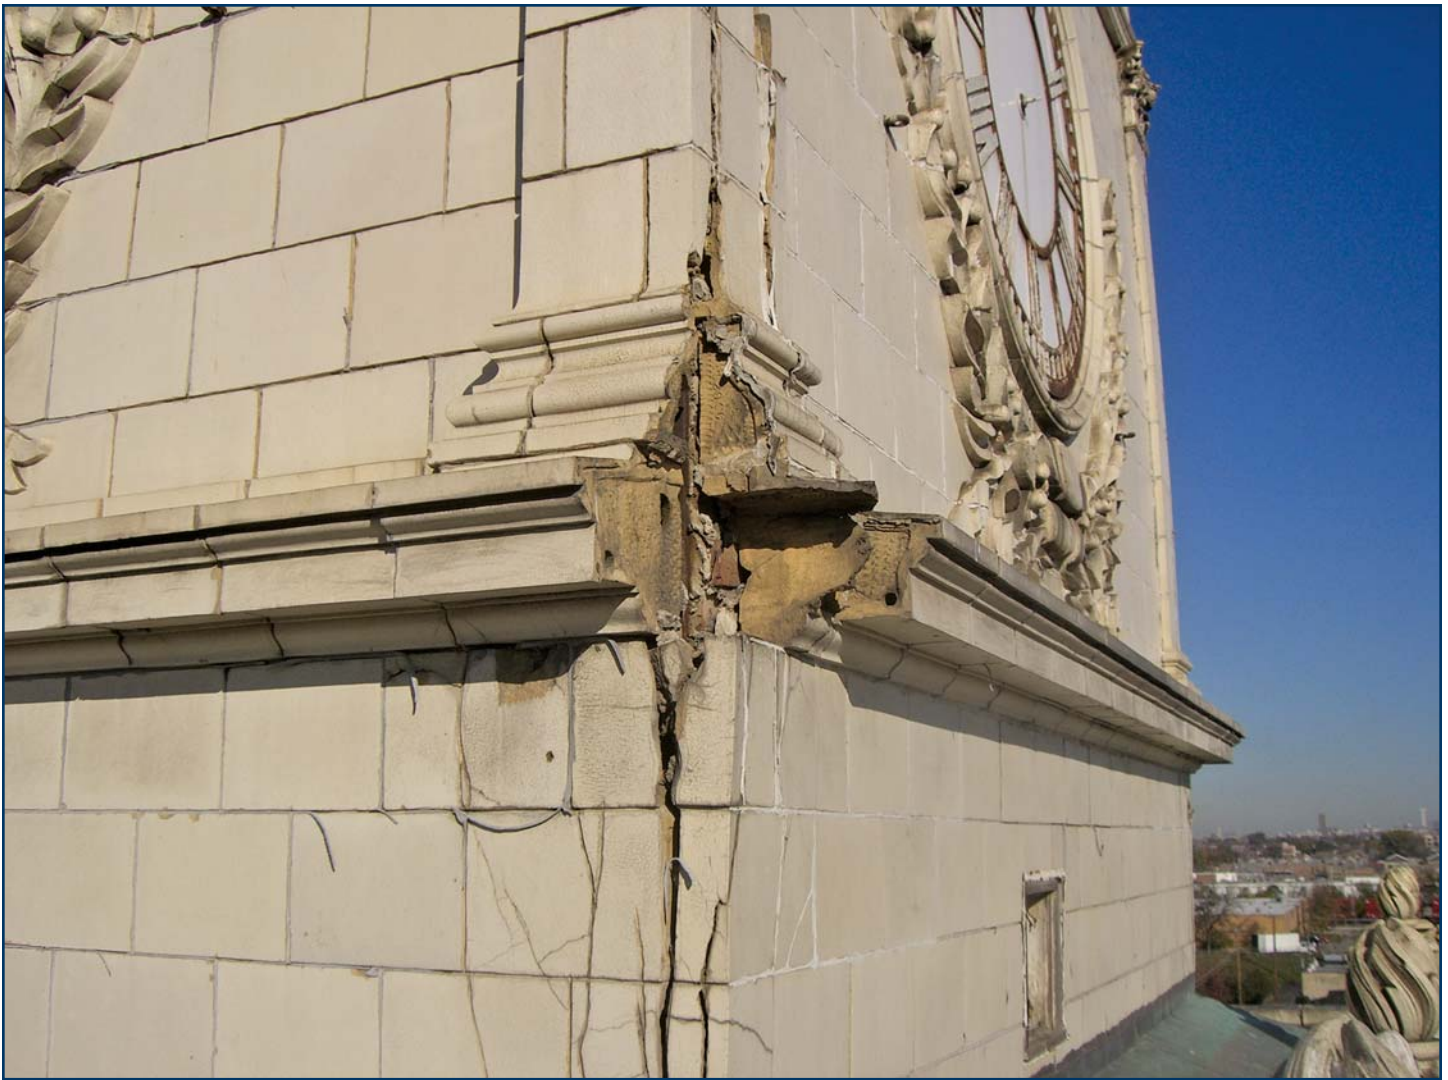
Figure 3 – Distress of masonry cladding resulting from corrosion of embedded steel structure.

The corrosion of exposed iron has long been recognized as a potential problem. The incorporation of iron into masonry construction and subsequent corrosion-related distress have resulted in dramatic changes in the construction and detailing of cladding systems to address water infiltration and corrosion. (See Figure 3.)

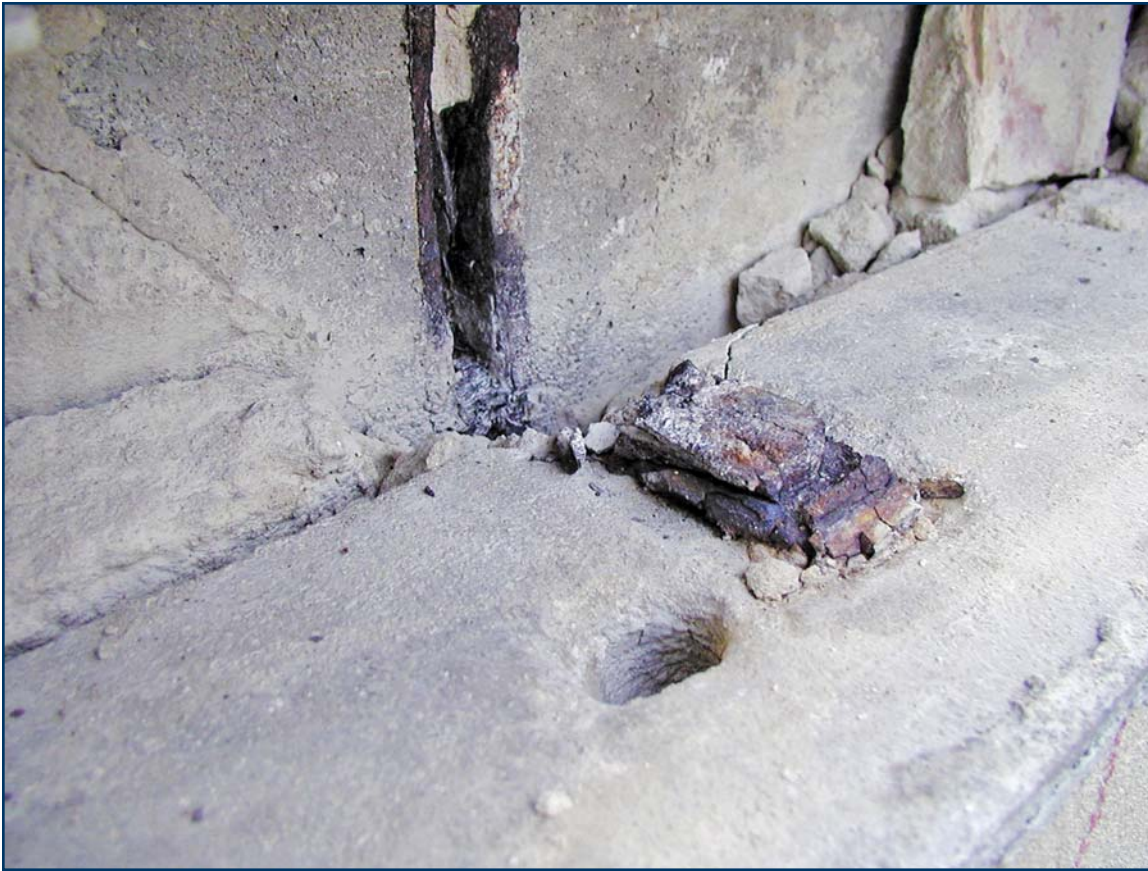
Figure 8 – Complete loss of lateral anchorage.

The deterioration of lateral anchorage within a wall system may be difficult to detect, particularly if the anchors are light-gauge straps that can disintegrate without causing externally visible distress, such as cracking or displacement. The most reliable method for evaluating the condition of these lateral anchors is by direct observation of representative anchors in areas with and without apparent external distress (Figure 8).

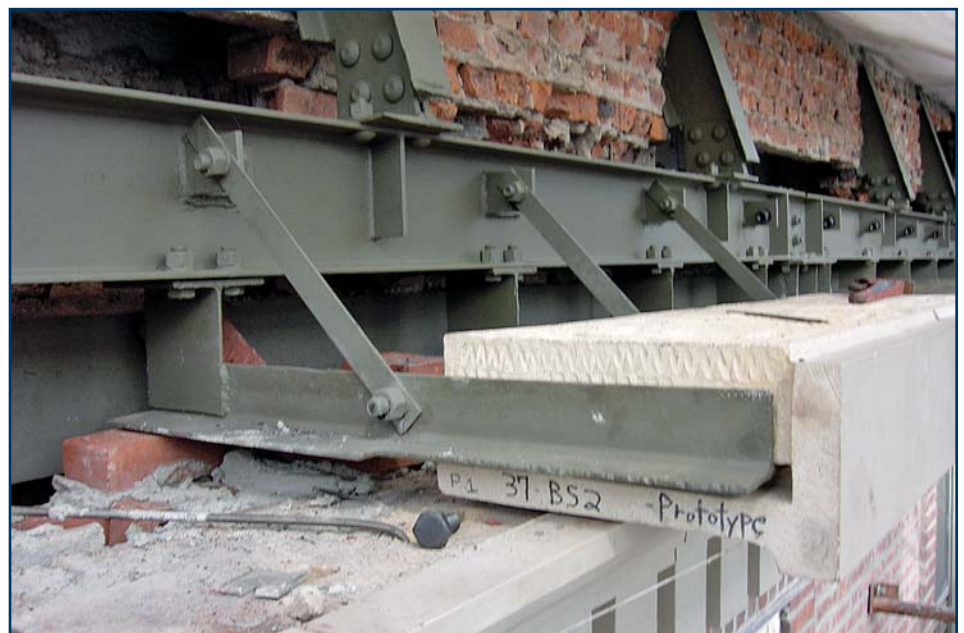
Figure 11 – Coating of existing steel support with corrosion-inhibiting system.

ate corrosion, cleaning and painting of the existing steel with a corrosion-inhibiting system (zinc, urethanes, and epoxies) can be an effective repair (Figure 11). In some cases, severely corroded areas can be widespread or directly adjacent to relatively intact areas, requiring either localized repairs or replacement of the piece.

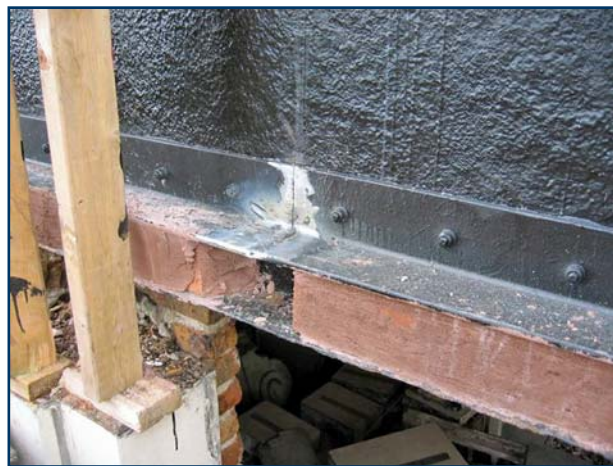
Figure 12A and 12B - Representative example of steel reinforcement.

Bolting of new pieces of steel to existing steel is the most straightforward method of repair (Figures 12A and 12B). This can be expensive, since access necessary to install the nut at the back of the bolt often requires removal of additional backup materials. Several new anchors that are conceptually similar to pop rivets have been introduced within the past decade to permit one-sided installation and eliminate the need to access both sides of the member.

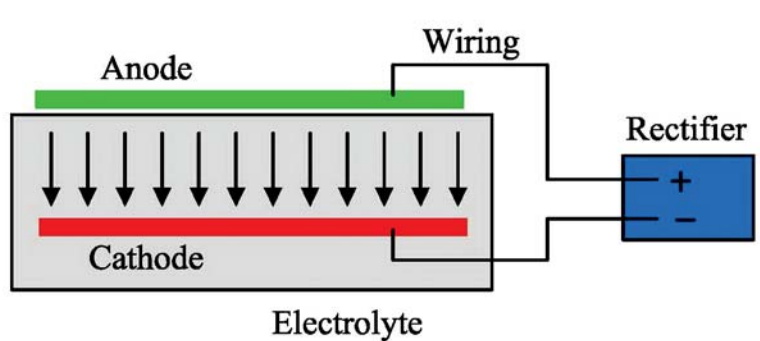
Figure 14 – Impressed-current system.

The corrosion process of a metal can be effectively halted by providing sufficient electrons to the anode to reverse the reactions at the anode and cathode (corroding steel). Early construction-related applications were used to protect subgrade piping in the 1920s. Prior to that, applications were limited to marine structures. Two systems exist as illustrated above. The galvanic system is an obvious outgrowth of the understanding of galvanic interaction between dissimilar metals (Figure 13) and uses the natural process of the galvanic interaction to protect the embedded steel. More recently, and for larger applications, impressed current systems are more appropriate (Figure 14). These electrochemical techniques, such as cathodic protection, have proven effective in parking garage installations and have been implemented on cladding systems in Europe within the past

30 years. Cathodic protection systems are theoretically capable of stopping corrosion, but they cannot reverse the corrosion process. Extensive evaluation of existing conditions, conductivity, and continuity is necessary to determine practicality of installing an effective cathodic protection system.
