# BUILDING ENVELOPE TECHNOLOGY SYMPOSIUM

## HIDDEN HOLES IN WOOD-FRAMED BALCONY WATERPROOFING

**ROCCO ROMERO, RA**

*WISS, JANNEY, ELSTNER ASSOCIATES, INC.*

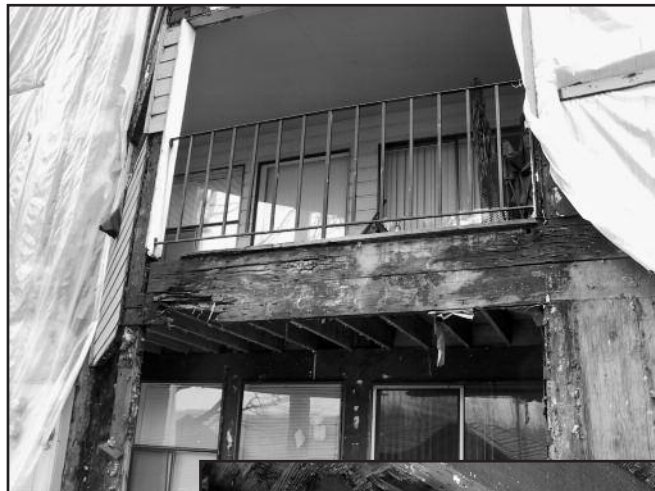
Figure 1

When the integrity of the waterproofing membrane system is compromised, there can be obvious signs of water intrusion and deterioration of the deck structure, such as water stains on soffits directly below the deck and “soft spots” on the walking area of the deck surface. However, substantial damage to the structure is sometimes hidden beneath the cladding (*Figures 1 and 2*).

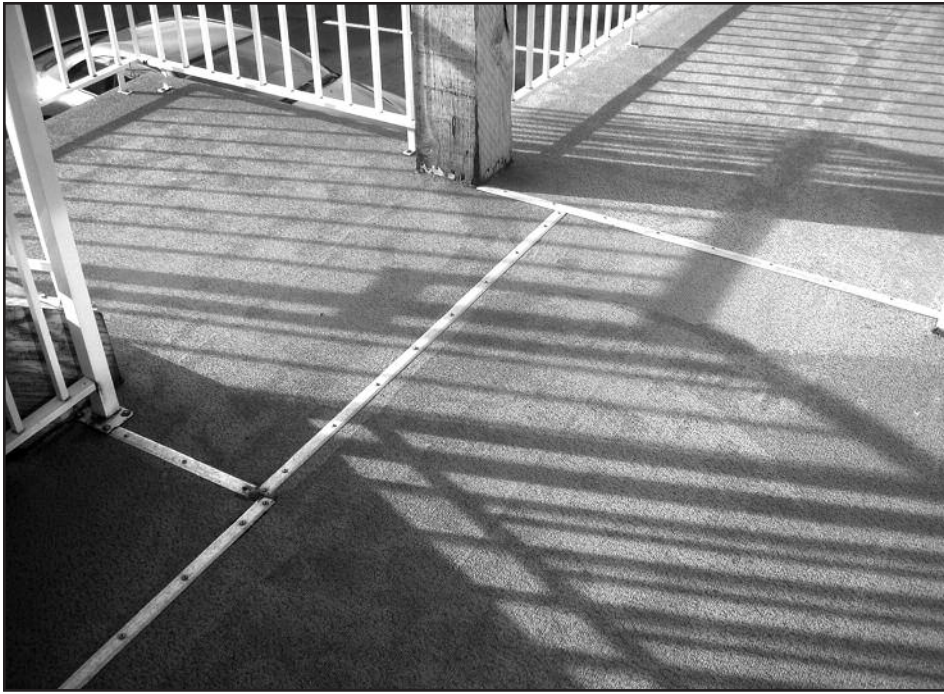
**Figure 3**

at approximately 6-in on-center intervals. It was at these penetrations that leakage was occurring.

leakage, a single-ply membrane had laps located transverse and sometimes parallel to the slope of the deck. It was readily determined that in an apparent attempt to protect the seams from foot traffic, metal cover strips (similar to termination bars) were fastened through the horizontal surface of the membrane (*Figure 3*) into the plywood substrate, resulting in membrane penetrations

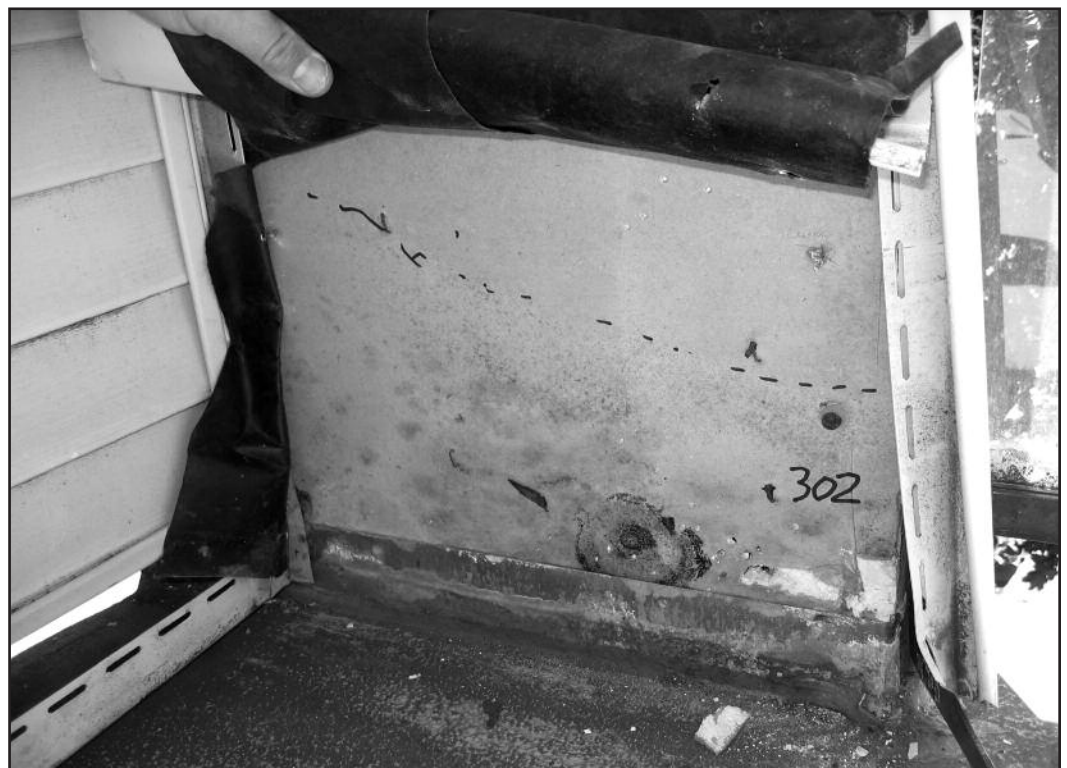
**Figure 4**

Base-of-wall flashings are often covered by the subsequent cladding of the guardrail walls. Removal of the cladding and weather-resistive barrier (building paper) can provide initial indications to the origins of the water intrusion source. For instance, water stains on sheathing that originate near the base of the wall are signs of failed flashing (Figure 4) as depicted by water wicking upward at the sheathing.

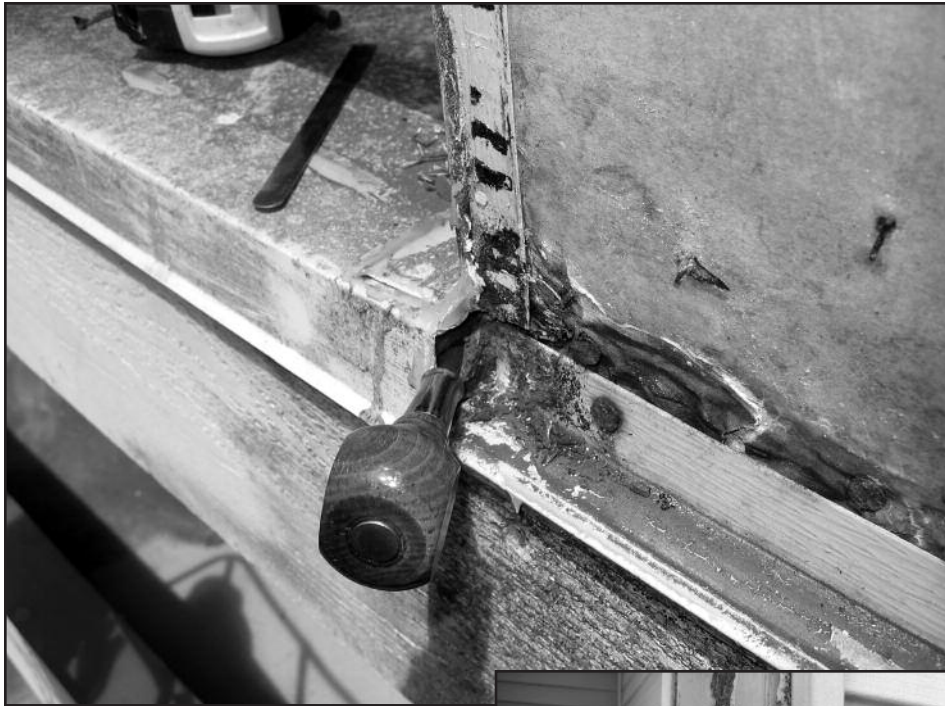
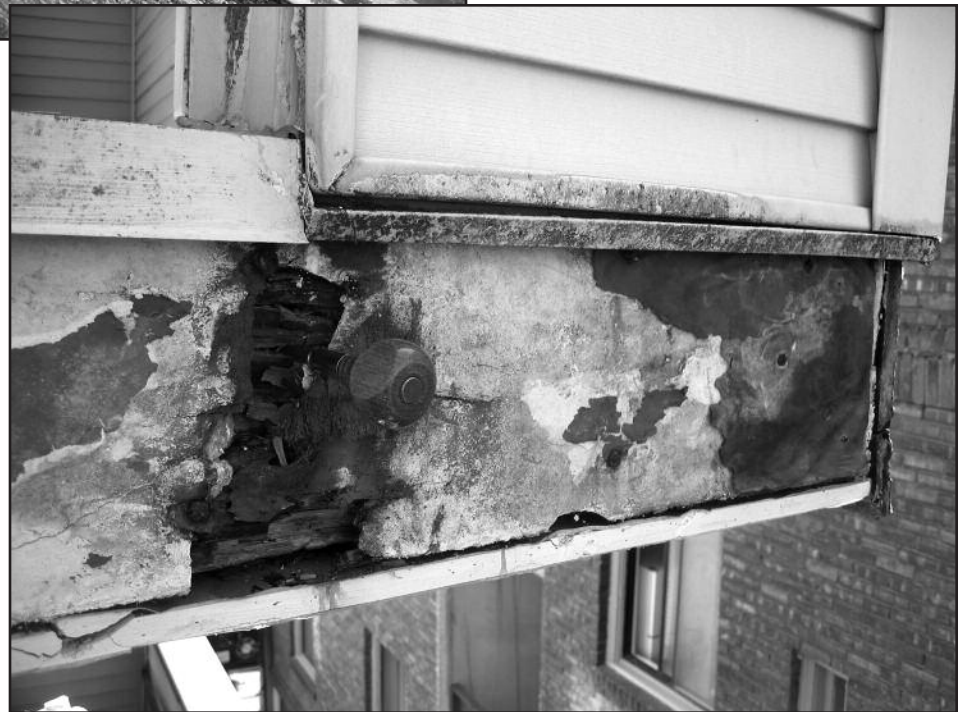
flashings are commonly used in fluid-applied elastomeric membrane applications. Where gaps or discontinuities occur in transitions between flashing components (Figures 5 and 6), water intrusion can occur. These discontinuities are often the result of lack of coordination in work performed by different trades, such as the waterproofing subcontractor installing the membrane flashing on the outside edge of the deck and the siding subcontractor installing the drip flashing at the adjacent wood fascia trim.

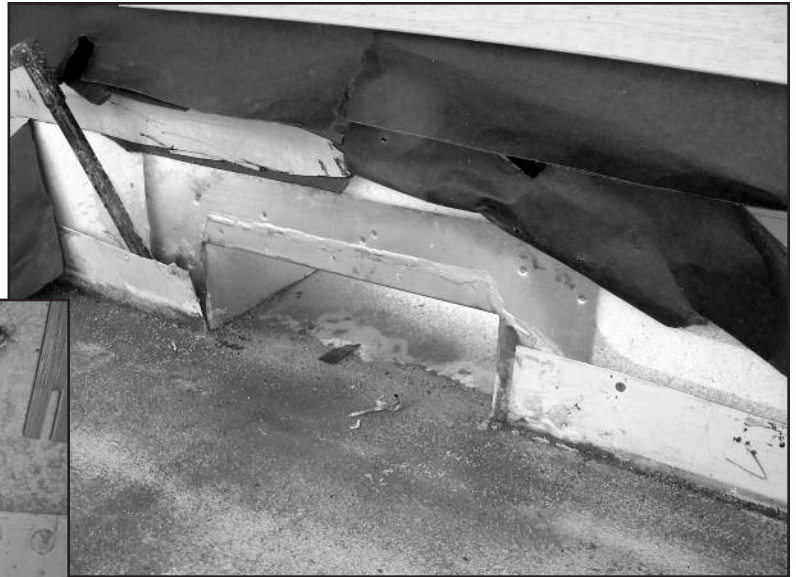
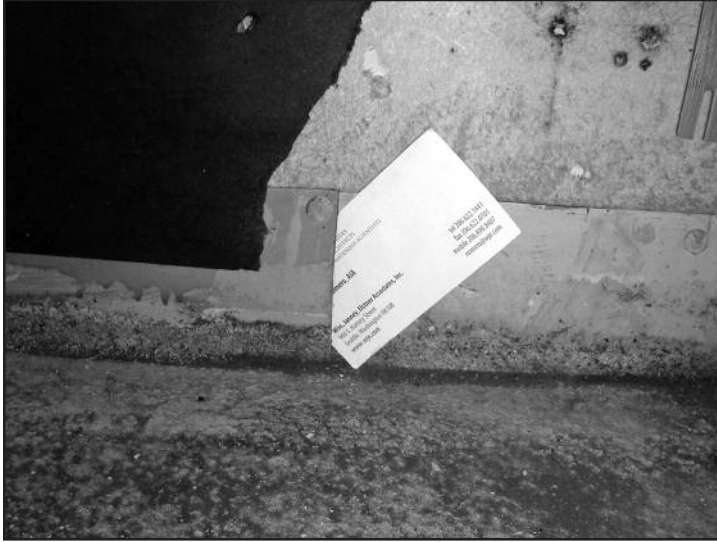
complete and successful membrane system. At sheet metal base-of-wall flashings, the metal work should be installed in sequence, following the slope of the deck from the low point to high point. Laps should be installed in a shingled manner so that the flow of water sheds over the laps. The waterproofing membrane should be installed prior to the cladding so that the membrane can be continuously applied vertically onto the sheet metal base-of-wall flashing, providing an additional seal at the sheet metal laps. Failure to follow this sequence can result in gaps at the flashing laps (Figures 7 and 8) and subsequent water leakage.

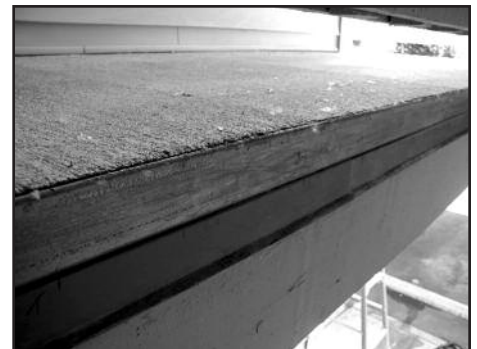
Figure 9

At the outside edges of the walkway, L-shaped galvanized metal edge strips are sometimes used as a permanent border of the deck construction to aid in the initial placement of the concrete wearing course (Figure 9). Problems can arise, however, when these edge strips are incorporated as part of the waterproofing membrane system.

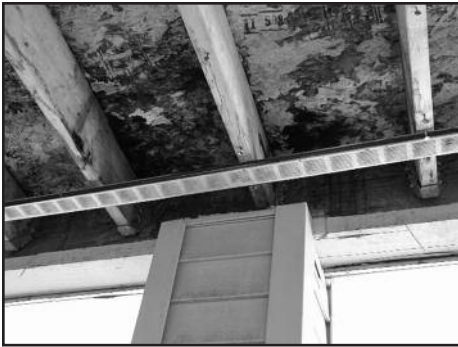
**Figure 10**

In a covered membrane application, the membrane cannot be exposed at the outside edge of the deck construction where the membrane terminates. If the waterproofing membrane is sealed to the top of the horizontal leg of the edge metal, water cannot readily exit the waterproofing membrane layer and can result in corrosion of the edge metal. Although a properly installed membrane can withstand the hydrostatic pressure of the trapped water, water can infiltrate underneath the membrane if the membrane is not well bonded to the metal flashing, causing localized water leakage

and deterioration of the deck construction (Figure 10). In addition, long-term membrane bond to the edge metal can be affected by the corrosion on the edge metal.

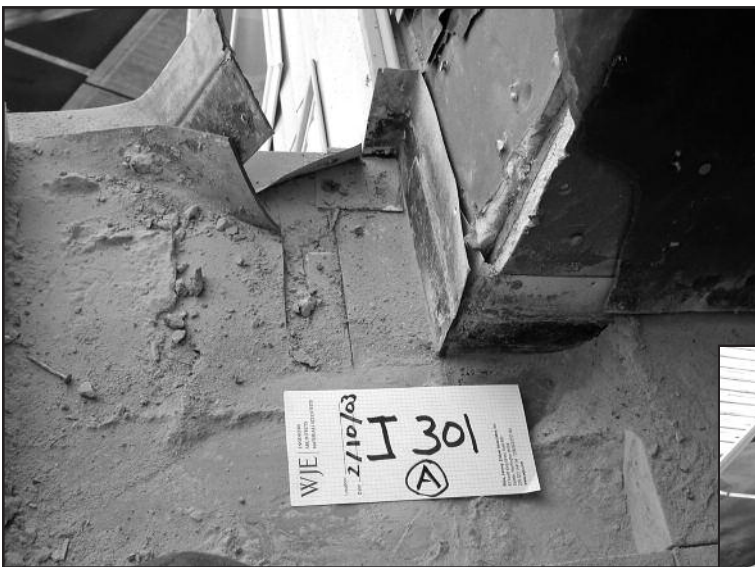
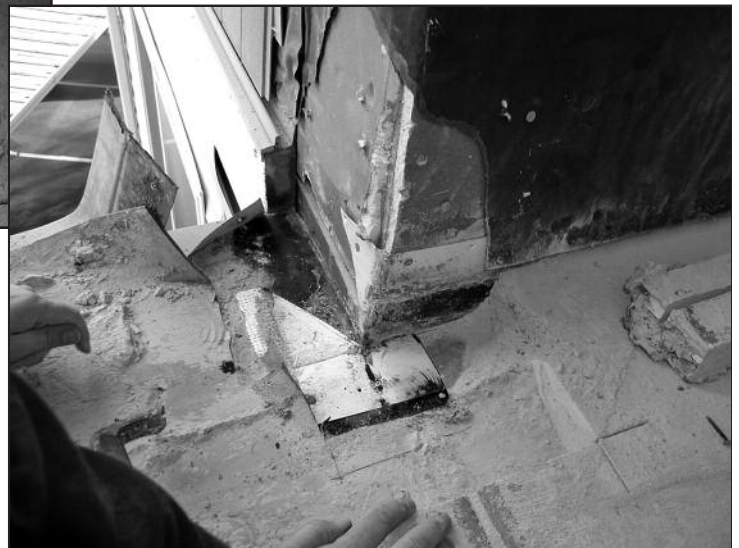
At corners where the application of sheet metal flashing components requires them to be cut and pieced together, laps and discontinuities must be completely sealed. Sheet metal flashing at corners are often poorly field-fabricated, creating holes at the apex of the cuts (Figures 11 and 12). Discontinuities in the sheet metal flashing, coupled with unsealed laps, can result in water intrusion under the membrane, contributing to the decay and deterioration of the deck structure.

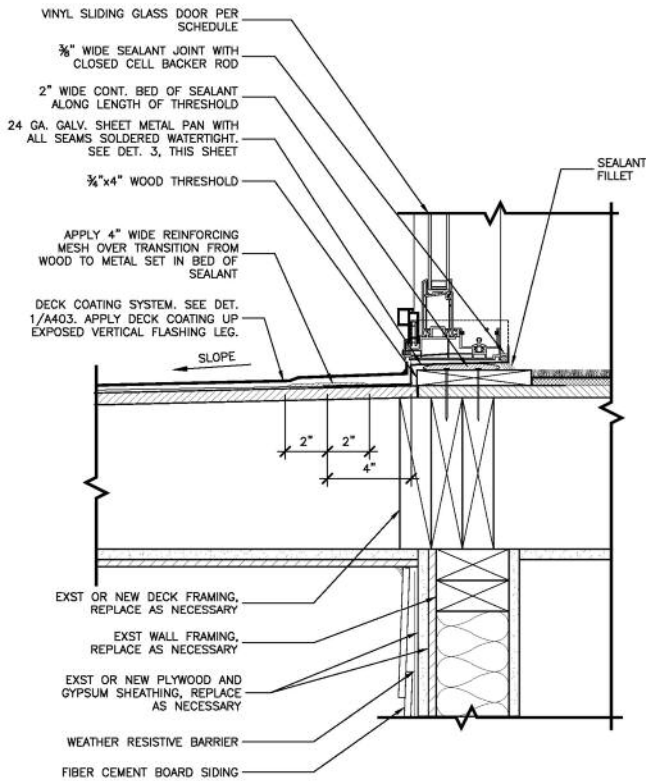
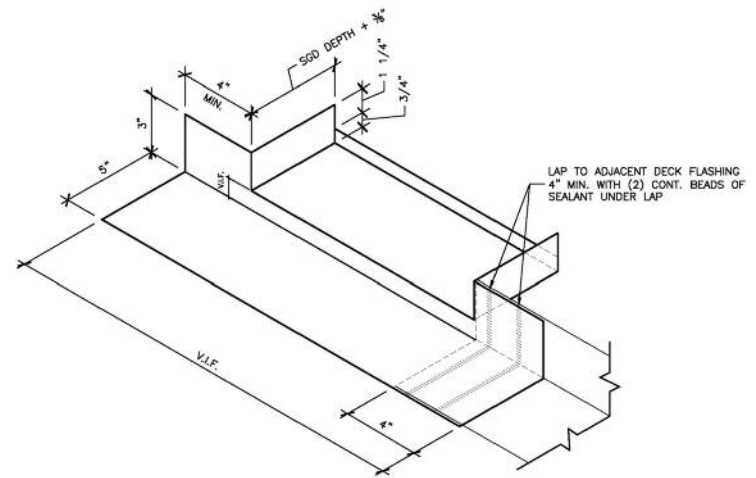
panels that are integrated with the waterproofing membrane and adjacent sheet metal flashing components (Figures 13 and 14). Where the door sets in the horizontal portion of the door pan, the pan should not be penetrated by threshold fasteners, as this defeats the purpose of installing a supplemental, watertight flashing component. Side laps in adjacent sheet metal flashing components must be adequately sealed with several beads of sealant that are transverse to the laps to make the flashing watertight prior to application of the waterproofing membrane. Sealant used in metal work that may be in contact with the waterproofing membrane must be compatible with the membrane.

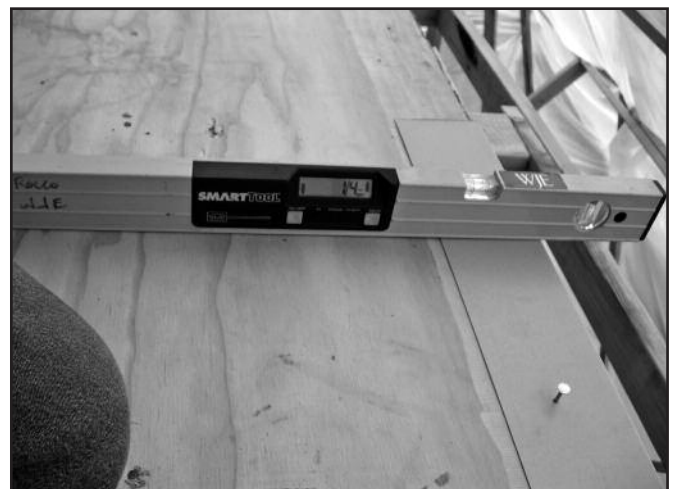
Figure 15

edge of the wood deck should be sufficiently planed so that the installed metal-drip flashing is slightly recessed and the membrane application does not build up at the transition to the deck-edge metal and inhibit drainage (Figure 15). If this condition is not sufficiently addressed, water may collect on the membrane at the deck edge. Sheet metal flashings should always be installed in shingle fashion, in a manner that sheds the flow of water so that it is not directed into laps.

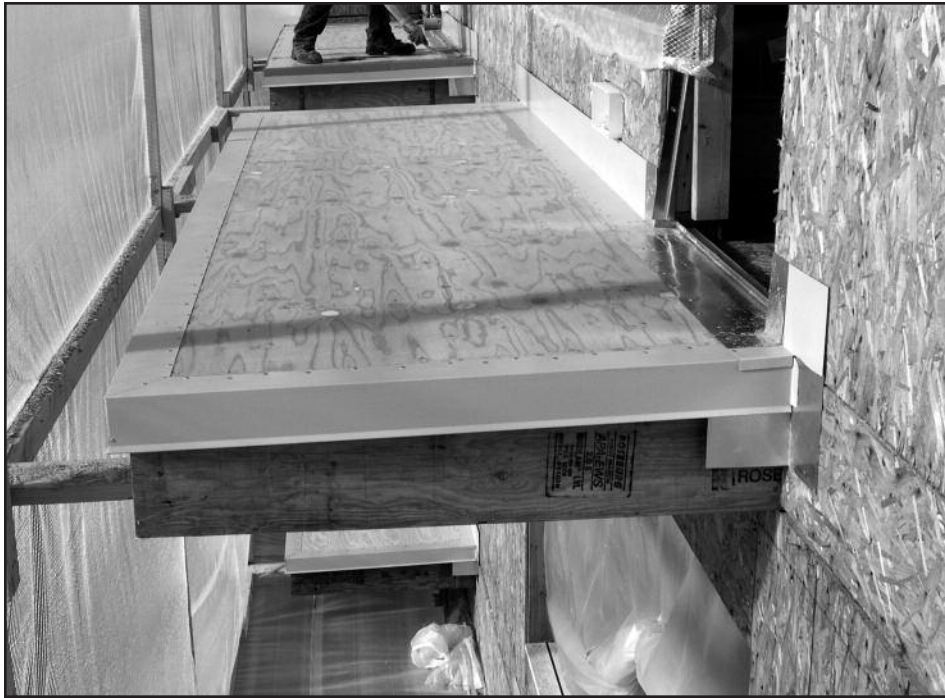
**Figure 16**

Base-of-wall flashing should be installed to a height of 6 in minimum, with laps sealed with several beads of sealant applied transverse to the lap. The flashing should be installed well in advance of the

installation of the weather-resistive barrier on the building walls (Figure 16). This sequencing allows the waterproofing membrane to be applied onto the vertical portion of the metal flashing, thus providing a redundant seal at the flashing laps. This sequencing can be tricky, as it requires coordination of the work of other trades that are likely on site performing work at the same time.

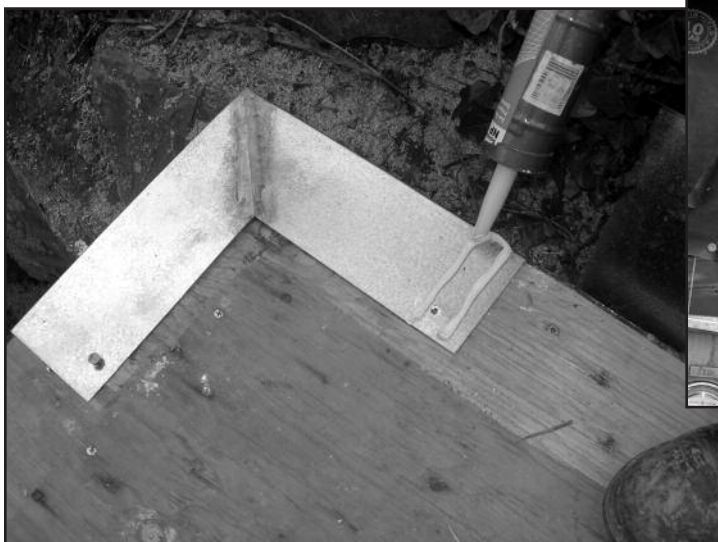
**Figure 17**

At the outside edge of balconies, one-component sheet metal flashings (Figure 17) provide a watertight transition at this critical area. At deck-to-wall transitions on outside building corners, flanges should be provided for integration with the waterproofing membrane and for integration with the weather-resistive barrier on the building wall (Figure 18). This detail helps create a watertight transition at the corner, which is otherwise susceptible to leakage.

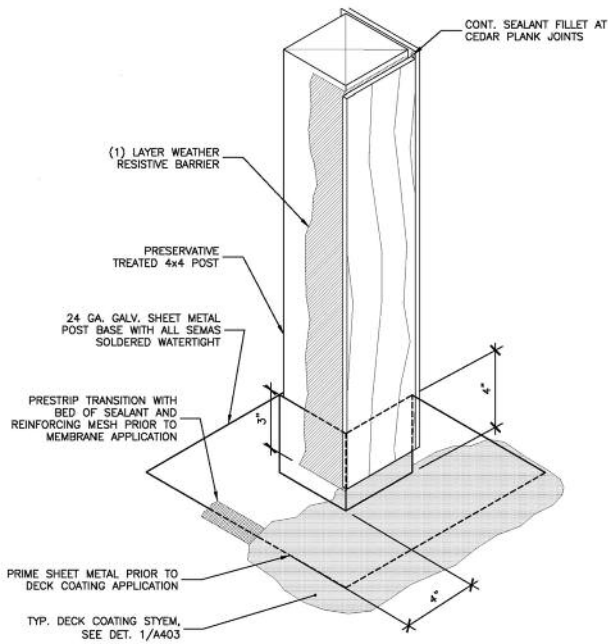
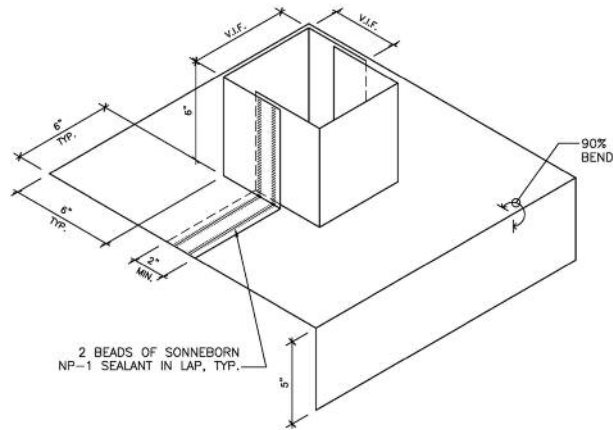
At post locations that penetrate through deck framing to support upper decks, boot flashings should be fabricated and installed as separate one-component sheet metal

flashings that fit together around the base of the post (Figure 19). As a part of proper installation sequencing, the post should be wrapped with a weather-resistant barrier that laps over the vertical leg of the sheet metal boot flashing and the post subsequently clad with wood siding. This detailing allows the membrane to have a consistent substrate at the horizontal-to-vertical transition. In addition, if water enters the post cladding, the weather-resistant barrier will direct the water over the metal boot flashing and safely onto the surface of the deck waterproofing membrane.

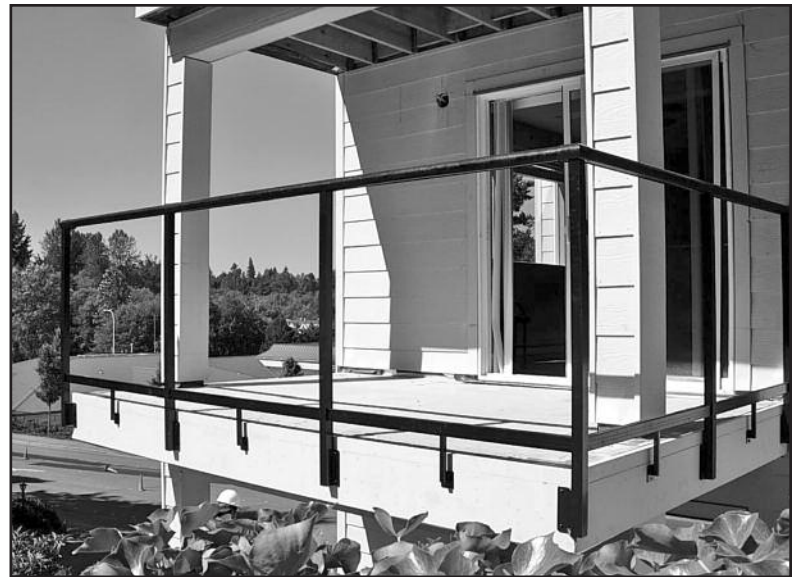
Figure 20

should be avoided since it is difficult to make the anchor penetrations watertight. Even if watertight initially, sealants used at the base plates will require routine maintenance. A more serviceable approach to railing attachment is to design the deck for railing post anchorage at the vertical edge of the deck (Figure 20). Anchorage of the railing at this location does not compromise the integrity of the waterproofing membrane system.
