# ROOF DECKS, A to Z

## Part 3: Structural Clay Tile and Plywood

*This is the third in a series of articles briefly examining various deck types. Among the numerous considerations when selecting a roof system, the type of decking is among the most important. With the variety of decks to be encountered (both new and old), it is incumbent upon roofing experts to be the authorities on these matters. This article will explore features of 1) structural clay tile and 2) plywood.*

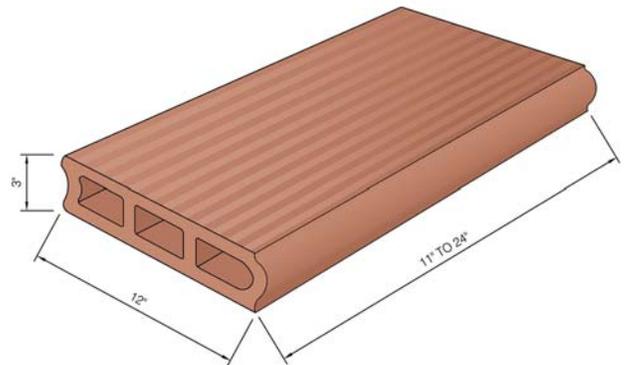
*Figure 2 – Structural clay tile units integrated into cast-in-place concrete on a concrete structure.*

(Figure 2). Most multistory buildings of decades past having this type of roof deck might also have this arrangement as the floor-to-floor construction.

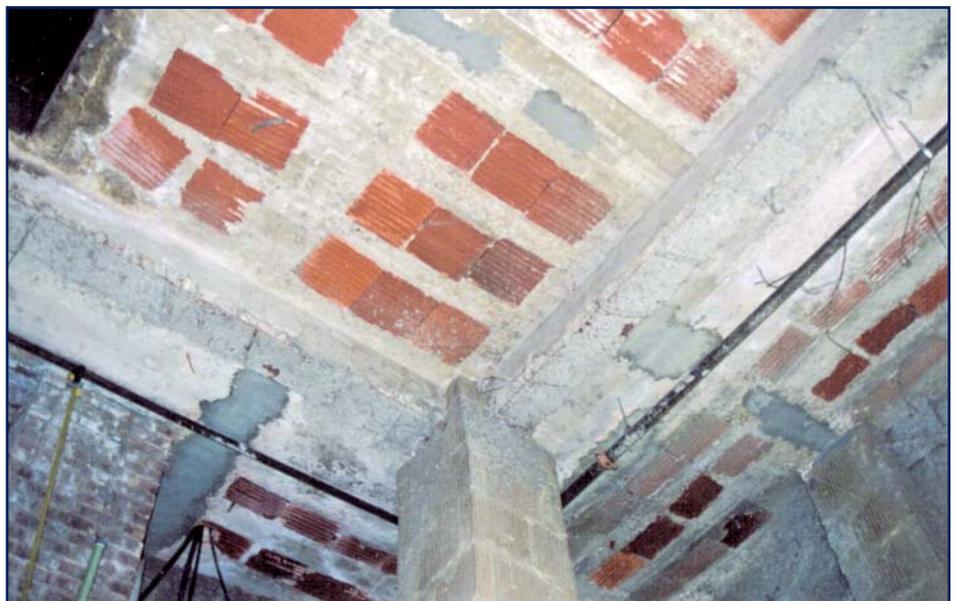
*Figure 1 – With the general appearance of a closed book, these units were popular during the late 1800s and early 1900s.*

Book tile is a form of structural clay tile that was popular during the late 1800s and early 1900s. The name is descriptive of the tile unit itself, which has the general appearance of a closed book, as shown in *Figure 1*. Book tile units were manufactured with concave and convex edges so that they would interlock when laid into position. This shape allowed units to abut one another. A common book tile unit dimension was 3 in thick by 12 in wide, supplied in lengths varying from 11 to 24 in. This thickness weighs approximately 18 pounds per sq ft.

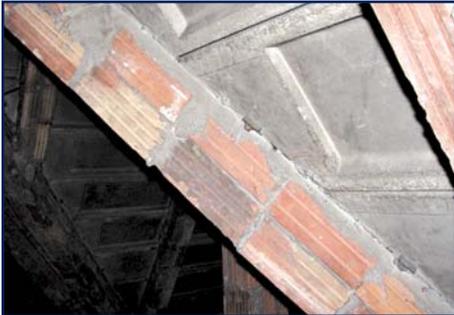
Figure 3 – Clay tile units mortared into place as fire-safing over structural steel in an old attic.

The manufacturing process for structural clay tile typically involved extrusion through a die with individual units cut off at prescribed lengths and then fired in a kiln. In the attics of buildings constructed in the early 1900s, these units were used widely on sloped planes as the roof deck and elsewhere on exposed structural steel as fire safing (Figure 3).

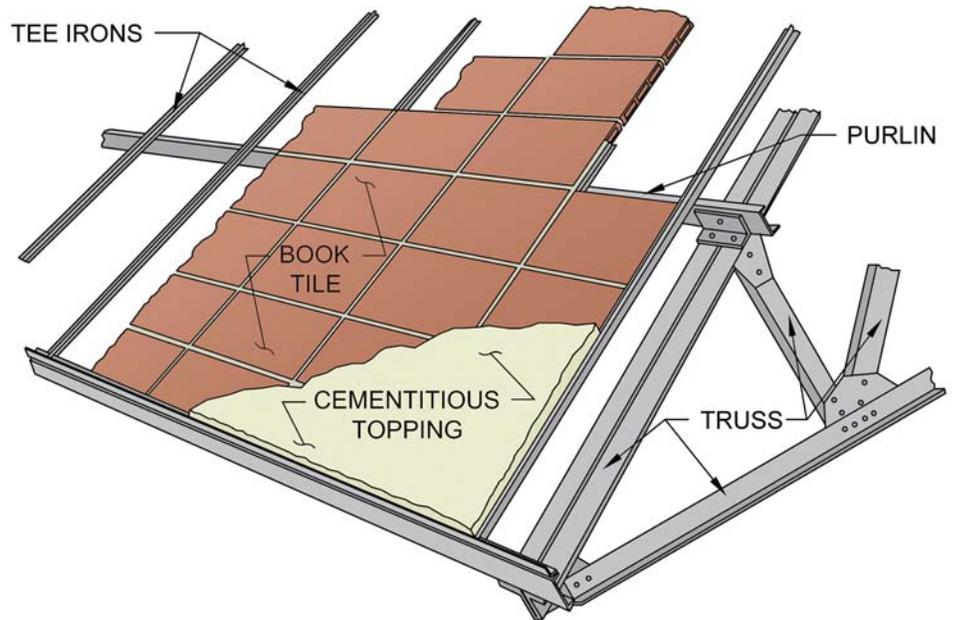
Figure 4 – The common arrangement of tiles nested onto sloped steel framing. Additional mortar would be struck into joints from the roof (top) side.

Book tile units were used for both steep and flat roof decks and were supported on inverted steel tees as shown in Figure 4. Space between the unit ends and the tee stems was filled with mortar. Tiles were sit-

uated over steel purlins spaced over rafters, joists, and trusses. The spaced purlin scheme allowed for quick and easy installation of a deck that was fireproof, and constructing it was not dependent on weather. Structural clay tile units were simply nested within the modules established by the tees, with fastening limited to bedding mortar as the pieces were set with additional mortar struck into the joints from the roof side in order to key the individual pieces together. The top and bottom surfaces of tiles usually had a rough texture so that a mortar-topping slab could be bonded on the top and a plaster finish adhered to the bottom side, if desired.

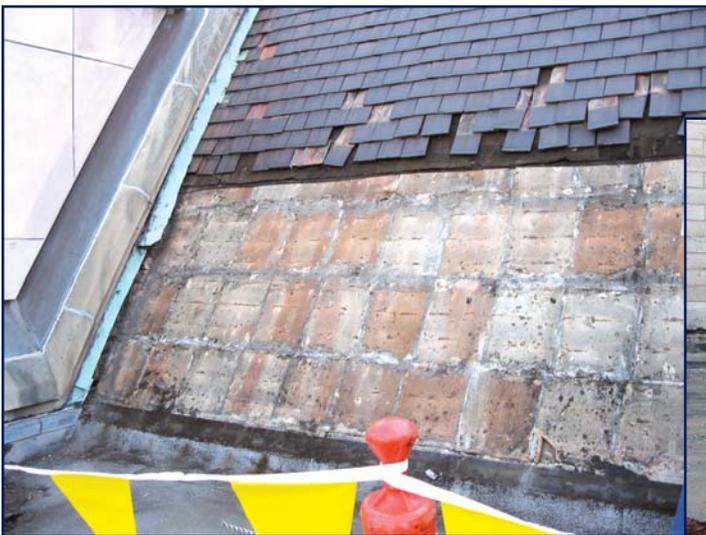
Figure 5 – Tile covering on clay tile deck on a vintage pitched roof.

able substrate for slate, copper, or roofing tile (Figure 5). Other variations could be structural tiles and a concrete slurry topping with integrated wood nailers or battens across the roof plane to which slates or tile would be anchored. These same vintage structures might also have tiles cast into the inboard face of parapets (Figure 6).

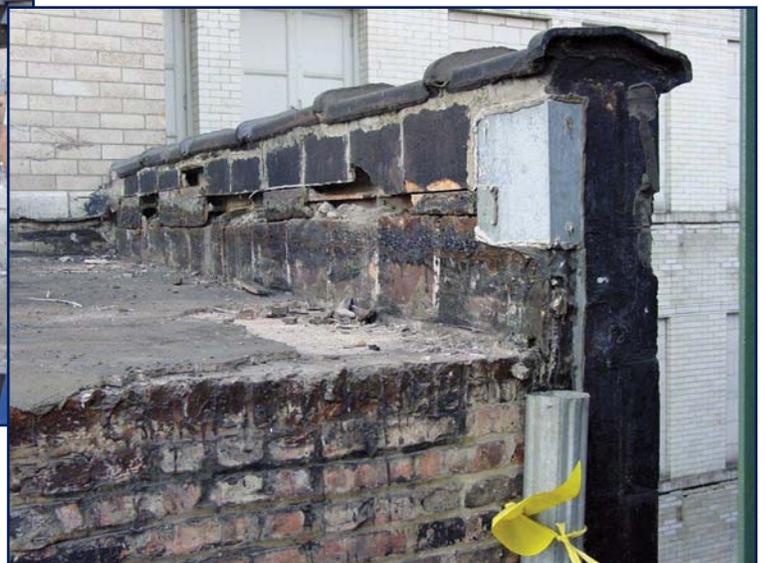
Figure 6 – Tiles cast into the inboard face of a parapet.

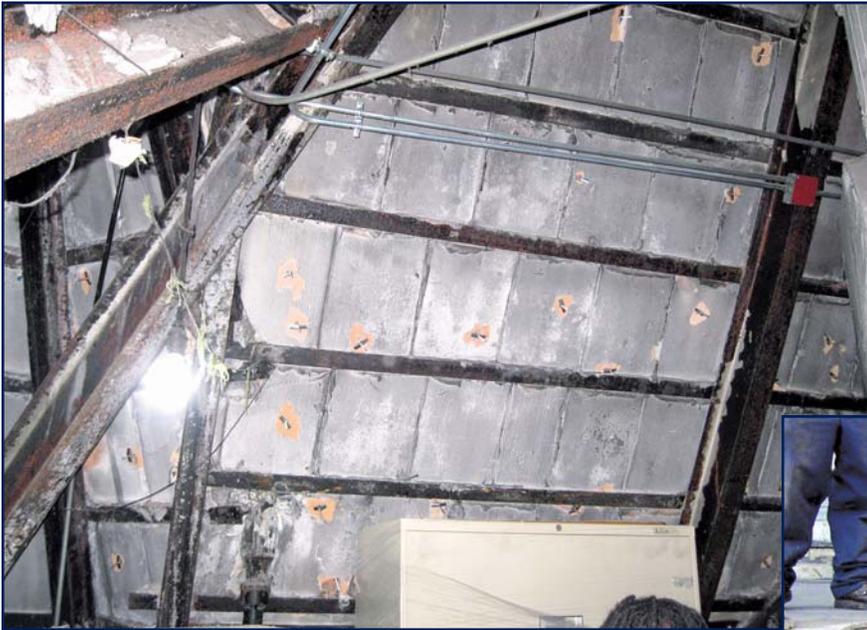
Figure 7 – Attachment of new plywood cladding using toggle bolts.

Low-slope clay tile decks are best suited for adhered or ballasted membrane systems. Mechanical fastening is generally discouraged because drilling and attachment may generate spalls and cracking of the tile. On pitched framing, reroofing can be carried out by attaching wood sheathing over the existing deck using toggle bolts (*Figure 7*) fitted

with stress plates. Low-rise foam adhesive can also be used to embellish this securement, but dust and any other parting agent would need to be removed for proper bonding.

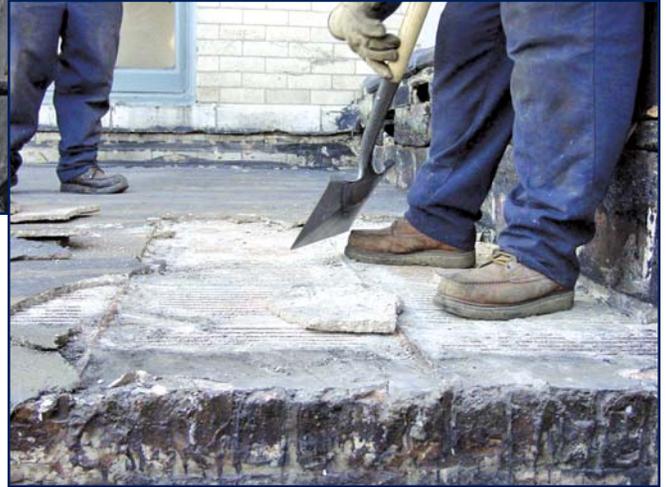
Figure 8 – Delamination and spalling of mortar topping course.

Structural clay tile decks are susceptible to deterioration as well as corrosion of the embedded steel components. Failure of the tees can cause cracking in the tile units, which can allow leakage and further deterioration of the steel components. There is also potential for cracking of the top shell of the units if care is not exercised during removal and installation of the roof system. Less serious but equally important issues are delamination and spalling of the mortar topping from the top surface of tile units (Figure 8). Hammer-sounding the surface—or removing a test square before proceeding with full-scale tear-off—is a prudent step.

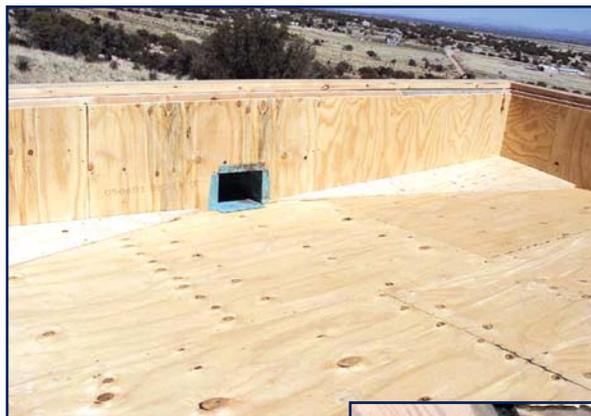
Figure 9 – Crickets/saddles can be crafted with plywood to effectively divert water.

In any event, plywood is perhaps the purest example of a “nailable” roof deck. It shares this attribute with oriented strand board (OSB), which has enjoyed great popularity over the past two decades as a substitute for plywood. But OSB is different enough to be considered in a separate article in this series. Meanwhile, although enjoying most of the residential roof deck market, plywood is certainly not limited to that domain. Indeed, western states widely use this substrate for low-slope assemblies, as it is compatible with virtually any type of roof covering. Even crickets/saddles can be crafted with plywood sheathing to effectively divert water (*Figure 9*).

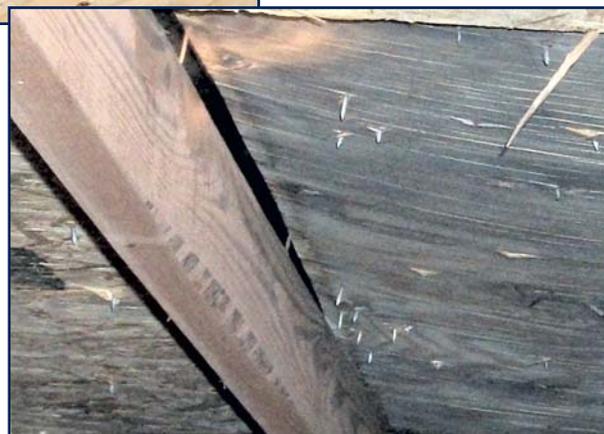
Figure 10 – Permanent distortion from insufficient fastening along edges, likely aggravated by substandard attic ventilation.

Wood products respond to variations in temperature and moisture content by changes in dimension. If no gap is provided between sheets, heat buildup will expand the plywood. Edges cannot go down because of the framing members; they cannot expand laterally because of neighboring sheets; consequently, the only path for expansion is upward. This often results in permanent thermal distortion (*Figure 10*), manifested as deck buckling (*Figure 11*). Aside from attachment deviations, poor attic ventilation is the single greatest cause of surface undulations. With sufficient plenum/attic ventilation and correct span/thickness relationships, virtually all undulations can be avoided.

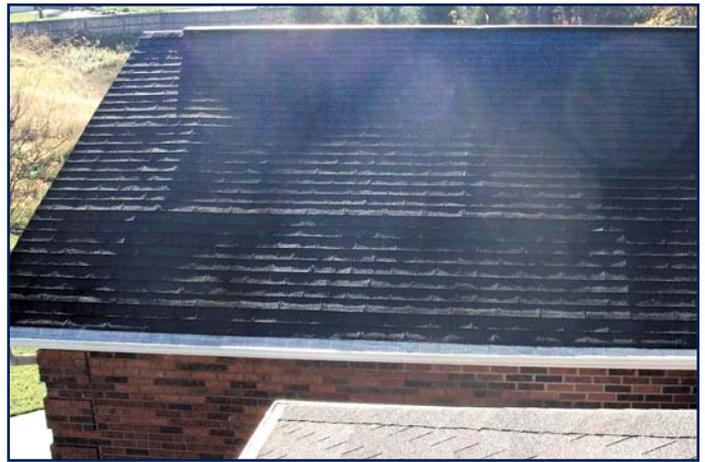
*Figure 11 – Deck buckling from substandard ventilation, improper attachment along panel edges, or failure to provide space between sheets.*

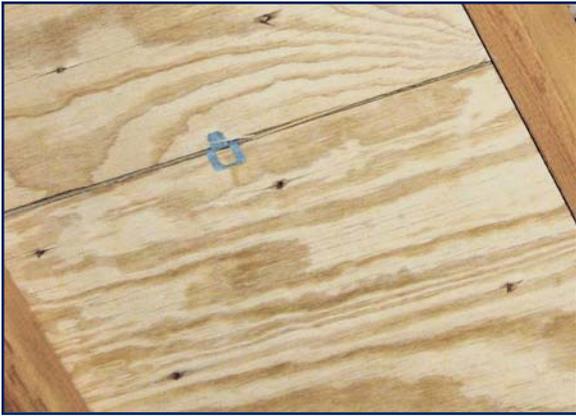
*Figure 12 – H-clips (panel edge clips) reduce the effective spacing of framing members, better distributing loads to adjacent panels.*

Formed metal “H-clips” (also called panel edge clips) should be used in most instances of plywood deck construction (*Figure 12*). Contrary to widely held beliefs, these clips are not intended to be the spacing element between panels, although they provide that incidental function. Instead, clips reduce the effective spacing of framing members; they make the panels stiffer by distributing loads to adjacent sheets, much in the same manner as tongue-and-groove edges do for wood planks.

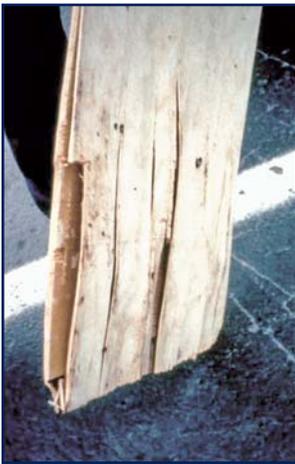
*Figure 13 – Some first-generation FRT products experienced degradation from elevated attic temperature and humidity.*

water-borne salts or fire-retardant chemicals. First-generation FRT products (apparently certain formulations only) experienced degradation from elevated attic temperature and humidity (Figure 13). A behavior termed “ac-

id hydrolysis” could be generated at temperatures of about 130°F—a fairly common environment in the attics of pitched roofs. When hydrolysis was well under way, a sharp reduction in loading capacity could be experienced, sometimes with no outwardly visible distress signal. The remediation of FRT
