BUILDING ENVELOPE TECHNOLOGY SYMPOSIUM

COMMON INSTALLATION PROBLEMS FOR ALUMINUM-FRAMED CURTAIN WALL SYSTEMS

AMY M. PEEVEY, RRO, PE, CDT

BUILDING EXTERIOR SOLUTIONS, LLC

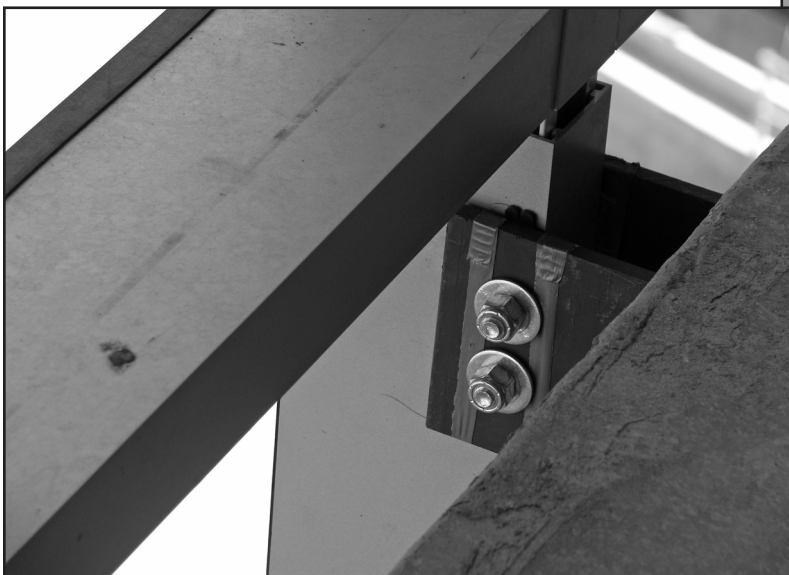
Figure 1 - Dead-load anchors placed less than 1 inch from the interior face of the mullion.

supporting structure (Figures 1 and 2), overshimming of connections (Figure 3), and impromptu “nonengineered structural connections (Figure 4).

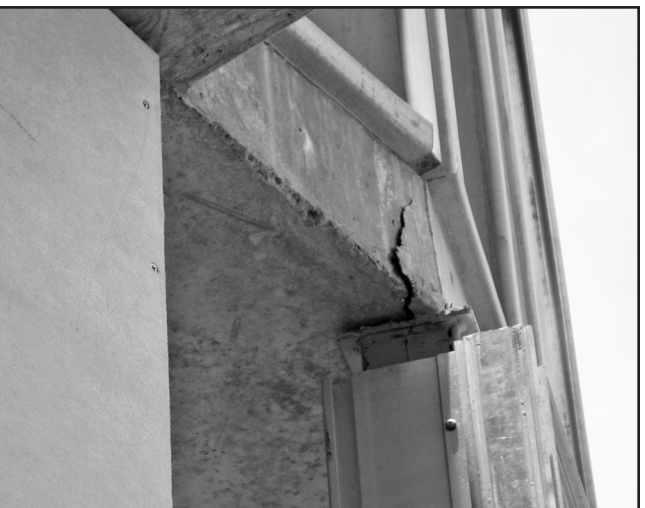
Figure 2 - Concrete distress at mullion-head connection due to lack of adequate edge distance.

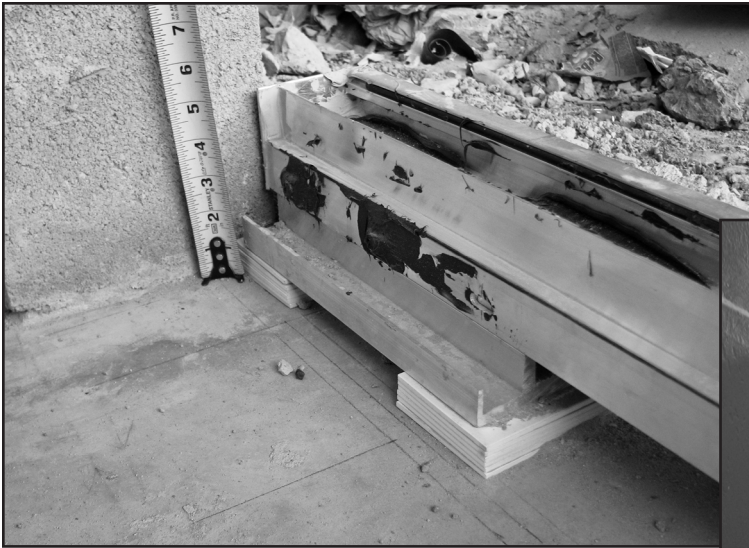
Figure 3 – Excessive shimming at unitized-system starter sill to accommodate concrete tolerances.

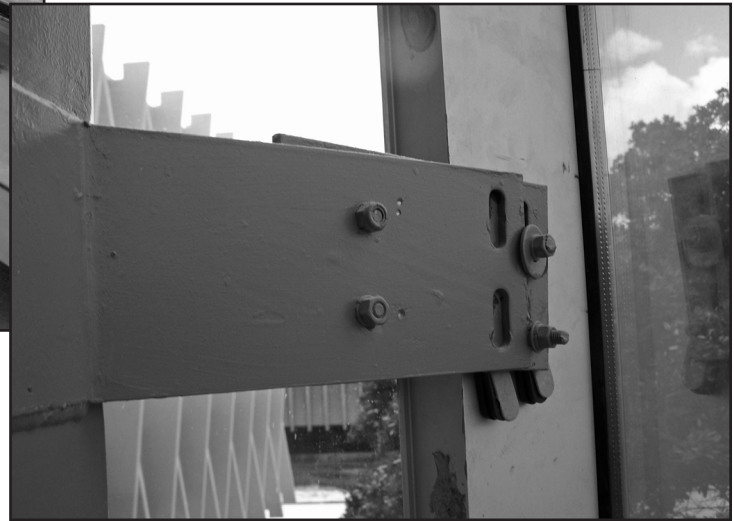
Figure 4 – Improvised wind clip at corner mullion to compensate for out-of-tolerance steel erection.

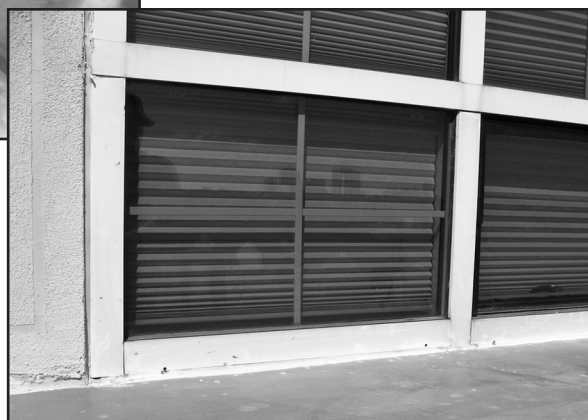
Figure 6 – Perimeter curtain wall sealant installed from adjacent cladding to snap cap of system.

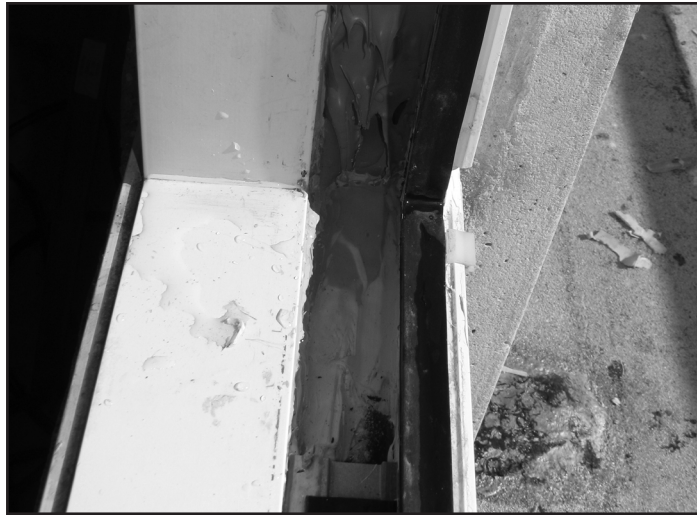
Figure 7A – Excessive sealant placed at the sill-to-mullion joinery.

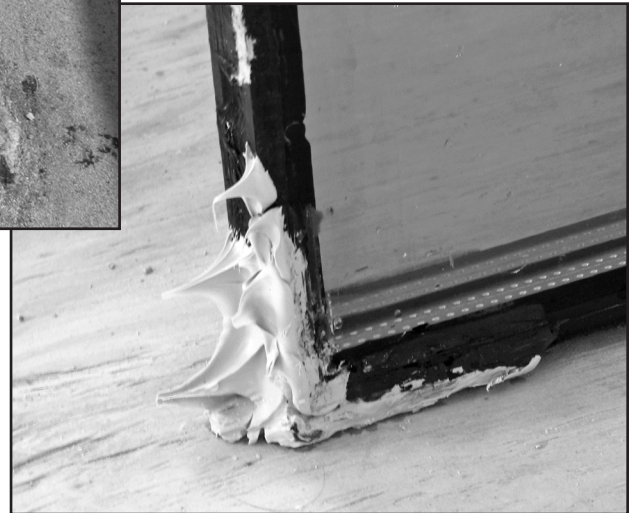
Figure 7B– View of insulated glass-unit corner after deglazing condition shown in Figure 7A.

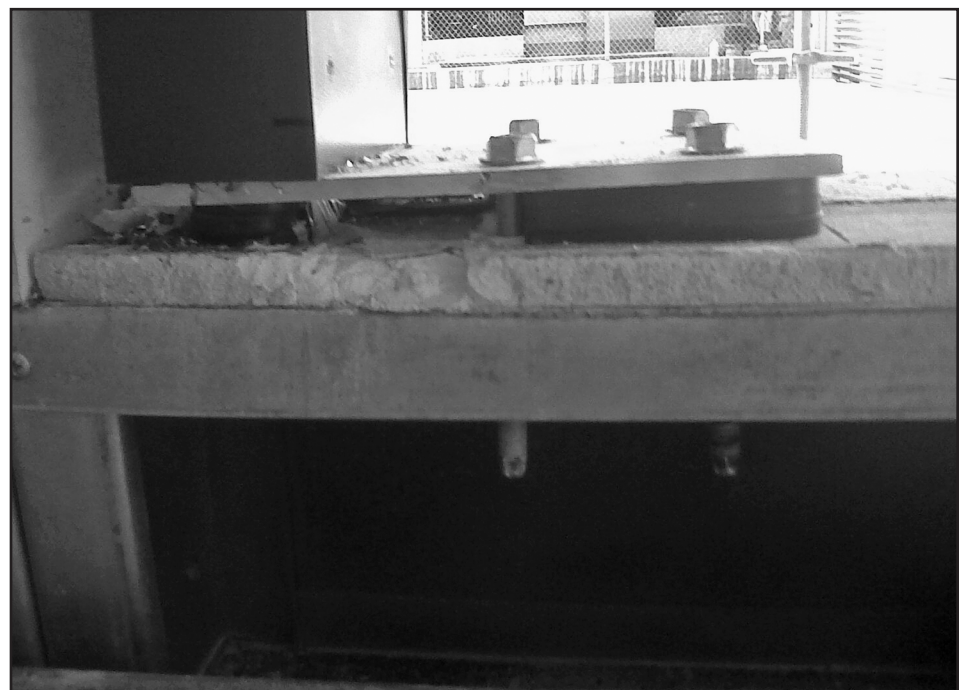
Figure 11 – Curtain wall mullion F bracket installed on gypsum sheathing at sill.

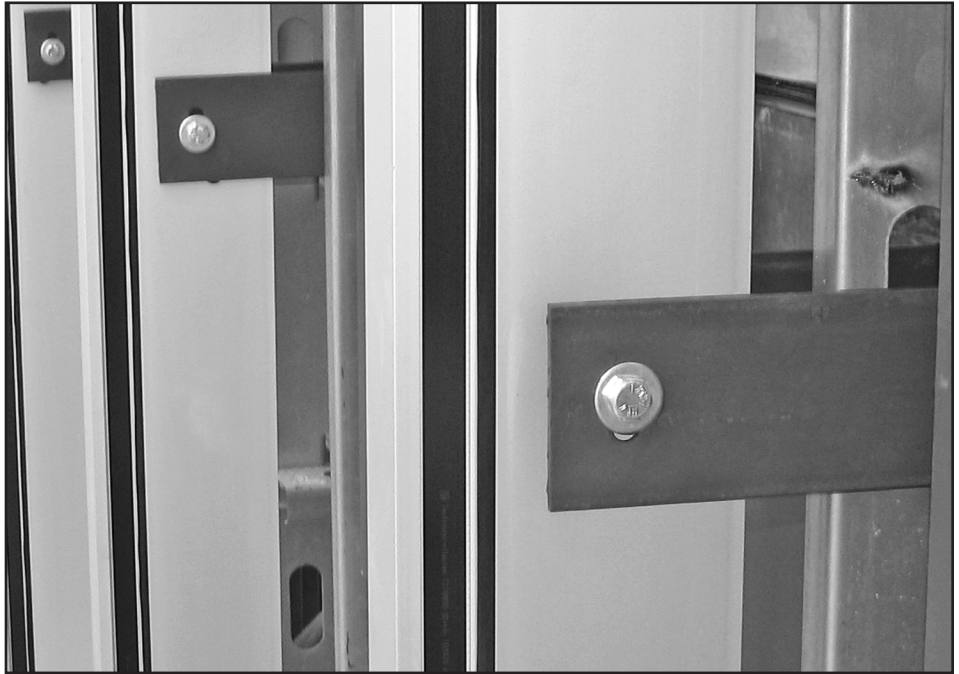
Figure 12 – Two adjacent wind clips, one with anchor at top of the slotted hole and one at base.

supporting structure due to thermal or structural loading. To allow for movement in each direction, the wind clip anchors are to be set centered within the slotted hole. However, in many cases this requirement is simply ignored (*Figure 12*). As a result, the system may bind during loading and result in structural issues, potentially resulting in glass breakage.

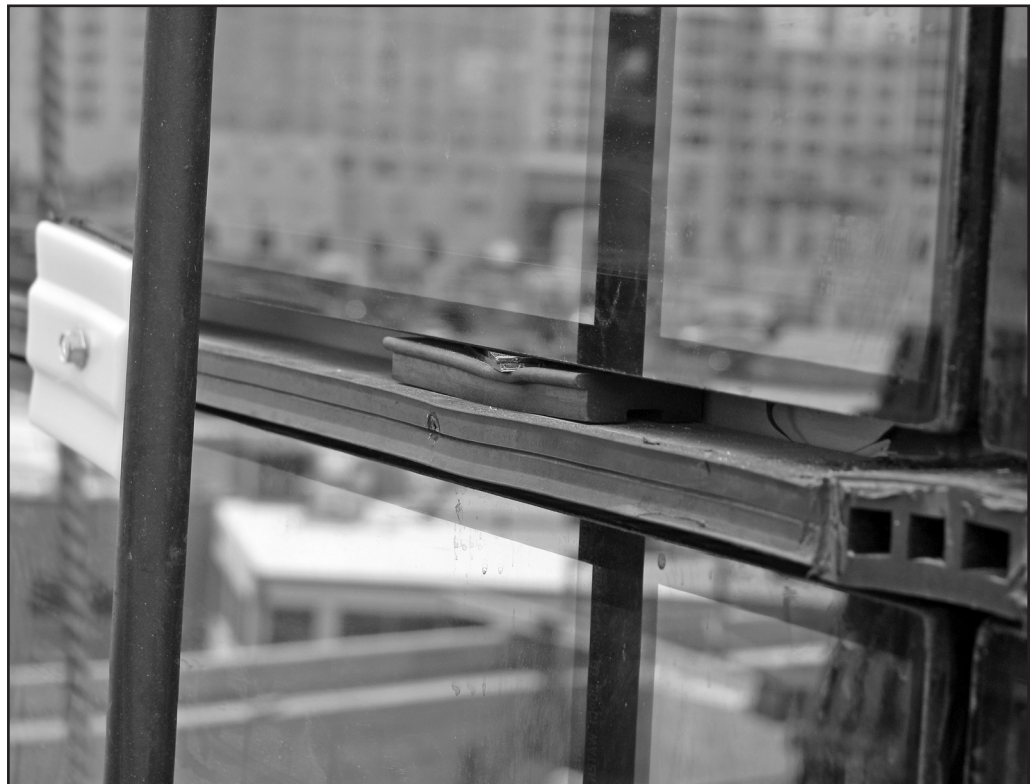
Figure 13 – Placement of shim above setting block.

within the sill track can be obstructed and result in water infiltration to the building interior. Another installer-related installation issue is the use of shims at setting blocks (*Figure 13*). Placement of shims between the setting block and the glass can result in stress concentrations in the glass and cause glass failure.

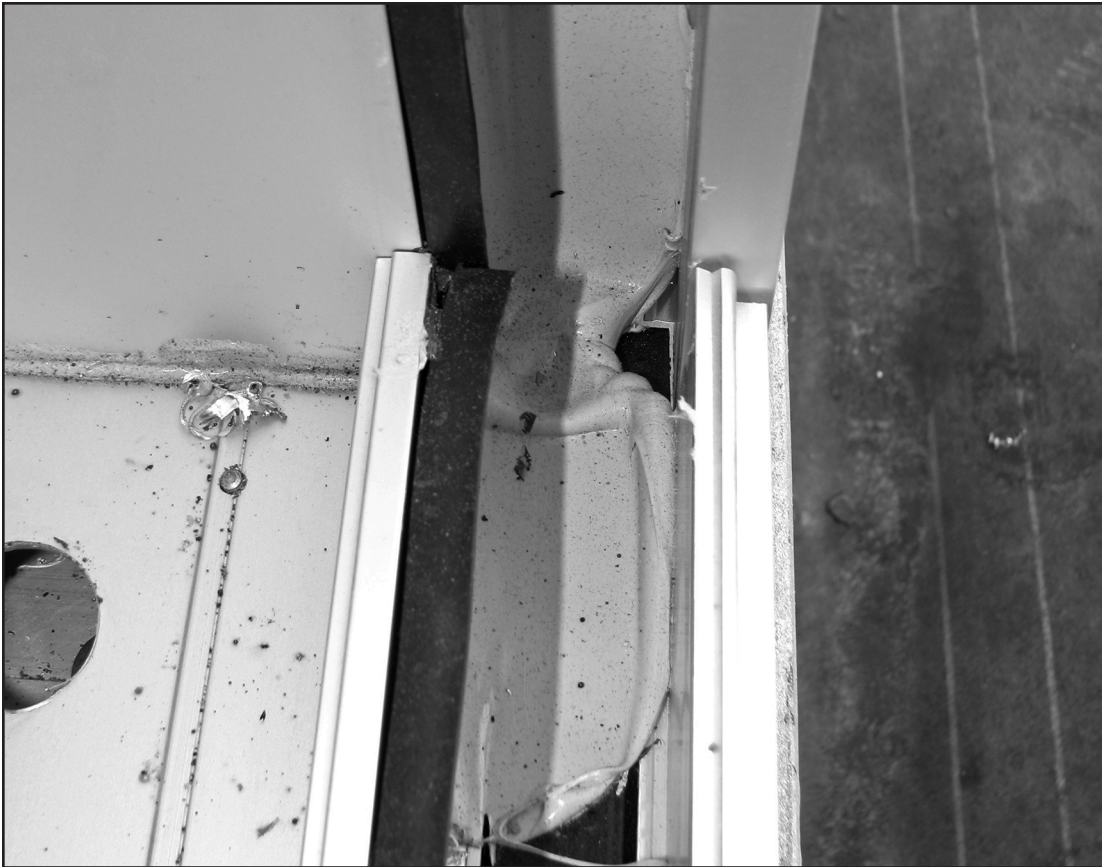
Figure 14 – Improperly tooled sealant at metal-to-metal joinery resulting in a large void.

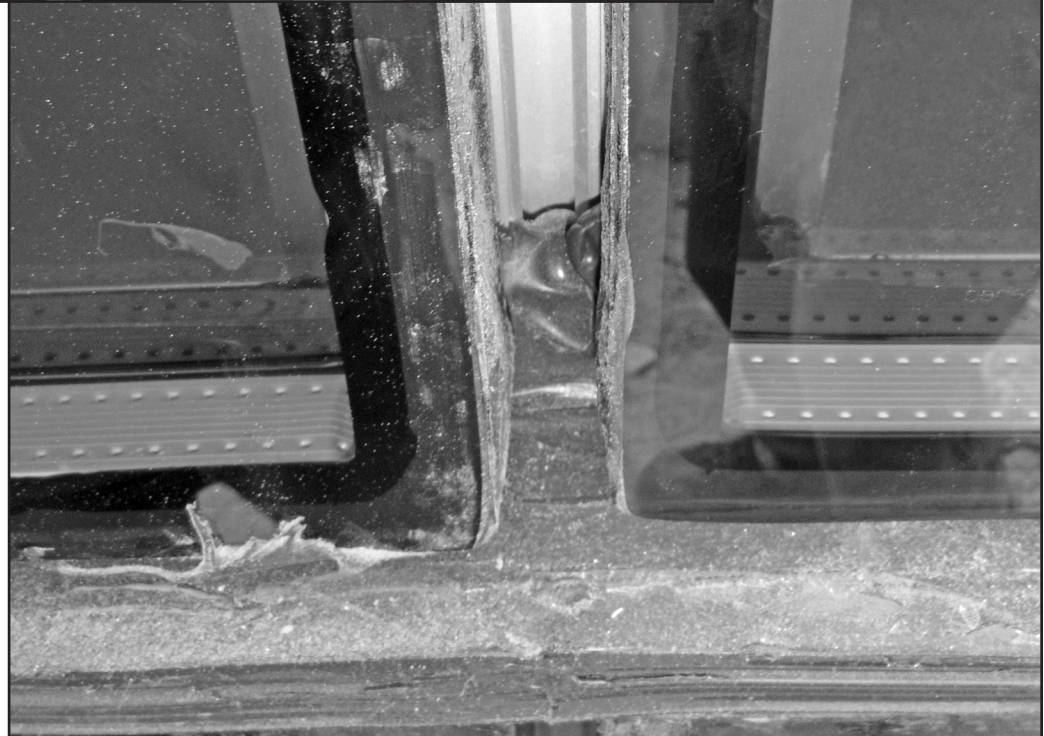
Figure 15 – Untooled sealant at an intermediate horizontal, blocking the drainage flow at mullion.
