# DRIFT JOINTS PROVIDE AN AVENUE FOR WATER INTRUSION INTO WALL CAVITIES

BY ROBERT CRAIG, RRO, CDT

This article focuses on the use (or misuse) of the common #40 horizontal two-piece drift/seismic joints (see *Illustration 1*) in stucco, the significant concern with water that is captured by the joint’s lower pocket, and subsequent leakage at the ends and joints of each piece. Further, the need for the horizontal upper metal accessory to provide weepage is discussed.

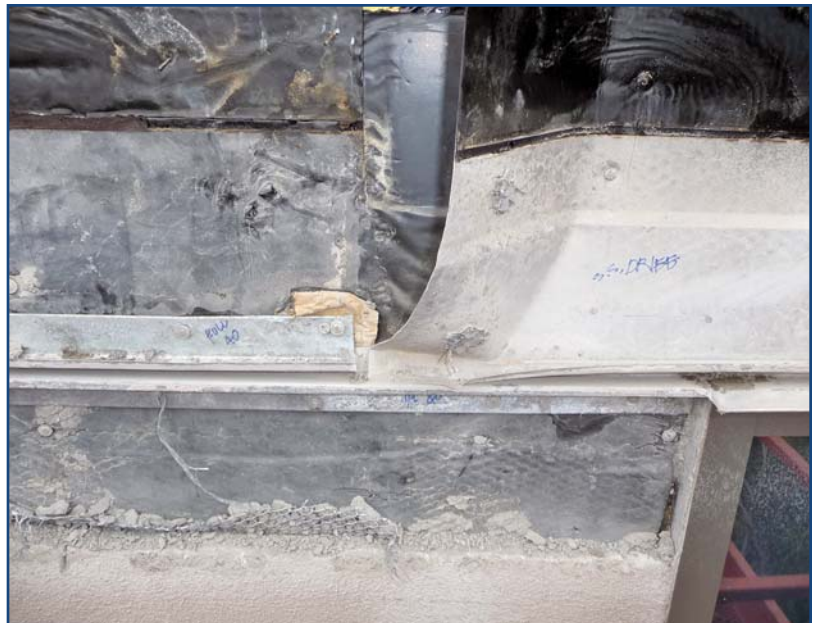
*Photo 1 – Note the exposed termination of the lower pocket of the #40 drift joint against the window jamb metal flange. It is unsealed and will drain water that is trapped in the lower pocket into and down the jamb WRB. Water was leaking into the building at the window perimeters during significant rain and leaked from spray testing.*

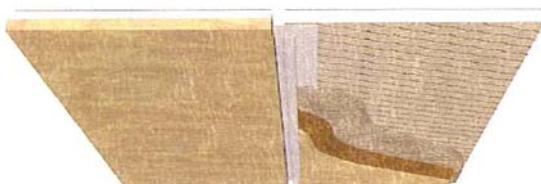
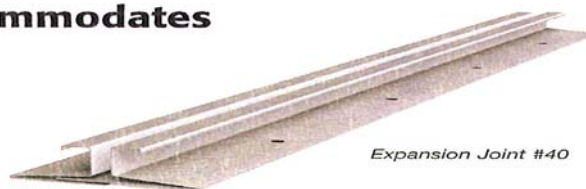
*Illustration 1 — A vendor’s illustration of a drift joint (from Dietrich Metal Framing).*

## Two-piece slip joint that accommodates movement in two directions.

- Allows for wall movement in multiple directions.
- Adjusts from 1/4" to 5/8".
- Provides effective plaster bond.
- Available with numerous modifications.

*Caution: Additional weather shields should be installed behind the joint to enhance the weather resistance of this system.*

joints, such as the accessory #40 joint, available in 10-ft lengths, have a male / female design. The female part, which has a receiver groove or pocket, is placed at the lower configuration.

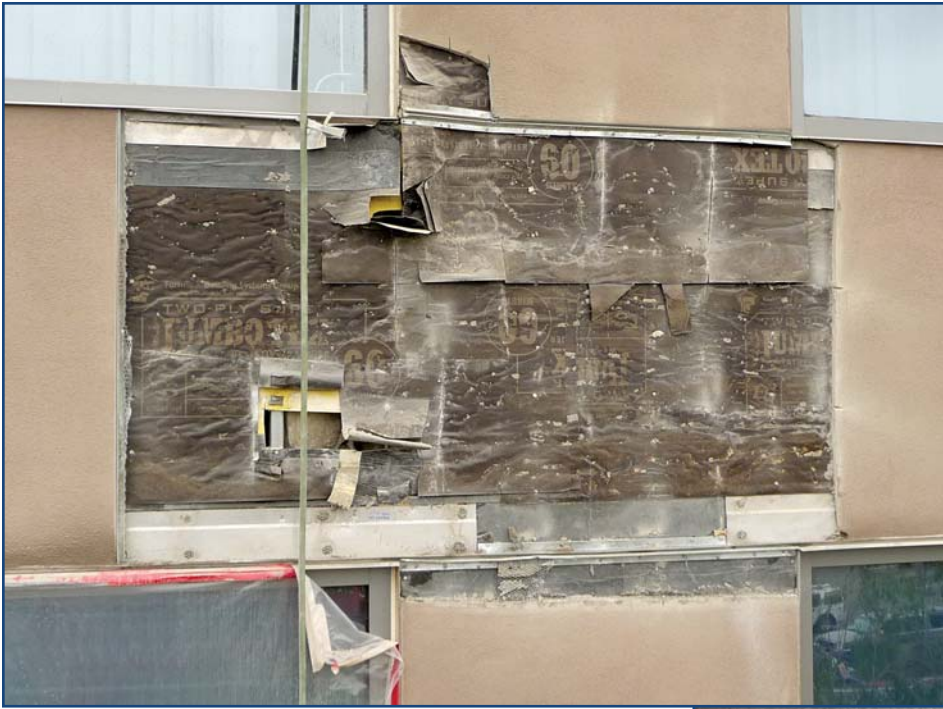
*Photo 2 – This photo shows the typical drift joints (along the top of the windows in the lower portion of the photo) terminating at the window jambs and forcing moisture into the WRB, leading to uncontrolled ingress of moisture behind the stucco and leakage into the interior during heavy rain.*

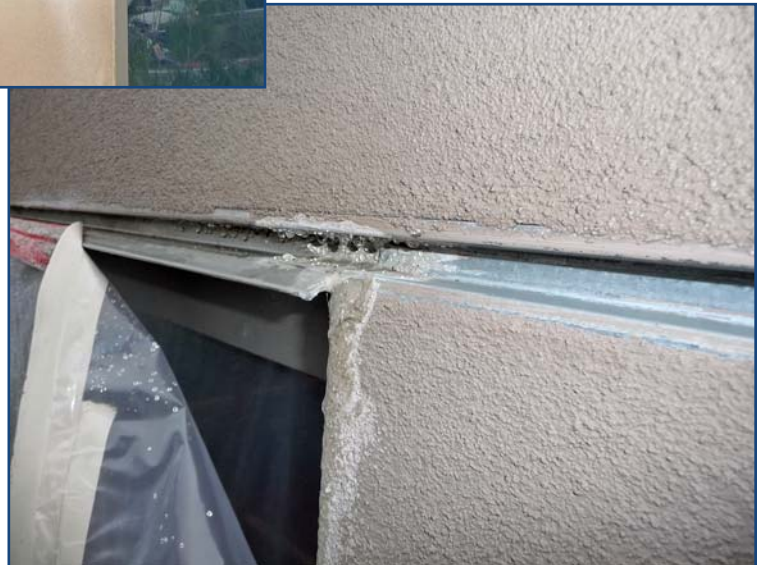
*Photo 3 – Horizontal #40 drift joint intercepts water running down the stucco, which then flows back into the joint and into the pocket of the lower accessory. Note that stucco against the metal jamb flange is actually trapping moisture, which is behind it in the drift joint lower pocket. Problems also exist with the upper stucco being able to weep effectively.*

This layout, very common in the field, will intercept and collect large amounts of water running down the stucco into the groove, where it travels horizontally to the ends of each piece and either joins the next piece or terminates at corners, edges, and jambs. Excessive amounts of moisture tend to leak out at these locations and enter into the wall system. Also, stucco that terminates at the bottom of the upper accessories that does not allow drainage causes moisture to accumulate, back up, and travel horizontally uncontrolled. The subsequent moisture intrusion can then overwhelm the weather-resistant barrier by excessive wetting and through-fastener holes and other voids.

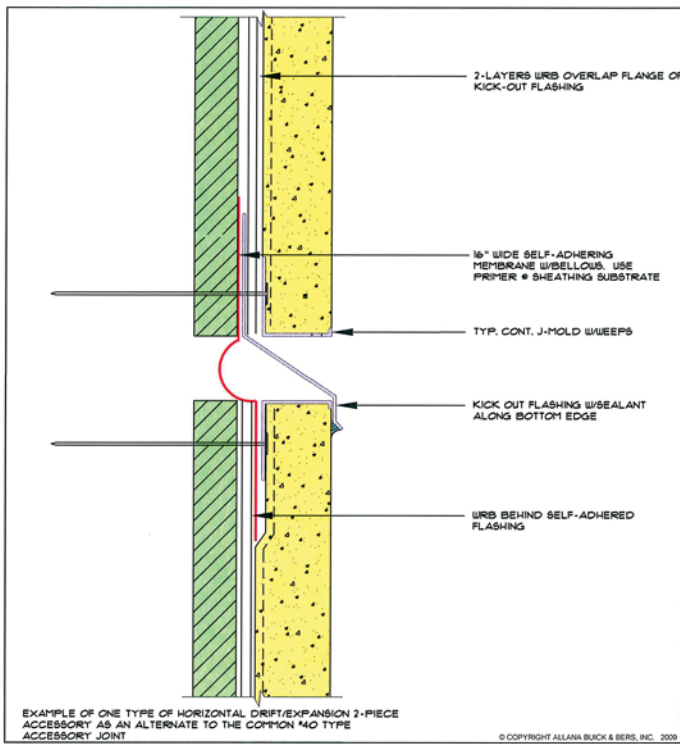
Detail 1

EXAMPLE OF ONE TYPE OF HORIZONTAL DRIFT/EXPANSION 2-PIECE ACCESSORY AS AN ALTERNATE TO THE COMMON #40 TYPE ACCESSORY JOINT

tem, design the joint to shed moisture (see *Detail 1*). Another type of horizontal drift-expansion joint that provides a different look similar to a reveal can be considered (see *Detail 2*).

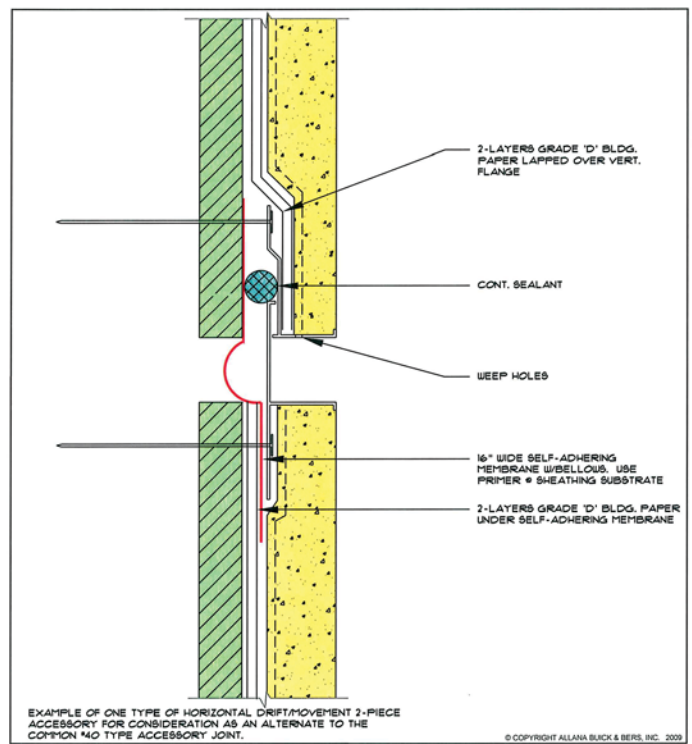
Detail 2

EXAMPLE OF ONE TYPE OF HORIZONTAL DRIFT/MOVEMENT 2-PIECE ACCESSORY FOR CONSIDERATION AS AN ALTERNATE TO THE COMMON #40 TYPE ACCESSORY JOINT.

mounted behind the joint move in two planes, and when caulked utilizing a backer rod and a quality silicone-caulking material, are generally much more water-resistant than the standard mechanical two-piece.<sup>3</sup>

Two-piece expansion joints formed with back-to-back double casing beads with flexible membranes

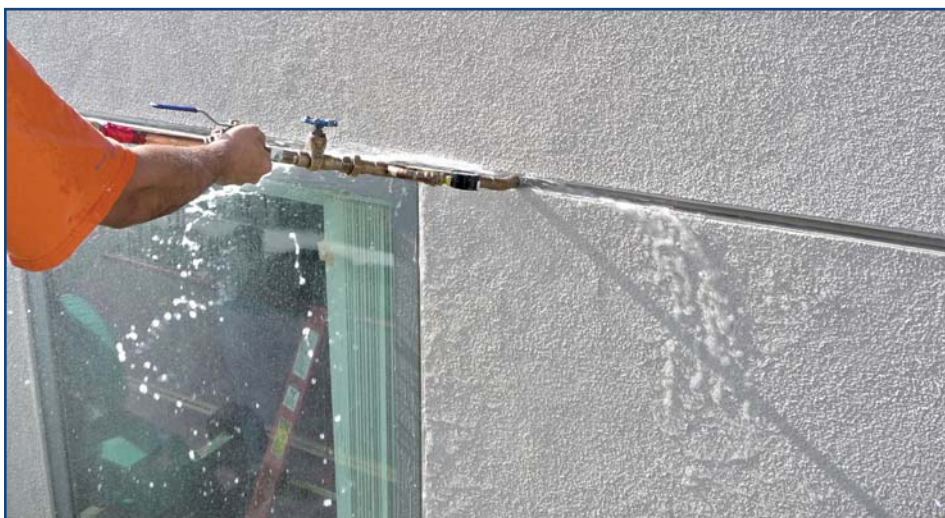
Photo 4 — Field water testing of #40 drift joints caused leaks. After remediation by installing sealant, subsequent field water testing did not result in leaks.

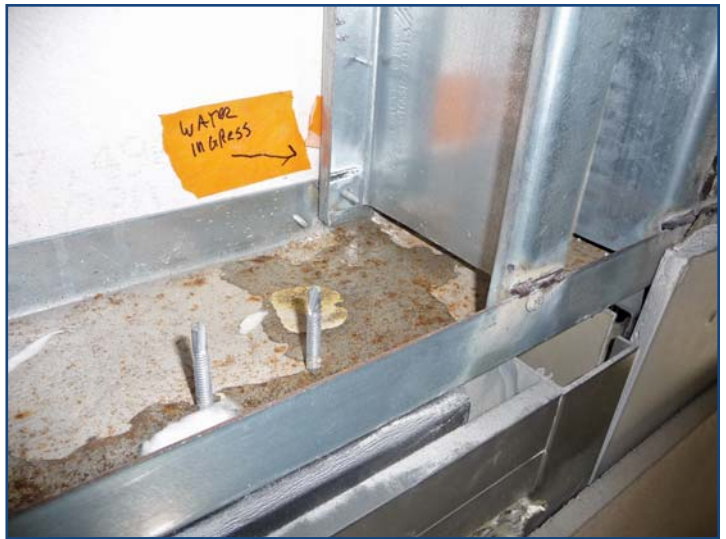
Photo 5 – Excessive uncontrolled water leaking out of the ends of the lower pockets at window jambs resulted in moisture intrusion through fasteners and into the interior of the building.

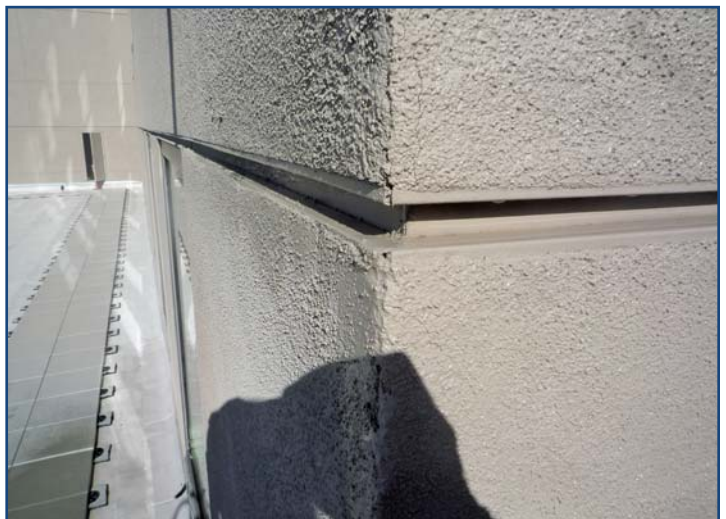
Photo 6 – Water leakage was occurring universally at the building interiors at the outside corners. This view shows the painted joint and stucco. The paint did not effectively seal the joint from water accumulating in the lower joint pocket and leaking out at the butt edges—first onto the WRB and eventually into the interior.
