BETTER DESIGN AND BUILDING PRACTICES FOR REDUCING WATER AND MOISTURE PROBLEMS IN WOOD-FRAMED COMMERCIAL AND MULTIFAMILY BUILDINGS

BY STEVE EASLEY

This article was originally published in the Proceedings of the 25th Annual RCI Convention and Trade Show.

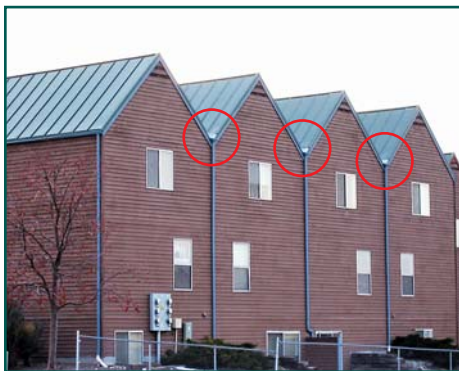
Photo 1 - Condo units.

down that valley can become trapped. If there’s enough water runoff at one time, it’s likely to back up under the shingles and flashing. This can turn to ice in colder climates. *Photo 1* shows that a whole series of horizontal valleys has been created between these condo units. These poor-draining roofs, combined, are more likely to lead to water leaks over the life of the building. Another common mistake, shown in *Photo 2*, is a sloping roof into a wall that creates a horizontal valley condition, trapping water and leading to leaks.

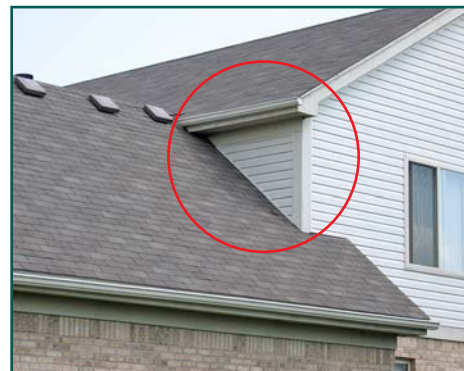
Photo 3 - Ridge intersecting eaves.

The problem with the design in *Photo 3* is that all the water that runs off the higher roof is collected in the gutter. Note that there is no downspout, so all the water that runs off the roof runs toward the poorly flashed ridge cap of the intersecting roof. The solution during the original design: drop the ridge so the eaves and the gutter can run above the ridge uninterrupted. The solution now is to pitch the gutter to a downspout at the exterior corner.

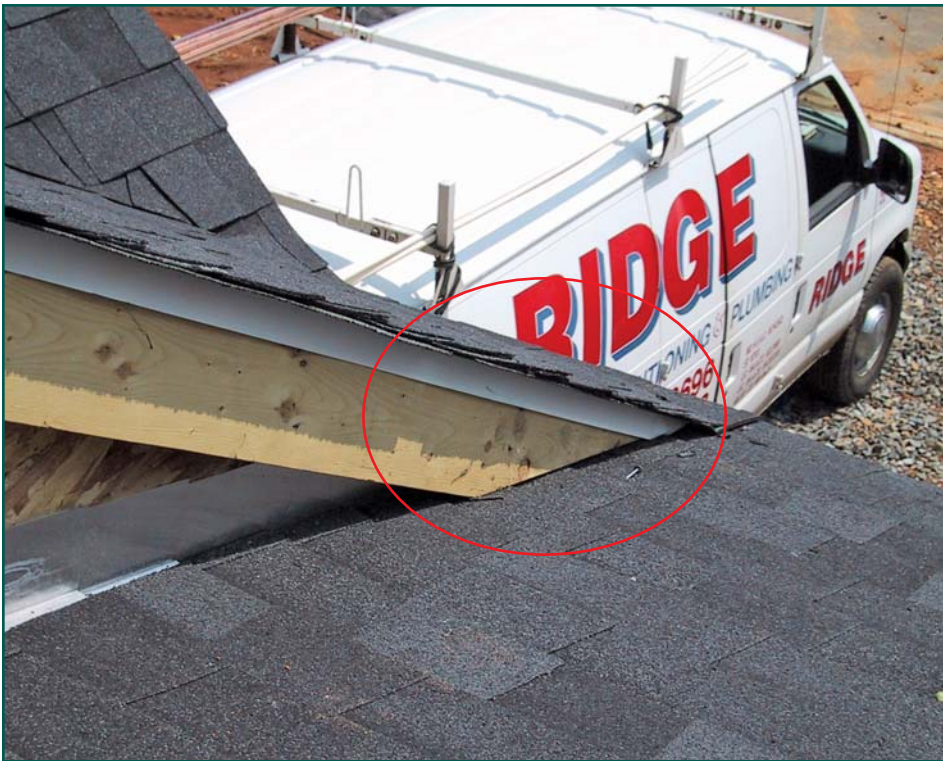
Photo 4 – Intersecting roof plane.

Whenever two roofs of different pitches intersect, it’s important to detail the intersection to ensure the water’s ability to shed away from the structure. In *Photo 4*, there’s no way water draining off the roof in the foreground can drain away without getting funneled into the roof/wall intersection where the rake of the second roof blocks its path.

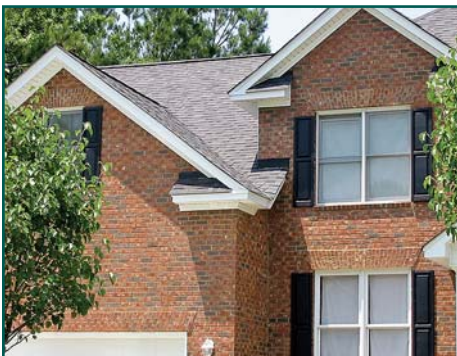
Photo 5 – Avoiding horizontal valleys.

Photo 5 shows how to detail the intersection to avoid a horizontal valley. By keeping the gable ends on different planes, the valley is allowed to run unbroken and water can drain freely.

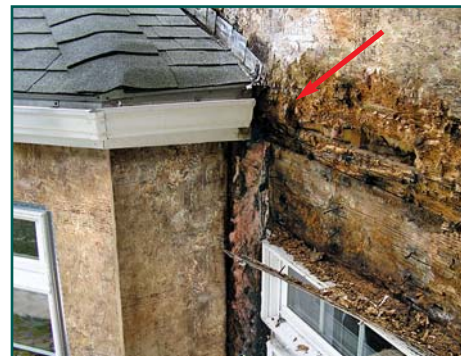
Photo 6 – Damage at roof/wall intersection.

kickout flashings (sometimes called diverters) are missing or poorly field-fabricated. Photo 6 shows damage due to lack of kickout flashing at roof/wall intersections. Kickout flashings divert water away from these troublesome details. Next to window flashing mistakes, roof/wall intersections are the most problem-prone areas.

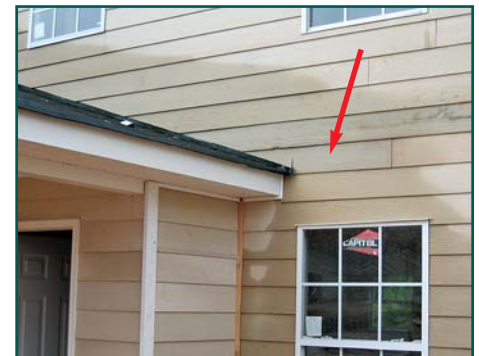
Photo 7 – Moisture at roof/wall intersection.

Notice the moisture concentration at the roof/wall intersection of Photo 7, which demonstrates the tremendous need for kickout flashing diverters.

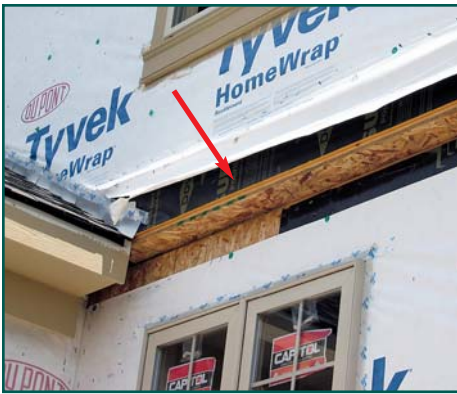
Photo 8 – Hole in water-resistive barrier (WRB).

Note the large gaps in the water-resistive barrier (WRB) at the roof/wall intersection in Photo 8. This will certainly lead to a failure. WRBs are often poorly installed at these areas. Sometimes, this leads to sloppy patchwork. Workers need to inspect and correct all unsealed penetrations.

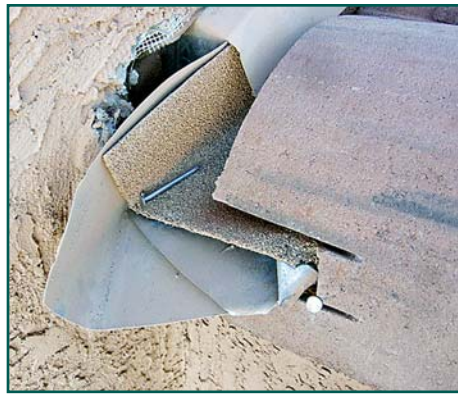
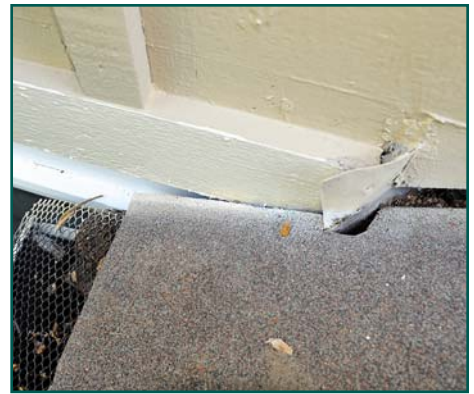
Photos 9 and 10 – Poorly fabricated kickout flashings will lead to water damage.

Field-fabricated kickout diverters, such as those shown in Photos 9 and 10, illustrate the lack of knowledge on how to properly field-fabricate a kickout diverter. Field-made diverters are often poorly made and do not work well. There is also tremendous inconsistency from one tradesperson to the

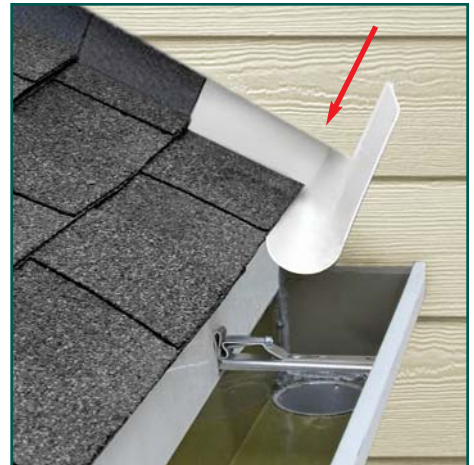
Photo 11 – Premolded kickout flashing (courtesy DryFlekt.com).

Premolded, seamless kickout flashings (Photo 11) are an excellent solution. They perform better than field-fabricated metal and cost only \$10 or so. This product can work with almost any roof pitch. It is made of polypropylene, so it works well in both cold and hot weather.

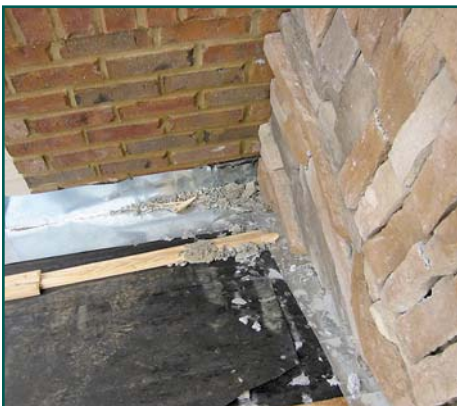
Photo 12 – Metal flashing reverse shingled over brick.

Properly installed flashing is the last defense against leaks. In Photo 12, the metal flashing is reverse shingled over the brick. The design is poor because it creates a horizontal valley. Proper inspection is required to avoid flashing-related leaks.

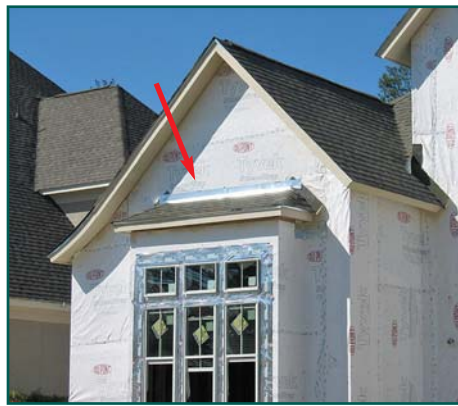
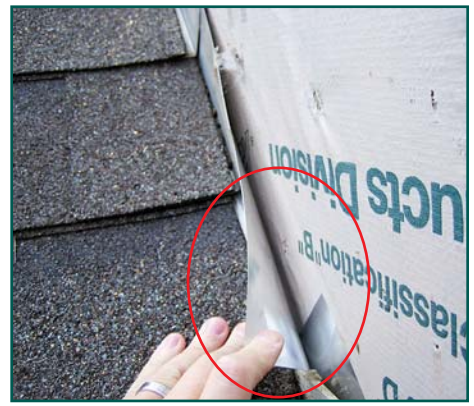
Photos 13 and 14 – Reverse-shingled weather barriers.

Look carefully at Photos 13 and 14, and it is apparent that the house wrap is reverse shingled. The house wrap is behind the step flashing, which means that any water that gets in behind the cladding can easily be funneled into the wall, rather than draining away from the wall. The wrap should go

over the step flashing.

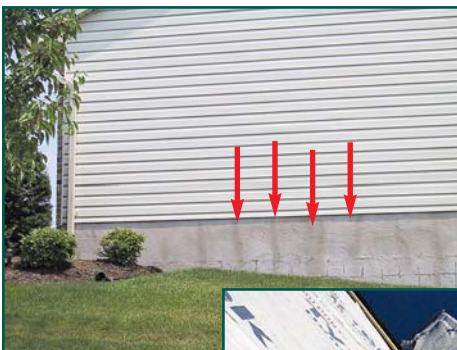
Photo 18 - Vinyl Siding Drainage

All cladding leaks, and vinyl siding is designed with weep holes to allow for drainage. In Photo 18, the secondary moisture barrier is doing its job, shedding enough water that wet spots are clearly visible underneath the vinyl siding.

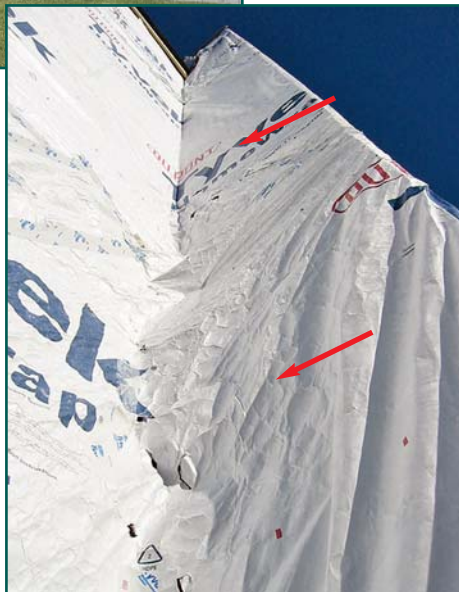
Photo 19 – Rips and gaps in WRB.

Water-resistive barriers work well but must be installed correctly. The rips and gaps in the WRB pictured in *Photo 19* will allow any water flowing through to leak into the wall at the corners. Manufacturers require that the

WRB be overlapped approximately 12 inches at the corners and, of course, sealed with an acrylic-backed tape. Often, when installers roll on the WRB, the WRB at inside corners is not tight to the inside wall, resulting in a radius or space between the WRB and the sheathing at an inside corner. The result is the cladding contractor has to slit the WRB to install the cladding, leaving a water entry point.

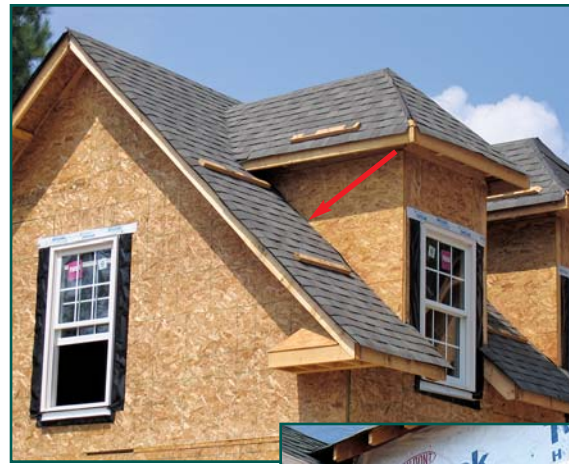
Photo 16 – Missing step flashing.

Where the sloping roof intersects the vertical wall in Photo 16, the shingles are in place without any step flashing. It will be difficult to install the step flashing without damaging the shingles. Step flashing should always be installed prior to roofing. The sloping roof in Photo 17 has no counter-flashing under the brick relief angle. Brick cladding is not watertight and requires a drainage plane.

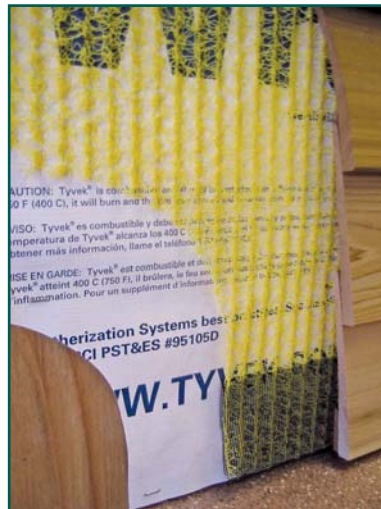
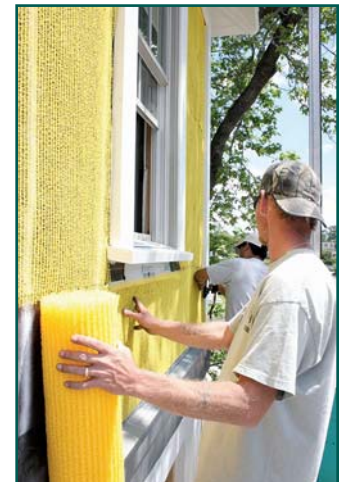
Photo 20A – Rainscreen product (Home Slicker cross section).

Photo 20B – Rainscreens (courtesy Benjamin Obdyke).

Rain screens, a space between WRB and siding, provide better drainage and drying behind claddings. The product in *Photos 20A and 20B* are manufactured by Benjamin Obdyke and are part of the Home Slicker line. Products like these reduce the potential for water intrusion in two ways:

1. They create a drainage space for water to drain, and
2. They create a capillary break to prevent water flow by capillary action.

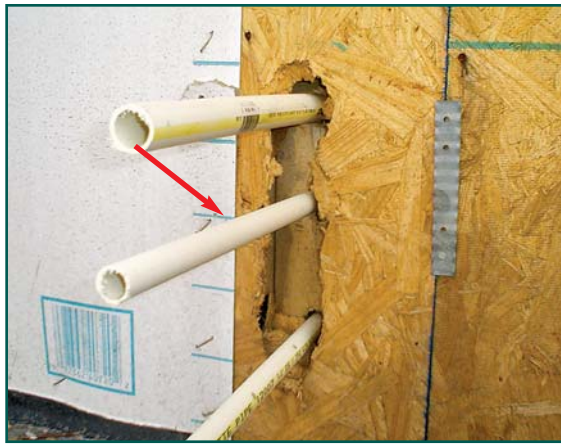
Photo 21 – No flashing around pipes.

It takes only minutes for wall components to get wet, but it takes days, weeks, or months for them to dry out. If the wetting rate exceeds the drying rate of building materials, mold and decay can occur. Notice there is no flashing around the pipes coming through the wall pictured in *Photo 21*. It would be very easy for water to run down the pipes and flow directly into the wall.

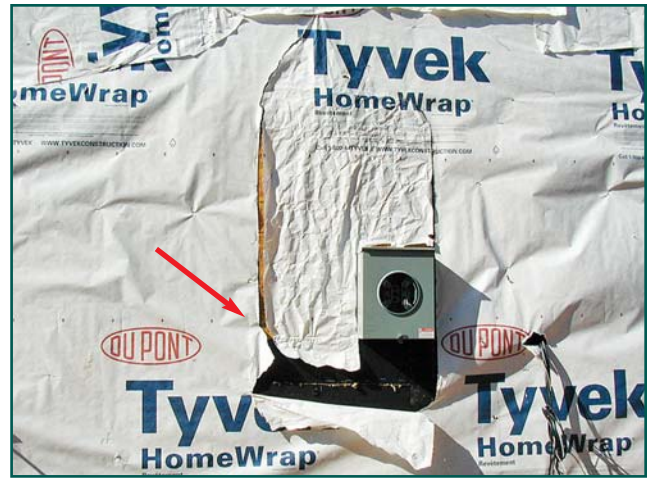
Photo 22 – Poor detailing at electrical meter.

Photo 22 shows poor detailing at the electrical meter base and will surely lead to problems.

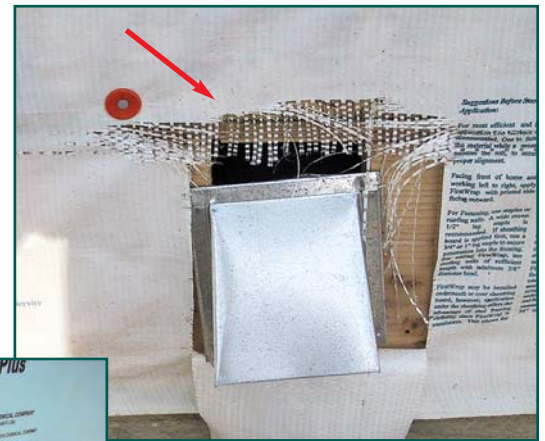
Photo 23 – WRB at vent should be flashed.

Cutting large holes in the house wrap, as shown in *Photo 23*, defeats its purpose. The proper cutting technique is to X-cut the house wrap, slide the vent through the X-cut, and seal around the penetration with an acrylic tape (or a peel-and-stick flashing) before securing the faceplate. *Photo 24* shows a prefabricated flashing device made by QuickFlash that stretches around the pipe and seals it.

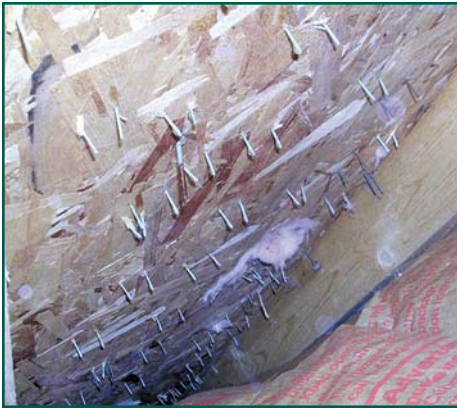
Photo 25 – Overstapling WRB.

Every staple through the water-resistant barrier is a potential water leak. Crews should be instructed to install the WRB according to manufacturers' instructions. *Photo 25* illustrates over-fastening with staples.

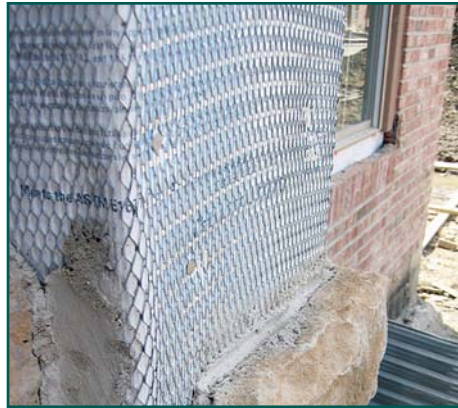
Photo 26 – Synthetic stone.

Synthetic stone (*Photo 26*) creates a unique challenge. Synthetic stone systems leave no air space to promote drainage like brick veneer. A solution is to apply two layers of water-resistant barrier material before installing the lath. The outer layer functions

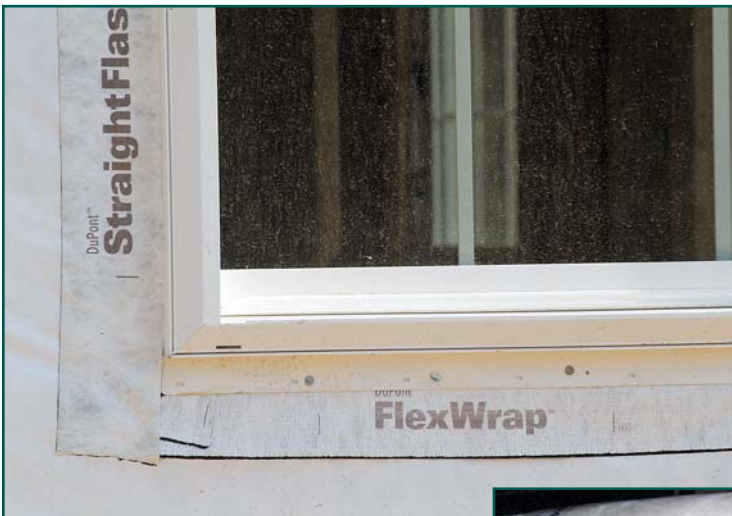
- **Step 1:** WRB and sill flashing are installed before the window (*Photo 28*). Begin with a sill flashing that covers the rough sill and has a bottom flap that laps over the top of the WRB (house wrap). This will help ensure that any water that leaks through the window drains out over the WRB.
- **Step 2:** Sealant is applied at the head and the jamb areas; then install the window. Jamb flashing can go in after the window has been installed and should lap over the window flange to prevent wind-driven water from getting past the window into the rough opening.
- **Step 3:** Install the head flashing from the nail fin at the window head onto the wall sheathing (see *Photo 29*). Reinstall WRB over the head flashing.

Photo 28 — Proper window flashing at sill. The sill flashing was installed before the window.

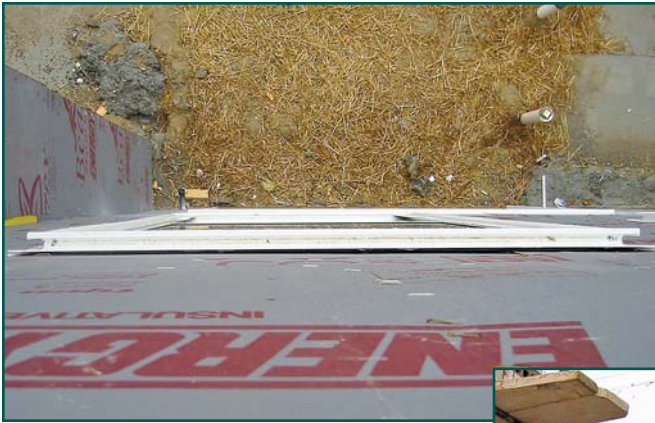
Photo 30 depicts what water running down a wall “sees” as it approaches the head of the window, underscoring how very important it is to properly flash at the win-

Photo 30 – Note the gap between the nail fin and the sheathing.

dow head. Sealant alone won't keep the water out. If the sealant ever separates and fails, there is a perfect entryway point for water into the structure. Always use compatible sealants and flashing.

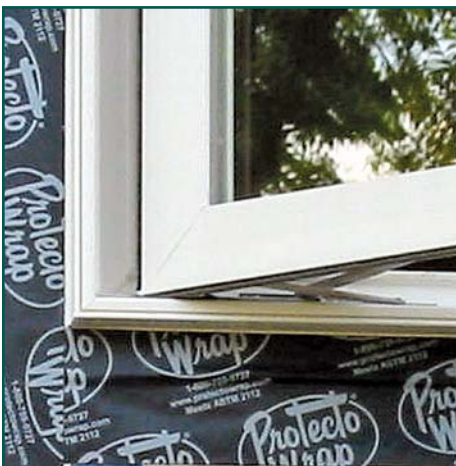
Photo 32 – Improper sill flashing.

The flashing in *Photo 32* is applied over the top of the nail fin below the window. This is a mistake. The sill flashing goes on *before* the window is installed.

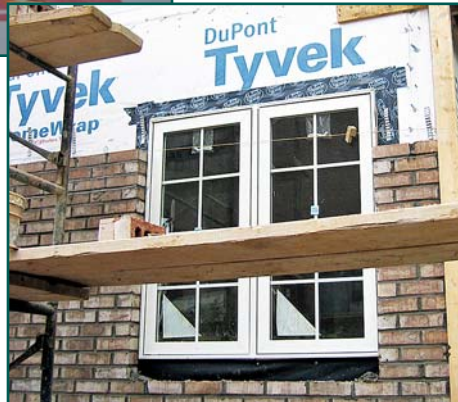
Photo 31 – Improper head flashing.

The head flashing on the window in *Photo 31* is reverse-lapped over the house wrap. Before applying the head flashing, a flap needs to be cut in the house wrap so that the head flashing can adhere directly from the nail fin at the head onto the wall sheathing (see *Photo 29*). Once the flap is folded back down over the head flashing, water draining down the wall above the window will drain outside, not behind the head flashing.

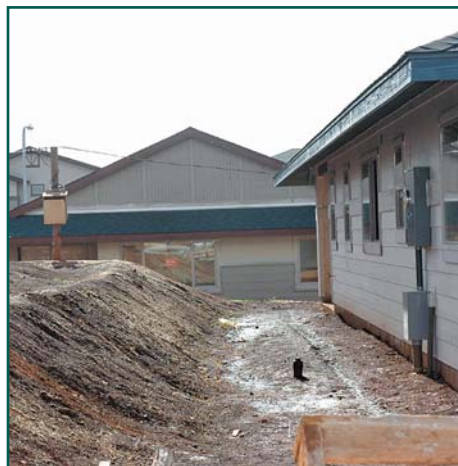
Photo 33 – Poor drainage design.

In the coastal subdivision pictured in *Photo 33*, water running off of one series of houses drains right into another. There is not enough natural drainage away from the lower structures to prevent subslab moisture accumulation.

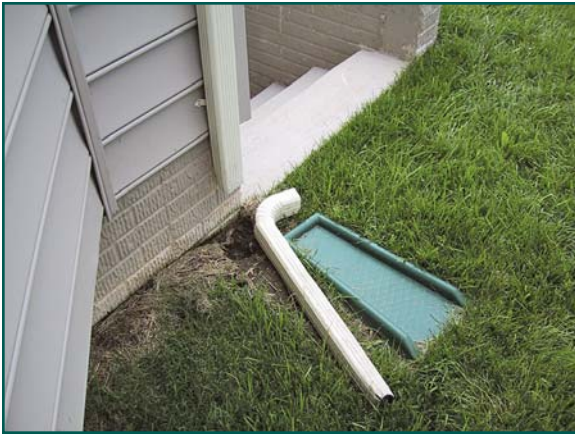
Photo 34 – Disconnected downspout.

Water problems can often be traced to poor drainage around the home. Exterior water problems can easily create interior moisture problems. *Photo 34* illustrates a

disconnected downspout. Water that runs off the roof is being funneled near the foundation, which can create a tremendous moisture load at the foundation.

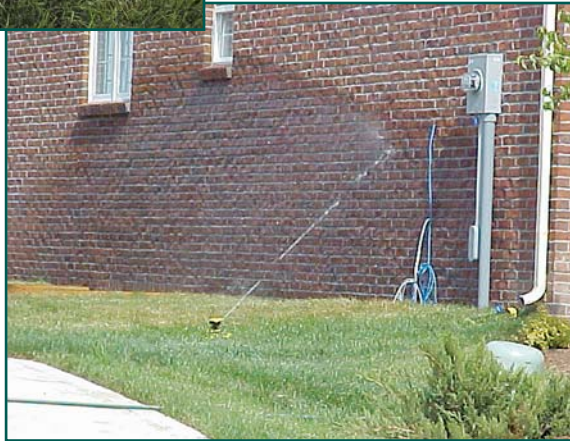
Photo 35 – The owner factor.

This sprinkler is pouring over 100 gallons per hour of water onto the wall depicted in Photo 35. This is an “unexpected design condition” and exemplifies why redundancy with flashing and WRBs is so important. The only way to avoid problems caused by the owner irrigating this wall is to make sure a WRB behind the brick is impeccably detailed, a drainage cavity and weep holes remain open, a backfill that drains well was installed, and there is good perimeter drainage.
