ACME CORRUGATED BOX COMPANY...

"It's All About the Wrapper!"

By William A. Kirn, RRC

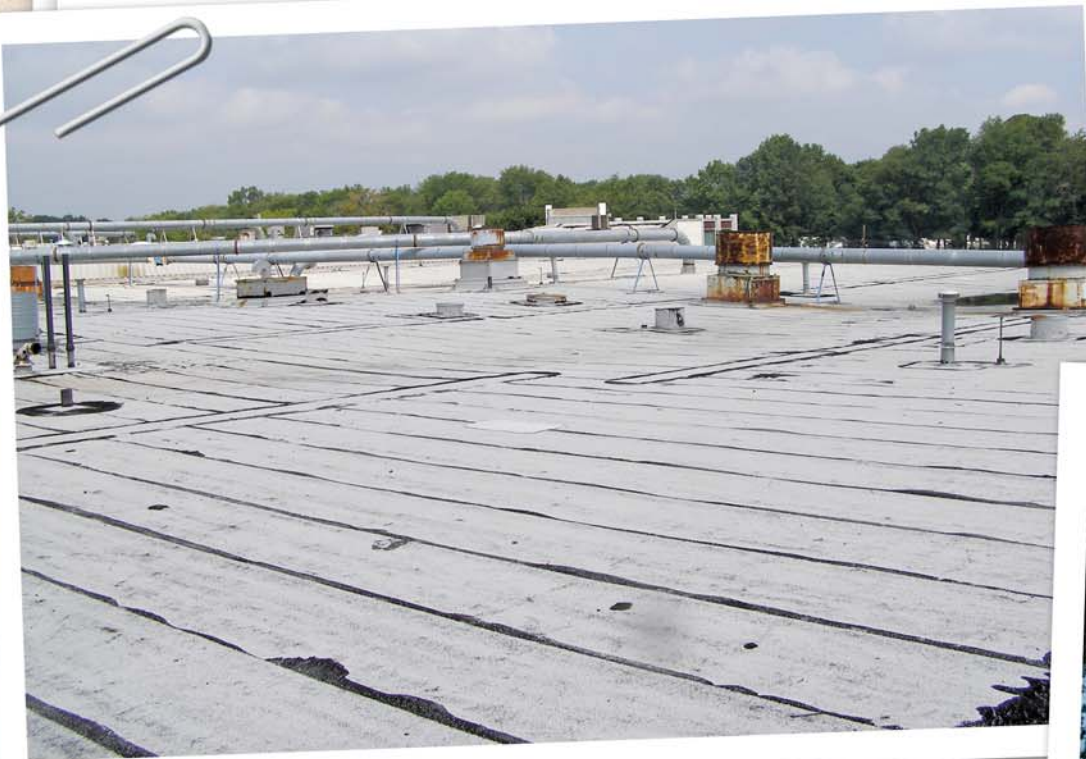
On most roof sections, the strata consisted of a cast-in-place gypsum deck and the original coal-tar built-up roof that had been recovered circa 1996 with a two-ply modified-bitumen membrane set in asphalt. There were numerous blisters in the membrane. In addition, the roof slopes were designed with a flat valley line between drain fixtures, which resulted in the undesirable condition of ponding water on the surface. Another issue of concern was the seasonal flow of coal-tar bitumen from beneath the metal edging along the edge. This condition was very unsightly and did not present a professional and industry-

Field of roof before restoration.

tion initiative. The objectives of the program were to stabilize the modified-bitumen membrane, minimize ponding water, and attempt to stem the seasonal flow of coal-tar bitumen along the roof edge. The rehabilitation program included repair of blisters in the modified-bitumen membrane; application of sprayed polyurethane foam along the edge, as well as between existing paired drains to create a "saddle" to displace ponding water; replacement of the existing light-gauge, brake-formed metal edging with a wind-rated edging assembly; and the application of National Coatings Corporation's "AcryShield Roof Maintenance" system.

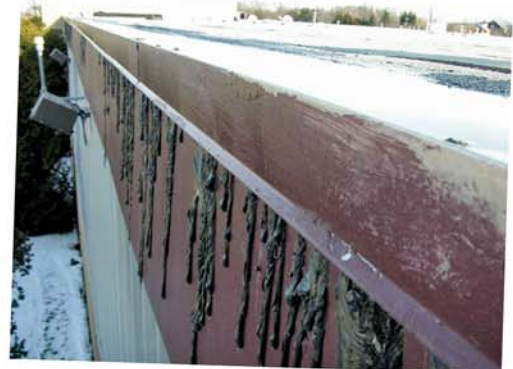
Coal tar seeping over roof edge.

fied-bitumen membrane, it was expected that the highly reflective system, in conjunction with the sprayed polyurethane foam, would reduce surface temperature and stop or significantly reduce the continued flow of the coal tar over the roof edge.

Roof surface temperatures taken during various times of the day graphically demonstrated how the coating system dramatically reduced the surface temperature, thereby stopping the continued flow of coal tar out from the existing roof. Roof-surface temperatures were taken before and after coating.

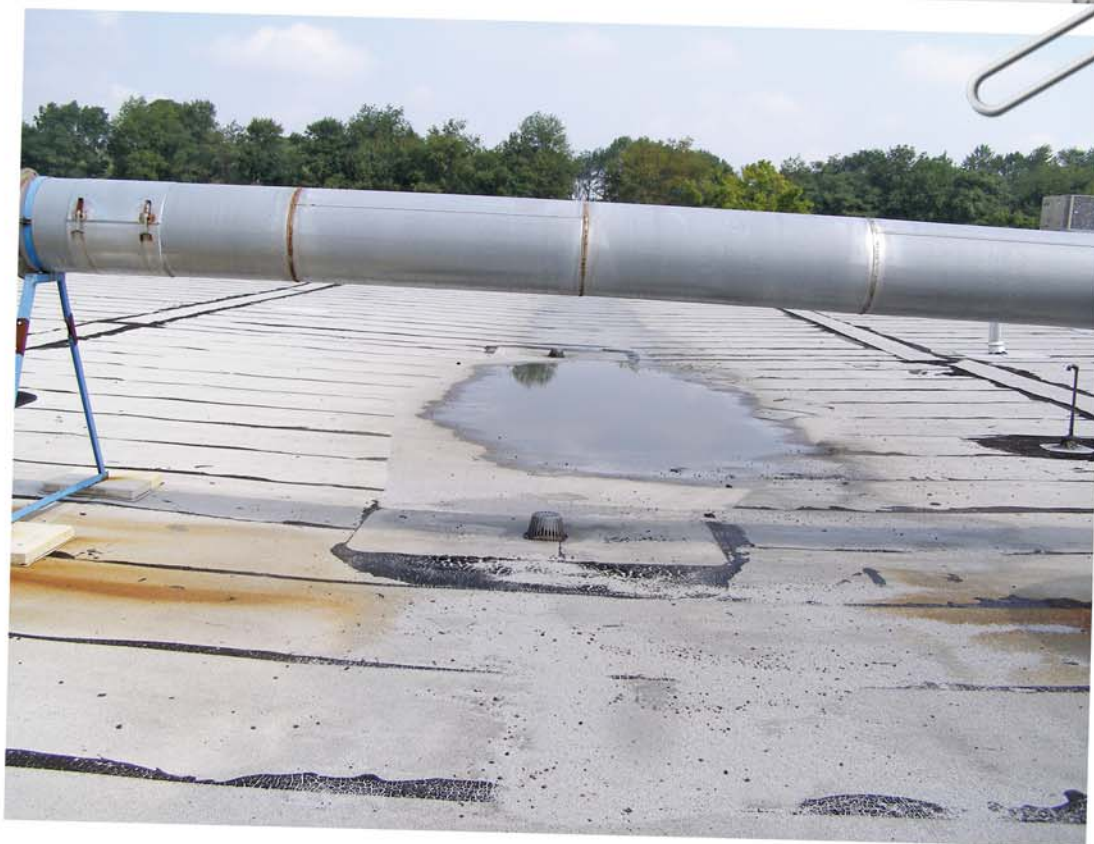
Ponding water in valley line before resloping with SPF.

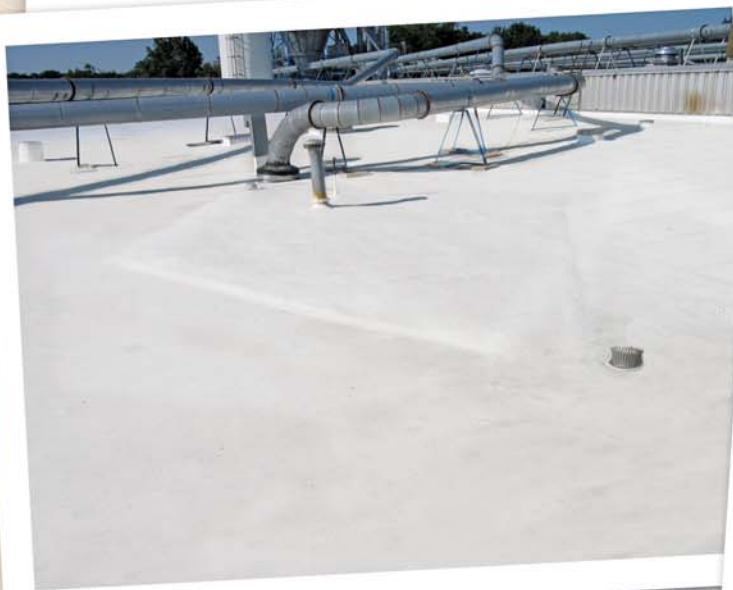
Valley line after resloping with SPF and coating.

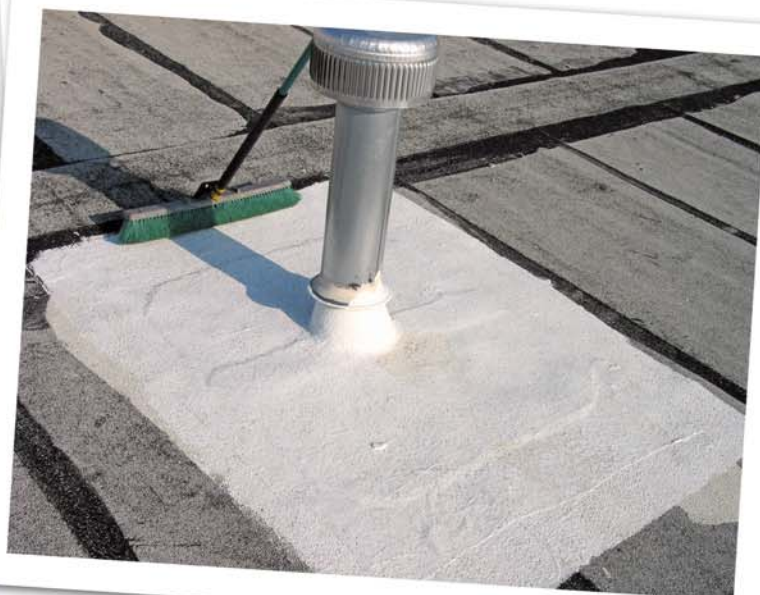
Detail of proper penetration repair using polyester scrim and coating.

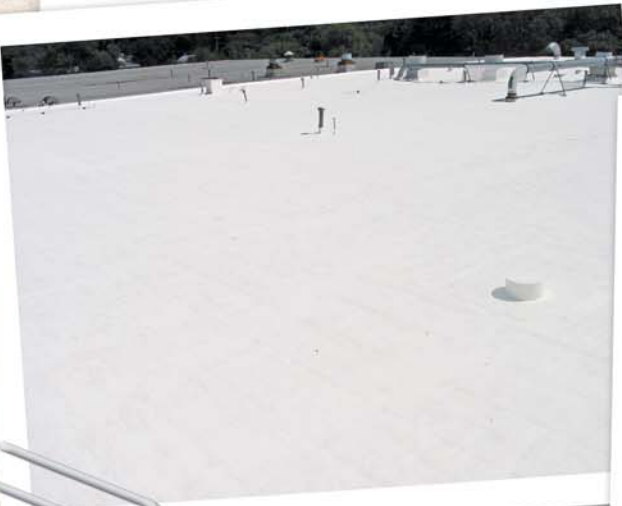
Field of roof of finished project.

Roof-surface temperature before coating
140°F

Roof-surface temperature after coating
100°F
