# Field Investigation of AGGREGATE BLOW-OFF OF SPRAY POLYURETHANE FOAM ROOFS

By ROGER V. MORRISON, RRC, PE

This paper was originally presented at the RICOWI Fall Symposium, November 11, 2010, in Rock Hill, SC.  
It is published for the first time here, courtesy of RICOWI.

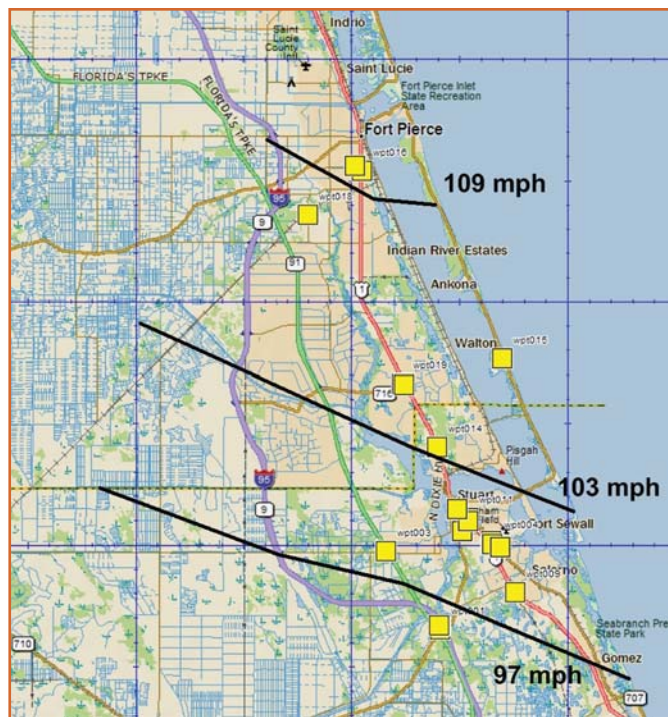
Figure 2 – Study area with Hurricane Jeanne wind contours. Yellow squares represent inspected roofs. Wind speeds are three-second gusts, 33 ft above ground, Exposure C. (Map from Topo North America 9.0, 2010, © DeLorme, Yarmouth, ME. Used with permission.)

Obtaining an accurate analysis of hurricane wind speeds is not a simple task. Hurricane Jeanne was chosen as the more critical storm event (Jeanne was a Category 3 storm, whereas Francis was a Category 2 storm). For this study, wind speeds were estimated using a combination of available Hurricane Jeanne surface-wind speed maps and adjusting those speeds to basic wind speeds of three-second gusts at 33 ft (10 m) above ground, Exposure C. The net result is the wind contour map/study area map in Figure 2.

Wind speeds were estimated based on the Figure 2 map for each building location. The aggregate samples were sieved (to determine average diameter) and measured for specific gravity.

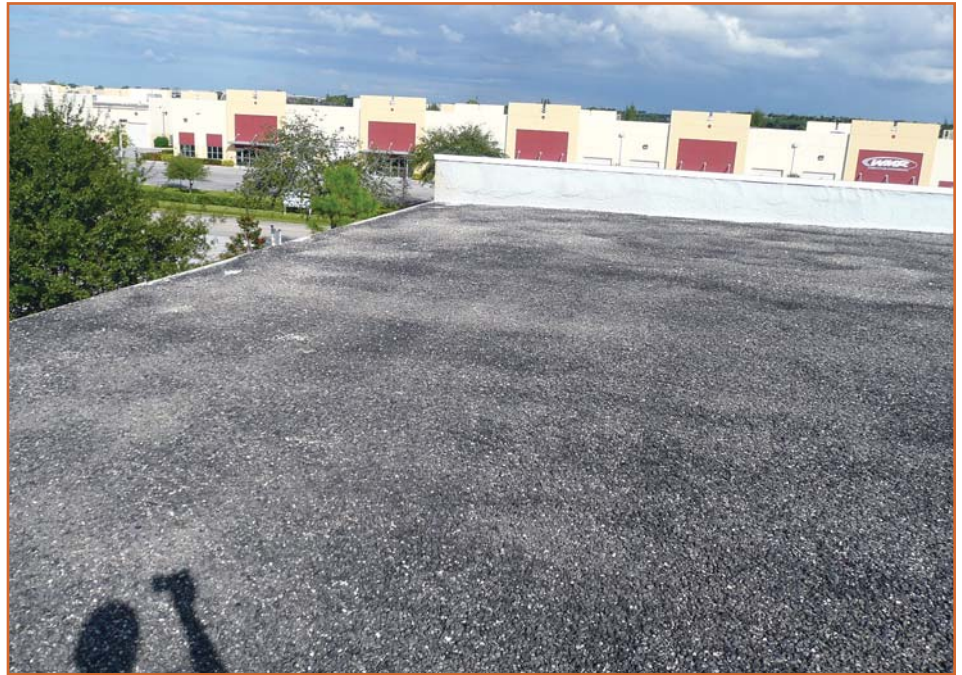
*Figure 3 – Discontinuous parapet on Roof No. 2.*

For example, Roof No. 2 (Figure 3) drained at the back of the building. The parapet height varied from 10 inches in front to 36 inches (due to roof slope) at the rear where the parapet stopped at the draining edge. Aggregate scour originated at the junction of the draining edge and the 36-in parapet; an effective parapet height of 36 inches was used in the calculations for this roof.

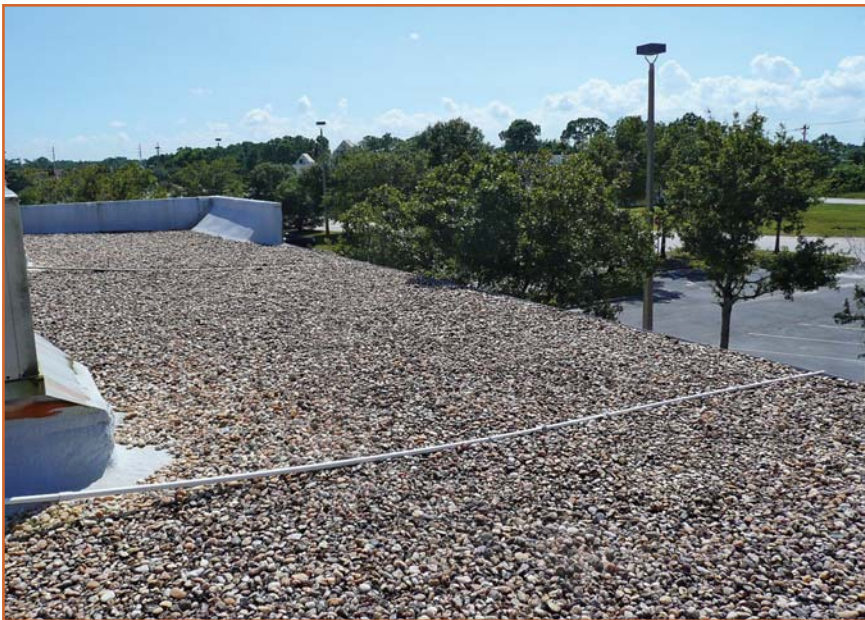
- Roof No. 19 (X-value: +88) had been a ballasted single-ply; when this had been converted to an aggregate-covered SPF roof, the ballast stone was reused. This roof had the greatest aggregate diameter of the study roofs (1.5 inch average). Additionally, while this roof had a draining edge, the 38-in-high parapet

Figure 4 – Roof No. 19 with 1.5-in aggregate and a wrap-around parapet.

wrapped around and protected the corner (see Figure 4).

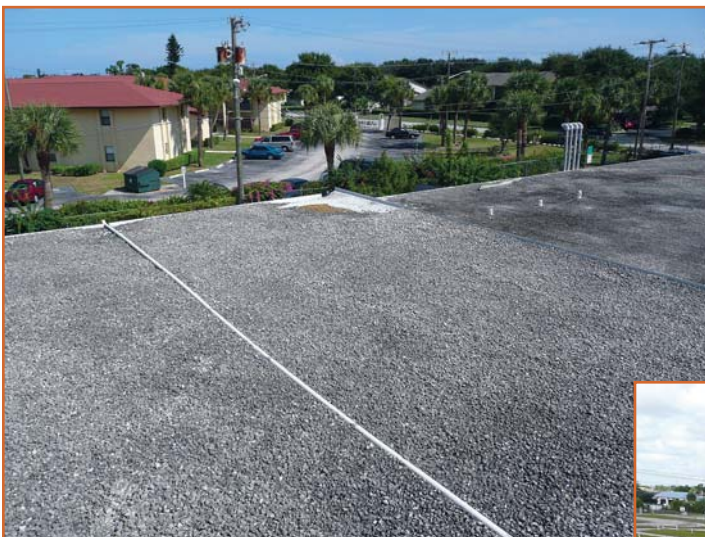
Roofs experiencing some degree of scour ranged in X-values from -23 to +37. Scour patterns were not unexpected. Exposed corners exhibited the classic “heart-shaped” or “V” pattern; corners with partial or discontinuous parapets exhibited a “teardrop” pattern. (See Photos 5 to 7.)

Figure 5 – Typical minor scour (Roof No. 16).

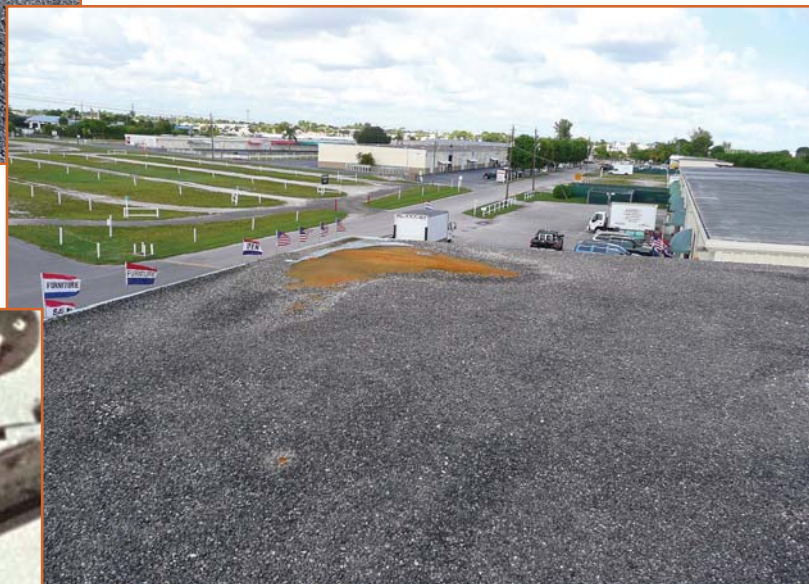
Figure 6 – Typical scour pattern (Roof No. 4).

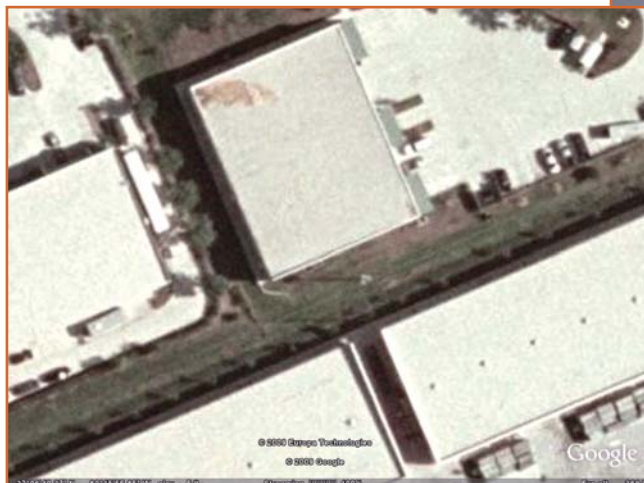
Figure 7 – Typical scour pattern (Roof No. 2).  
Photo courtesy Google Earth.

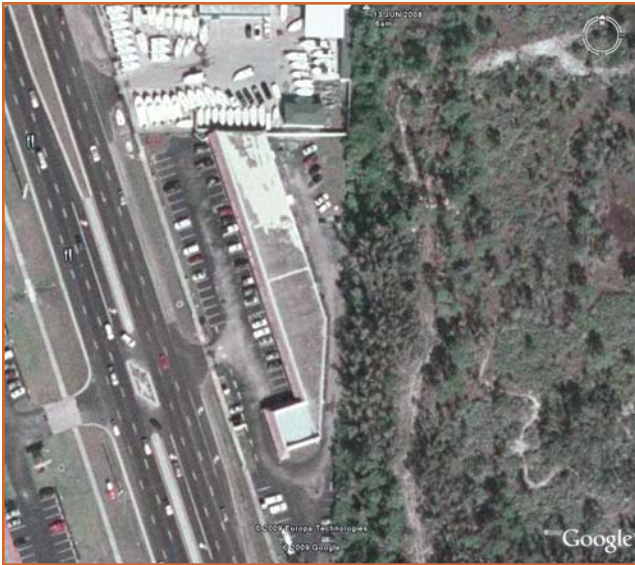
Only one roof in the study was observed or reported to have had a loss of aggregate. This particular building (Roof No. 13) had the smallest aggregate diameter of the study (0.245 in) and was classified as Exposure C (Figure 8). The roof has a high parapet on the west exposure (66 inches), but the eastern side (exposure was an open field) had no parapet. The aggregate loss apparently caused no damage, as it was never determined where it landed (likely in the adjoining field). The X-value for this roof was the most negative of the study at -52.

Figure 8 – Roof No. 13 exhibited aggregate loss. The roof had no parapet on the side facing Exposure C. Aggregate loss was from the northern half of this roof. Photo courtesy Google Earth.

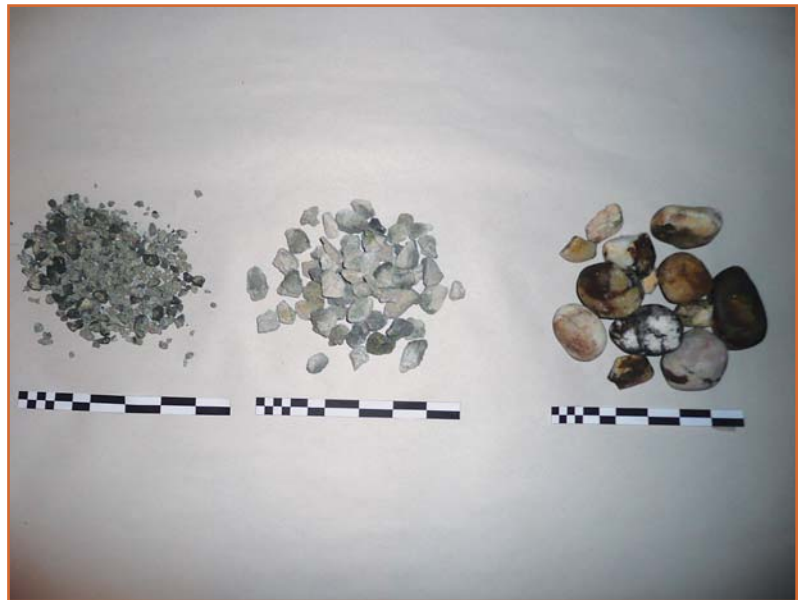
Average diameter varied from 0.245 to 1.50 in (*Photo 9*). The largest size was aggregate recycled from a ballasted single-ply roof. The smallest sizes (7, 78, and 8) were locally described as “pea gravel.” Fines were found to be minimal and well within ASTM D448 specification.

Figure 9 – Aggregate varied in average diameter between less than one-half inch and 1½ inches. Most roofs had Size 67 (nominally one-half-inch diameter).
