EFFLORESCENCE – The White Whiskers of Winter

By Joseph “Cris” Crissinger, CCS, CCCA

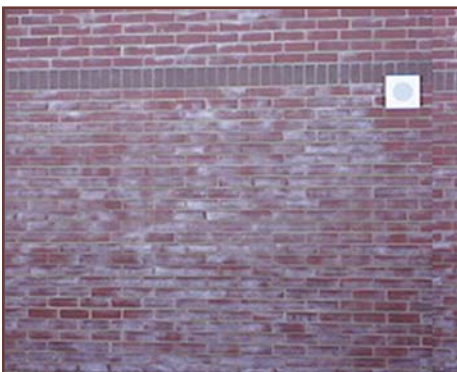
Figure 1 – Efflorescence caused by cold, damp weather. Very severe efflorescence can make masonry appear as if being observed through a frosted glass. The wall was clear by late spring.

One of the first signs of a moisture problem in cementitious materials is efflorescence. Depending on its source, it is usually a white powdery substance (*Figure 1*). If efflorescence has any purpose in life, it is to sound the moisture alarm.

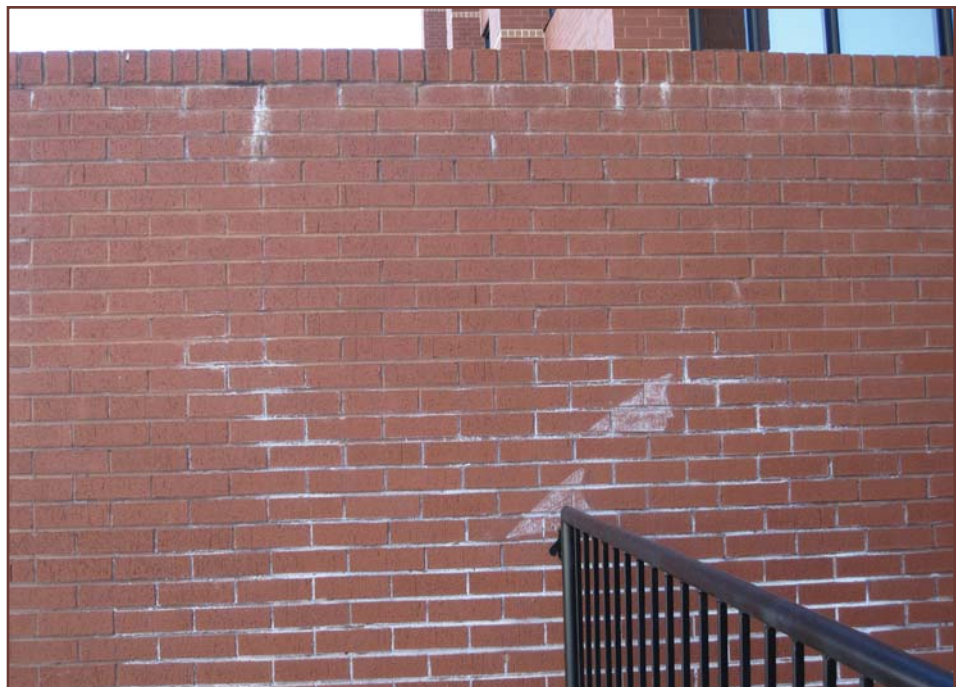
Figure 2 – Moisture migrating through the brick cap of a brick retaining wall produced traces of lime run and efflorescence.

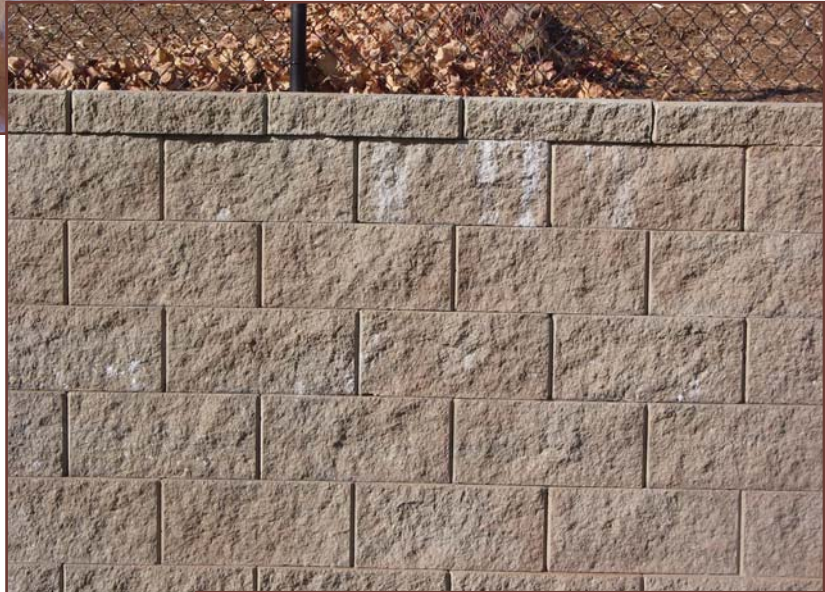
Figure 4 – Efflorescence caused by improper drainage and no waterproofing behind the retaining wall.

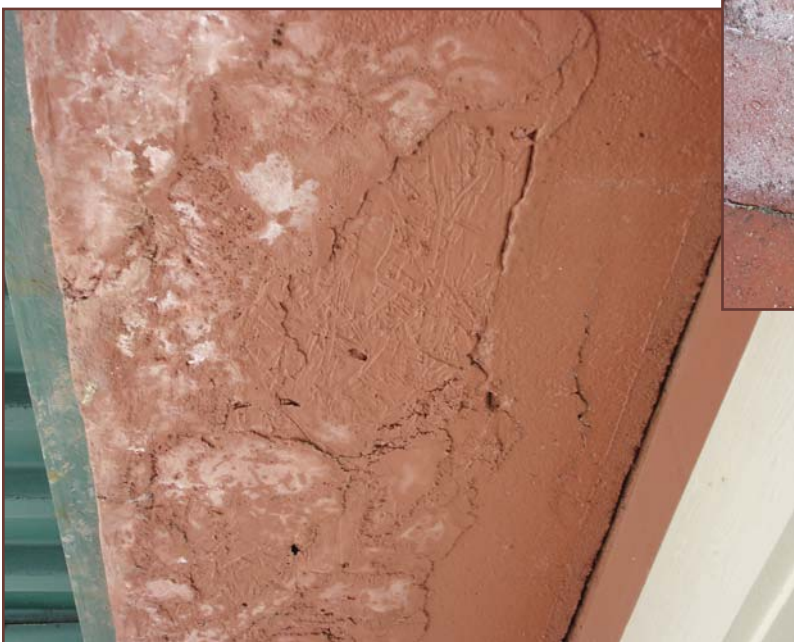
Figure 5 – An improper metal canopy tie-in directed moisture to the concrete lintel, causing efflorescence, spalling, and deterioration of attempted repairs.

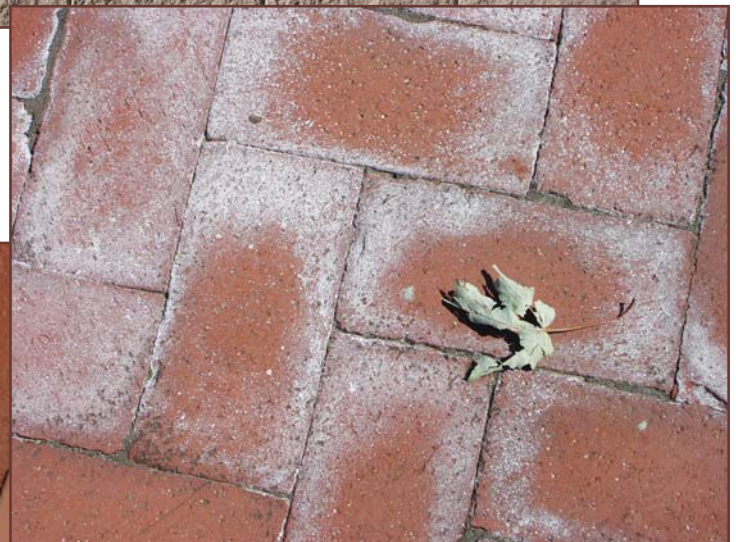
Figure 6 – Efflorescence on shaded clay pavers over an unprotected base.

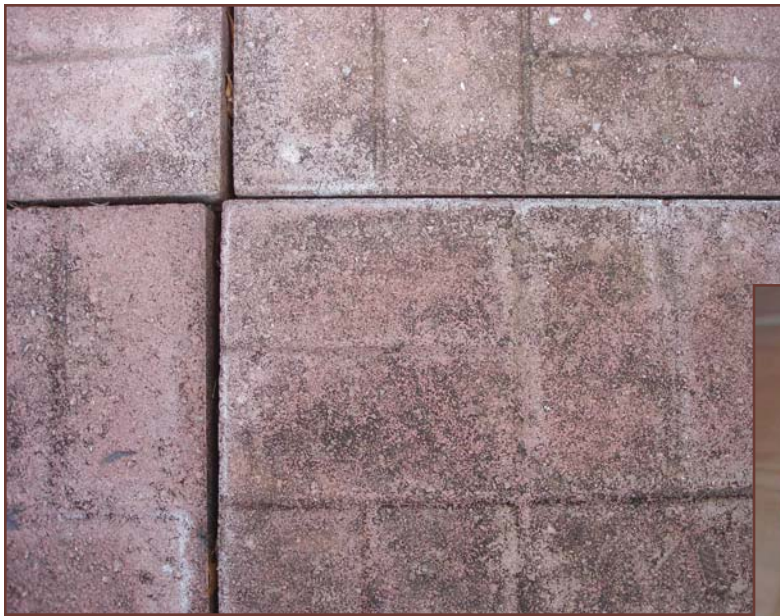
Figure 7 – Efflorescence mixed with traces of mildew on shaded concrete pavers caused by moisture migrating from unprotected base.

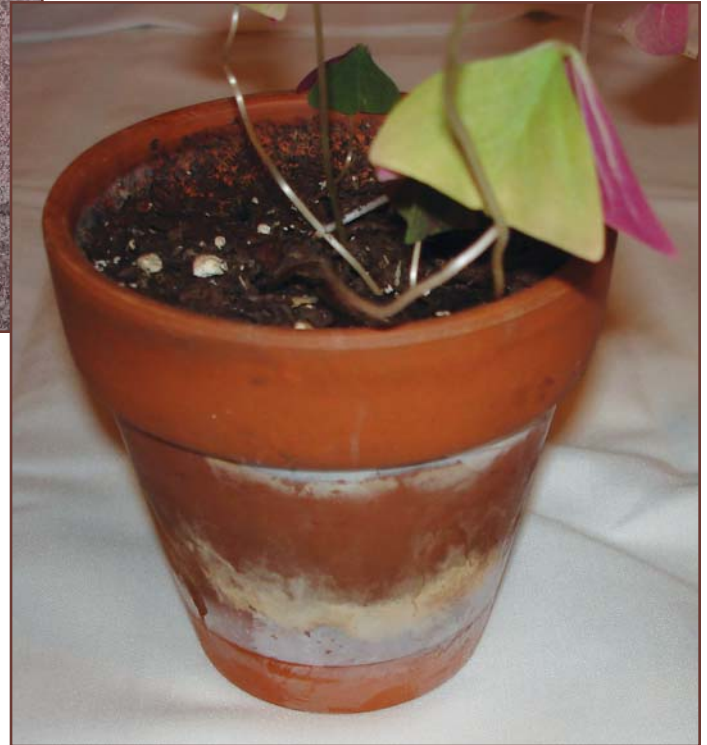
Figure 8 – Moisture mixed with the salts in a clay pot planter that was kept in the shade and formed a heavy crust of efflorescence.

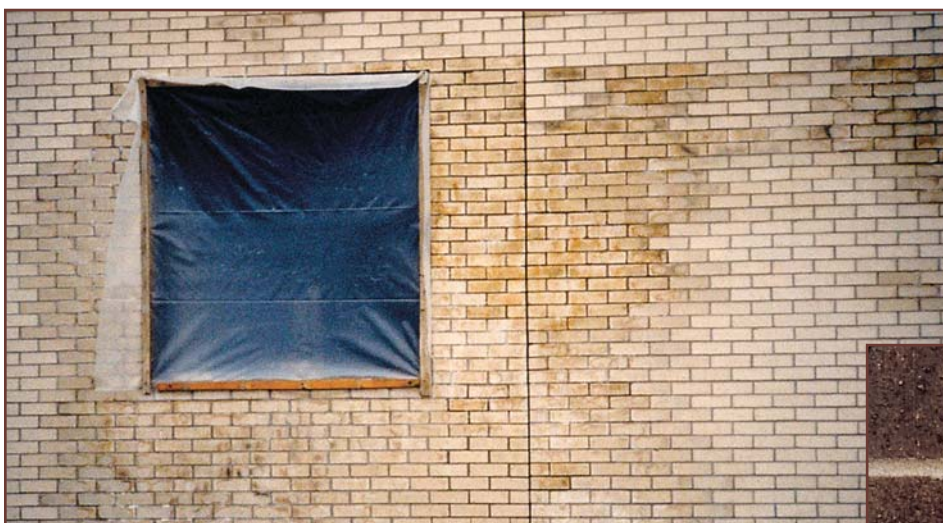
Figure 9 – Vanadium metallic stain leaves varied shades of yellow to light tan to light green splotches. (Courtesy of PROSOCO.)

Figure 10 – Manganese metallic stain leaves its dark mark that often resembles tobacco stain. (Courtesy of PROSOCO.)

brown streaks that can resemble tobacco stains (Figures 9 and 10).

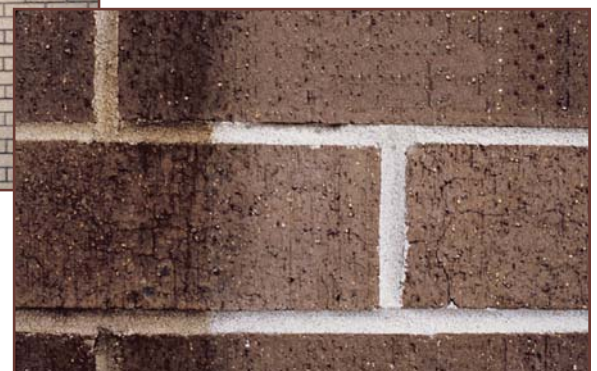
Figure 11 – A form of lime run beginning at the mortar joint and trailing down the face of the masonry.

Lime run is another discoloration similar to and often confused with efflorescence. Lime run usually forms in the joints and runs down the face of the masonry units during cleaning (Figure 11). The salts and resulting colors are different, but the production processes are basically the same.

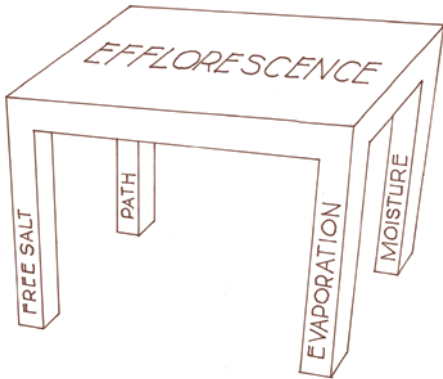
Figure 12 – Efflorescence requires four legs to form. Removing any one leg will prevent its formation. (Courtesy of Charlie Martin.)

Efflorescence is supported by the four mentioned components (Figure 12). It is analogous to a four-legged table where eliminating any one of the legs will cause the table to fall down. Thus, eliminate any one of efflorescence's legs, and efflorescence is stopped and the efflorescence problem is solved.

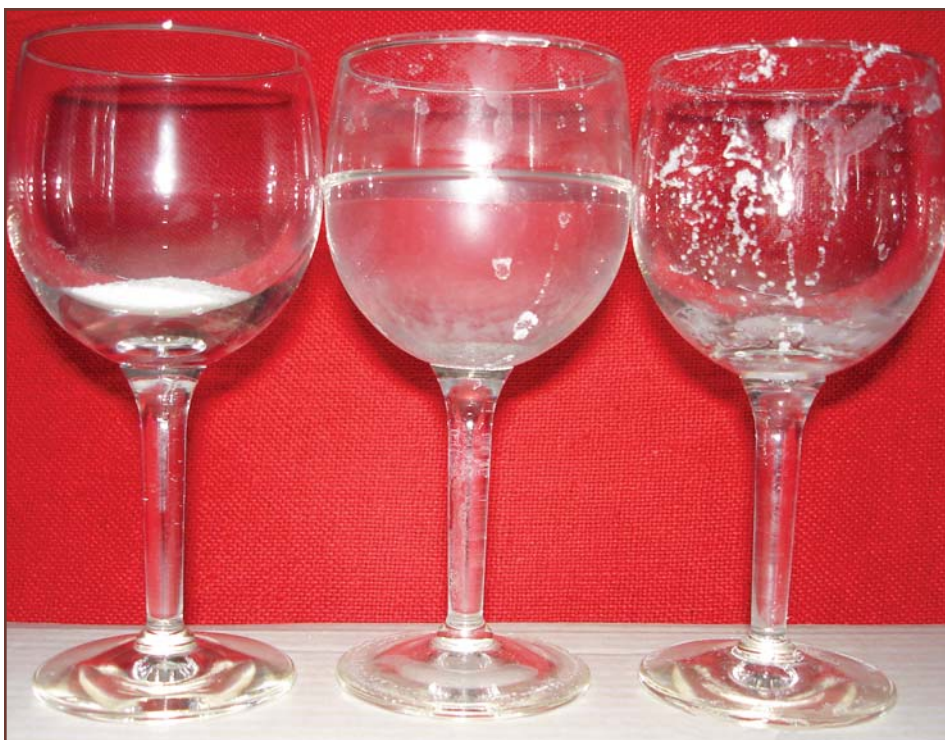
Figure 13 – Efflorescence begins with a salt deposit, combines with moisture, and then saline solution evaporates and leaves the characteristic white film.

migrated to the surface. For instance (Figure 13), sprinkle some table salt (sodium chloride) in a clear glass, add water, and watch the salt disappear (dissolve). Pour out the water and let the residual moisture in the glass evaporate. After evaporation, a cloudy white salt film is left on the glass. The glass on the left represents salt compounds in a structure. The center glass represents added moisture, and the right glass represents evaporation.

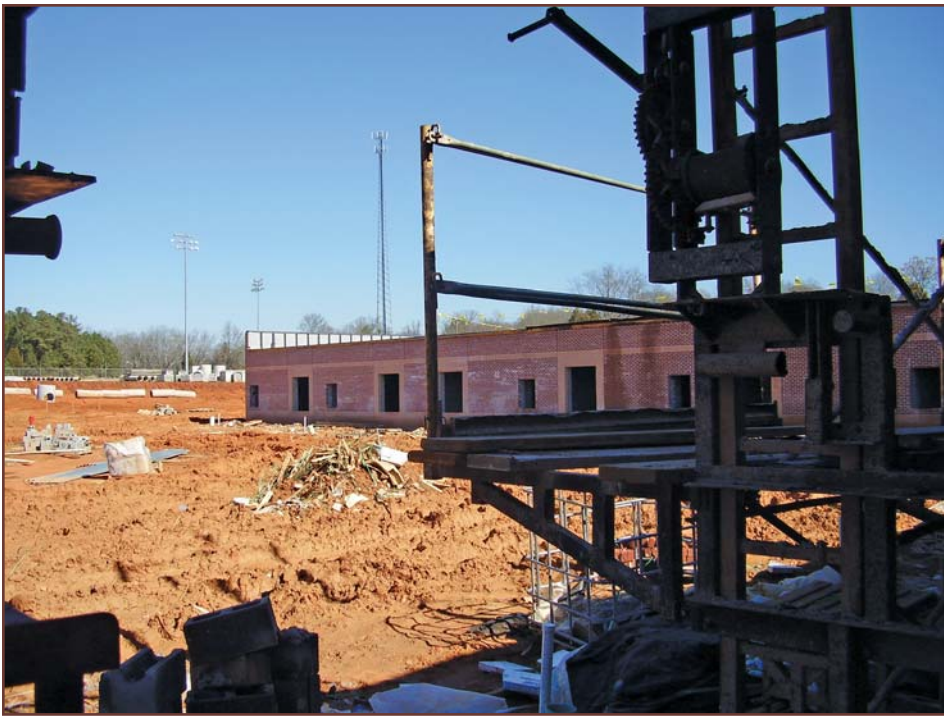
Figure 14 – New-building bloom during winter construction usually disappears after everything dries out, especially after the interior acclimates.

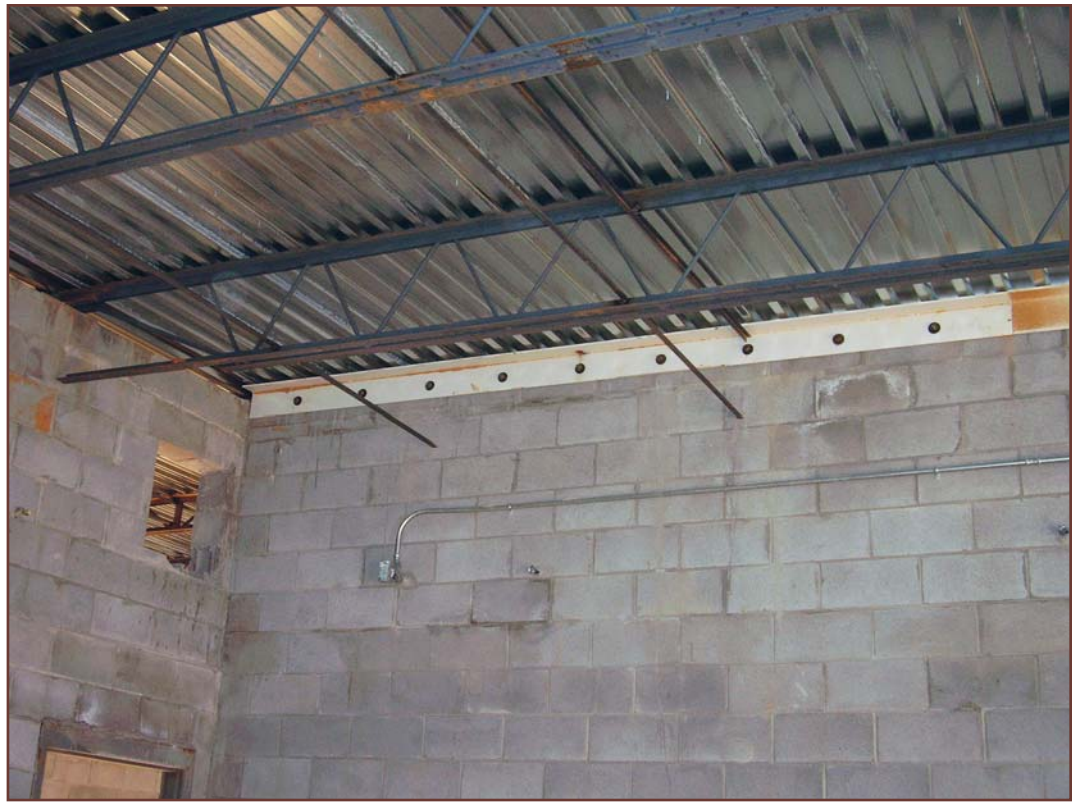
Figure 15 – New construction efflorescence from residual moisture that usually disappears after the building dries out.

Until the structure is dry, efflorescence can occur even on an interior wall (Figure 15). Drying will occur from the inside
