BUILDING ENVELOPE TECHNOLOGY SYMPOSIUM

CURTAIN WALL ISSUES, PROBLEMS, AND SOLUTIONS

KARIM P. ALLANA, RRC, RWC, PE; AND
DON CARTER

ALLANA BUICK & BERS, INC.

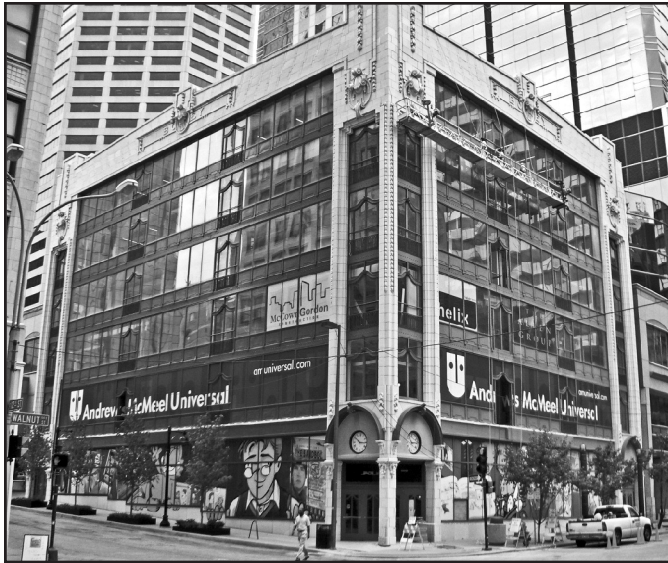
Figure 2 – Boley Clothing Company building, Kansas City, MO. Source: Wikipedia.

The first glass curtain wall in the United States reportedly was designed by the architect Louis S. Curtiss and installed in 1909 in Kansas City on the Boley Clothing Company building. That building is now listed on the National Register of Historic Places and is still in use (*Figure 2*).

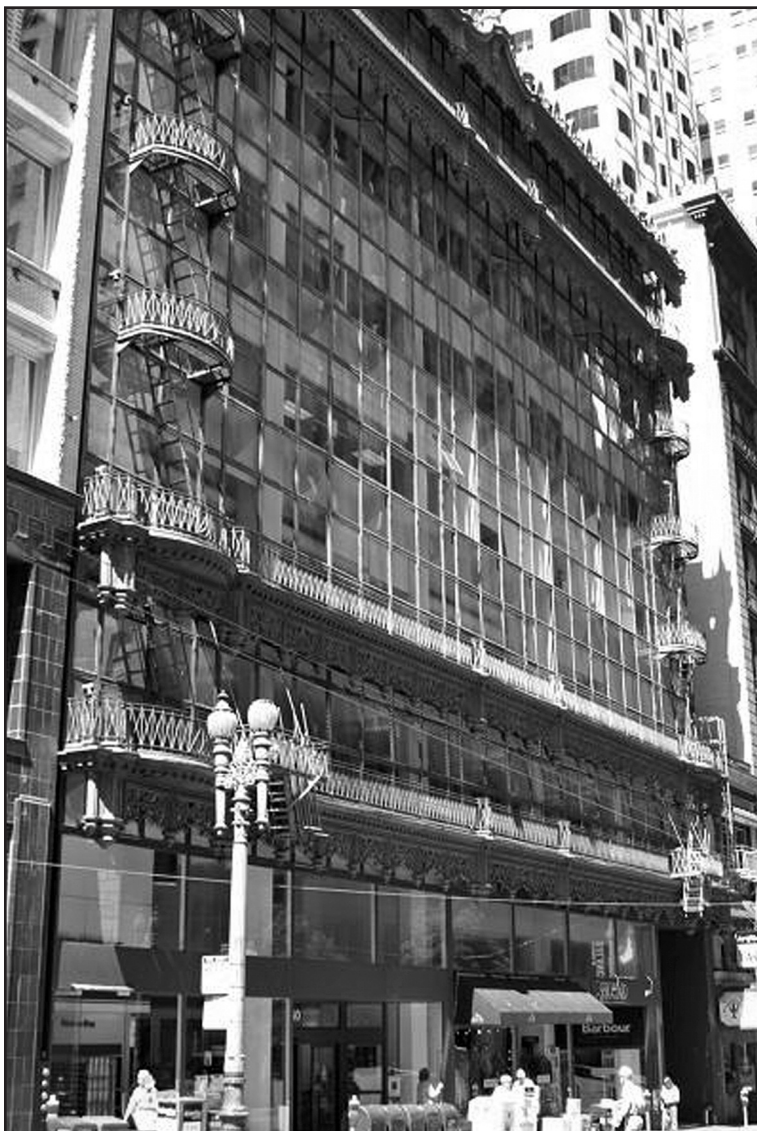
Figure 3 – Hallidie building, San Francisco, CA. Source: WorldArchitectureMap.org and Wikipedia.

Francisco, which was constructed nine years later in 1918, is still in operation and houses the Northern California Chapter of the American Institute of Architects (AIA). Although not the first glass curtain wall building, it is a good example of a modernist building with a curtain wall (Figure 3). Note the steel mullions (vertical members) and other support members. Glass was typically held in place with clips and weather-proofed with glazing compound.

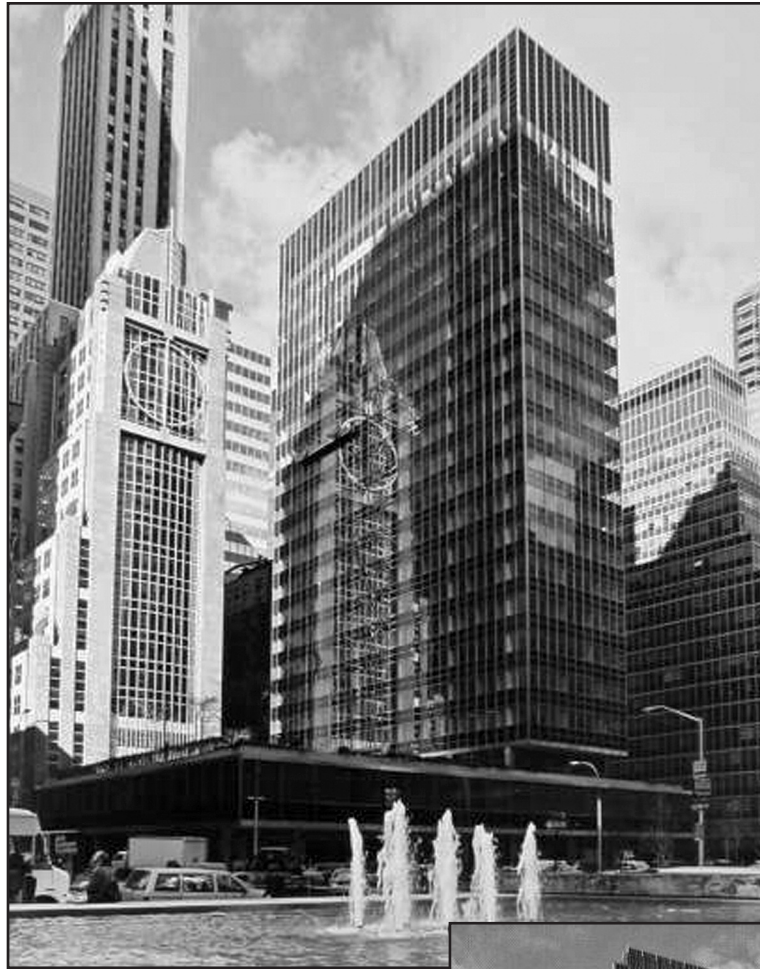
Figure 4 – Lever House, New York City. Source: Wikipedia.

The first curtain wall installed in New York City, in the Lever House building (Skidmore, Owings, and Merrill, 1952), was a major innovation in the extensive use of steel mullions (Figure 4).

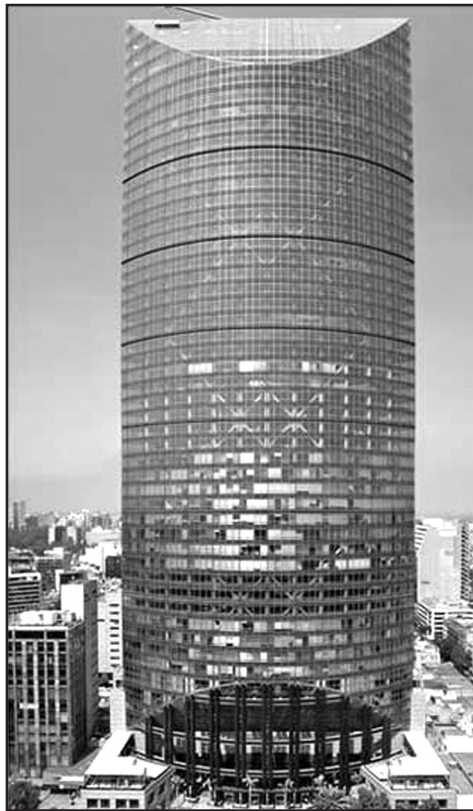
Figure 5 – Bell Atlantic Tower, Philadelphia, PA. Source: Building Design and Construction Magazine.

Figure 5 depicts the Bell Atlantic Tower in Philadelphia, clad in glass and 65% granite. The stone for this 500,000-sq.-ft. curtain wall was quarried in Sweden, then shipped in blocks to Italy, where it was fabricated into 3-cm-thick infill panels with polished, honed, and flamed finishes. The granite panels were then shipped to Miami, installed into 10,500 unitized panels, and shipped to Philadelphia by flatbed trailers, where floors 3 through 42 were wrapped in curtain wall at the rate of two floors per week.

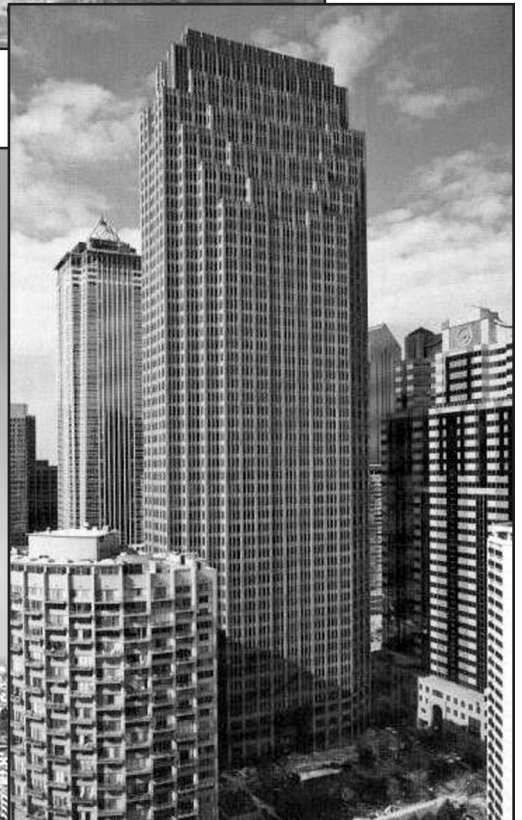
Figure 6 – Torre Mayor building, Mexico City. Source: Teratec, Inc.

façade in Figure 6. In January 2003, a 7.6 magnitude earthquake shook Mexico City, but the building was not damaged, and many occupants were unaware of the quake. This curtain wall provided design challenges due to sloped and reverse-slope glazing and the building face curvature, achieved with segmented panels.

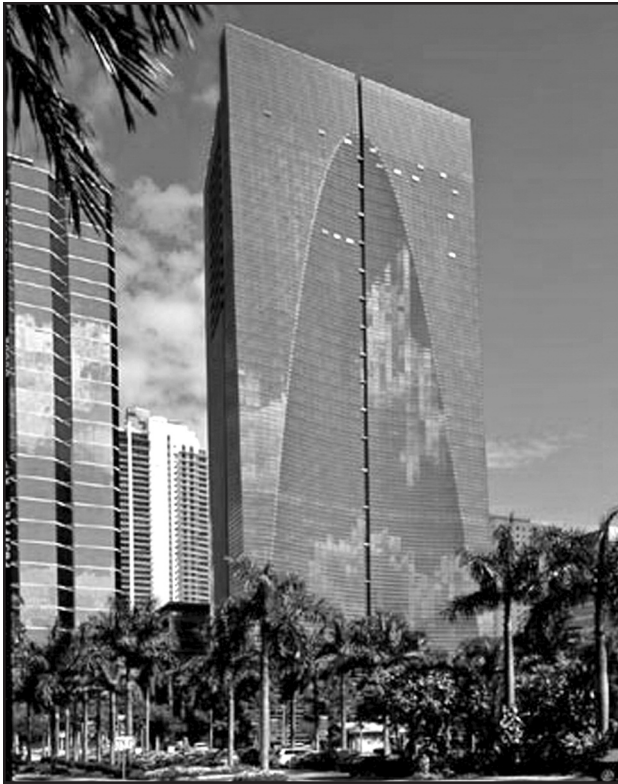
Figure 7 – Espirito Santo Building, Miami. Note conical shape and complexity of building face. Source: Viracon, Inc.

Figure 7 is a photo of the Espirito Santo Building, the 36-story Miami building, the architecture of which is based loosely on the Saint Louis Arch. Design and installation challenges faced in this building also included sloped glazing, the conical façade, hundreds of custom extrusions, a very large number of complicated construction details, thousands of fabrication document sheets, and extensive laboratory testing, including large- and small-missile impact. Design wind loads for the curtain wall were +140/-180 psf. The design and construction of this building was aided by 3-D modeling.

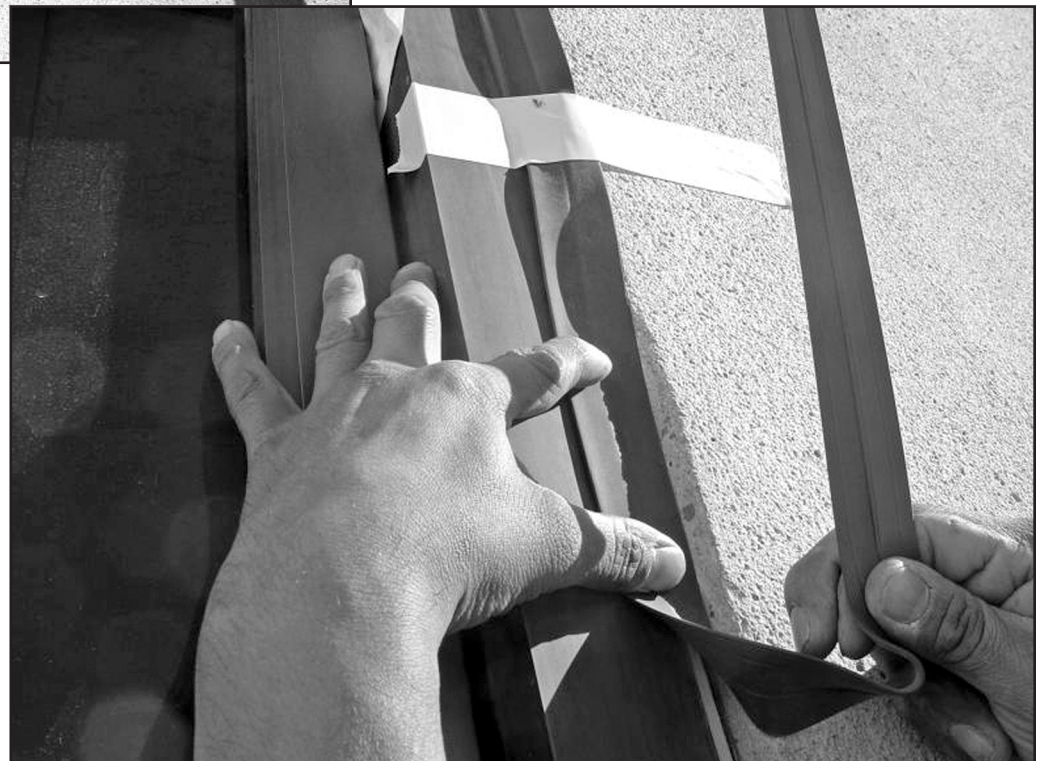
Figure 22 – Precured sealant can handle 200% extension.

overlay the failed sealant with precured silicone with at least four times the extension capacity of the original sealant (see Figure 22). One half inch of each edge of the precured silicone was adhered to the aluminum and concrete with silicone sealant.

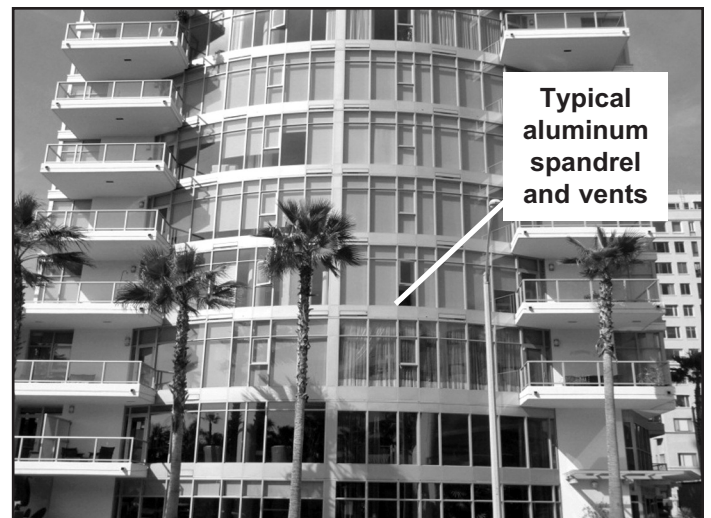
Figure 23 – Segmented window wall.

The segmented (chorded in plan) window wall was unitized and installed from the building interior (Figure 23). Like all window walls, it was anchored between other construction—floor slabs in this case—but the bottom 8 to 10 in. were notched vertically to permit the remaining 2.5-in. exterior portion to bypass the face of slab, terminating with a sealant joint against the outboard cantilevered head receptor of the window wall on the floor below (Figure 24).
