# INFRARED THERMOGRAPHY FOR ROOF INVESTIGATIONS

BY SCOTT WOOD

## ABSTRACT

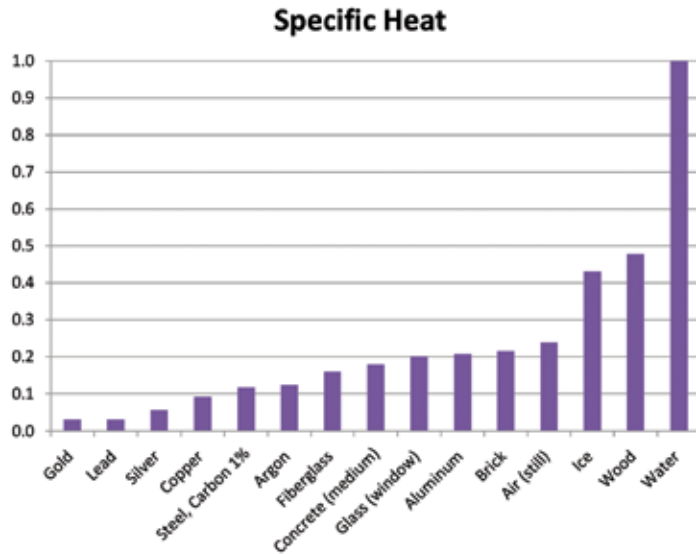
Figure 6 – Heat capacity of various materials in Btu/lb. °F.

The thermal patterns observed on the roof where wet insulation is present are due to material differences in “thermal capacity” or “heat capacity.” This is the amount of heat (energy) required to raise a unit mass one degree in temperature. The chart in *Figure 6* provides a graphic representation of specific heat of various materials, from gold to water. It is clear that water has the highest heat capacity of the materials listed. In fact, it has such a high-heat capacity that it takes water almost ten times longer to heat than steel. Once materials with a high specific heat are heated, they stay warmer

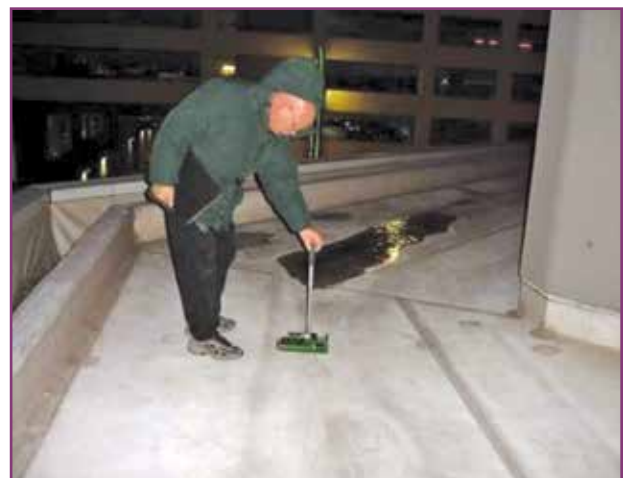
Figure 13 – Visual image showing frozen water and a roof capacitance moisture meter (Tramex RWS moisture meter roof and wall scanner).

for trapped moisture. The small hot spots in Figure 10 are due to the high conductivity of the fasteners. Whenever there is a concern, moisture meter testing (Figures 12-13) or nuclear radioisotopic thermalization<sup>12</sup> (Figures 14-15) should be used to confirm the patterning observed by infrared thermography. If following the ASTM C1153 standard, coring must be performed to confirm the results of the thermography inspection.
