Water Entry Through Attic Vents

By Stephen L. Quarles, PhD; Tanya M. Brown, PhD; and Anne D. Cope, PhD, PE

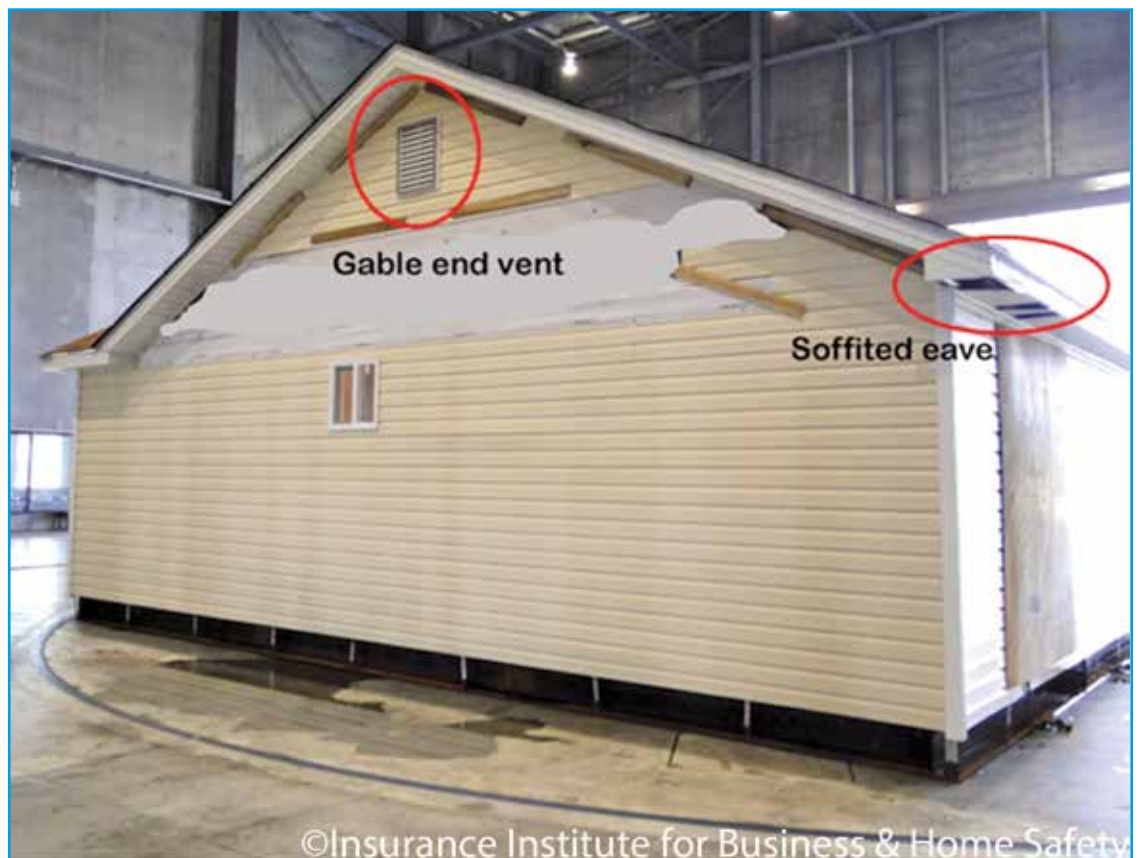
Figure 1 – End view of the building, showing location of gable end vent (open) and soffited eave. Note: Some of the panels have detached as a result of exposure to the elevated wind speeds.

1.5- x 2-ft. (0.46- x 0.6-m) gable end vents and nominal 1-ft. (0.3-m)-wide soffits at the eaves. In this series of tests, water entry through the soffit material (both installed and not installed) and through gable end vents was evaluated (Figure 1). A wind-driven rain deposition rate of 8 in./hour (203 mm/hour) was used. This rate was based on the value specified for wind-driven rain

In the first three tests (Table 1, Tests 1-3), water entry through the eaves was evaluated with no soffit material installed, to simulate a case where the soffit covering (see Figure 1) detached during a high-wind event. Subsequent testing was conducted after the perforated vinyl soffit covering was installed (Table 1, Tests 4-8). Water entry through the gable end vent was also evaluated with (Table 1, Tests 3-4) and without (Table 1, Tests 1-2 and 5-8) a plywood covering attached to the outside of the gable end vent. Additional testing details are provided in the Testing Program section of this article.

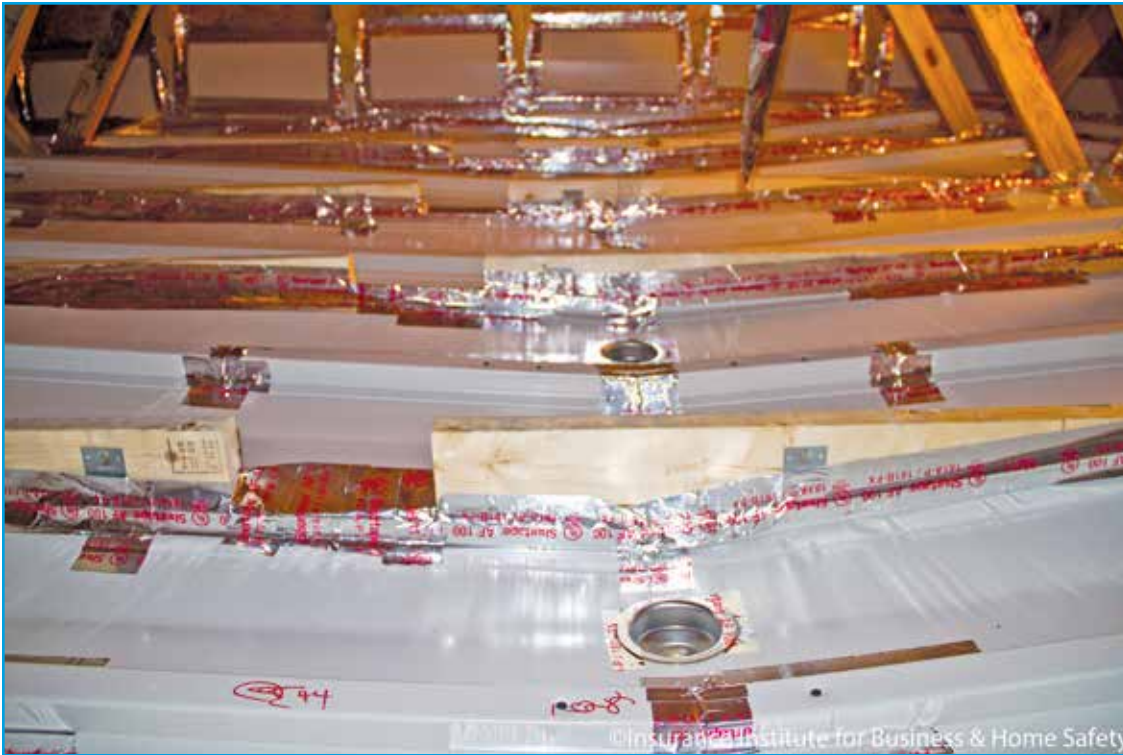
Figure 2 – Water collection channels between ceiling trusses in the attic of the test building.

Drainage panels and tracks (DrySpace™)

were installed in the attic of the test building to create water collection channels between the ceiling trusses, as shown in *Figure 2*. These channels were outfitted with drains and pipes that allowed water to be collected in plastic containers arranged throughout the interior (nonattic) space in the two halves of the building. The drainage system was installed so that the collected water could be segregated by zones. These zones were roughly 10 ft. (3 m) long by 2 ft. (0.6 m) wide. The trusses extended from the front to the back of the test building. The between-truss spacing was divided into three sections, each about 10 ft. (3 m) long. Typical drain and collection locations are shown in *Figure 3*. Each test was conducted for a 20-minute period, during which a constant wind speed was maintained. At the completion of each test, water in the buckets was measured and recorded.

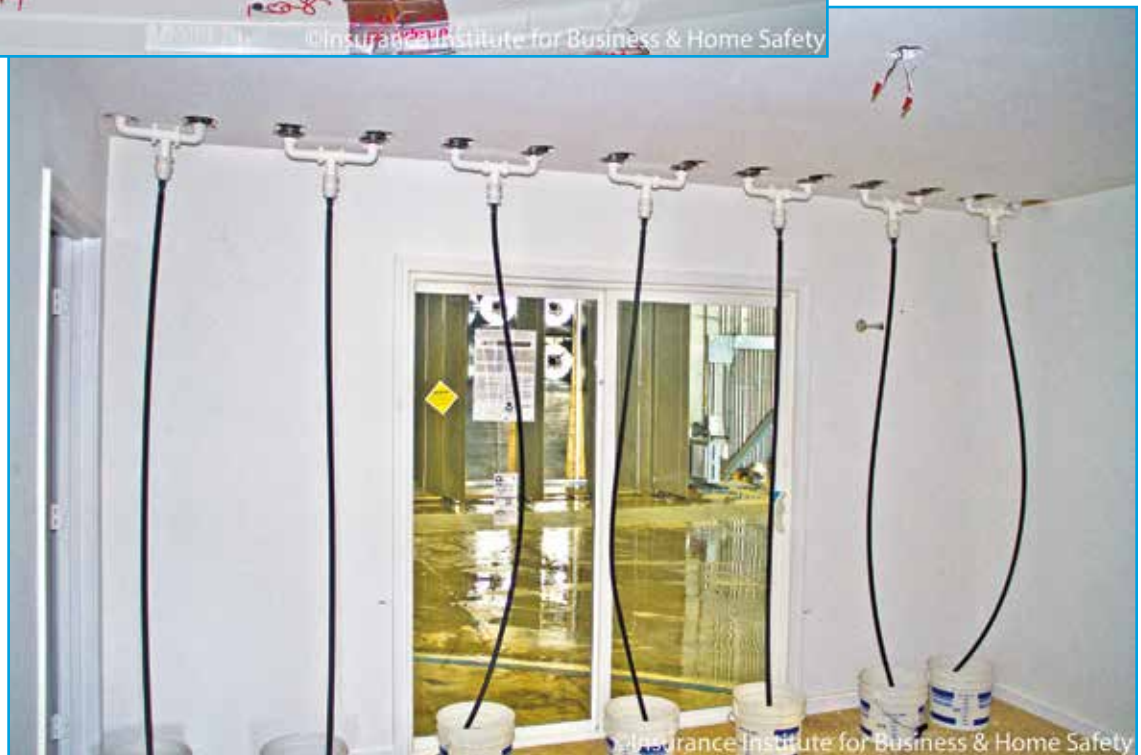
Figure 3 – Water collection system inside the test building.

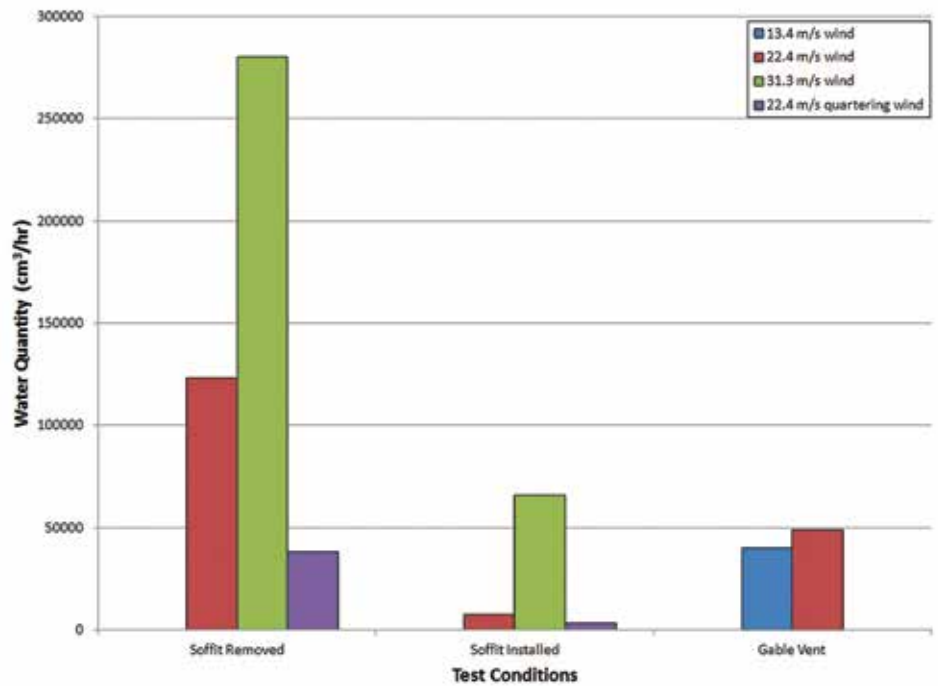
Figure 4 – Total amount of water entry into the attic per hour for under-eave and gable end conditions.

A graph comparing the volume of water collected through the gable and soffit eave openings is shown in *Figure 4*. Note the difference between water entry through the soffit when installed versus removed. Water entry through the open soffit was several times higher than that with the soffit cover installed, demonstrating the importance of keeping the soffit material intact during high-wind events. Water entry through the eave (soffit material installed or removed) more than doubled when the wind speed was increased from 50 to 70 mph (22.4 to 31.3 m/s). Water entry through the gable end vent was not as affected by wind speed. Although the 70-mph (31.3-m/s) condition was not tested for gable end vents, the amount of water entry measured at the 30- and 50-mph (13.4- and 22.4-m/s) wind speeds was similar; and in each case, most of the water impacting the vent entered the attic.
