INFRARED THERMOGRAPHY FOR ROOF INVESTIGATIONS

BY SCOTT WOOD

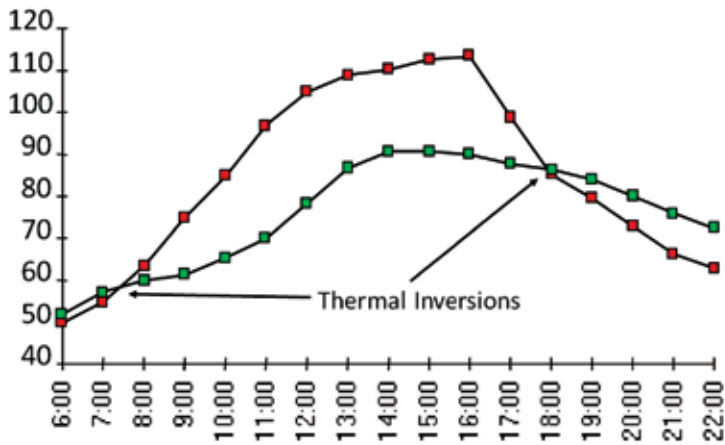
Figure 8 – Graph showing the temperatures of wet insulation (green points) and dry roof deck (red points).

rising, due to the thermal capacity differences of water and roofing material. The temperature data shown in Figure 8 indicate temperature differences of wet or dry insulation during the day and evening.

Unfortunately, ASTM Standard C1153 does not provide guidance for daytime roof thermography. But since the physics do not change, thermal patterning can be observed during the day as well as the evening. The graph in Figure 8 clearly shows that temperature differences appear throughout the day, as well as in the evening. Day thermography may be more difficult than evening thermography due to high daytime temperatures overwhelming the cool patterns of the wet insulation with hot spots or shadowing, as shown in Figures 20-21. The comparison of an evening inspection (Figure 18) and morning inspection (Figures 16-17) of the same area shows the dramatic temperature differences, in part due to solar insolation differences of day and night, shadowing, and night radiation heat transfer.

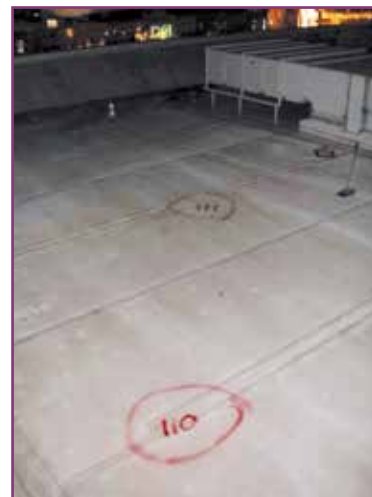
Figure 11 – Visual image of an on-roof viewing.

Walk-on inspections may require a wide-angle lens or the stitching of multiple images to provide a wide angle of view shown in Figure 9 as compared to the standard lens shown in Figures 10 and 11. Additional thermal patterns may be confused

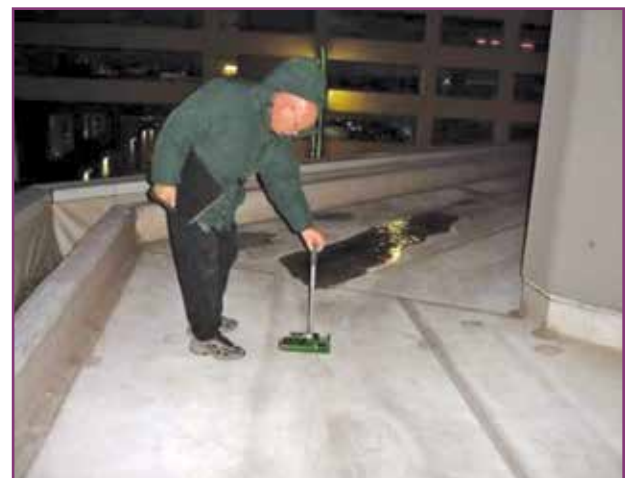
Figure 13 – Visual image showing frozen water and a roof capacitance moisture meter (Tramex RWS moisture meter roof and wall scanner).

for trapped moisture. The small hot spots in Figure 10 are due to the high conductivity of the fasteners. Whenever there is a concern, moisture meter testing (Figures 12-13) or nuclear radioisotopic thermalization¹² (Figures 14-15) should be used to confirm the patterning observed by infrared thermography. If following the ASTM C1153 standard, coring must be performed to confirm the results of the thermography inspection.

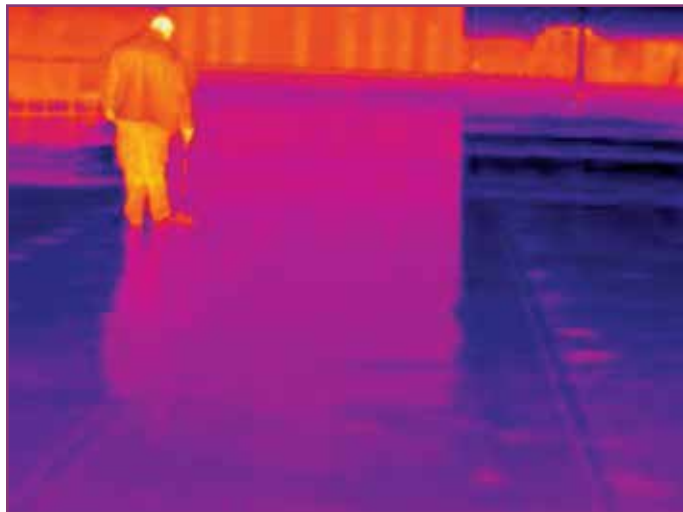
Figure 22 – Reflection due to high angle obscures the roof.
