Gutter Installation on a Standing-Seam Metal Roof

By Harvey Freeman

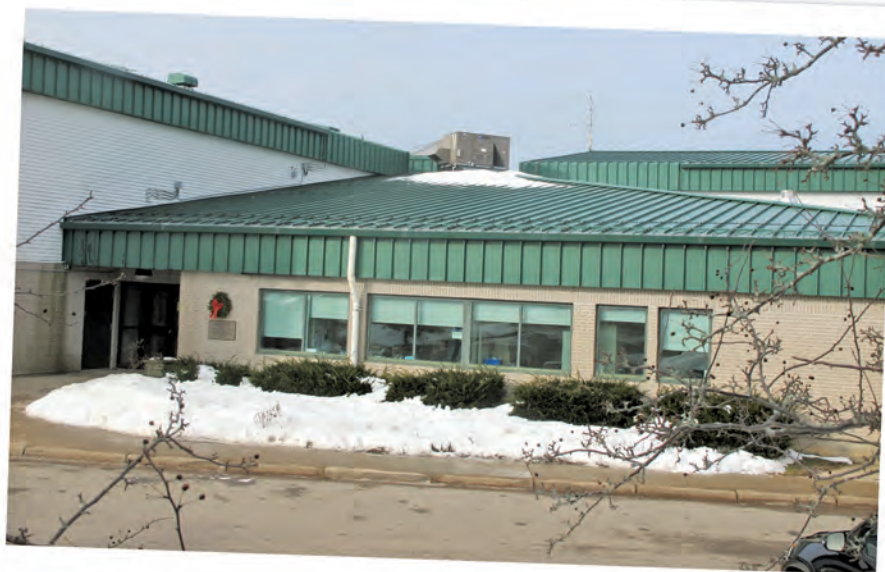
regular rainstorm, most of the water from the two roof levels misses the gutter. In addition, the winter ice buildup on the sidewalk at entrances from this water caused a maintenance and safety issue.

Figure 2 – The public entrance is located below the water spill from two roof levels.

The public entrance and service entrance are in the low roof area, but tight against the sidewalls of the wings with the higher roofs. Figure 2 shows the location of the public entrance. The original design included a 5-in. residential gutter at the bottom of the 3-ft. fascia. Figure 3 shows the location of this gutter at the service entrance. In any

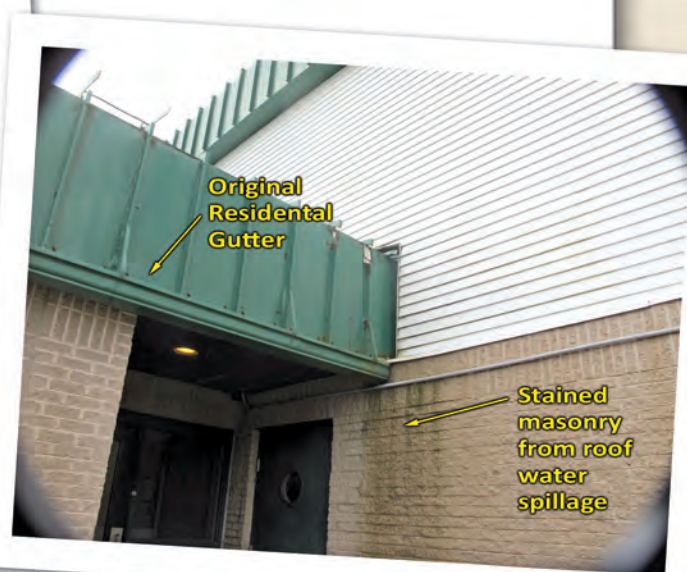
Figure 3 – The service entrance showing the original 5-in. gutter at the bottom of the 3-ft.-high fascia.

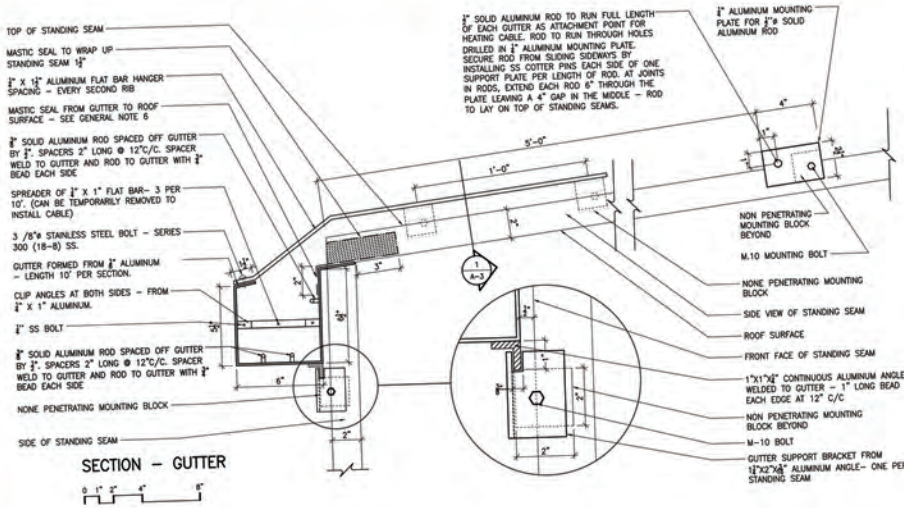
Figure 4 – Roof edge and gutter detail.

The gutter has a double line of commercial heat-tracing cable lying on the bottom of the gutter and running as a double loop down all downspouts to at least 3 ft. below grade, as well as 5 ft. up the roof slope. A 1/2-in. aluminum rod runs parallel to the eave at the 5-ft. mark up the slope to provide a secure anchor point for the cable on the surface of the roof.

in the area. There was already an underground drainage system in place, so the location of downspouts had been predetermined. See Figure 4.

The gutter is made from 1/8-in. aluminum, which is painted on the visible surfaces to match the green of the roof and is supported on a nonpenetrating mounting block that clamps to the standing seams of the fascia, as shown in the section detail. The same mounting block is used to connect the

tieback straps to the ribs. The gutter has a flange on the inner edge that is notched to fit around the standing seams.

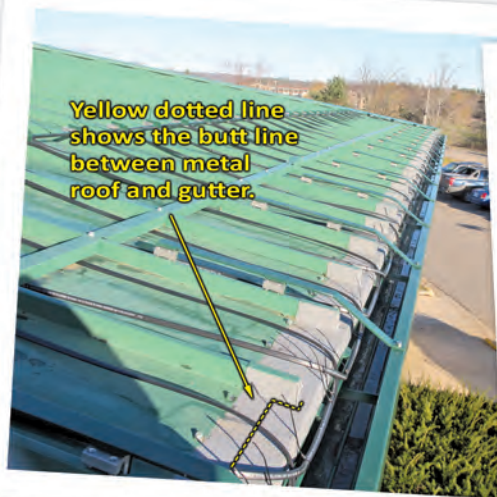
Due to the standing seams in the fascia, the back flange of the gutter had to be notched around the ribs. The butt line of gutter to roof is shown by the yellow line in Figure 5. The grey mem-

Figure 5 –View of the complete installation of gutter and heating cable.

brane is a liquid-applied modified silicone product that goes on in two coats with an open-weave fabric mesh used between the coats to reinforce the joint between pre-painted steel roof and aluminum gutter.

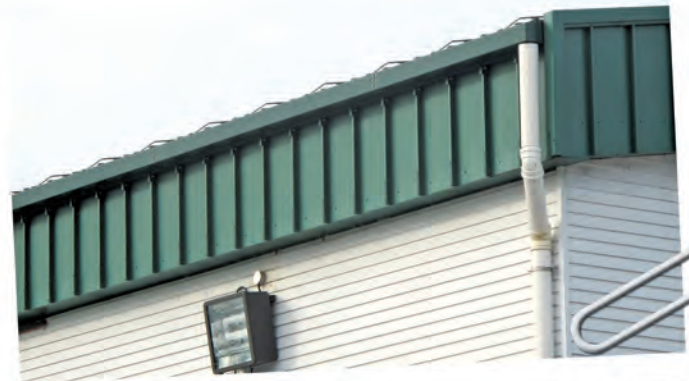
Figure 6 –View of the complete installation as seen from the ground.

This modified silicone product works well to seal the complicated junction of the standing-seam roof to the gutter but only comes in grey. The manufacturer of this product specified that it should extend a minimum of 3 in. beyond the joint. We kept to this dimension to ensure that the grey seal would not be visible from the ground (Figure 6).
