Wind Uplift and Spray Polyurethane Foam

By Trent Shidaker

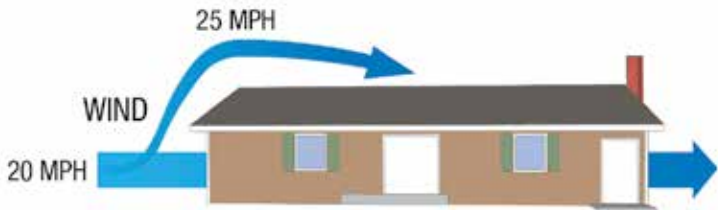
Figure 1 – During strong gusts on relatively flat roof surfaces, air pressure can drop and act as a vacuum, pulling roofing material into the air stream.

by wind flowing over the roof surface, while positive pressure to the underside of the roof deck develops from the wind blowing through open windows and doors of the building. The result is an upward force on the roof. The combination of the negative pressure and positive pressure can double the destructive force of the wind, causing roof assembly failure. (See Figure 1.)

During strong gusts on relatively flat roof surfaces where the wind is flowing more than striking, air pressure can quickly drop as air speed increases. This loss of air pressure can act as a vacuum and start to pull roofing materials into the air stream, where the direct force of the wind will potentially sweep them away.

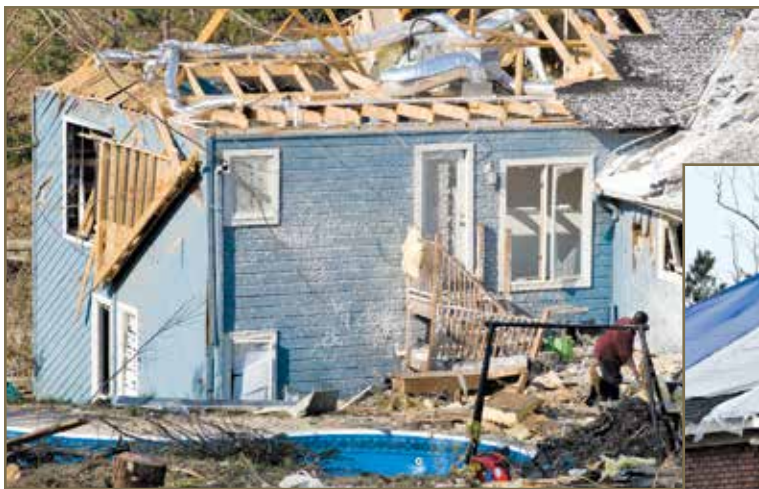
Photo 2 – Blown-off roof.

When windows or garage doors implode during a hurricane, air pressure within the home increases suddenly and significantly. While exterior surfaces are generally designed and built to withstand extreme air pressure, interior walls and doors are not. The increased air pressure can inflate the home like a balloon. When this happens, roof sheathing can quickly be blown up and away from the home. Not only do the high wind speeds create a vacuum above the roof, but inflation within the home increases air pressure beneath the roof, causing it to be blown off (*Photos 2 and 3*).

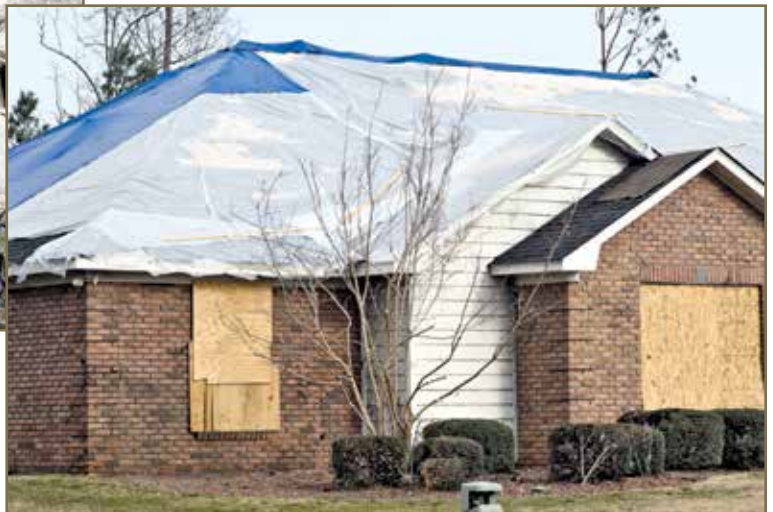
Photo 3 – House is still standing, but the roof has been torn off.

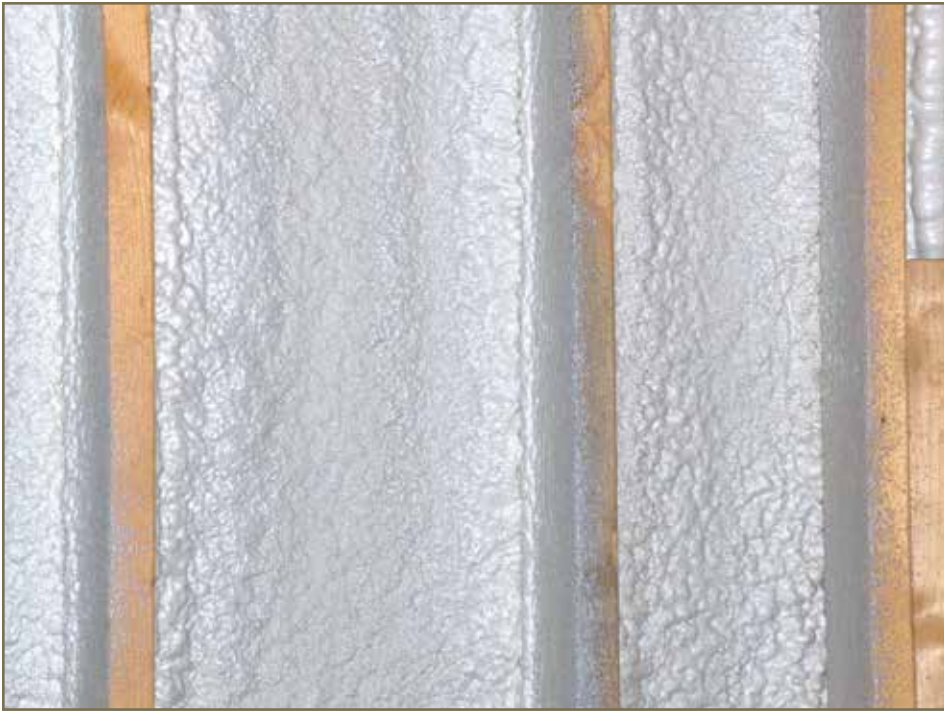
Photo 4 – Close-up of spray foam applied to walls.

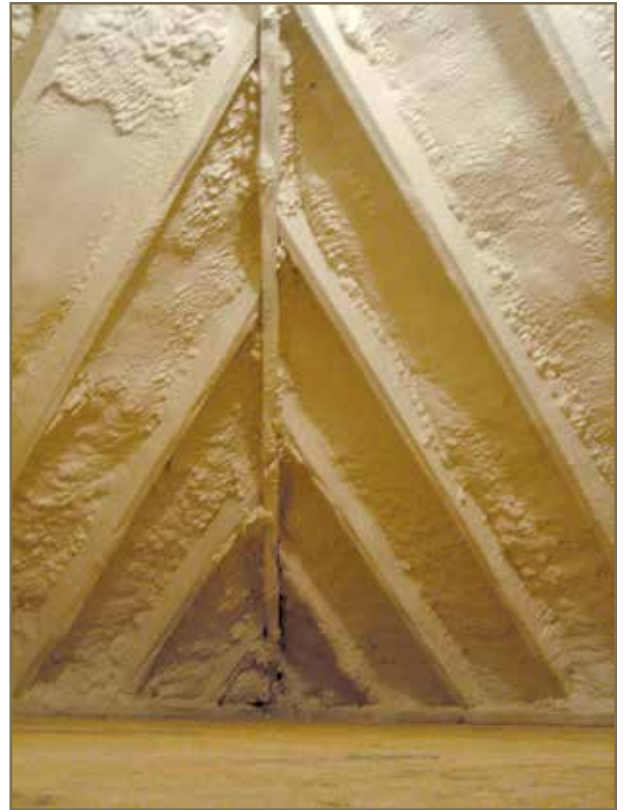
Photo 5 – Closed-cell SPF applied to the underside of a roof increases the racking strength.

The most recent study, conducted in 2006, demonstrated that even 1.5 inches of closed-cell SPF provides equivalent racking strength enhancement to polyiso sheathing as 3.5 inches of closed-cell SPF (Photo 5.)
