28th RCI International Convention and Trade Show

THE EFFECTS OF HAIL ON METAL ROOFING SYSTEMS

JIM D. KOONTZ, RRC, PE, AND TROY L. WHITE, PE

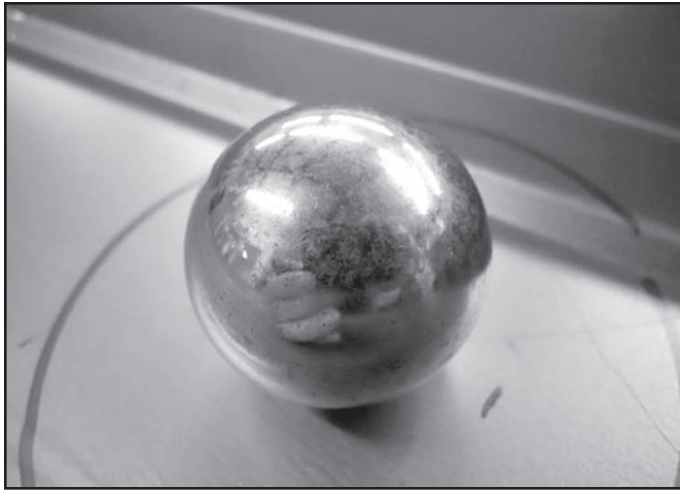
Figure 2 – Steel sphere.

The ten targets of metal roofing were impacted using both 1.5- to 2-in.-diameter steel spheres and 1.5- to 2-in.-diameter ice spheres (refer to *Table 2*). The ice spheres had a density of .91 g/cm³. The steel sphere testing was per UL 2218 Class 2 and Class 4 test standards. The steel sphere impact testing involves dropping a steel sphere from a prescribed height to generate a given kinetic energy (*Figure 2*). Since a steel sphere of an exact weight is dropped from the same height each time, the specific kinetic energy produced is very reproducible. The UL procedure calls for impacting the same location twice. For the purposes of this study, only one impact was performed in order to have a comparison to a single ice sphere impact.

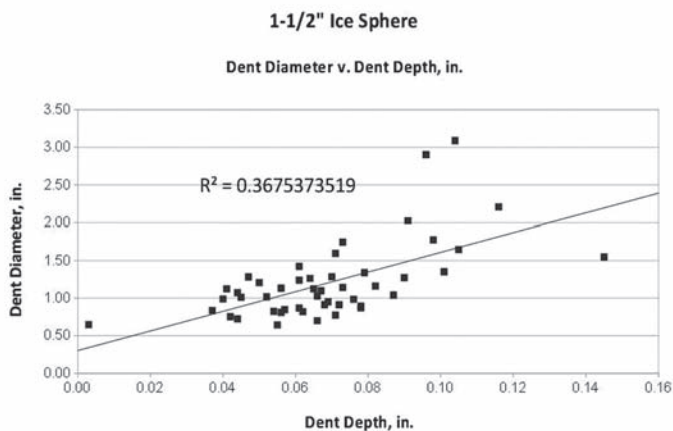
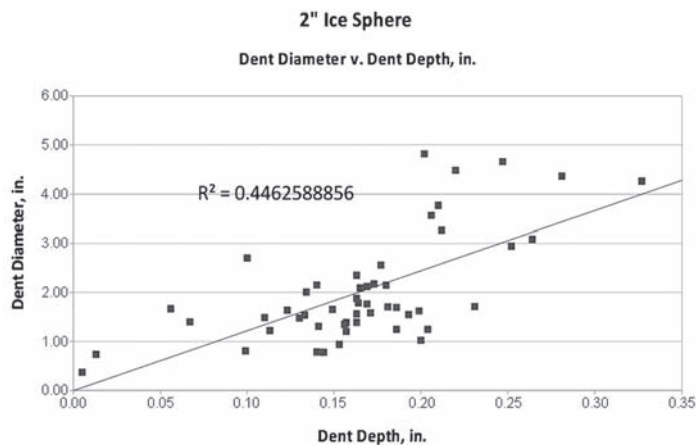
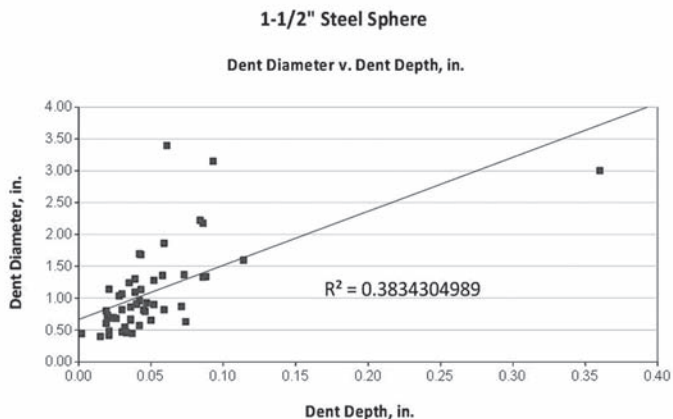
There is a correlation between indentation depth and dent diameter. The indentation obviously varies depending upon gauge, type of metal roof, and diameter of impacting sphere. Refer to *Figures 7 through 10*. The higher the impact energy (i.e., the greater the diameter of hail or steel sphere), the wider and deeper the indentation.

Figure 7 – 1½-in. ice sphere.

Figure 8 – 2-in. ice sphere.

Figure 9 – 1½-in. steel sphere.

Figure 10 – 2-in steel sphere.

- With the exception of a 32-gauge corrugated metal penetration, splitting of the metal did not occur with any of the metal roofing tested per the UL and NBS impact procedures.
- Indentations resulted in all metal roofing tested when impacted by either ice or steel spheres.
- The depth and width of dents varied, depending upon impact location, gauge, and type of metal. For the most part, the characteristics of the

dents, diameter, and depth are generally random. There are some differences between steel and ice sphere impacts; however, it does appear that with high-density ice spheres, the degree of indentation is slightly higher than that observed with steel spheres.

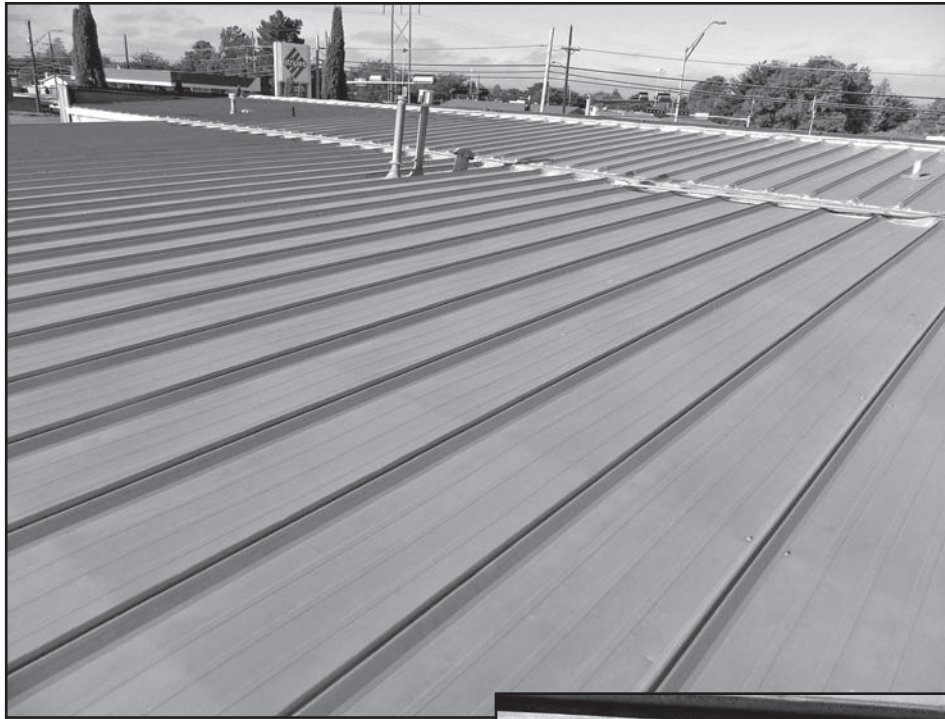
Figure 11 - 24-gauge metal roof installed in 1980.

Figure 12 - Minor dents have not resulted in any apparent deterioration.

The 24-gauge metal roof of standing seam, two foot on center, was installed in 1980 (see *Figures 11 and 12*). Multiple hail events have occurred at this location. Minor dents observed have not resulted in any apparent deterioration or loss of functional or aesthetic value.
