# Fasteners and Self-Sealability of Weather-Resistive Barriers

By Karl Schaack, RRC, PE

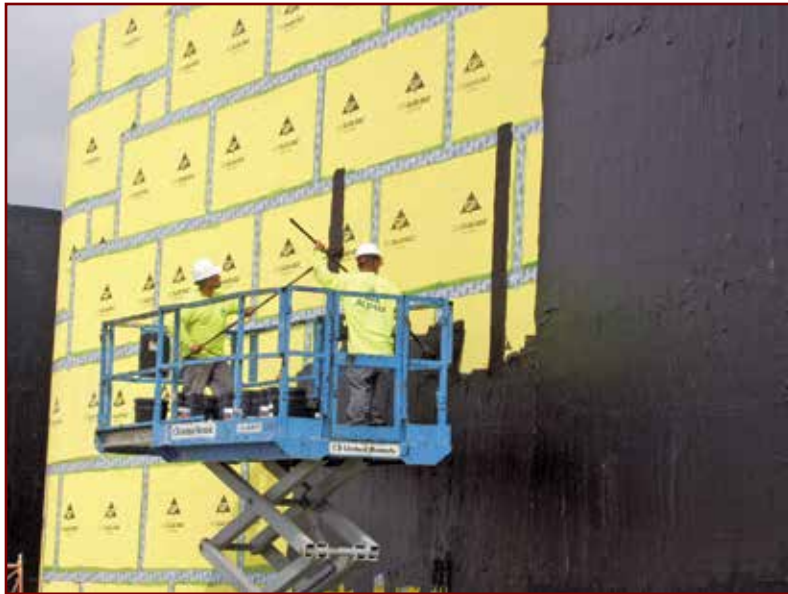
Photo 1 – Application of emulsion dampproofing.

The exterior wall assembly has changed from the application of dampproofing on exterior sheathing such as traditional bituminous-based emulsions that were troweled, rolled, or sprayed onto the backup wall (Photo 1) to now include elastomeric sheets, synthetic building wraps, spray-applied polyurethane foam, rigid foam board, and liquid-applied synthetic materials that are either mechanically attached or adhered to the backup wall.

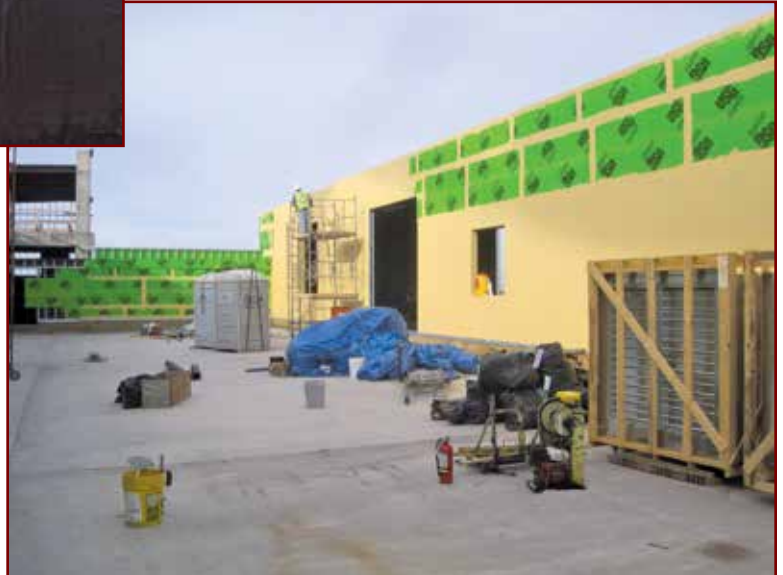
Photo 2 – Application of liquid-applied WRB.

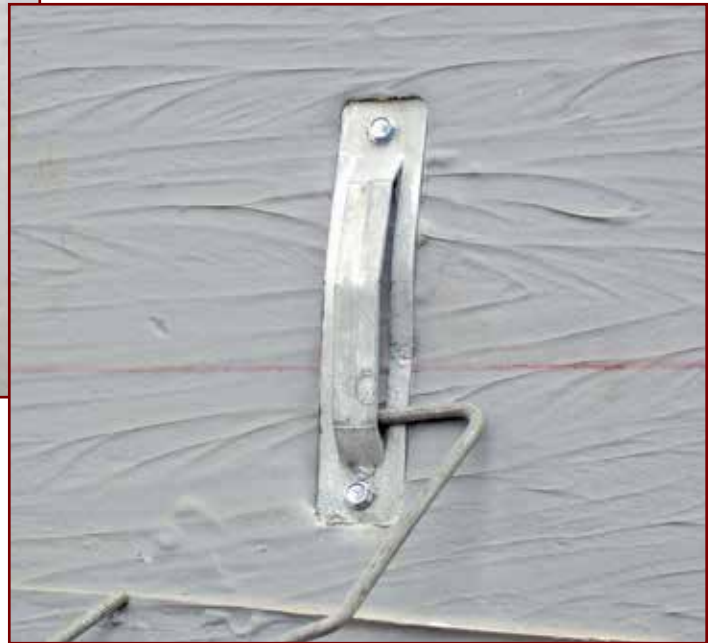
Photo 4 – Brick tie depressed into and damaging WRB.

Unlike securement into a plywood substrate that has historically been used in exterior wall construction (particularly for plaster applications), when a fastener is installed into and through gypsum sheathing that does not penetrate into a sound substrate, the fastener continues to spin, reaming out the hole. The density of gypsum sheathing is not substantial enough to allow the fastener to “bite” and attain adequate compression against the WRB material (either liquid-applied or self-adhering sheets); consequently, the fastener hole becomes enlarged as the fastener spins. With a plywood backup, a fastener could be placed in almost any location to achieve adequate compression, even though it may not penetrate into a framing member. In addition, variabilities introduced during field installation of fasteners can create conditions that result in inadequate application. For example, if the fastener or other element is not installed straight and true or is installed over-aggressively, the WRB can be damaged, which can result in water leakage, even if the fastener is driven into a framing member (*Photo 4*).

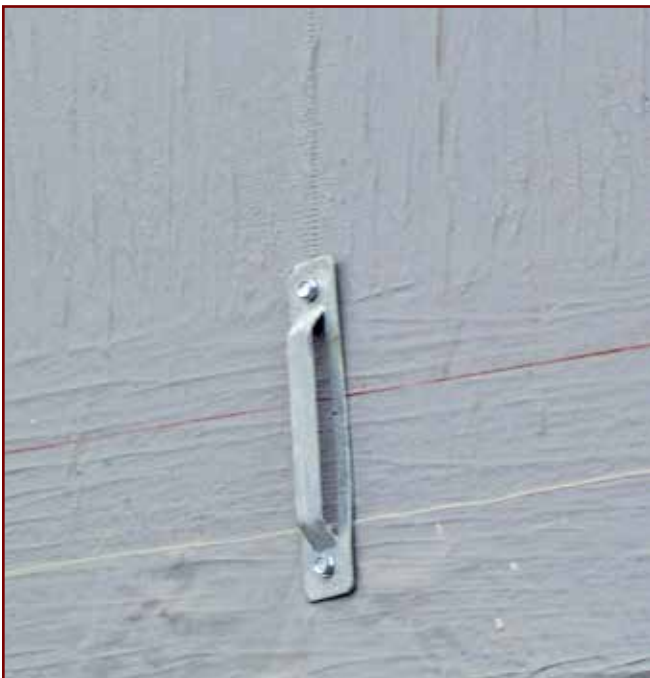
Photo 5 – Steel brick tie not conforming to substrate.

hats, and masonry ties are installed on top of the WRB, and fasteners are secured into the backup structure, the rigid steel sub-framing or steel tie typically cannot conform to uneven areas in the substrate, and the fastener cannot develop full compression against the WRB to achieve an adequate seal (*Photo 5*).

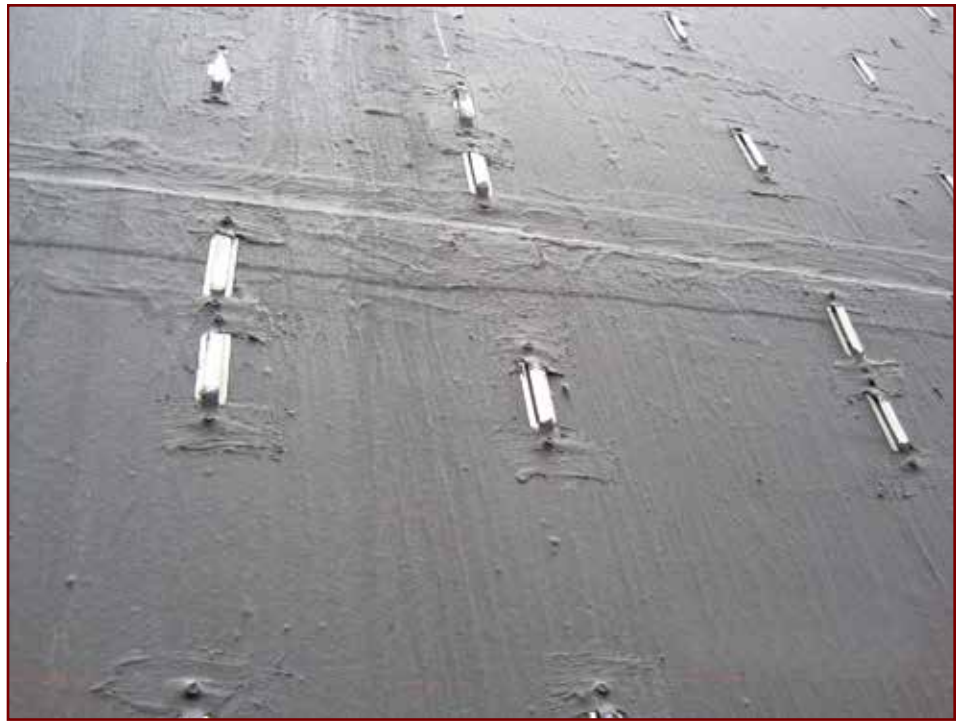
Photo 6 – Sealant applied over fastener heads securing brick ties.

seal (*Diagram 3* and *Photo 6*). Another practice could include setting the masonry tie in “wet” liquid-applied WRB when securing to the substrate.

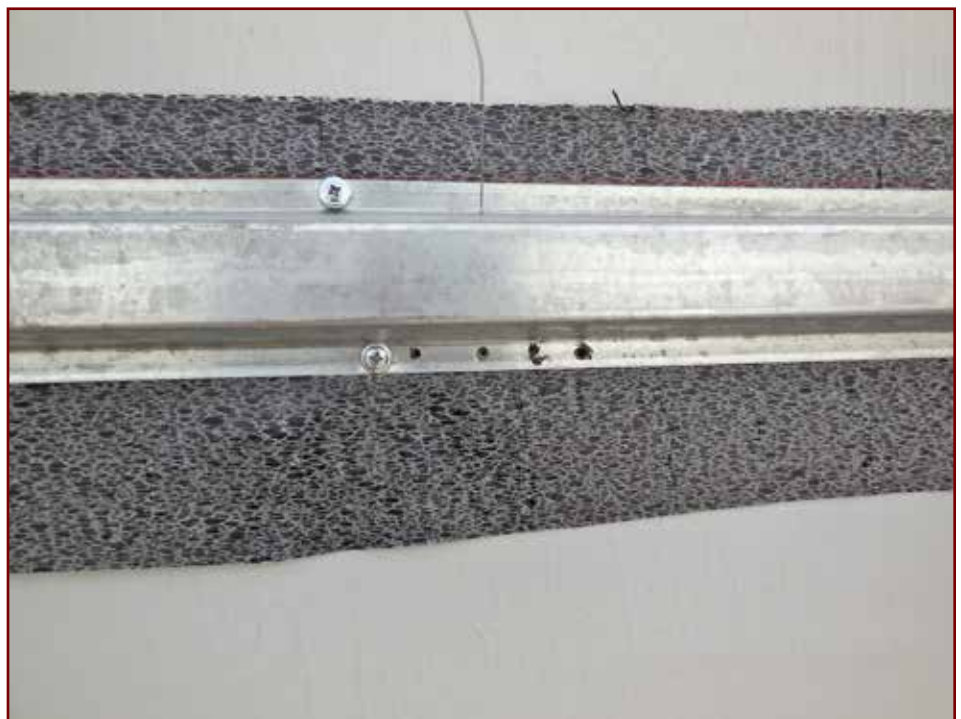
Photo 7 – Multiple fastener holes in flange of hat channel.

Once the WRB has been applied over the sheathing, screw heads used to attach the sheathing to the studs are concealed and the actual location of the stud is not readily visible or known by the installer of the cladding. Furthermore, if the actual stud placement varies from the project drawings or specified spacing due to large or excessive tolerances or construction variances, then locating the stud becomes a “hit-or-miss” target practice by the installer (*Photo 7*).

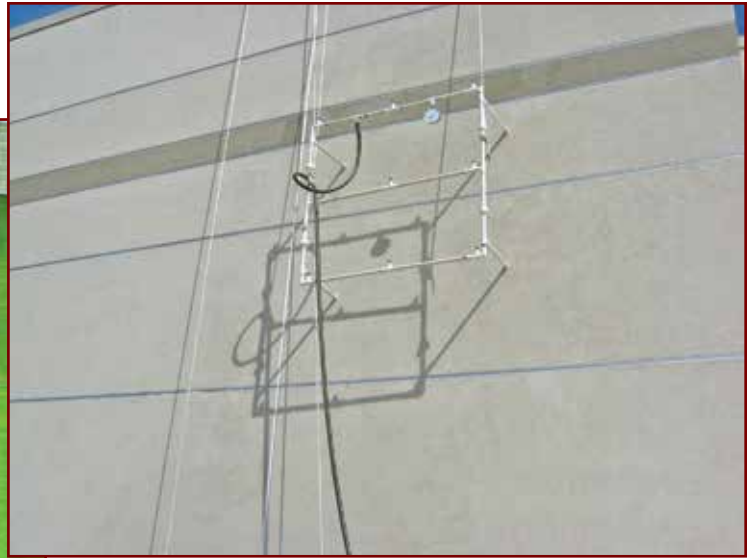
Photo 9 – Calibrated water spray rack on wall.

Water spray testing was performed by others using a calibrated water spray rack as specified in ASTM E1105, *Standard Test Method for Field Determination of Water Penetration of Installed Exterior Windows, Skylights, Doors, and Curtain Wall by Uniform or Cyclic Static Air Pressure*, on the subject exterior walls in an attempt to recreate the leakage that had recently occurred during rain events (Photo 9).

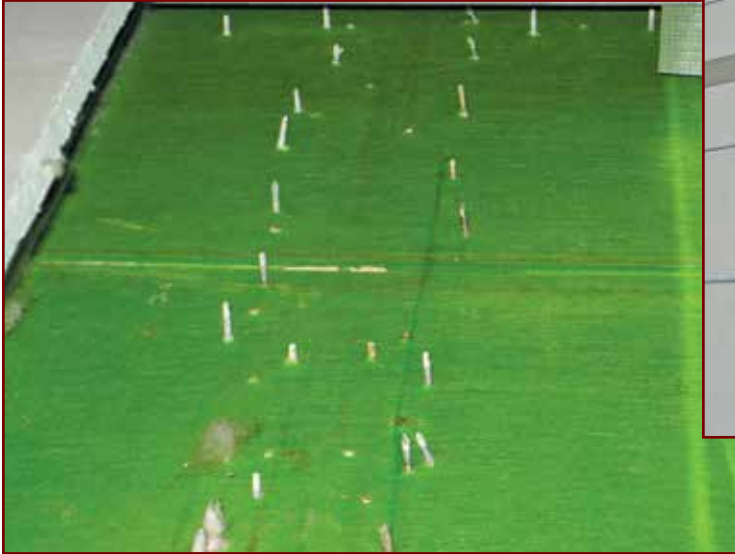
Photo 8 – Fasteners missing studs.

Upon initial visual inspection of the interior, the pointed ends of many screw fasteners were protruding through the exterior gypsum sheathing and not penetrating into any metal stud framing at numerous locations throughout the floors that did not have any interior finishes (*Photo 8*). These “missed” fasteners were typically located at

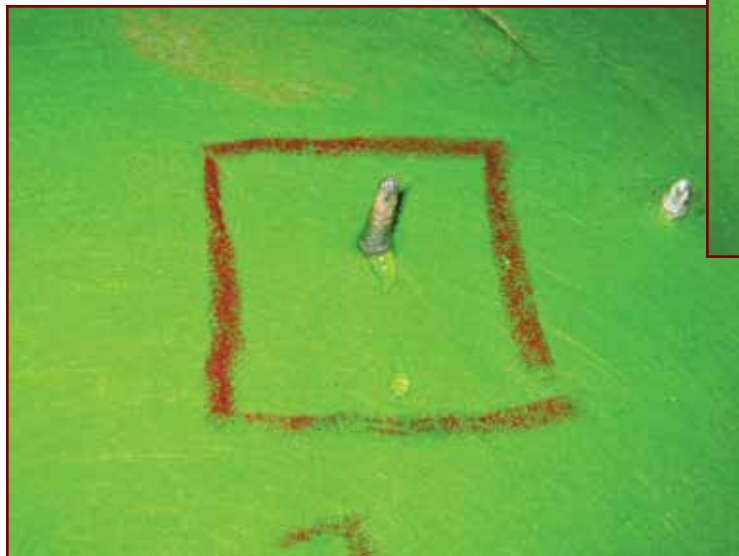
Photo 10 – Water dripping from fastener installed through gypsum sheathing.

the source, the moisture manifested itself in the building interior at the many “unsealed” fastener penetrations that were not installed into metal studs (Photo 10).

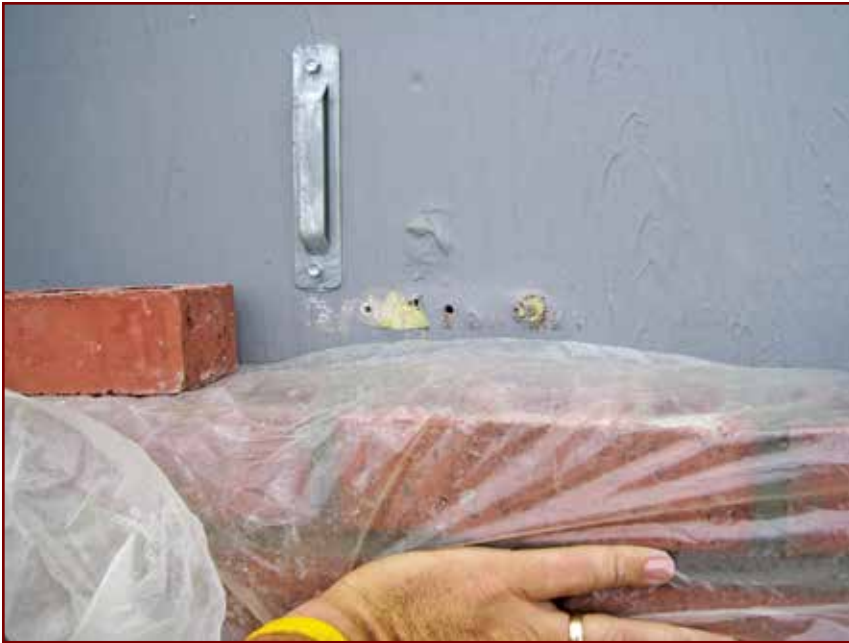
Photo 12 – Multiple holes in WRB.

In the process of performing on-site inspections for building envelope commissioning or for general project requirements, PCI has observed many of the air barrier conditions noted in this article. One of the most common issues PCI observed has been holes in the WRB due to installation and removal of fasteners and lack of a subsequent suitable repair (Photos 12 and 13).

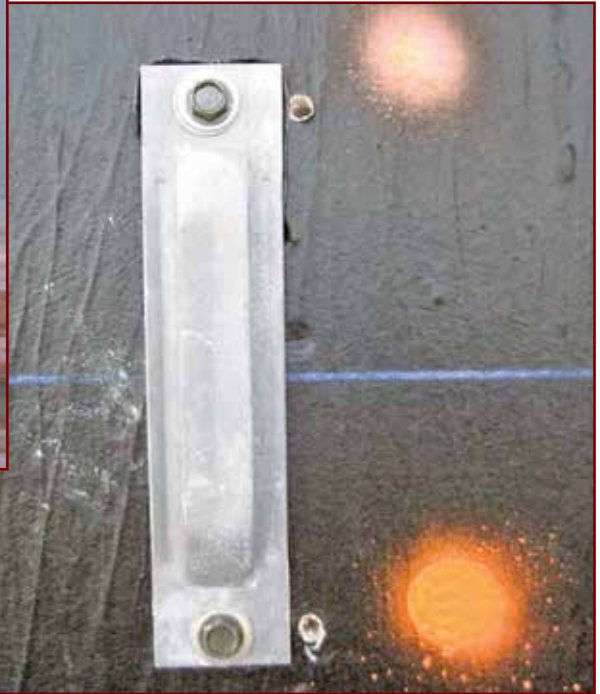
Photo 13 – Holes in WRB adjacent to brick tie.
